NPDES MSGP STORMWATER COMPLIANCE INSPECTION

MSGP Permittees: USN Naval Base Guam
(NPDES 2008 MSGP - GUR05A211)

Facilities: Apra Harbor Naval Waterfront

Dates of Inspection April 28, 2010 and May 6, 2010

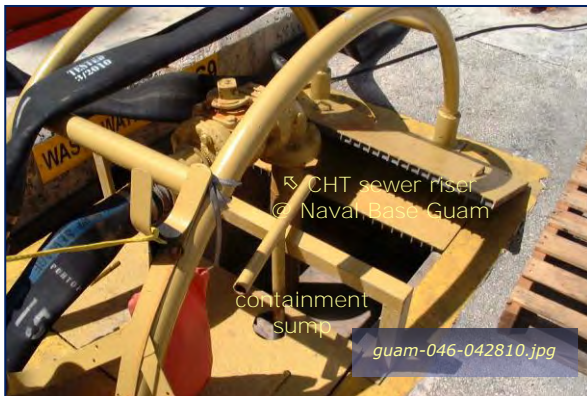
Photo #3-3: Sierra Wharf - CHT Sewer Riser
Taken By: Greg V. Arthur
Date: 04/28/10

Naval Base Guam – Navy Port Operations (through DZSP21, a base support contractor) connect and disconnect the CHT hoses to the Naval Base Guam sewer system risers including those for the tenants at the Victor and X-ray Wharves. DZSP21 uses Annex 0600 Instruction POP-I-0026 covering the CHT systems. Ships personnel connect, fresh water flush, and disconnect the hoses on and off the ship’s risers. The flush just before disconnection lasts for around 10 minutes at full pressure according to the NAVFAC MO-340 Ship-to-Shore Hose Handling Operations Manual. The CHT risers operated by the Naval Base Guam included those found to be disabled (Uniform), and functioning in good condition (Alpha, Bravo, Delta, Echo, Victor, Sierra, Tango). See Photos #3-3 and #3-4 in Section 3.4 of this report on page 15.

General Waterfront – Listed below are the effective storm water control measures (+) and ineffective, improvable, or missing control measures (-) observed during this inspection of the waterfront. See Photos #3-3 and #3-6 in Section 3.4 of this report on page 15.

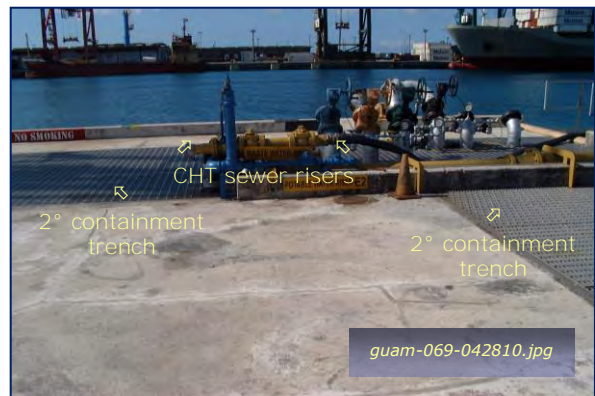
Photo #3-4: Echo Fueling Pier - CHT Sewer Riser
Taken By: Greg V. Arthur
Date: 04/28/10

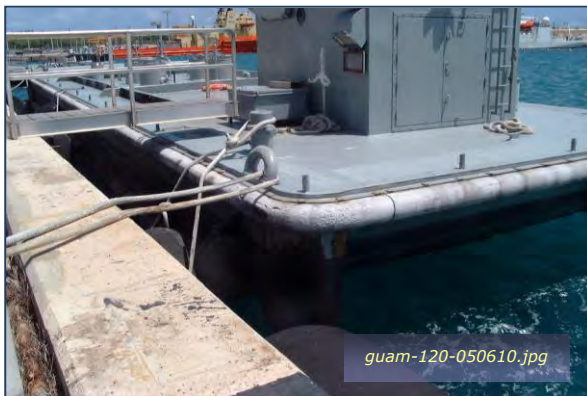
Photo #3-5: Victor Wharf - SWOB Bilge Barge
Taken By: Greg V. Arthur
Date: 05/06/10

Naval Base Guam, Point Orote – The Navy Port Operations (through DZSP21, a base support contractor) off-loads bilge water from most of the berthed ships to SWOB barges or tanker trucks, and suction out the barges and tankers to the Victor Wharf BOWTS under Annex 0600 Instruction POP-I-0015. The 55,000 gallon capacity SWOB barges are floated to the Victor Wharf to be pumped out through pump station risers on the wharf which feed by underground pipe into the BOWTS. Tanker trucks are pumped out by hose directly into the BOWTS. See Photos #3-5 and #3-6 in Section 3.4 of this report on page 15.

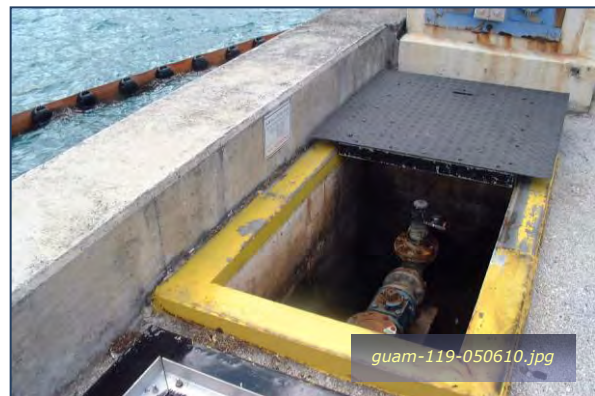
Photo #3-6: Victor Wharf - Bilge Pump Station Riser
Taken By: Greg V. Arthur
Date: 05/06/10

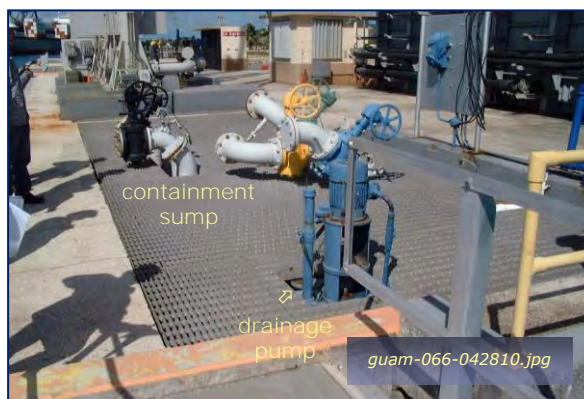
Photo #3-12: Delta Fueling Pier - Containment Sumps
Taken By: Greg V. Arthur
Date: 04/28/10

Fueling Piers – There were no fueling operations observed during the April 28th inspection of the fueling piers, fuel farm, and fuel reclamation unit. Nevertheless, a number of effective control measures were observed in-place and in operation. See Photos #3-4, #3-10, #3-12, and #3-14 in Section 3.4 of this report on pages 15, 16, and 17.

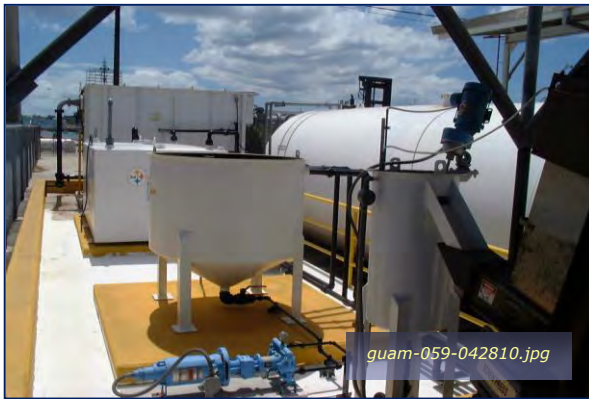
*Photo #3-13: Beta Wharf – Curbing Around BOWTS
Taken By: Greg V. Arthur
Date: 04/28/10*

Polaris Point – Submarines were observed at berth during the April 28th inspection of the Polaris Point BOWTS, but all had departed by the May 6th inspection of the waterfront. As a result, there were no waterfront activities observed during this inspection and thus no control measures were needed or deployed. See Photos #3-7, #3-13 in Section 3.4 of this report on pages 16 and 17.

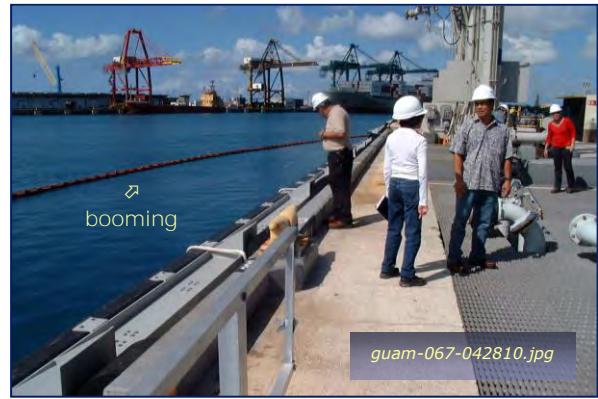
*Photo #3-14: Echo Fueling Pier – Boom Deployment
Taken By: Greg V. Arthur
Date: 04/28/10*

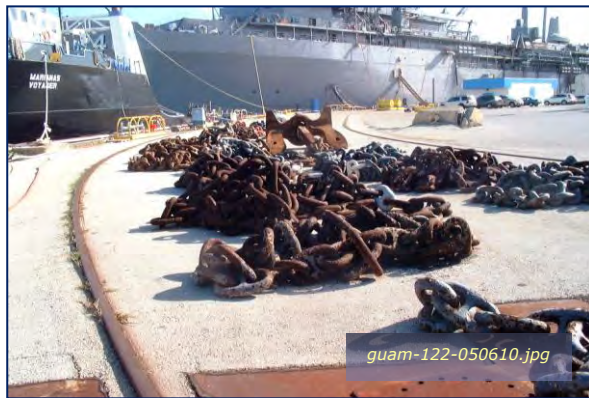
*Photo #3-15: Mike Wharf – Swale Between Rails
Taken By: Greg V. Arthur
Date: 05/06/10*

Shipyard Control Measures - The Guam Shipyard waterfront qualifies for MSGP regulation under Sector R for Ship and Boat Building and Repair. There were ships berthed at the Lima, Mike, November, and Oscar Wharves, and a floating dry dock at the Papa Wharf. Listed below are the effective storm water control measures (+) and ineffective, improvable, or missing control measures (-) observed during this inspection of the water-front. See Photos #3-11, #3-15, #3-16, #3-17 and #3-18 in Section 3.4 of this report on pages 16 and 17.

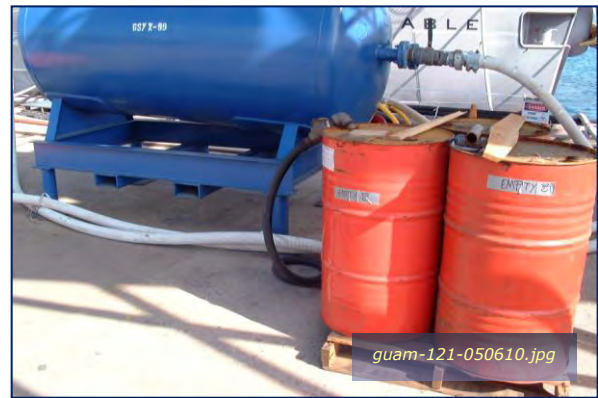
*Photo #3-16: November Wharf – Condensate Capture
Taken By: Greg V. Arthur
Date: 05/06/10*

- + Air compressor condensate is drained from the lines and collected to drums.
- + Portable bilge oily water storage tanks were deployed within secondary containment.
- Guam Shipyard does not have written operating procedures covering the CHT.
- Not all CHT ships sanitary risers were found in good condition.
- + Drain lines from the CHT riser boxes are closed when the CHT risers are in use.
- Piers scupper are not sandbagged during the transfer of bilge to tankers, or during CHT ships sanitary riser use.
- Observed fire pump and fresh water line leaks can carry contamination into the harbor through the storm water drains.

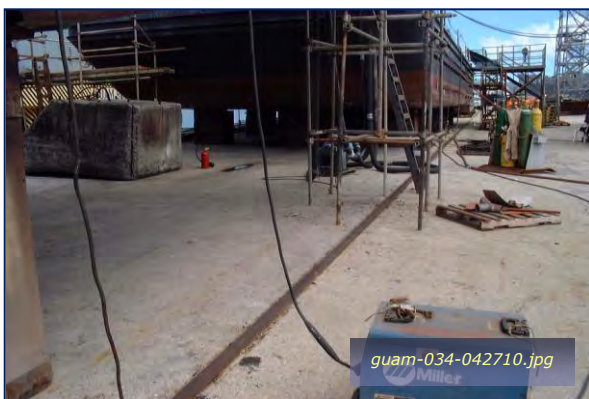
*Photo #3-17: Lima Wharf – Swept Outside Rails
Taken By: Greg V. Arthur
Date: 04/27/10*

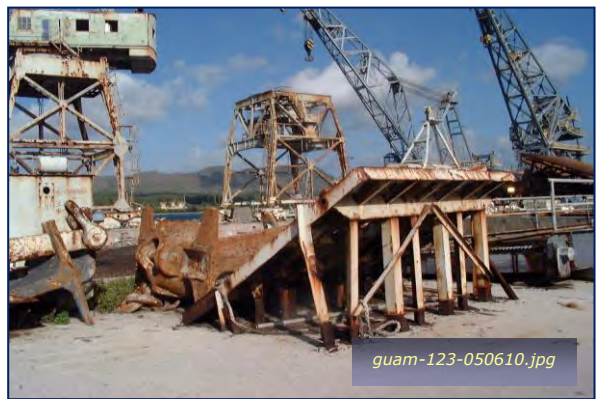
*Photo #3-18: Finger Pier – Scrapyard
Taken By: Greg V. Arthur
Date: 05/06/10*

- + The SWPPP is detailed, up to date, with the control measures well understood, and the procedures clearly described.
- + Inland storm drains are covered during ship building and repair activities.
- + Storm water drain inlets have stenciled information signs.
- + Walk-throughs are performed weekly to identify the need to deploy control measures.
- + Debris on the waterfront is swept weekly to the center point between the crane rails.
- + Spill containment kits were deployed and ready for use.
- + No oily debris, oil staining, or oil sheen on the water was observed.
- Debris haul-off is on a weekly schedule but rusty debris was found on the wharves.
- Piers scupper are not sandbagged during ship repair activities.
- Recyclable materials have remained staged for off-hauling and thus exposed to storm water contact for long periods of time.
