**Re: May 6, 2010 Storm Water Inspection**

**U.S. ENVIRONMENTAL PROTECTION AGENCY**

**NPDES MSGP STORMWATER COMPLIANCE INSPECTION**

Facilities: Apra Harbor Naval Waterfront

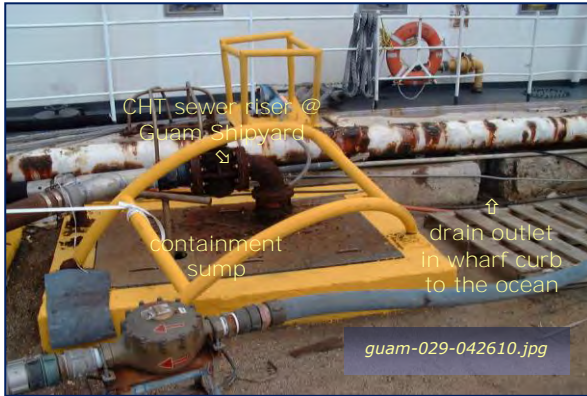
Photo #3-1: Oscar Wharf - CHT Sewer Riser  
Taken By: Greg V. Arthur  
Date: 04/26/10

Guam Shipyard – Guam Shipyard’s Pier Services Department connects and disconnects the CHT hoses on and off the shipyard sewer system risers under the lease contract with the Navy. Guam Shipyard does not have written operating procedures covering the CHT. The CHT risers operated by the Guam Shipyard included those found to be disabled (Lima), functioning in near disrepair (Oscar), and functioning in good condition (November). See Photos #3-1 and #3-2 in Section 3.4 of this report on page 15.

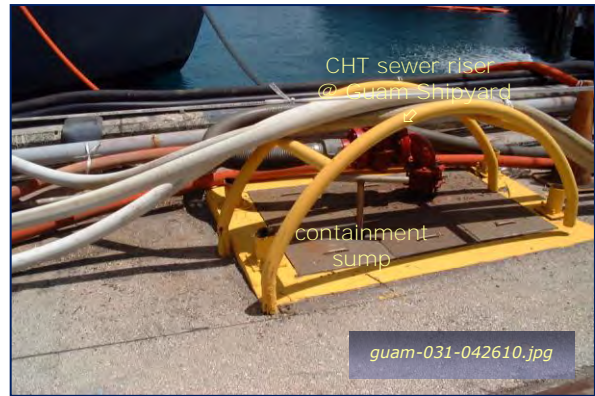
Photo #3-2: November Wharf - CHT Sewer Riser  
Taken By: Greg V. Arthur  
Date: 04/26/10

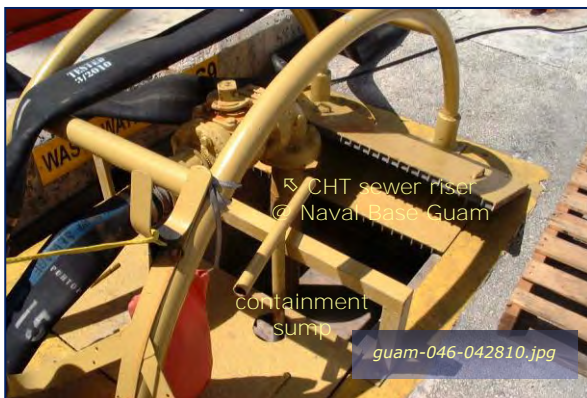
Photo #3-3: Sierra Wharf - CHT Sewer Riser  
Taken By: Greg V. Arthur  
Date: 04/28/10

Naval Base Guam – Navy Port Operations (through DZSP21, a base support contractor) connect and disconnect the CHT hoses to the Naval Base Guam sewer system risers including those for the tenants at the Victor and X-ray Wharves. DZSP21 uses Annex 0600 Instruction POP-I-0026 covering the CHT systems. Ships personnel connect, fresh water flush, and disconnect the hoses on and off the ship’s risers. The flush just before disconnection lasts for around 10 minutes at full pressure according to the NAVFAC MO-340 Ship-to-Shore Hose Handling Operations Manual. The CHT risers operated by the Naval Base Guam included those found to be disabled (Uniform), and functioning in good condition (Alpha, Bravo, Delta, Echo, Victor, Sierra, Tango). See Photos #3-3 and #3-4 in Section 3.4 of this report on page 15.

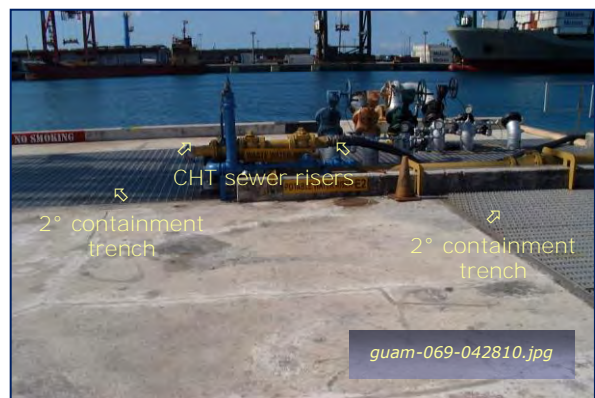
Photo #3-4: Echo Fueling Pier - CHT Sewer Riser  
Taken By: Greg V. Arthur  
Date: 04/28/10

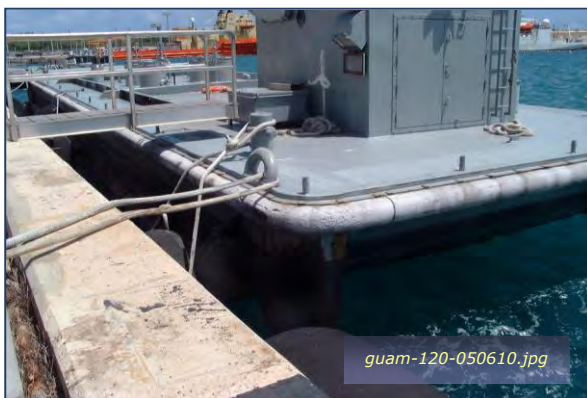
Photo #3-5: Victor Wharf - SWOB Bilge Barge  
Taken By: Greg V. Arthur  
Date: 05/06/10

Naval Base Guam, Point Orote – The Navy Port Operations (through DZSP21, a base support contractor) off-loads bilge water from most of the berthed ships to SWOB barges or tanker trucks, and suction out the barges and tankers to the Victor Wharf BOWTS under Annex 0600 Instruction POP-I-0015. The 55,000 gallon capacity SWOB barges are floated to the Victor Wharf to be pumped out through pump station risers on the wharf which feed by underground pipe into the BOWTS. Tanker trucks are pumped out by hose directly into the BOWTS. See Photos #3-5 and #3-6 in Section 3.4 of this report on page 15.

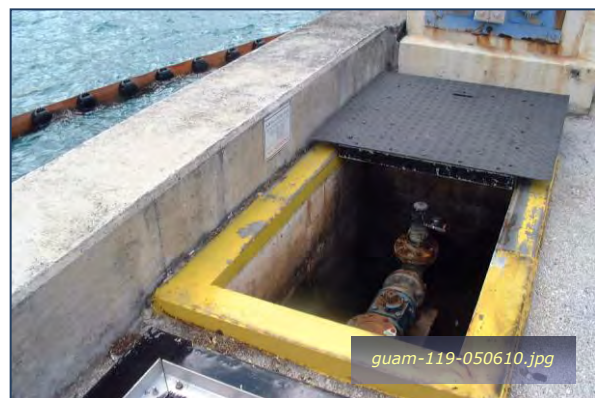
Photo #3-6: Victor Wharf - Bilge Pump Station Riser  
Taken By: Greg V. Arthur  
Date: 05/06/10

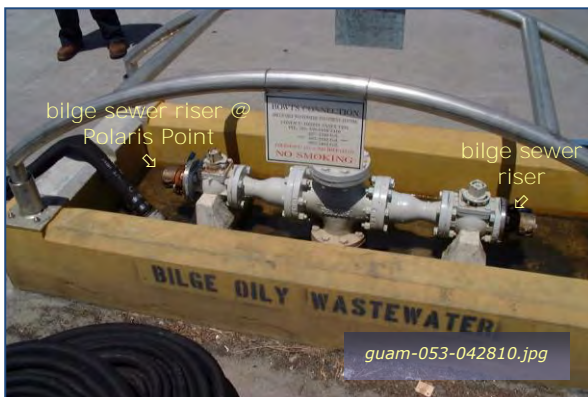
Photo #3-7: Bravo Wharf - Bilge Sewer Riser  
Taken By: Greg V. Arthur  
Date: 04/28/10

Naval Base Guam, Polaris Point – The Alpha and Bravo Wharves have parallel bilge and CHT sewers. The bilge sewers include seven riser stations that feed to the Polaris Point BOWTS. The Navy Port Operations (through DZSP21) connect and disconnect bilge hoses to the waterfront bilge risers. See Photo #3-7 in Section 3.4 of this report on page 16.

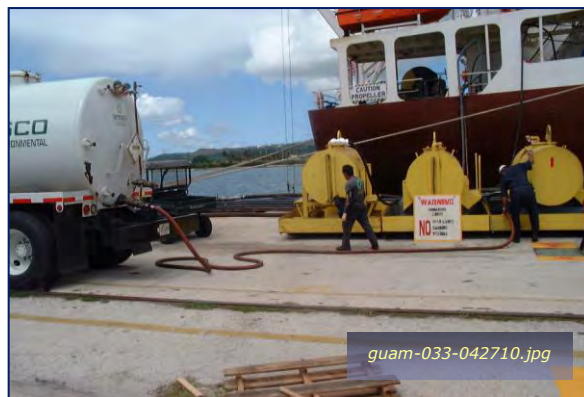
Photo #3-8: Lima Wharf - Bilge to Holding to Tanker  
Taken By: Greg V. Arthur  
Date: 04/27/10

Guam Shipyard, Papa Wharf – The Guam Shipyard’s Pier Services Department off-loads bilge from berthed or dry docked ships to truck tankers or on-shore tanks for delivery either to the Papa Wharf oil water separator or to off-site disposal by Gresco or Unitek. The Guam Shipyard SWPPP has specific BMPs for the waterfront. See Photos #3-8 and #3-9 in Section 3.4 of this report on page 16.

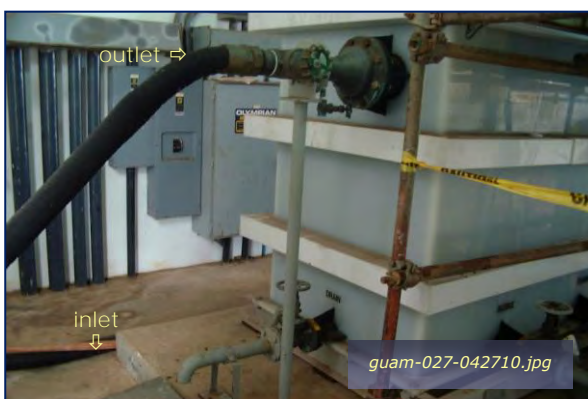
Photo #3-9: Papa Wharf - Bilge Oily Water Separator  
Taken By: Greg V. Arthur  
Date: 04/27/10

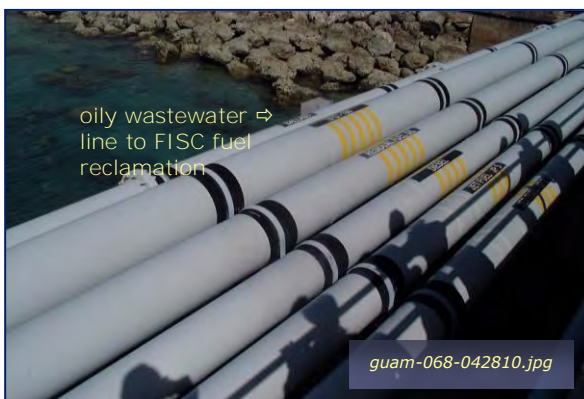
Photo #3-10: Fueling Piers - Bilge and Ballast Line  
Taken By: Greg V. Arthur  
Date: 04/28/10

Naval Base Guam, Fueling Piers – The FISC fueling piers are constructed with containment pits built into the piers and located beneath the pumps and valving used in the off- and on-loading of fuel to and from ships at berth. Drainages, captured contamination, and off-loaded bilge all are conveyed by the dedicated „ballast’ pipeline to the fuel reclamation system. The Navy Port Operations have a specific SWPPP covering the operation of the fueling piers including the handling of bilge waters and drainages, and the deployment of booming. See Photo #3-10 in Section 3.4 of this report on page 16.

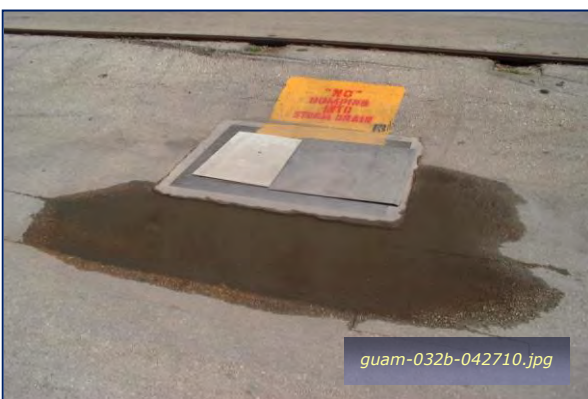
Photo #3-11: November Wharf - Covered Drain  
Taken By: Greg V. Arthur  
Date: 04/27/10

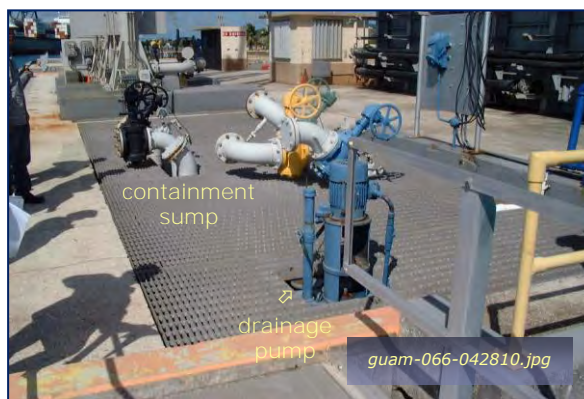
Photo #3-12: Delta Fueling Pier - Containment Sumps  
Taken By: Greg V. Arthur  
Date: 04/28/10

Fueling Piers – There were no fueling operations observed during the April 28th inspection of the fueling piers, fuel farm, and fuel reclamation unit. Nevertheless, a number of effective control measures were observed in-place and in operation. See Photos #3-4, #3-10, #3-12, and #3-14 in Section 3.4 of this report on pages 15, 16, and 17.

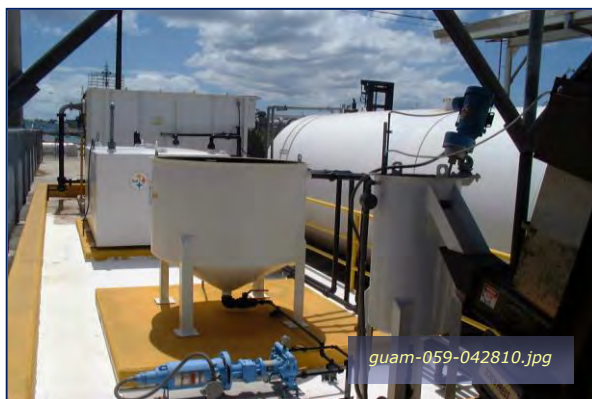
*Photo #3-13: Beta Wharf – Curbing Around BOWTS  
Taken By: Greg V. Arthur  
Date: 04/28/10*

Polaris Point – Submarines were observed at berth during the April 28th inspection of the Polaris Point BOWTS, but all had departed by the May 6th inspection of the waterfront. As a result, there were no waterfront activities observed during this inspection and thus no control measures were needed or deployed. See Photos #3-7, #3-13 in Section 3.4 of this report on pages 16 and 17.

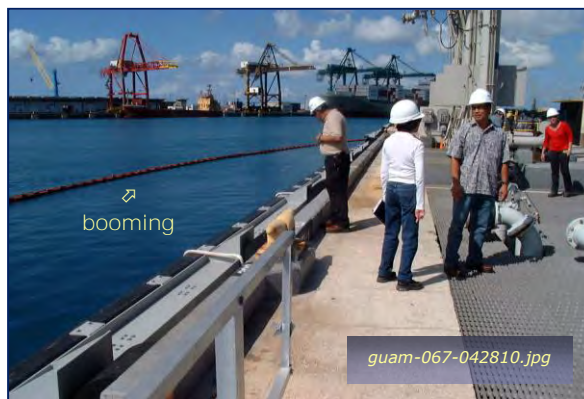
*Photo #3-14: Echo Fueling Pier – Boom Deployment  
Taken By: Greg V. Arthur  
Date: 04/28/10*

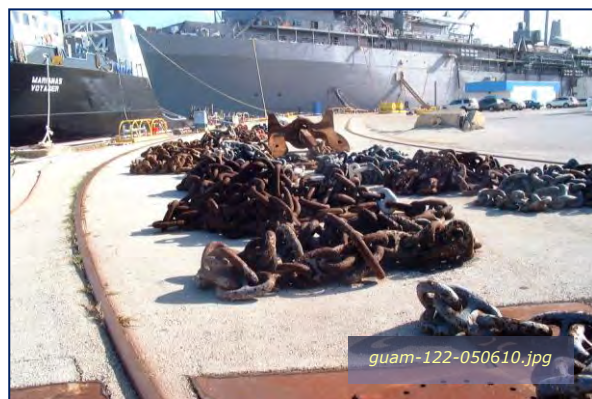
*Photo #3-15: Mike Wharf – Swale Between Rails  
Taken By: Greg V. Arthur  
Date: 05/06/10*

Shipyard Control Measures - The Guam Shipyard waterfront qualifies for MSGP regulation under Sector R for Ship and Boat Building and Repair. There were ships berthed at the Lima, Mike, November, and Oscar Wharves, and a floating dry dock at the Papa Wharf. Listed below are the effective storm water control measures (+) and ineffective, improvable, or missing control measures (-) observed during this inspection of the water-front. See Photos #3-11, #3-15, #3-16, #3-17 and #3-18 in Section 3.4 of this report on pages 16 and 17.

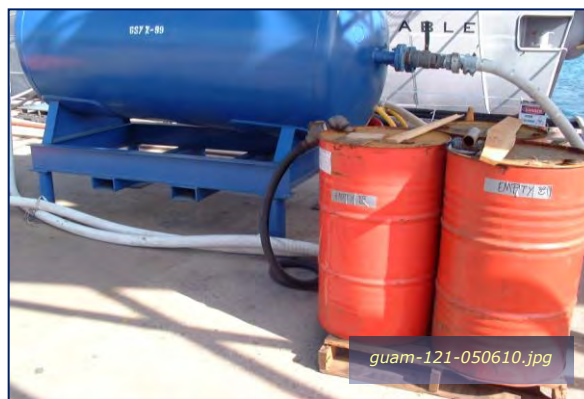
*Photo #3-16: November Wharf – Condensate Capture  
Taken By: Greg V. Arthur  
Date: 05/06/10*

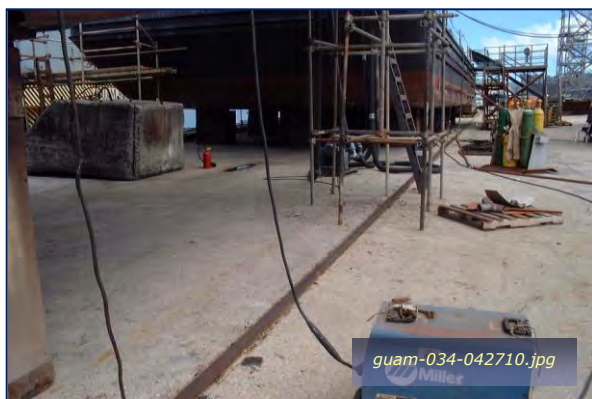
*Photo #3-17: Lima Wharf – Swept Outside Rails  
Taken By: Greg V. Arthur  
Date: 04/27/10*

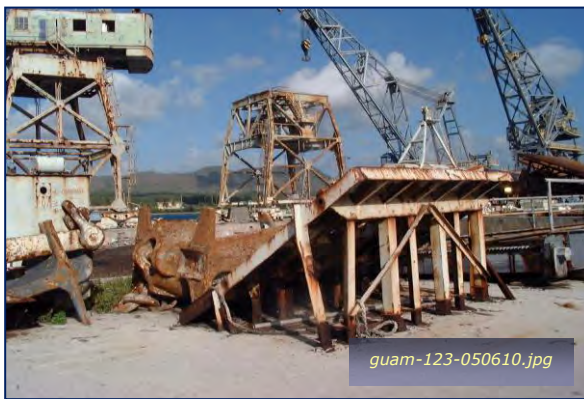
*Photo #3-18: Finger Pier – Scrapyard  
Taken By: Greg V. Arthur  
Date: 05/06/10*
