Sausalito – Marin City Sanitary District (NPDES No. CA 0038067)
Wastewater Treatment Plant Inspection
US EPA and San Francisco Regional Water Quality Control Board
Date of Inspection: Wednesday, March 21, 2007

Inspection team: JoAnn Cola, EPA
Andrew Sallach, EPA
Myriam Zech, Regional Water Quality Control Board

Report prepared by: JoAnn Cola Date prepared: 5/31/07

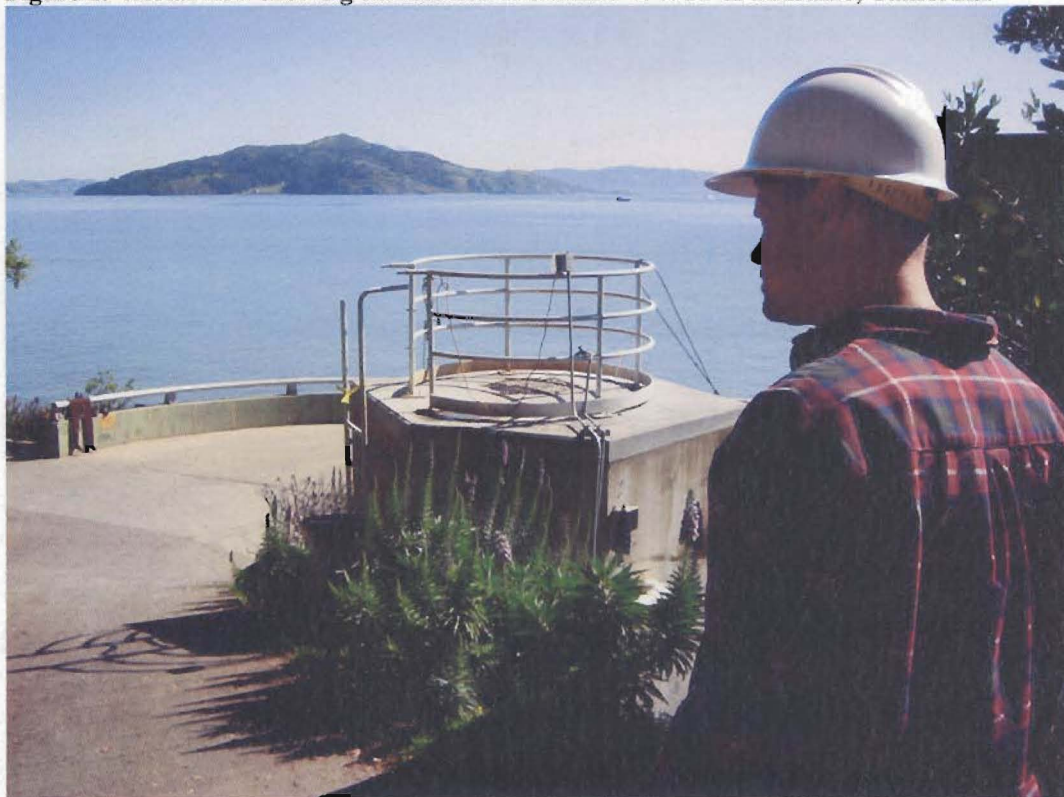
Figure 2: Energy dissipation box

Influent flow is measured at each of the two pump stations (Main St. and NPS) and enters the plant at an energy dissipation box (Fig. 2). Influent sampling occurs at the Main St. pump station, from which 97% of flow enters. The remaining 3% of the influent flow enters from Ft. Baker (NPS). The total influent flow metering capacity at the two pump stations, according to the CH2M Hill report, is 10.4 MGD. The inspection team was told that the instantaneous wet weather flow probably exceeds this. This may mean that SMCSD does not accurately measure influent flow rates when wet weather peaks exceed 10.4 MGD.

One of the most remarkable features of this plant is the absence of a headworks. Influent flow is not screened prior to entering the primary clarifier. Without a headworks, debris enters the primary clarifier, reducing its efficiency. In addition, the debris appears to be carried on to the Fixed Film Reactors, effectively reducing the efficiency of the secondary treatment.

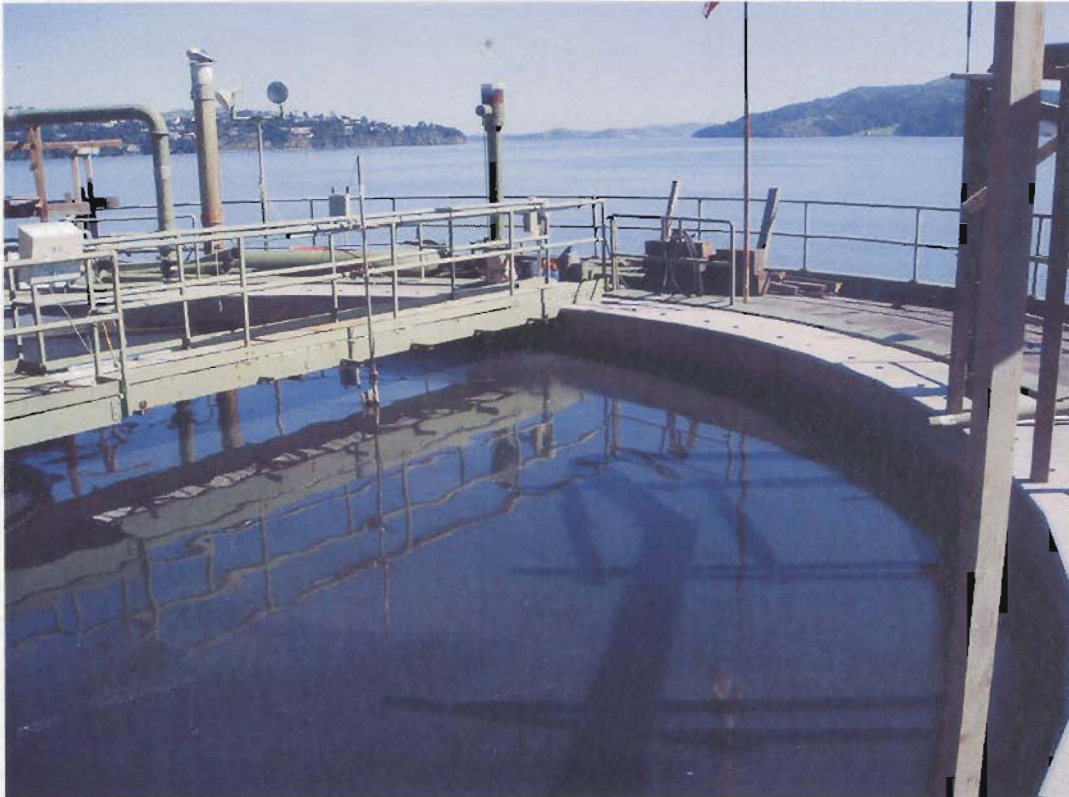
Figure 3: Primary clarifier. Note covered weir.

Flow from the energy dissipation box enters the primary clarifier (Fig. 3), along with plant return flows. The primary clarifier weir is covered and the covers must be removed prior to cleaning or maintenance of the weirs, which seems to significantly add to the complexity of routine maintenance. Without preliminary screening, the need for cleaning

and routine maintenance would seem to be increased. Mr. Simmons did not recall how frequently the clarifier was maintained. Because there is only one primary clarifier, it must be taken off-line to perform certain routine maintenance procedures. During such procedures, primary clarification is bypassed, routing the flow to one of the secondary clarifiers, which serves temporarily as primary clarification. When this occurs, capacity of secondary clarification is reduced, which could adversely affect removal of BOD and TSS.

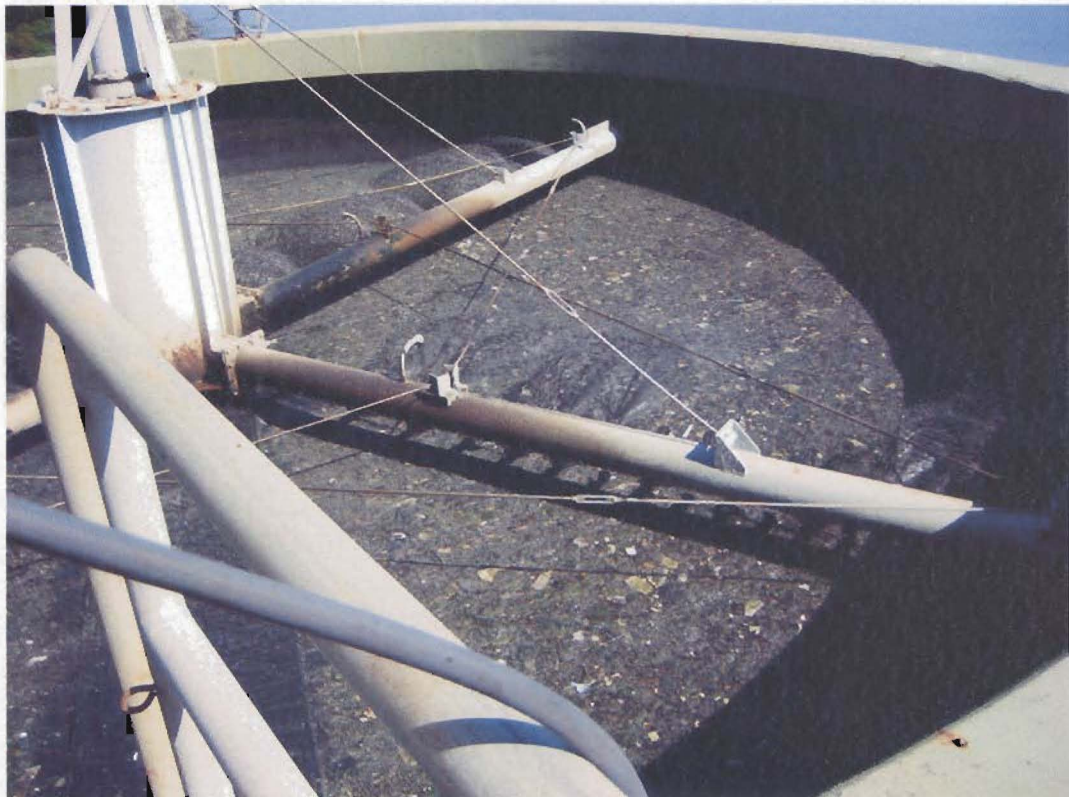
Figure 4: FFR #2. Note extensive debris on screen and debris-clogged nozzles.

Primary clarifier effluent is normally passed through a grit screen, but capacity is limited and the screen is bypassed at higher flows. Primary clarifier effluent not passing through the grit screen would enter the FFRs containing an excess amount of debris, potentially clogging the FFRs. Primary clarifier effluent enters one of two fixed film reactors (FFRs), which operate in parallel and can handle a total of up to 6 MGD. When 6 MGD capacity of the FFRs is exceeded, the excess flow bypasses the FFRs. According to Bob Simmons, this occurs approximately 7 times per year. FFRs operate in counter-current mode. Distributors spray primary clarifier effluent in at the top of the reactor, while air is blown upward from the bottom. The FFRs are not covered. Mr. Simmons said it was suggested to the District by CH2M Hill that co-current operation with both water and air entering from the top of the unit may result in improved odor control. Inspectors noted significant debris on the screen at the top of each fixed film reactor, which was likely due to the absence of a headworks to provide preliminary screening. Such a layer of debris could cause poor performance of the reactor.

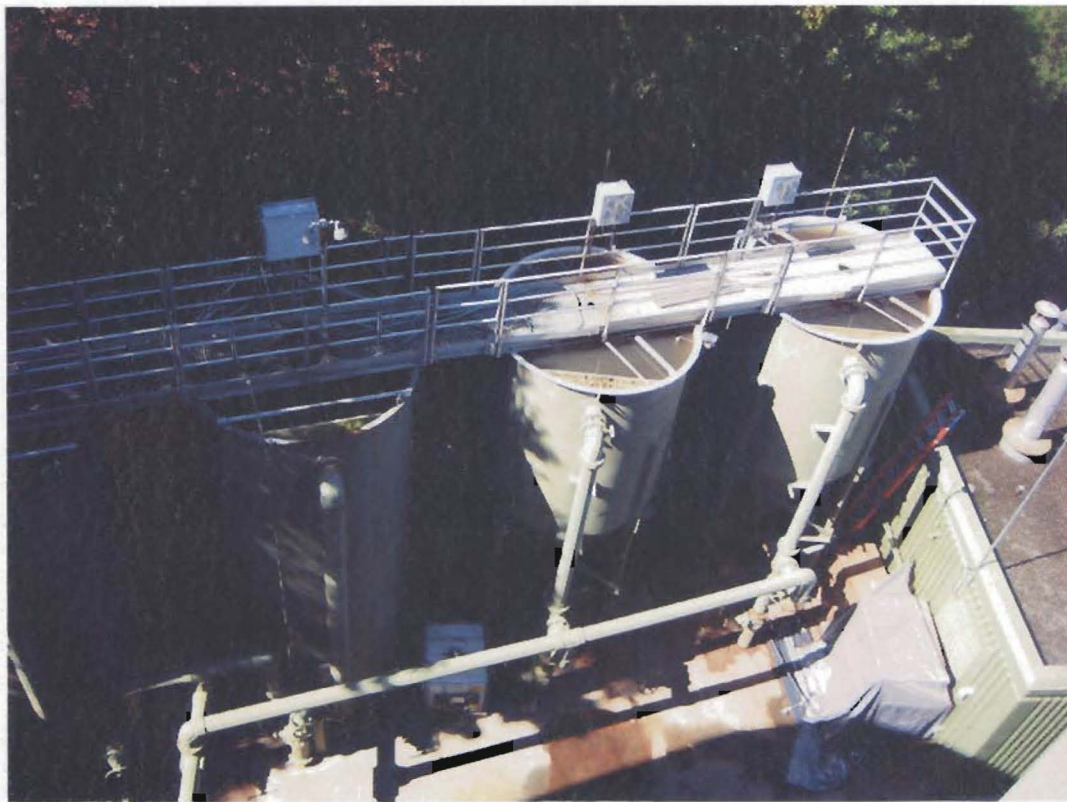
Figure 6: Sand filters. Photo taken from top of FFRs.

Effluent from the secondary clarifiers is then passed through sand filters (Fig. 6) for additional removal of suspended solids. The sand filters are limited to 1.5 MGD. Flow over 1.5 MGD bypasses the sand filters. This would occur during peak diurnal flow periods. The purpose of the sand filters is to remove suspended solids remaining after secondary treatment. When flow bypasses these units, more suspended solids remain in the final effluent. The sand filters are self-cleaning and the filter backwash is returned to the primary clarifier.

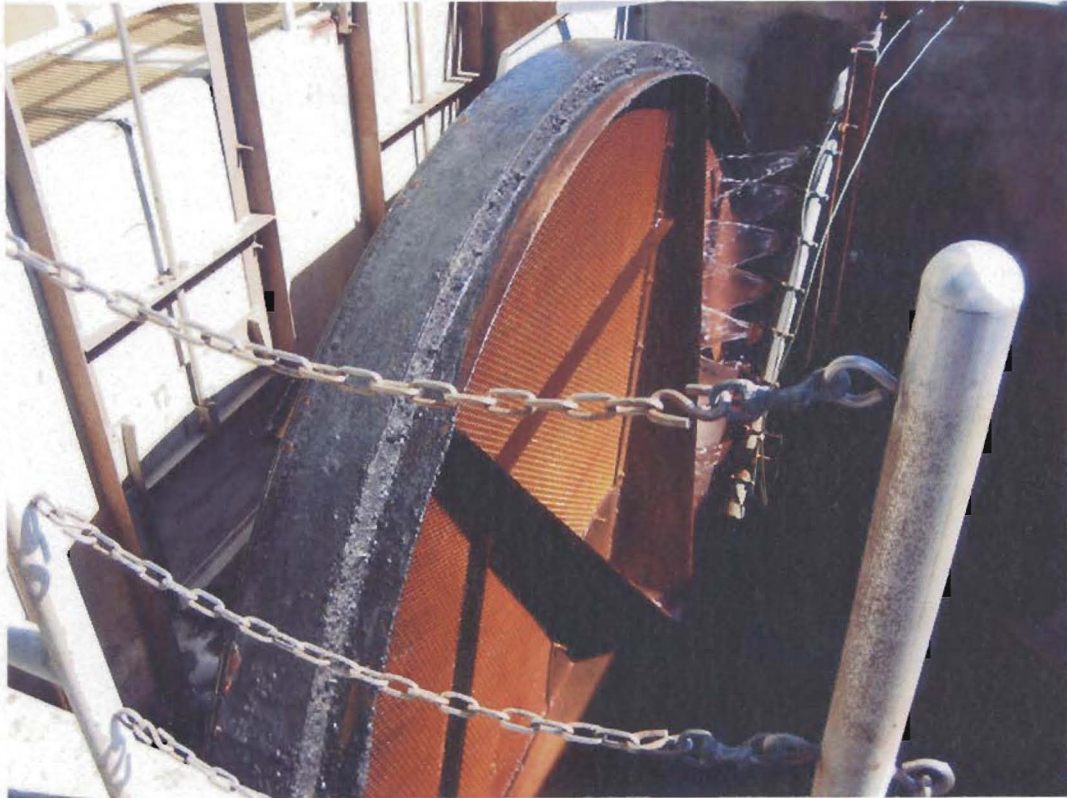
Figure 7: Secondary effluent passes through rotating screen.

The effluent from the sand filters passes through a rotating screen (Fig. 7) and from there to the chlorine contact chamber which is also located underneath the FFRs (Fig. 9).

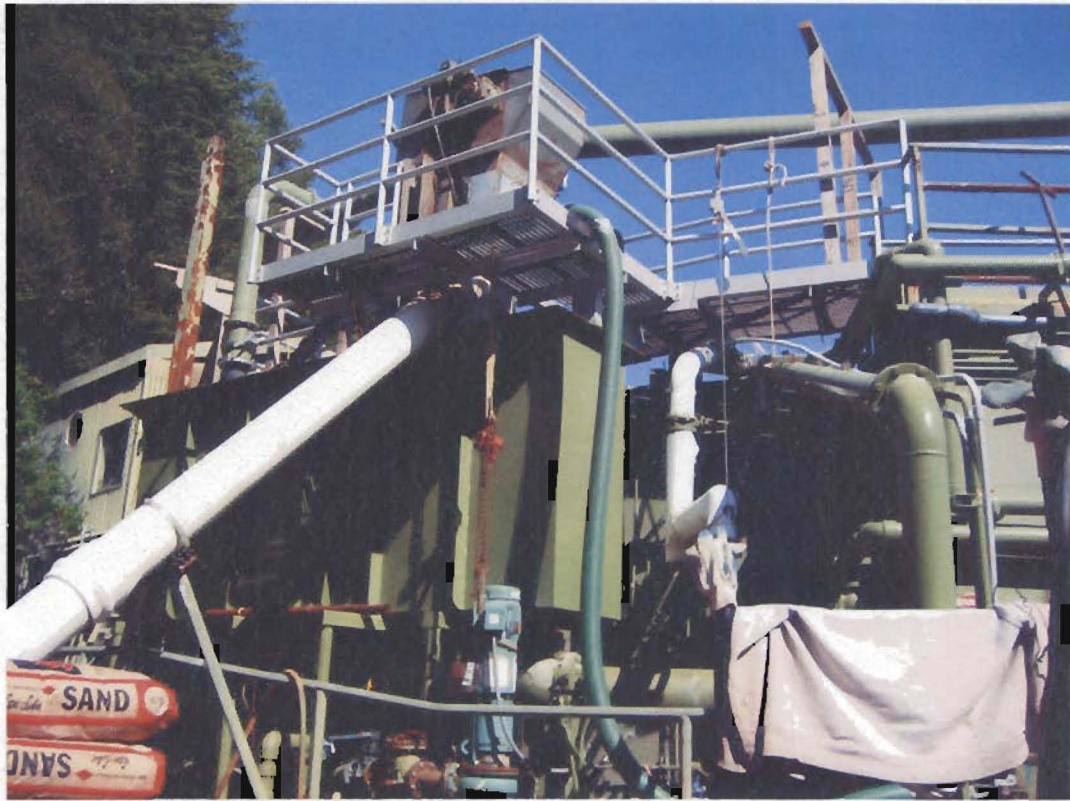
Figure 11: Grit removal at primary clarifier.

Solids removed from the primary clarifier are screened for grit (Fig. 11) prior to entering the sludge thickening tank (Fig. 12). The thickened sludge enters the digester, located under the primary clarifier (Fig. 13). The digester is 14 feet deep, with most of it below the level of the Bay. Supernatant from the digester is returned to the primary clarifier. Dewatered biosolids are sent to the Redwood Landfill.

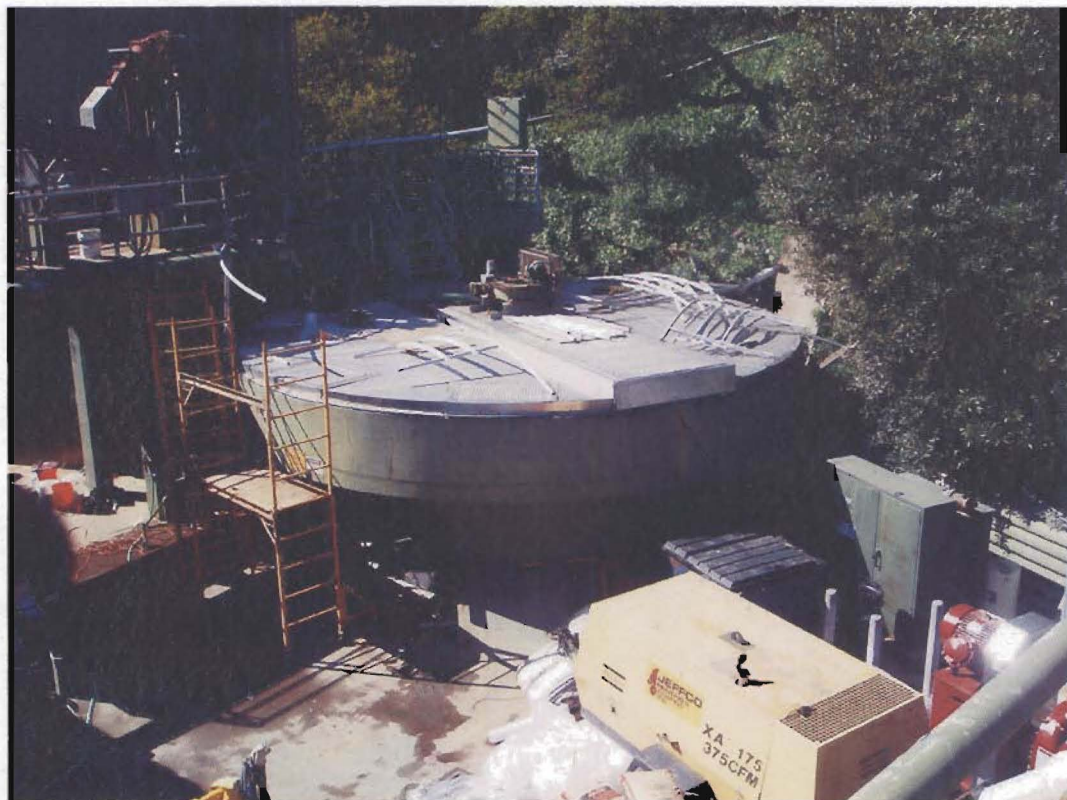
Figure 12: Gravity thickener tank.

Primary and secondary sludge is thickened prior to entering the digesters. The sludge in the gravity thickeners does not settle well, which results in high solids levels in waste streams generated by the sludge processes. These include overflow from the thickeners and sludge belt press filtrate. According to CH2M Hill's audit report, SMCS D must "get control" of its recycle streams to improve settling of solids. Currently the thickener overflow and belt press filtrate are routed to the primary clarifier. CH2M Hill's recommendation is to route these streams to the influent channel and treat the total influent with chemical addition.
