Environmental Technology Verification Report

Stormwater Source Area
Treatment Device

Stormwater Management, Inc.
StormScreen[®] Treatment System

April 2005

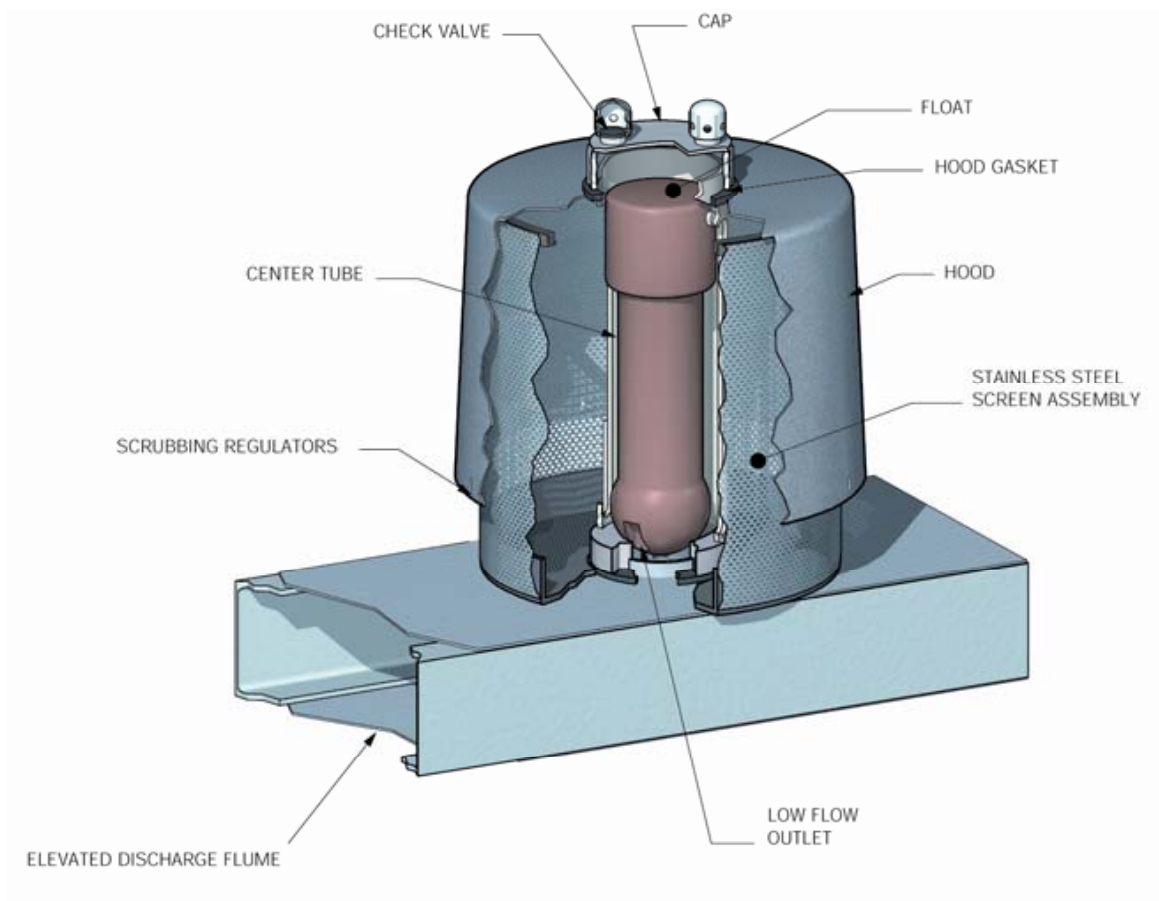
The StormScreen’s screening process works by passing stormwater through 22 gage stainless steel screens having 2.4 mm pore openings and 42 pores per square inch. Each cartridge has a surface area of 7.5 square feet. A diagram identifying the cartridge screen components is shown in Figure 2-3.

Stormwater enters the cartridge bay through the flow spreader, where it ponds. Air in the cartridge is displaced by the water and purged from within the cartridge hood through the one-way check valve located on top of the cap. The water infiltrates through the screen assembly and into the center tube. Once the center tube fills with water, a float valve opens and the water in the center tube flows into the under-drain manifold, located beneath the cartridge. This causes the check valve to close, initiating a siphon that draws stormwater through the cartridge and screen. The siphon continues until the water surface elevation drops to the elevation of the hood’s scrubbing regulators. When the water drains, the float valve closes and the system resets.

Figure 2-3. StormScreen cartridge.

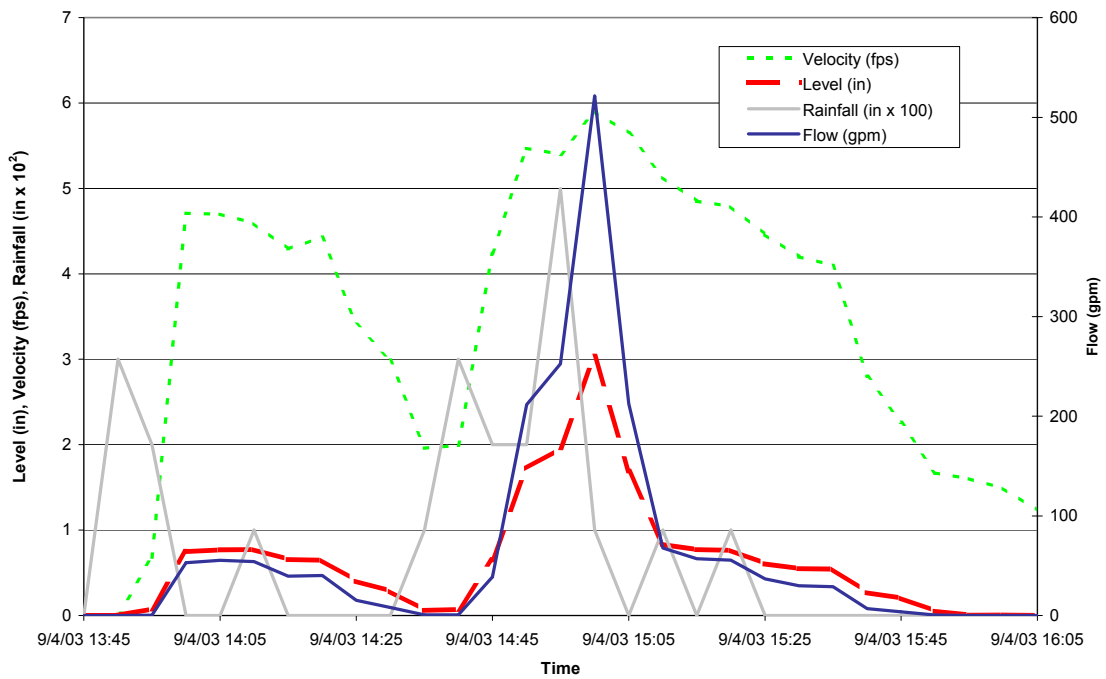
Figure 5-2. Inlet and StormScreen outlet hydrographs, September 4, 2003.

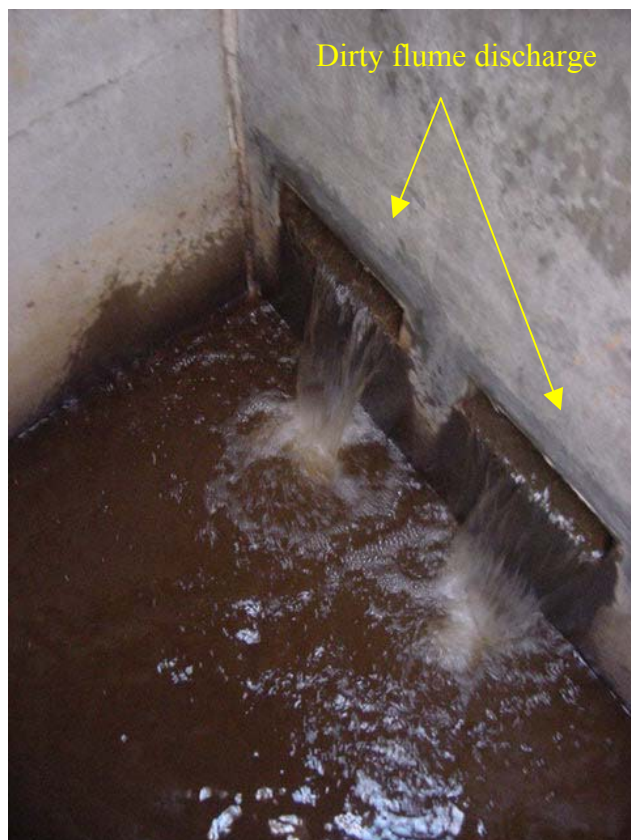
This short test suggests that a clean system could discharge at least 0.8 cfs per flume or 3.2 cfs for the four-flume system used in the verification test, versus the maximum flowrate of 1.3 cfs

(a) Flumes at trickle flow
(approximately 0.08 cfs each)

(b) Cleaned flume discharging at
approximately 0.8 cfs

Figure 5-4. Photographs from flow test.

With permission from the city, PCG personnel attached a fire hose to a nearby hydrant, which was used to fill the StormScreen vault with water. The manhole covers were removed to observe the water in the vault. As the water elevation in the vault crested the discharge flumes, a baseline trickle flow passed through all four flumes. The area-velocity flow probe recorded this flow at 0.31 cfs (140 gpm), which was consistent with the background flowrate noted during most of the verified storm events.

The City of Griffin instructed PCG to shut off hydrant flow with between two and three inches left to reach design water elevation in the vault. As the water level in the vault dropped, the head differential within the cartridges with the cleaned screens caused the floats in the cartridges to rise, and a brief period of high flow occurred, peaking at 1.12 cfs (500 gpm) and lasting approximately 10 seconds. Unfortunately, the data storage interval of the flow monitor was set too high to register this peak in the hydrograph; however, the vendor photographed the high-flow discharge, shown in Figure 5-4. Because the driving head across the system never achieved design capacity, this test could not conclusively prove that the StormScreen could discharge at design flow. The observed peak and attached photos do, however, indicate that when the screens were cleared of debris, they were capable of discharging more water than the flows measured throughout the testing period.

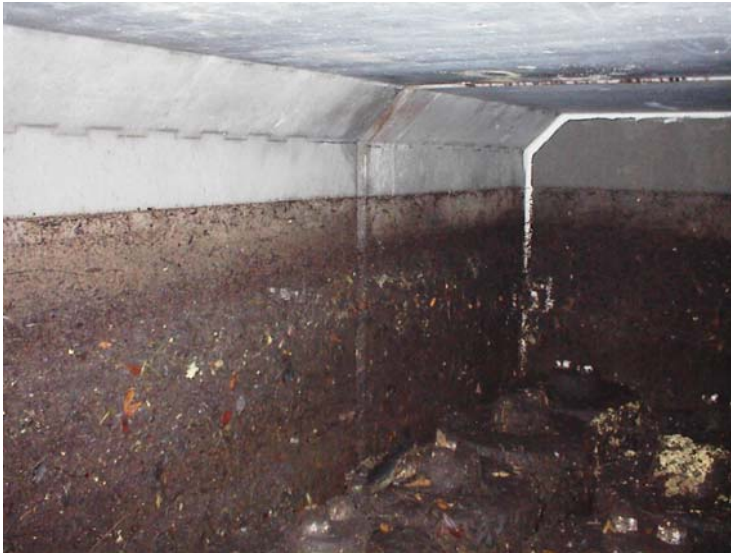
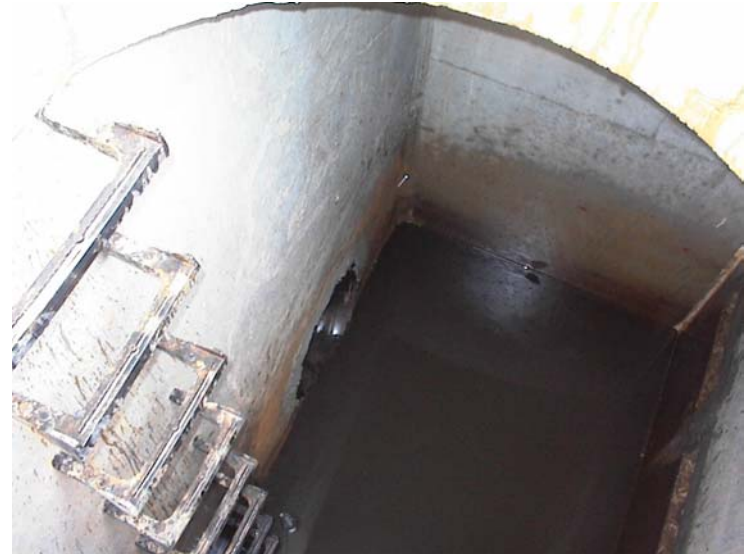
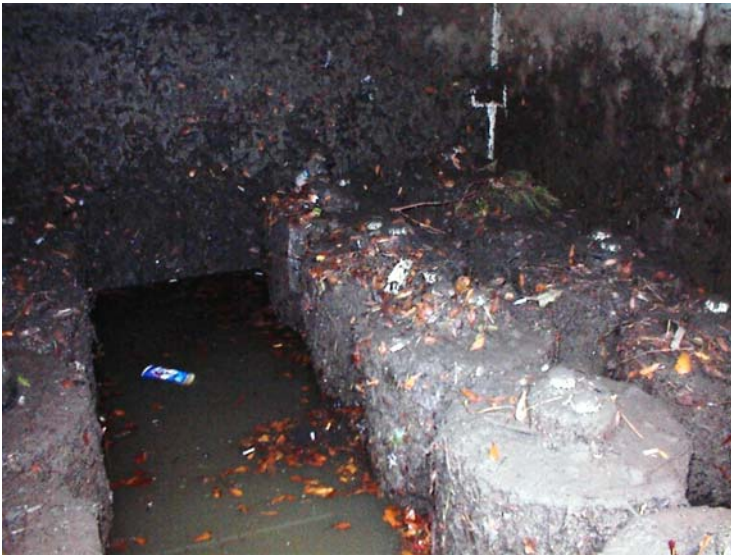
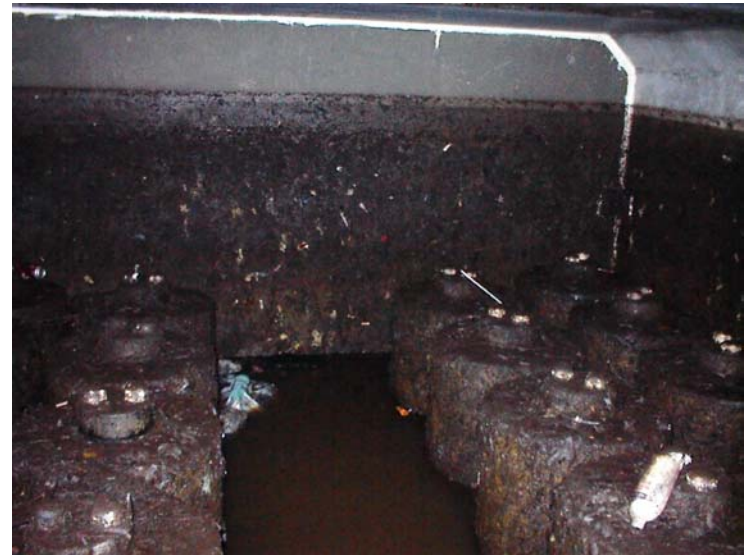
Figure 5-6. StormScreen photographs, May through August 2003.

(a) StormScreen vault, June 4, 2003

(b) StormScreen outlet bay, June 4, 2003

(c) StormScreen vault, August 12, 2003

(d) StormScreen vault, May 22, 2003

In addition to the observation forms presented for all events, Appendix E includes photographs taken from each event. Field observations and photographs indicate StormScreen performed in accordance with the claim that it can remove trash, debris, and some large solids. There was no direct physical inspection performed of the screen condition under the hoods during the verification test, only visual inspection from the surface. Trash, debris, and solids were noted after all events, while the effluent bay was clear of trash and debris and only showed a slight buildup of sediment.

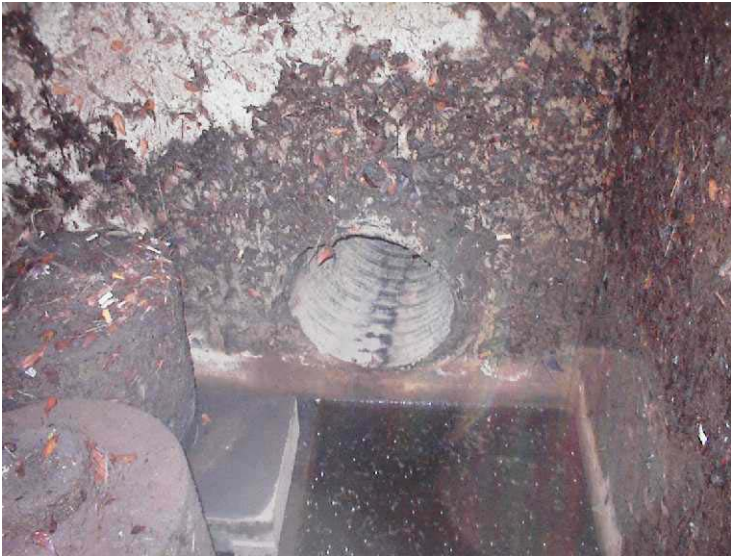
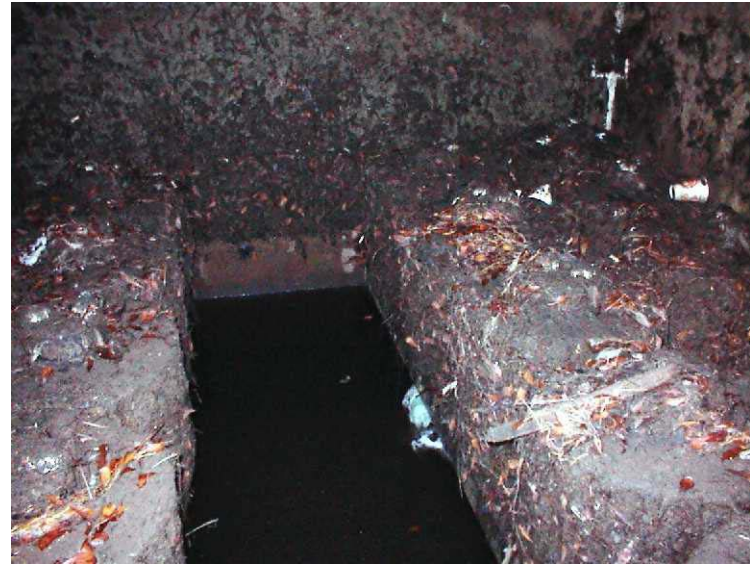
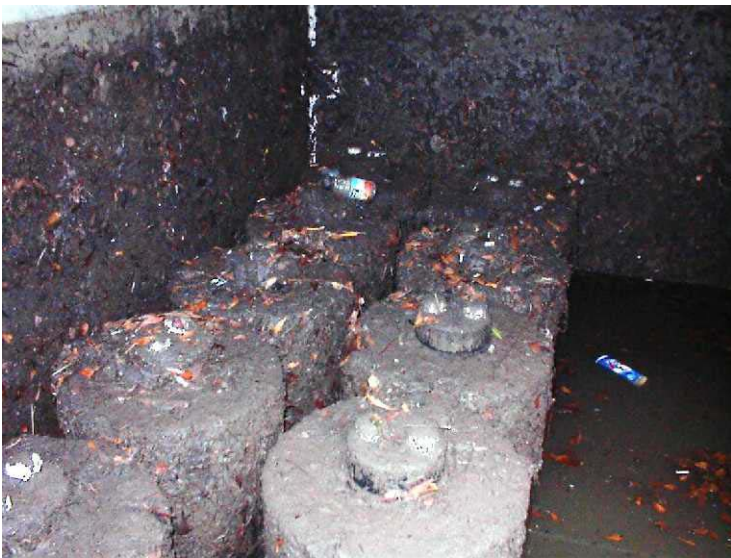
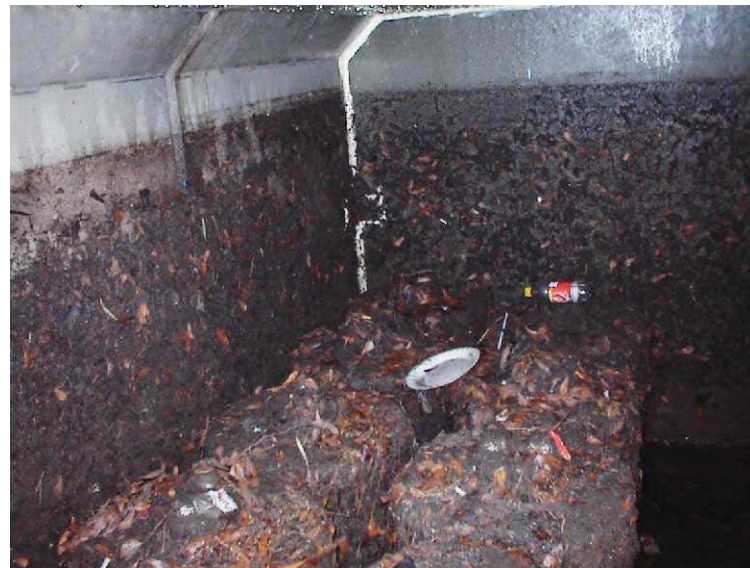
Figure 5-7. StormScreen photographs, August through September 2003.

(a) StormScreen inlet, September 4, 2003

(b) StormScreen vault, September 4, 2003

(c) StormScreen vault, August 12, 2003

(d) StormScreen vault, September 24, 2003

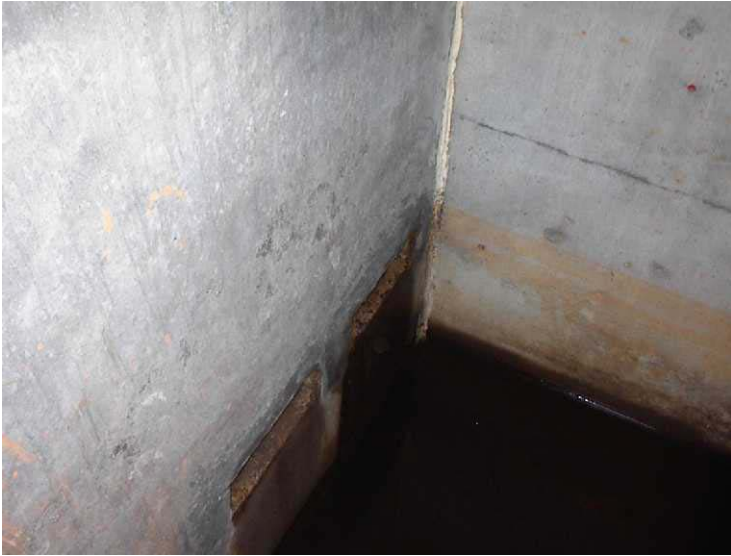
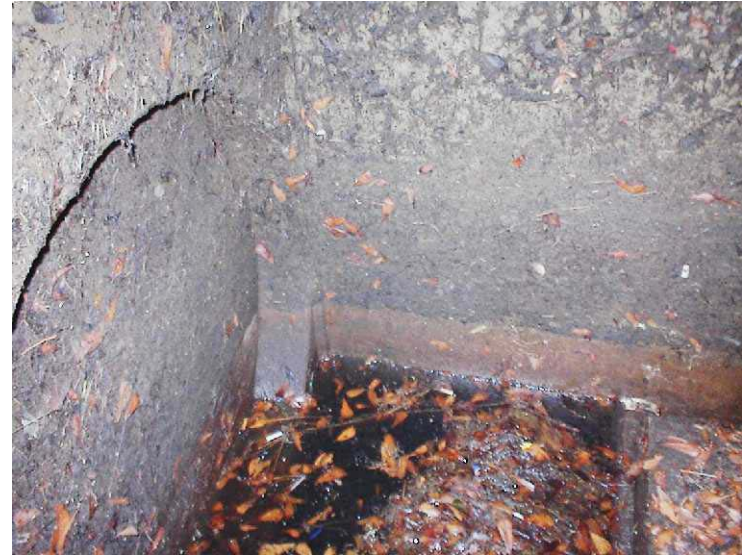
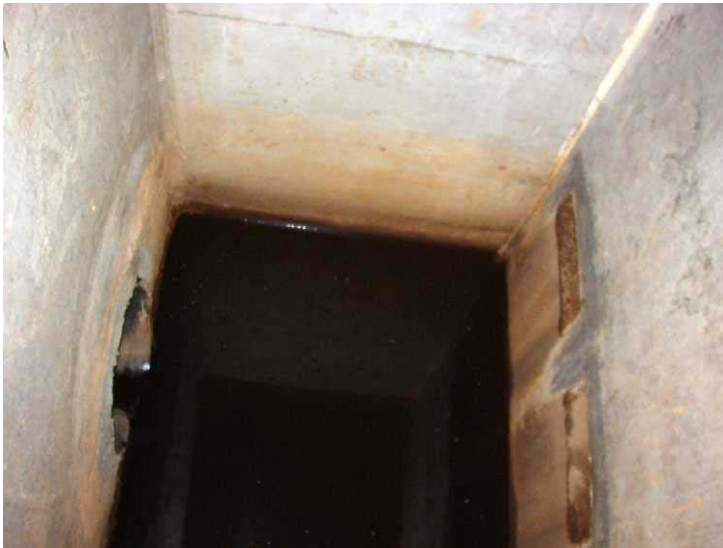
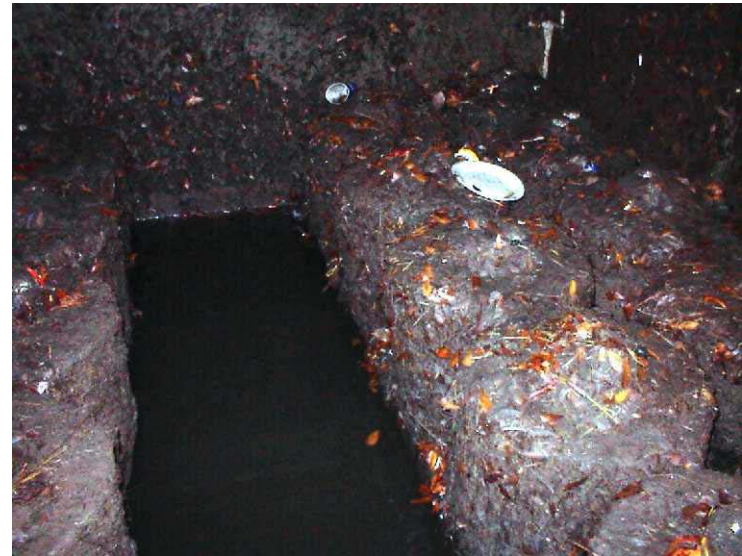
Figure 5-8. StormScreen photographs, September through October 2003.

(a) StormScreen outlet bay, September 24, 2003

(b) StormScreen vault, September 24, 2003

(c) StormScreen outlet bay, October 26, 2003

(d) StormScreen vault, October 8, 2003

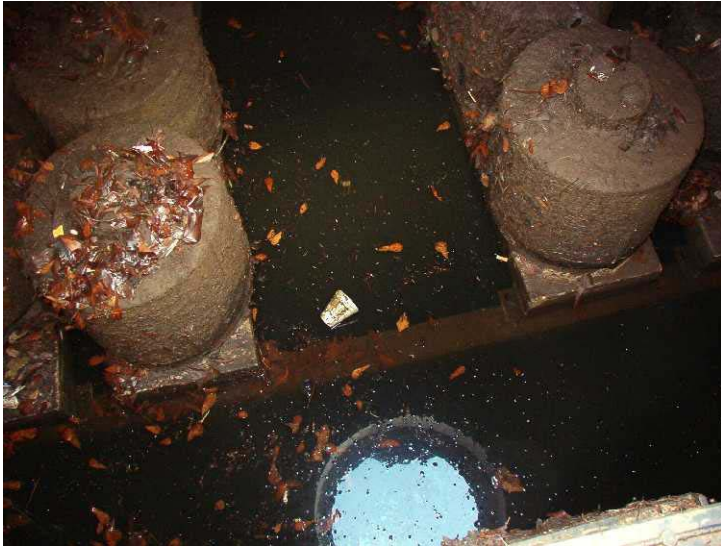
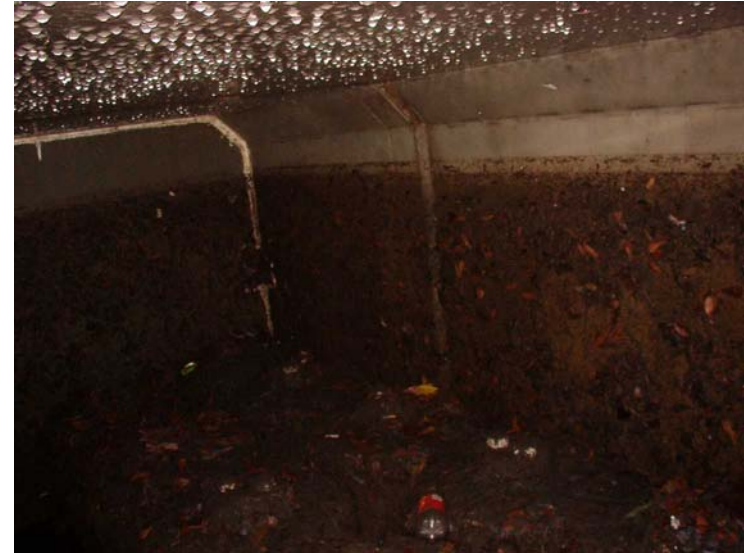
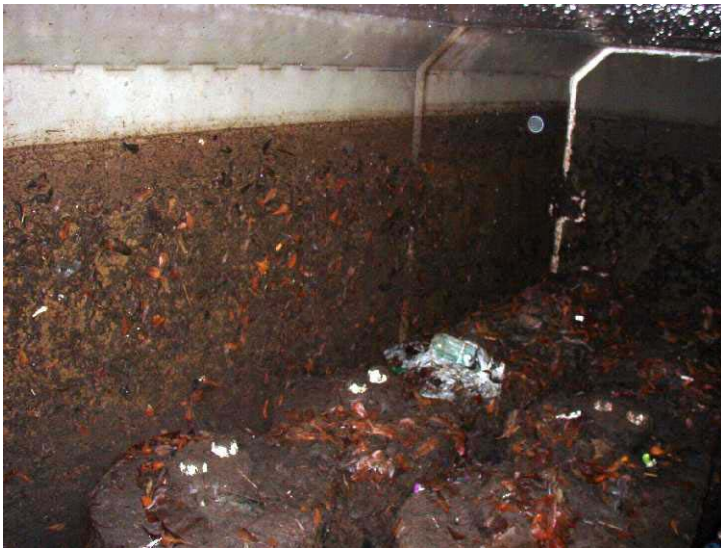
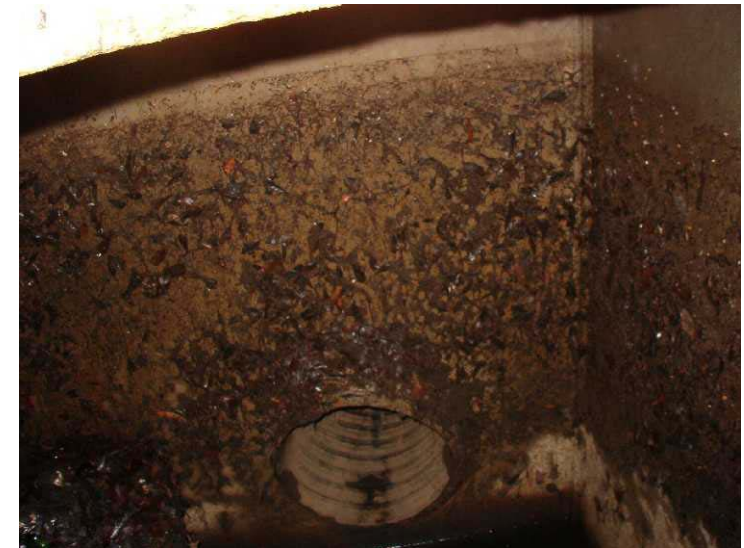
Figure 5-9. StormScreen photographs, November 2003.

(a) StormScreen vault, November 5, 2003

(b) StormScreen vault, November 5, 2003

(c) StormScreen vault, November 5, 2003

(d) StormScreen vault, November 5, 2003

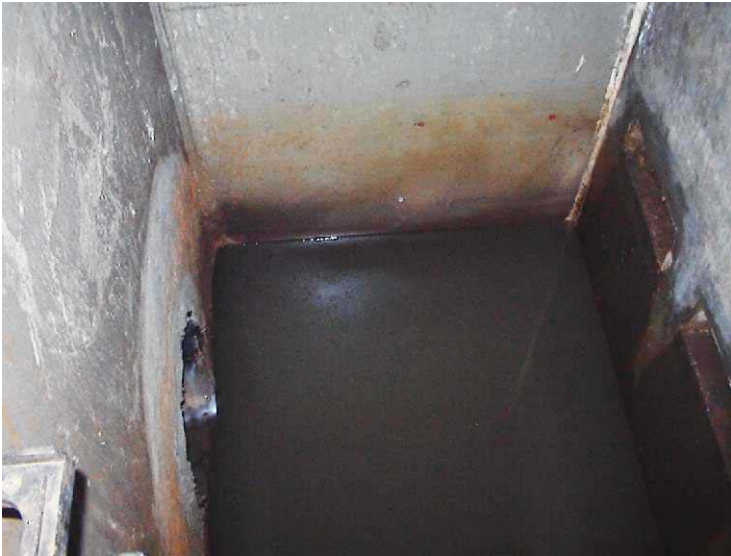
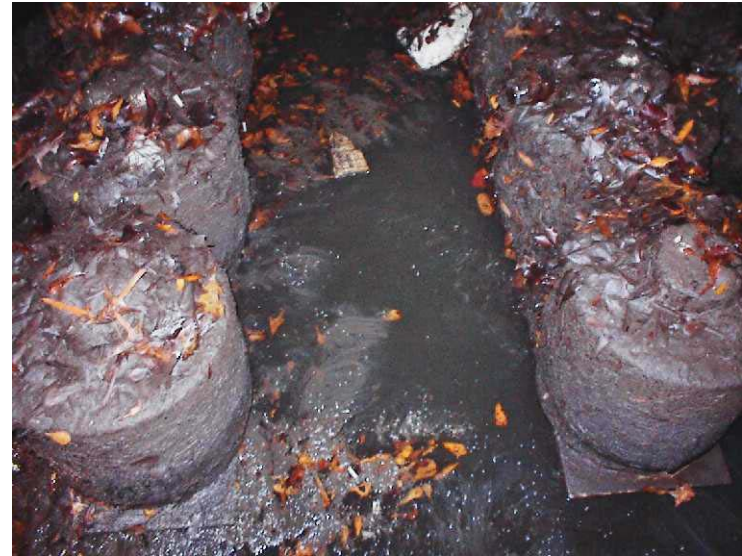
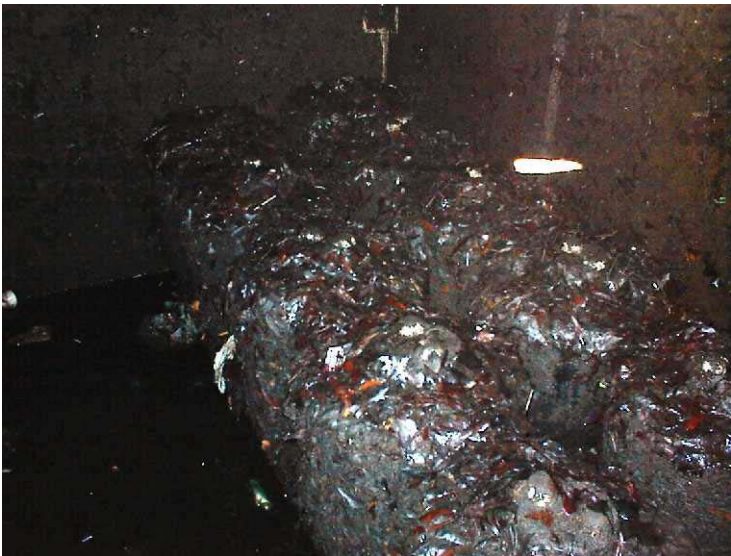
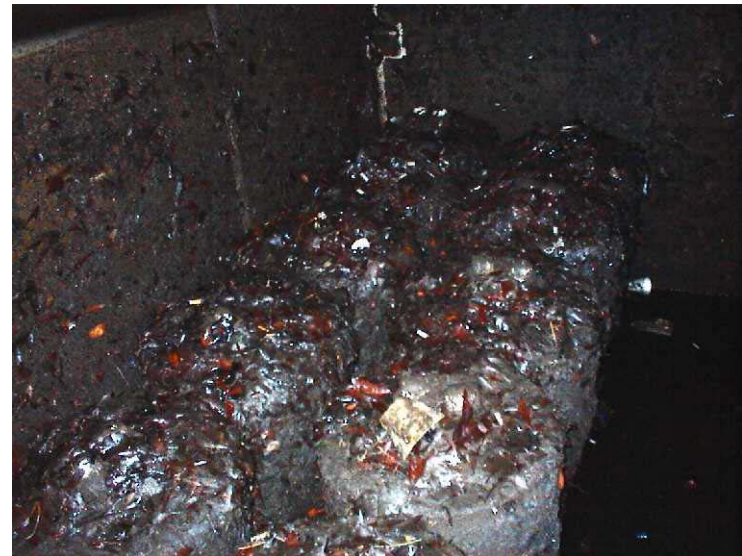
Figure 5-10. StormScreen photographs, January 2004.

(a) StormScreen outlet bay, January 7, 2004

(b) StormScreen vault, January 7, 2004

(c) StormScreen vault, January 17, 2004

(d) StormScreen vault, January 17, 2004

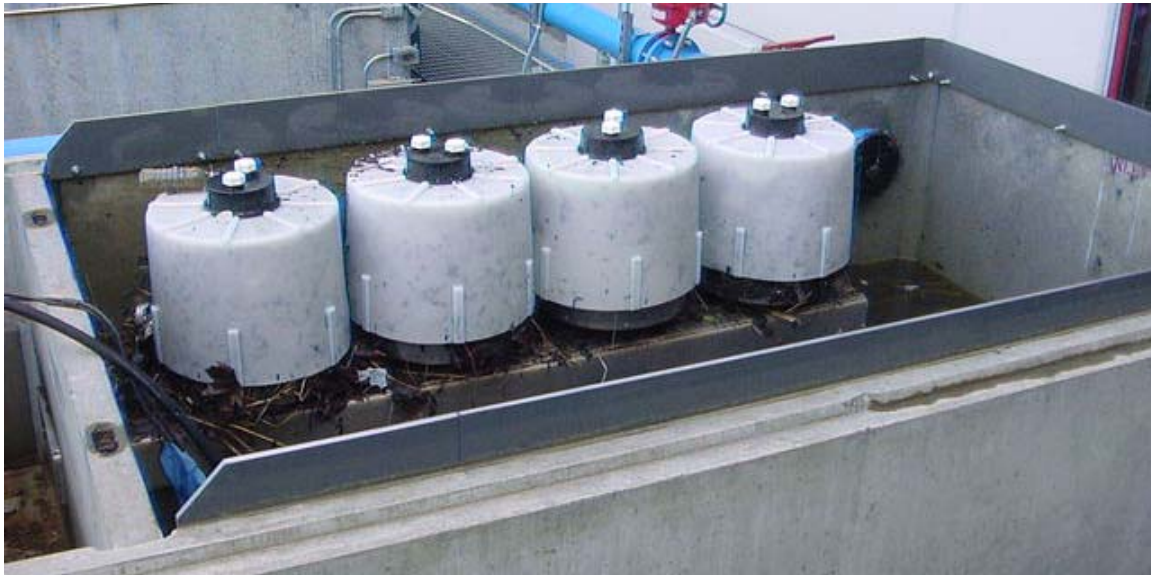
Testing was performed at the Stormwater Management Inc. (SMI) testing and demonstration facility, located at their Portland, Oregon headquarters. This facility consists of a series of full-scale models from the SMI product line, a pumping and conveyance system, and a reservoir tank, which holds approximately 3,800 gallons. The StormScreen model at the facility contains four standard StormScreen cartridges mounted on a single aluminum discharge flume within a standard 6-ft by 12-ft concrete vault, as shown in Figure 7-1. Water discharged from the StormScreen vault through the discharge flume to the outlet bay, shown in Figure 7-3, where it was piped back to the reservoir tank. Water was pumped to the StormScreen from the reservoir via an eight-inch steel pipe by a 15-horsepower Berkeley centrifugal pump. Flow was restricted by a gate valve upstream of the StormScreen inlet pipe which was controlled by a Bray Series 70 electric actuator, as shown in Figure 7-2. Flow was monitored by a Data Industrial 200 Series impeller gage with a 1500 Series LCD readout. Stage was measured in inches relative to the top of the discharge flume.

Figure 7-1. StormScreen testing and demonstration system.

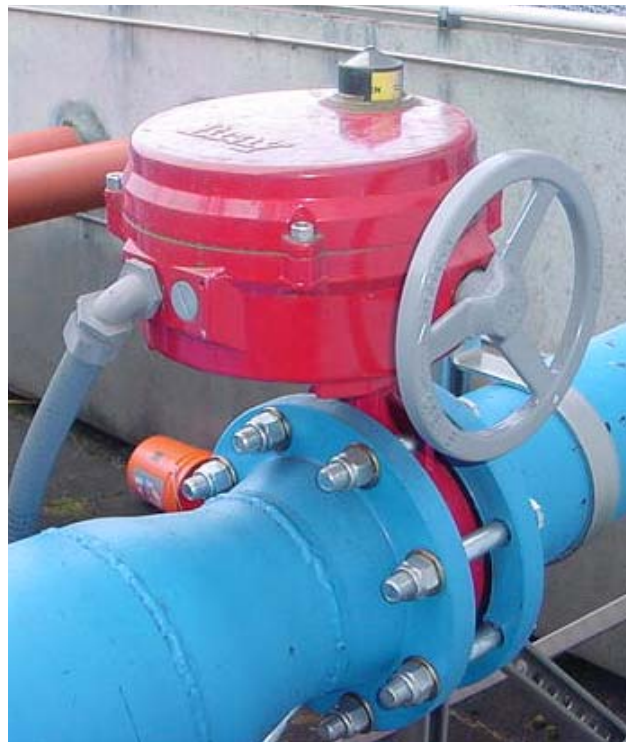
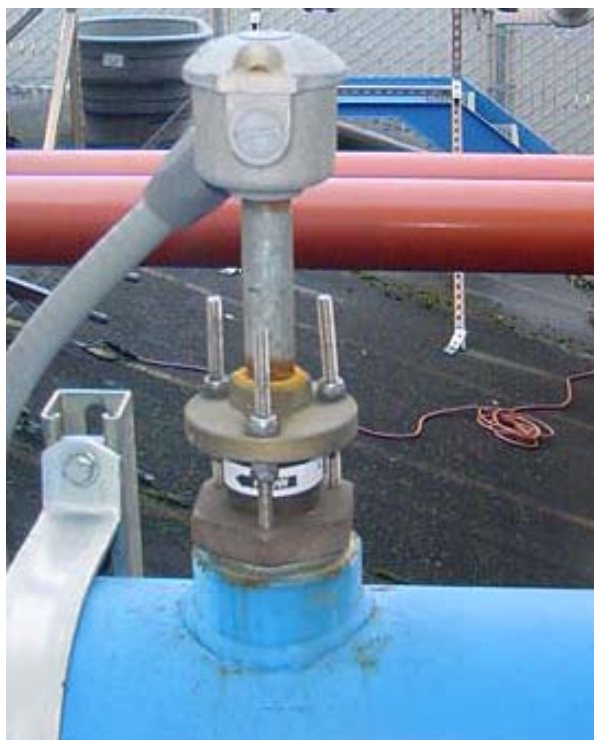
Figure 7-2. Electrically actuated control valve and in-line flowmeter.

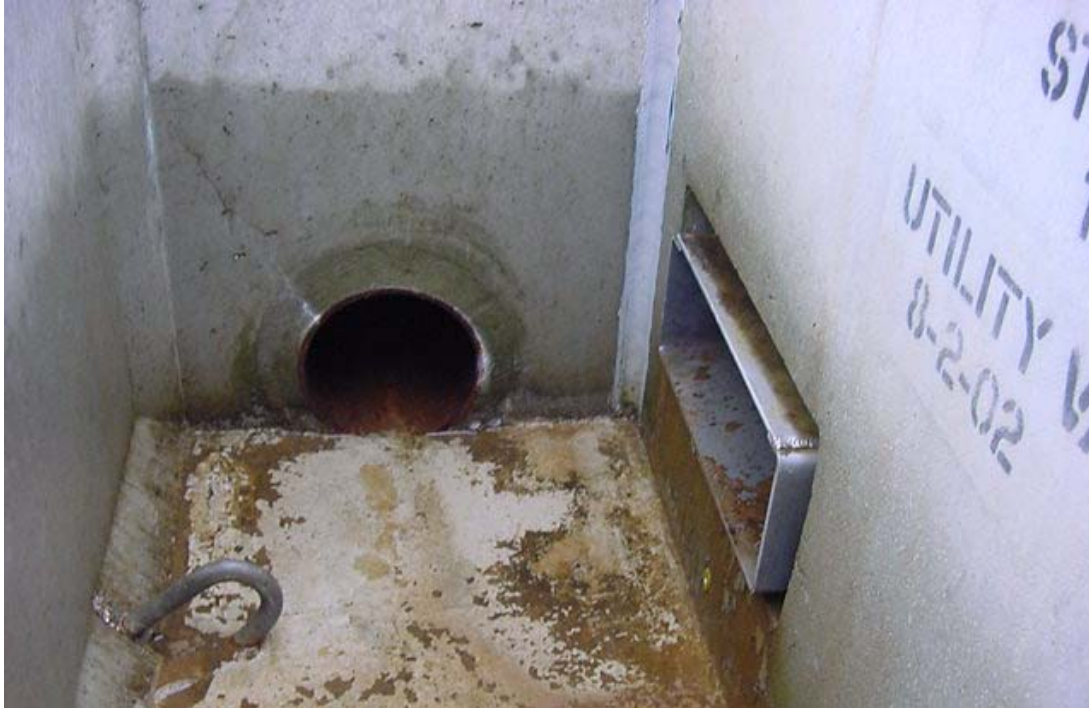
Figure 7-3. Effluent bay of StormScreen testing vault, showing rectangular discharge flume and 8-in return pipe to reservoir.

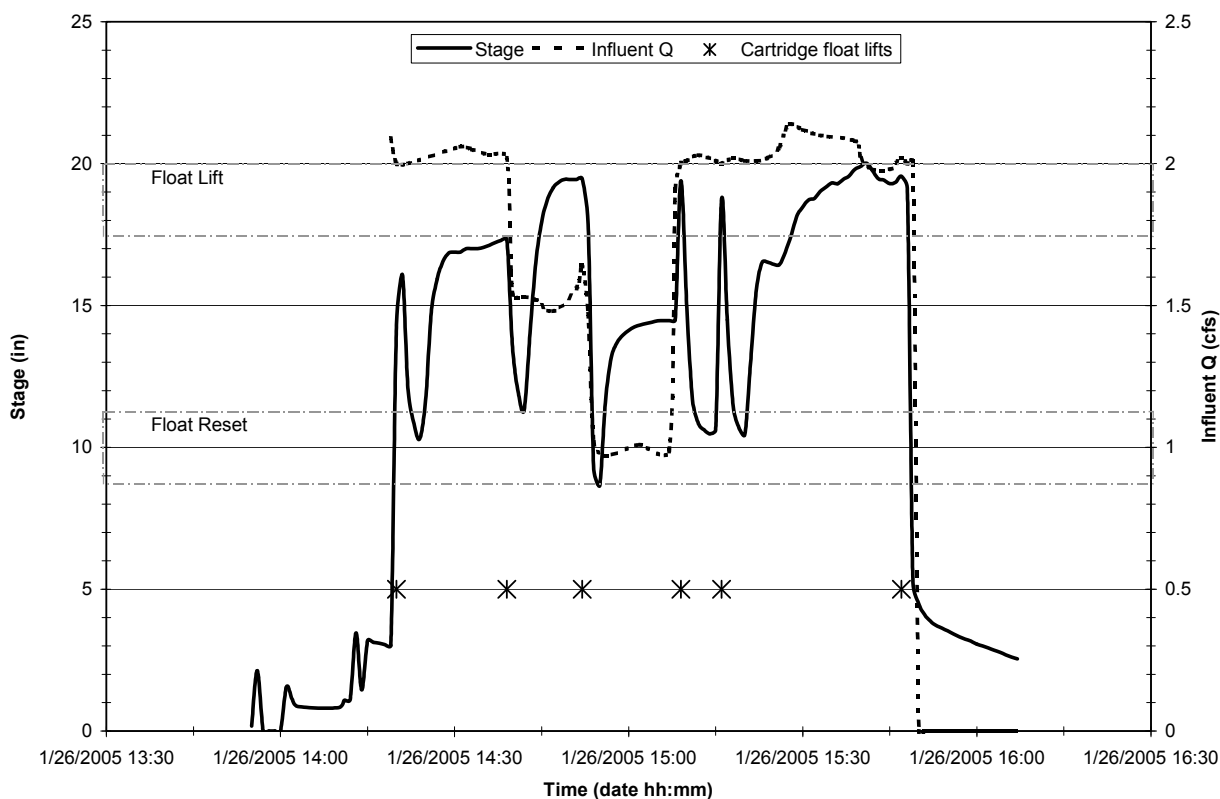
Results of the testing were plotted, as shown in Figure 7-5. Float valves in the cartridge center tubes restrict flow through the system until the water elevation relative to the cartridge base reaches about 19 inches, at which point the float buoyancy causes the float to lift, the valve to open, and the water discharge rapidly through the discharge flume until float valves reset. The initial peak stage measurement was understated due to the rapid initial filling of the vault relative to the one-minute data recording interval. Float reset occurs between approximately 9 and 11 inches. Small peaks seen up to 14:20 are due to noise associated with the calibration of the area/velocity probe.

Figure 7-5. StormScreen stage versus flow relationship with float valves.

Due to slight differences in cartridge installation elevation, not every cartridge float reset to a closed position after all floats initially lifted. Thus, periods of near steady stage are observed during which peak flow is maintained by several cartridges while the remaining cartridges discharge only at the nominal “trickle” rate. Stage slowly rises during these periods until the final float(s) are lifted, at which point the stage drops rapidly. At no point did stage surpass the top of the cartridge hood (21 inches), even when the influent flow exceeded 2 cfs over a period of 15 minutes. The rapid stage decrease observed during the separate periods of 2 cfs influent flow demonstrates that the StormScreen float valves consistently lift and allow discharge in excess of the influent flow.
