Environmental Technology Verification Report

FLIR SYSTEMS
GASFINDIR™ MIDWAVE (MW) CAMERA

Prepared by
Battelle

ETV Advanced Monitoring Systems Center

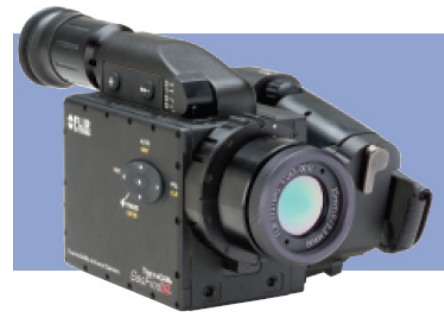
**Figure 1. FLIR
GasFindIR™ MW Camera**

The GasFindIR™ MW camera takes focal plane arrays and optical systems that are tuned to very narrow spectral infrared ranges to enable the camera to detect the energy emitted from certain gases. Images are processed and enhanced by the GasFindIR High Sensitivity Mode™ feature to show the presence of gases against stationary backgrounds. Gases that are detectable by the GasFindIR™ camera appear on screen as smoke.

GasFindIR™ MW camera is designed for use in harsh industrial environments and operates in wide temperature ranges. The GasFindIR™ MW camera is a real-time infrared camera that scans at 30 hertz (Hz) or 30 images per second. The camera includes a 25-millimeter (mm) wide-angle lens for scanning of a variety of components and operations. For longer-range needs, 50-mm and 100-mm lenses are available from FLIR Systems.
