# Environmental Technology Verification Report

AVANTE INTERNATIONAL TECHNOLOGY,  
INC.  
PANASEC MOBILE PERSONNEL AND ASSET  
VISIBILITY SYSTEM

Prepared by  
Battelle

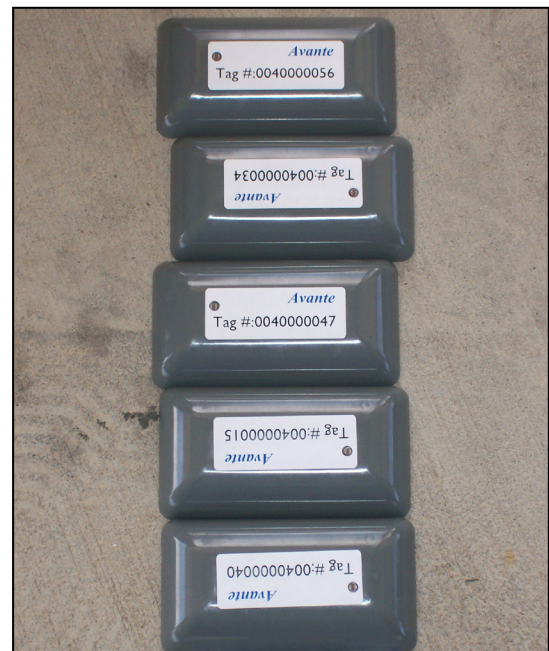
**Figure 2-1. AVANTE's RFID Tags**

Each container of HAZMAT is individually tagged with an active ZONER™ tag. Figure 2-1 shows these active RFID tags that get attached to containers with pressure-sensitive adhesive or other mechanical fasteners. The identity of each container is linked to the active tag identification. During verification testing, AVANTE's PAVS used two different methods for RFID tag reading and communication: (1) external roadside readers and (2) an uplinked system using a vehicle mounted and powered RELAYER™.

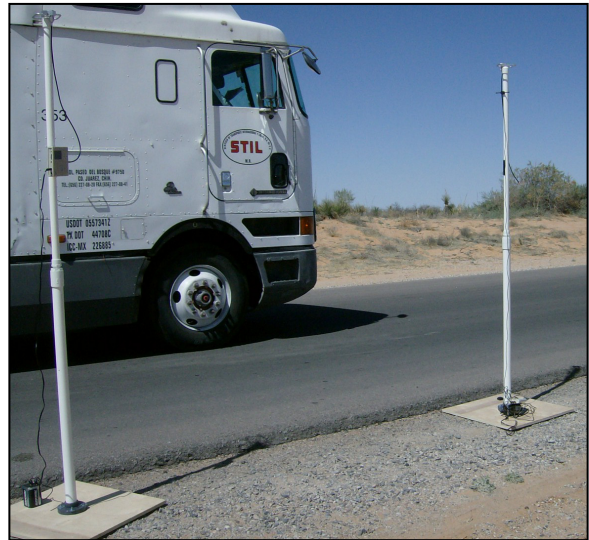
**Figure 2-2. AVANTE's External Readers**

*External Readers.* The roadside reading configuration of the PAVS consisted of pole-mounted antennae coupled with an external tag data storage device. These are shown in Figure 2-2 and are referred to in this report as external readers. The external readers are located in a fixed position (e.g., on the side of a road or at the entrance to a facility); this location is referred to as a read location. As the RFID tags come within range of the external readers (e.g., as the truck drives past), the external readers collect the information transmitted by the RFID tags and records this information onto a secure digital memory card loaded into the external reader. The information collected by the external reader is collected by removing the memory card and downloading the information to a computer.

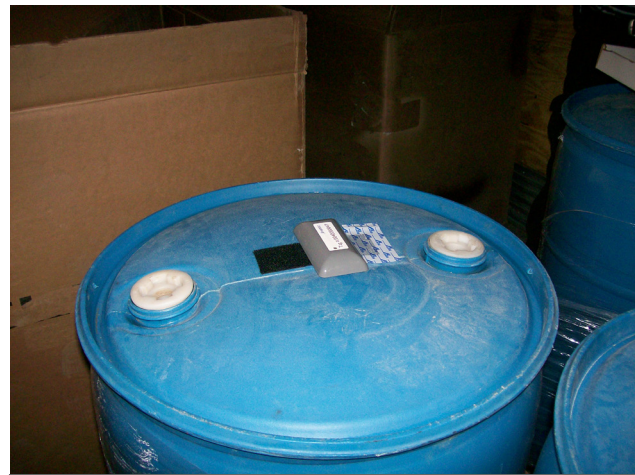
**Figure 3-1. RFID tag affixed to poly drum**

According to current shipping data, most of the HAZMAT entering MX from the U.S. are contained in either poly or steel 55-gallon drums, and much of the HAZMAT waste returning from the maquilas and entering the U.S. is solid and packaged in one-cubic yard corrugated boxes or as drummed liquids. Therefore, when the functioning of the RFID tags had been confirmed, four RFID tags were secured to poly 55-gallon drums, four were secured to the steel 55-gallon drums, and four were affixed to corrugated boxes for a total of twelve individual containers. One tag was affixed to each individual container. Figure 3-1 is a photo of an AVANTE RFID tag affixed to a poly drum. In the interest of safety, no actual HAZMAT waste was transported during the verification test. Each poly and metal 55-gallon drum used in the verification testing was filled with tap water and each corrugated box was filled with loosely folded cardboard. RFID tags were secured to the top of each poly and metal drum and to the side of each corrugated box using Velcro tape.

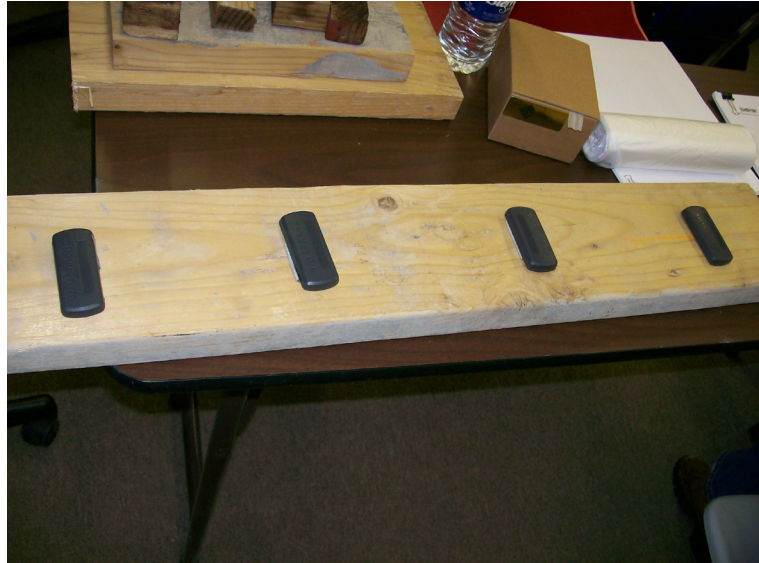
**Figure 3-4. Collision Tags**

A collision test was performed during each RT to evaluate the ability for the PAVS to discriminate the AVANTE RFID tags from other commercially available active tags. Battelle supplied four commercially available tags for collision testing; the collision tags were 433 MHz, the same frequency at which the PAVS operated, active tags (Wavetrend® TG801). The collision tags were affixed to a wooden block as shown in Figure 3-4. At the beginning of the day of testing, the function of each collision tag was verified separately by measuring the frequency and the effective radiated power of the tags using the spectrum analyzer.

A collision test was performed during each verification test run at the NMDPS truck inspection facility. The truck conducted its first pass of the 25 and 15 mph read locations. The truck then began its second pass of the 25 mph read location. After passing the 25 mph read location the second time, the truck stopped, the trailer was opened, and the collision tags were added to one of the one-cubic yard corrugated boxes. The trailer doors were then closed and the truck proceeded past the 15 mph read location. After passing the 15 mph read location, the truck stopped and the collision tags were removed.

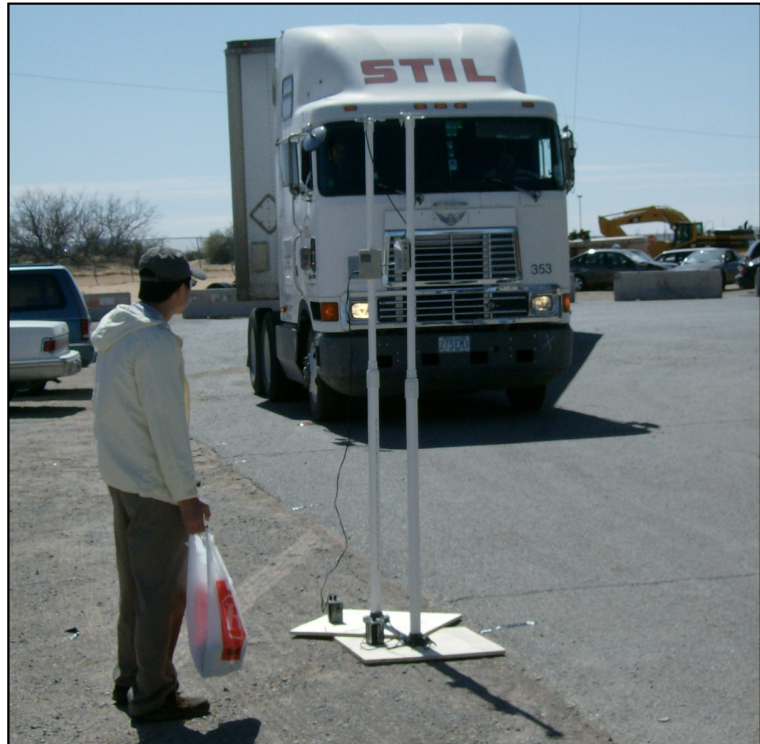
**Figure 3-5. Stationary Tag Read with External Readers**

The HAZMAT waste containers were loaded into the trailer and placed in the tightly-packed configuration for both of the U.S. RTs. The truck began all of the RTs (U.S. and MX) at the NMBA facility. Prior to embarking on each RT, an external reader was situated on a stand at 90° with respect to the road with the stand placed four feet from the side of the front bumper. This is shown in Figure 3-5. At that time, RFID tag reads were made at distances of 5, 15, 30, 50, and 70 feet from the front bumper of the stationary truck by moving the external reader straight forward from the initial placement of the reader. The external readers were kept at each distance for approximately one minute. Following the stationary RFID reads, the reader was moved to the exit of the NMBA and the truck embarked on its RT by first driving past the reader for a slow moving read. During only the start of the first U.S. RT, a second reader was placed at 45° with respect to the road, in addition to the reader at each read point that was placed at 90°.

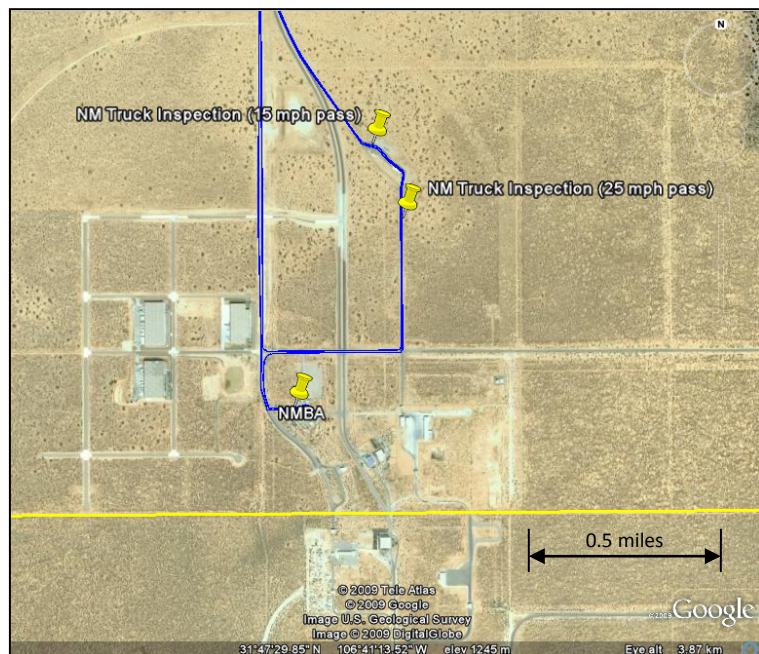
**Figure 3-6. U.S. route used during testing (border area enlargement)**

Upon exit from the NMBA, the truck travelled to the NMDPS facility. Figure 3-6 shows the path of the truck between the NMBA and the NMDPS facility. The total distance between the two locations was approximately 0.75 miles. External readers were placed at two locations at the facility. The first reader was designated as a 25 mile per hour (mph) read location and the second reader was designated a 15 mph read location. The readers used here were also placed at 90°
