REVISED DRAFT
RCRA FACILITY ASSESSMENT
REPORT

Evoqua Water Technologies, LLC.
2523 Mutahar Street
Parker, Arizona
AZD 982 441 263

Date of Revised Draft	September 2016
US EPA Region 9	
Site No.	AZD 982 441 263
Document Control No.	REPA3-0903-017
Contract No.	68-W-02-022
Draft RFA Prepared by	Booz Allen Hamilton
Revised Draft RFA Prepared By	USEPA Project Manager
Telephone No. (415) 972-3348	"Mike" Mahfouz Zabaneh

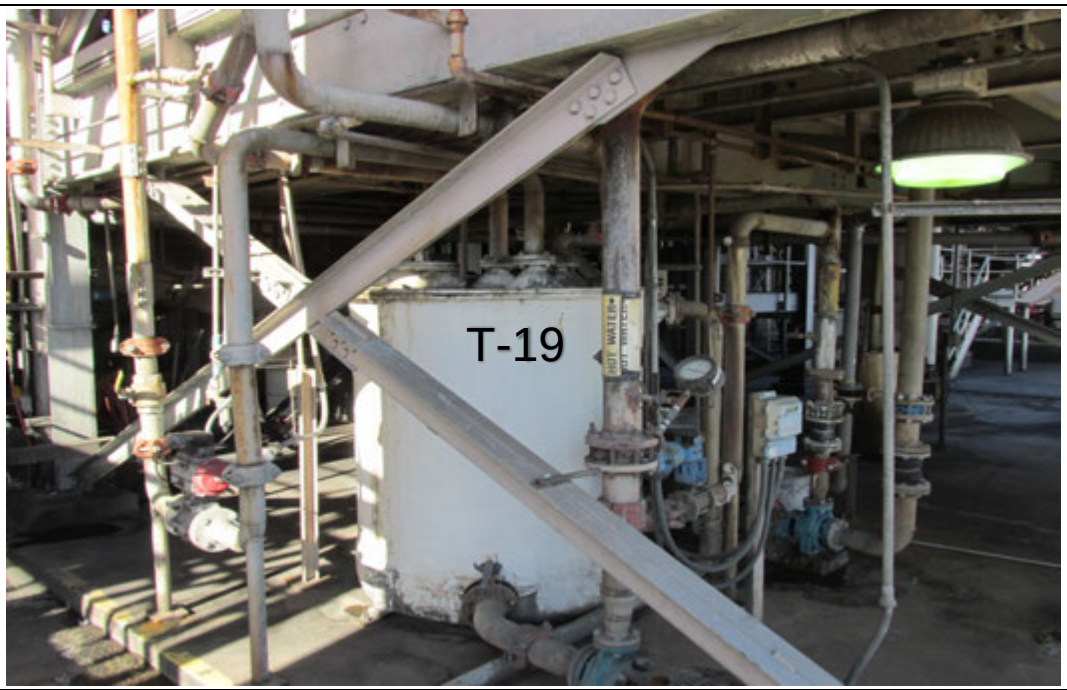
SWMU No.	SWMU Type/Designation	Picture of Unit
7	Sump by cooling screw under Venturi scrubber tank LOCATION: East of warehouse beside RF-2 NOTES: Used for washdown and rainwater drainage	
8	RF–2 scrubber water equalization tank, T-19 LOCATION: Under RF-2 Structure

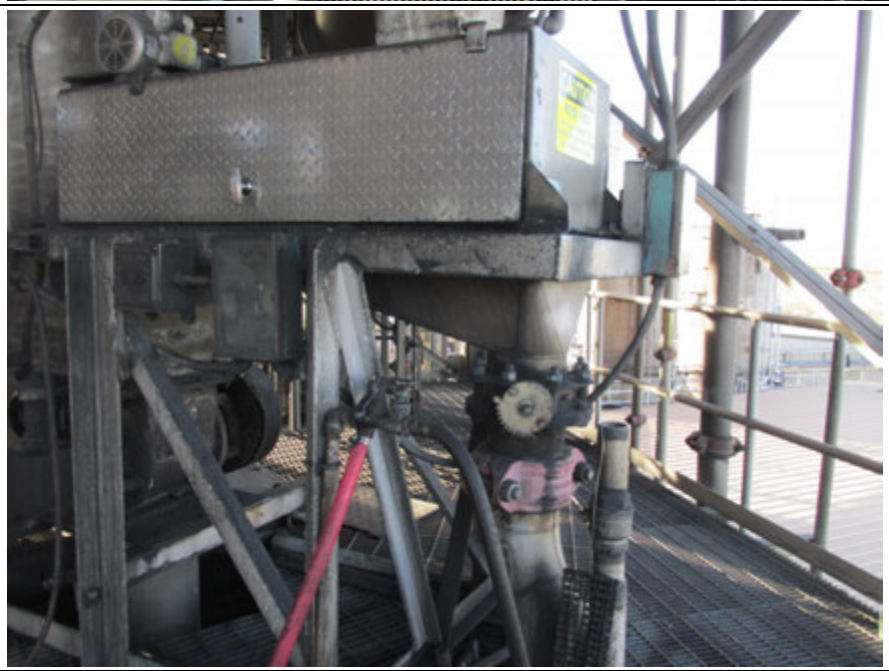
No.	AOC Type/Designation/Location	Management Requirements at Closure
7A	Furnace feed system – Dewatering screw LOCATION:	
7B	Furnace feed system – Weigh Belt LOCATION:

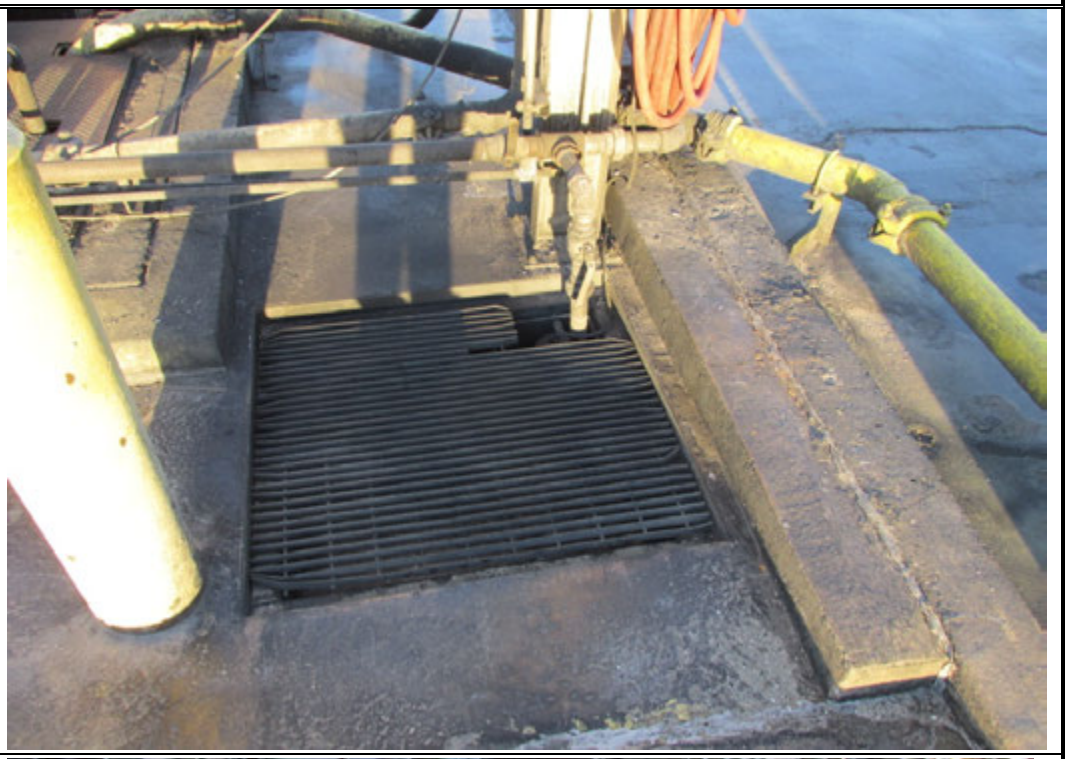
No.	AOC Type/Designation/Location	Management Requirements at Closure
12	Sump by unloading hopper H-1 LOCATION:

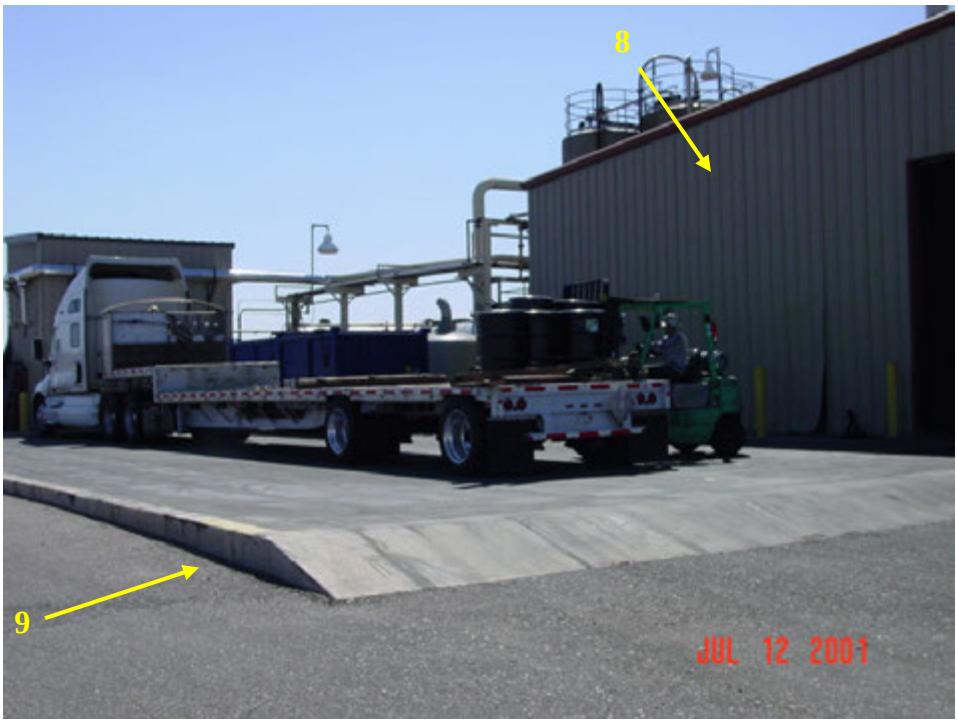
Photograph No.: F-1
Photographer: Andrea Austin
SWMU No.: 9
SWMU Name: Transfer Area Containment Pad
Date: 07/12/2001
SWMU Description: Concrete loading pad with secondary containment berm adjacent to the spent carbon storage warehouse (SWMU8). No evidence of spills.

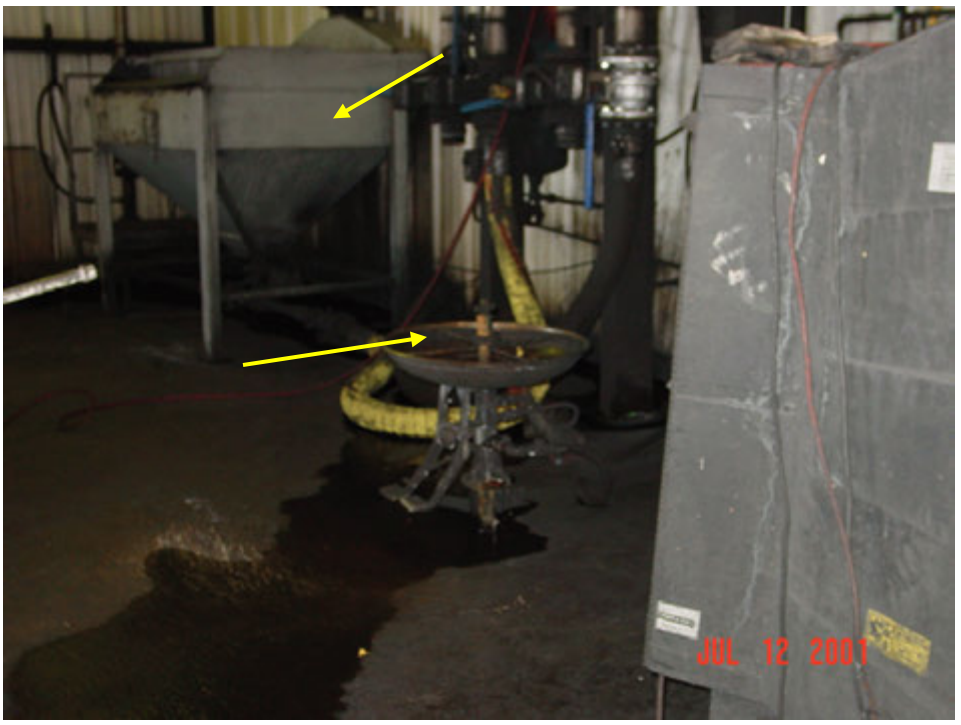
Photograph No.: F-10
Photographer: Andrea Austin
SWMU No.: 22
SWMU Name: Spent Carbon Storage Warehouse Barrel Washer
Date: 07/12/2001
SWMU Description: Barrel washer adjacent to H-2 (SWMU 5). Water used to rinse empty drums drains into trenches and flows to the sump and vault (SWMU 21) (Photograph No. F-9). From there the water is recycled to tank T-9 (SWMU 16) or (SWMU 17) T-12. Water observed on the floor from recent wash-out of empty drums.

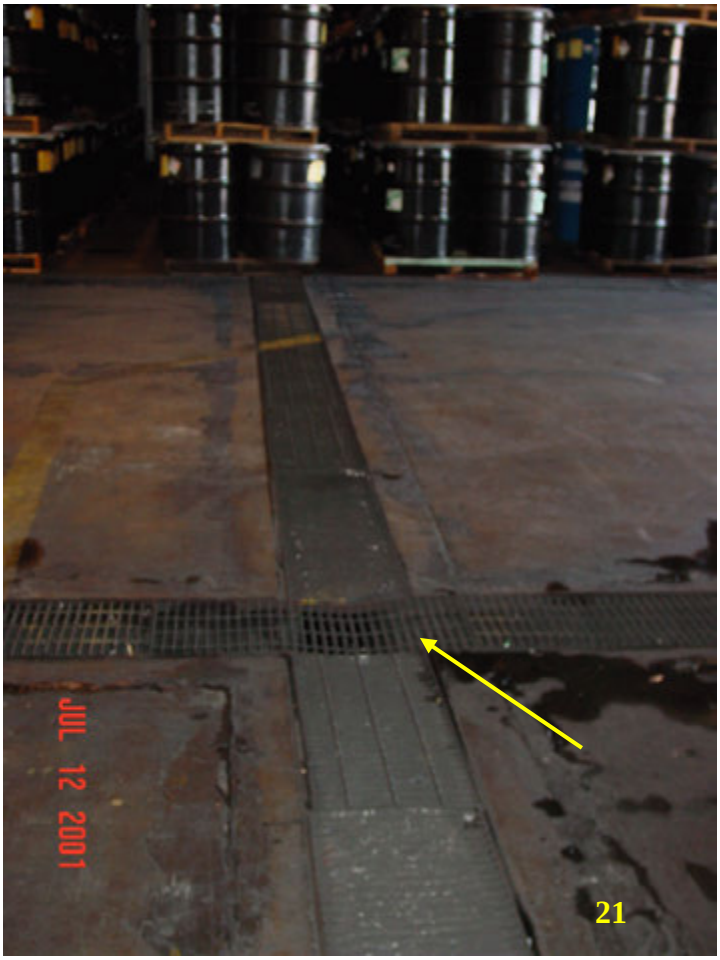
Photograph No.: F-11
Photographer: Andrea Austin
SWMU No.: 21
SWMU Name: Spent Carbon Storage Warehouse: Grated Trenches
Date: 07/12/2001
SWMU Description: The grated trenches in the spent carbon storage warehouse are present to capture any spills. The dark wet area on the concrete is water from recently washing out empty drums. The trenches lead to the sump and vault and transport the wastewater via a pipe system to Tank T-9 (SWMU 16) and T-12 (SWMU 17) where water is recycled.

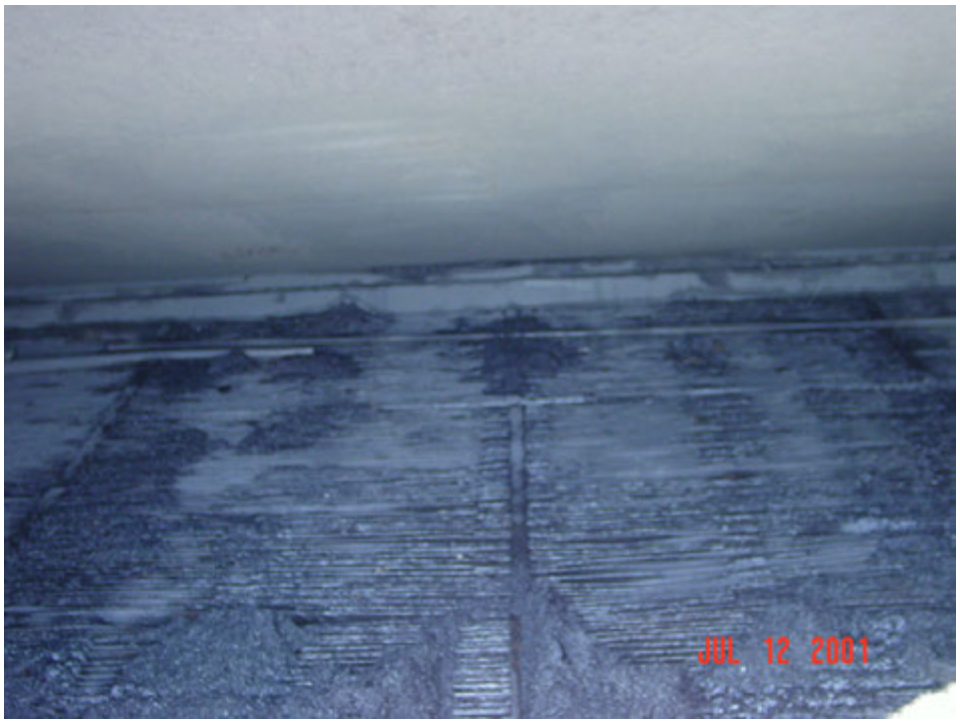
Photograph No.: F-13
Photographer: Andrea Austin
SWMU No.: 4
SWMU Name: Unloading Hopper (H-1)
Date: 07/12/2001
SWMU Description: Inside unloading hopper (H-1); the grate onto which spent carbon is unloaded. Approximately sixty percent of the spent carbon is handled at H-1. The capacity of H-1 is 5,000 lbs. Residual spent carbon was observed on the grate of H-1.

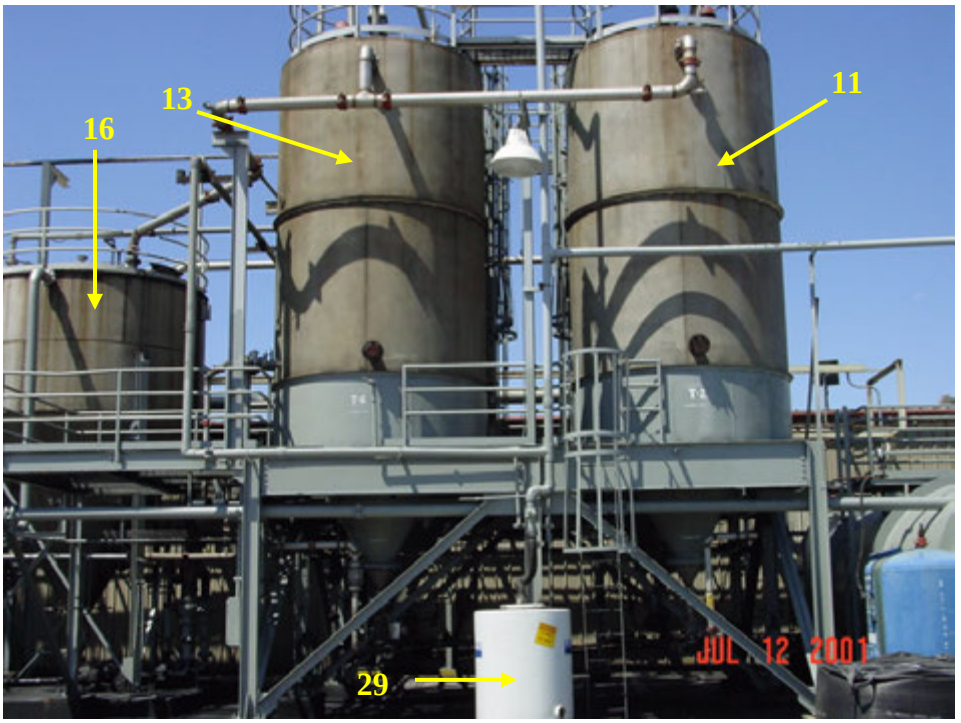
Photograph No.: F-19
Photographer: Andrea Austin
SWMU Nos.: 10, 11, 12, 13, and 29
SWMU Name: Spent Carbon Slurry Storage Tanks: T-1, T-2, T-5, T-6, and Carbon Adsorber WS-1 (SWMU 29).
Date: 07/12/2001
SWMU Description: Four spent storage tanks; Tank T-1 (SWMU 10) is behind Tank T-2 (SWMU 11); Tank T-5 (SWMU 12) is behind Tank T-6 (SWMU 13). Carbon adsorber tank (WS-1) [the white carbon canister], used to control volatile emissions from tanks T-1, T-2, T-5, T-6, T-9 (SWMU 16), and T-12 (SWMU 17). WS-1 is emptied into the spent carbon unloading hopper (H-1) (SWMU 4) when the carbon inside reaches its adsorption capacity. Tank T-9 (SWMU 16) also appears in the photo.

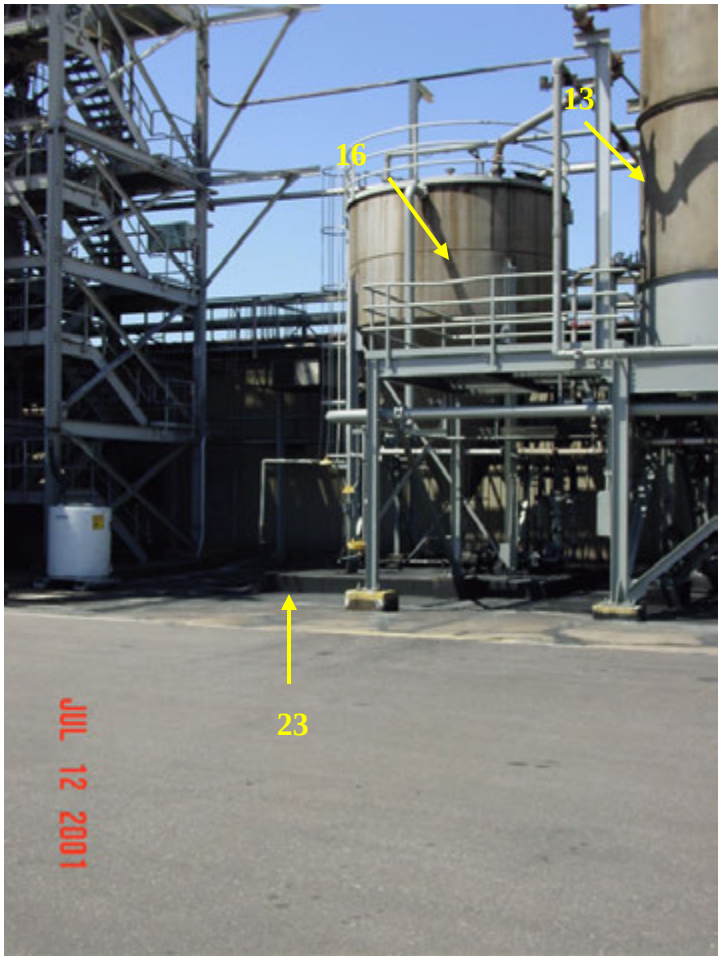
Photograph No.: F-20
Photographer: Andrea Austin
SWMU No.: 16
SWMU Name: Recycled Motive Water Storage Tank (T-9)
Date: 07/12/2001
SWMU Description: Motive water for creating a carbon slurry is supplied from Tank T-9 and moves the spent carbon through the pipe conveyance system. Bermed containment area in the Process Area (SWMU 23) is interconnected with the bermed area for the Transfer Containment Area (SWMU 9). No evidence of release to the ground/concrete. Tank T-6 (SWMU 13) also appears in the photo.

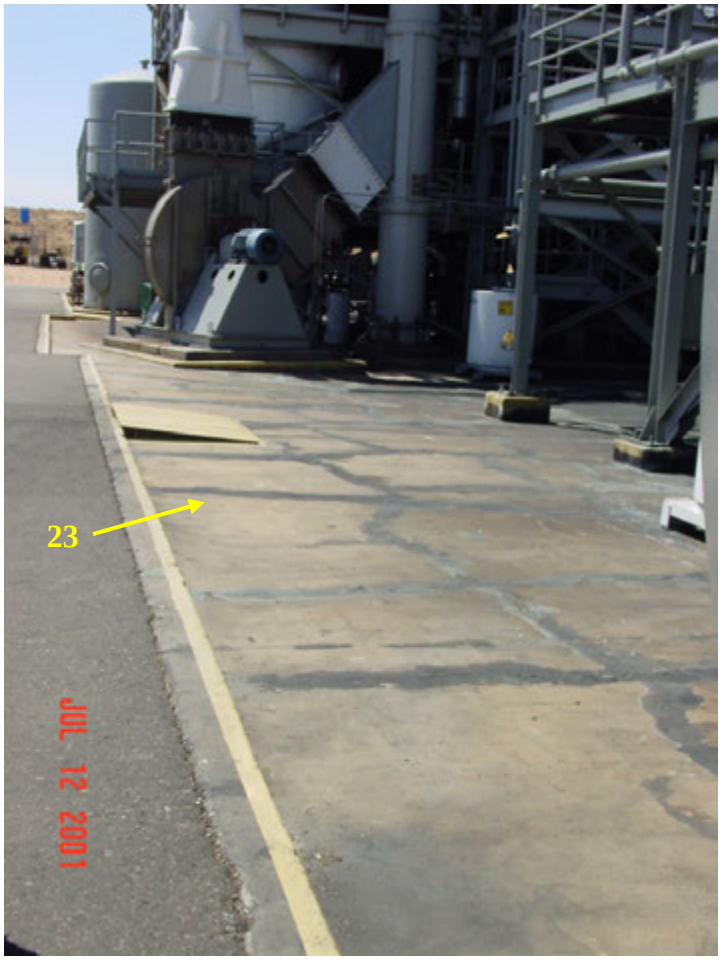
Photograph No.: F-21
Photographer: Andrea Austin
SWMU No.: 23
SWMU Name: Bermed Containment Area in Process Area
Date: 07/12/2001
SWMU Description: Concrete pad and bermed secondary containment area under platforms for the reactivation furnaces. Cracks have been sealed with a polyresin, Sikadur 35®. No evidence of a spill.

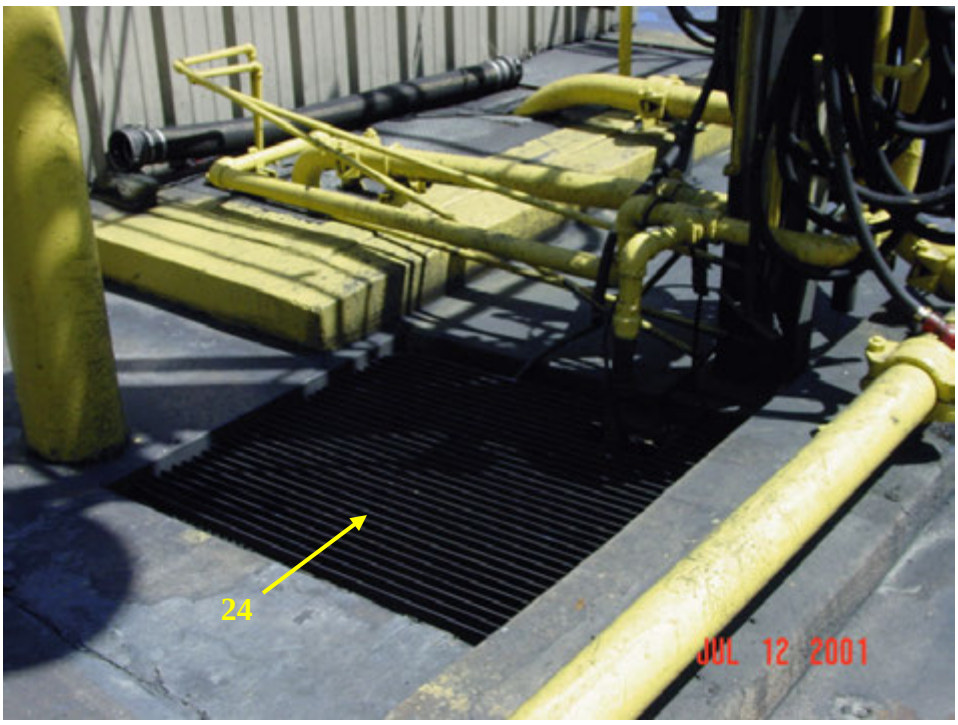
Photograph No.: F-22
Photographer: Andrea Austin
SWMU No.: 24
SWMU Name: Sump by Unloading Hopper No. 1 (H-1)
Date: 07/12/2001
SWMU Description: Sump collects wastewater such as washdown water from trucks unloading spent carbon into unloading hopper (H-1) (SWMU 4), and from (SWMU 9). Captured liquid is then transferred to Tank T-9 (SWMU 16) and T-12 (SWMU 17) via a closed piping system. No evidence of overflow release to the ground.

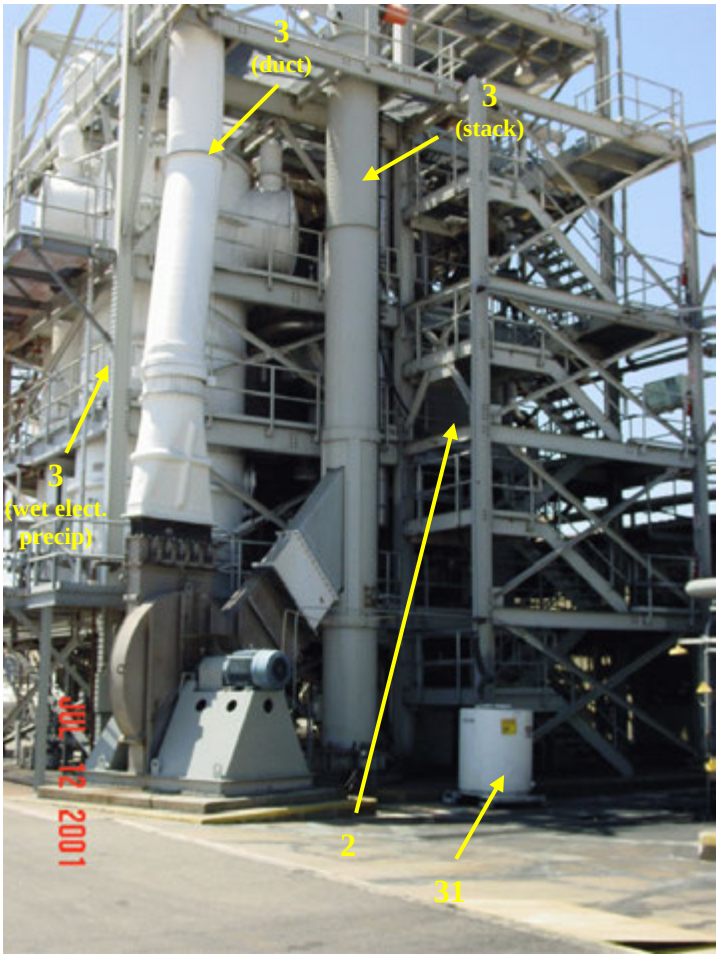
Photograph No.: F-23
Photographer: Andrea Austin
SWMU No.: 2, 3, and 31
SWMU Name: SWMU 2: Reactivation Furnace No. 2 (RF-2)
SWMU 3: Air Pollution Control Equipment
SWMU 31: Carbon Adsorber No. 3 (WS-3)
Date: 07/12/2001
SWMU Description: RF-2 (SWMU 2) is the gray vessel at the center of the photograph, inside the platform. On the left-hand side is the wet electrostatic precipitator. The wide white duct comes from the top of the wet electrostatic precipitator and goes to the bottom of the stack for RF-2. The small carbon canister (SWMU 31) at the foot of the platform is the carbon adsorber used to control volatile emissions from Tank T-18 (SWMU 15), the feed tank to the reactivation furnace, RF-2. No evidence of release was observed.

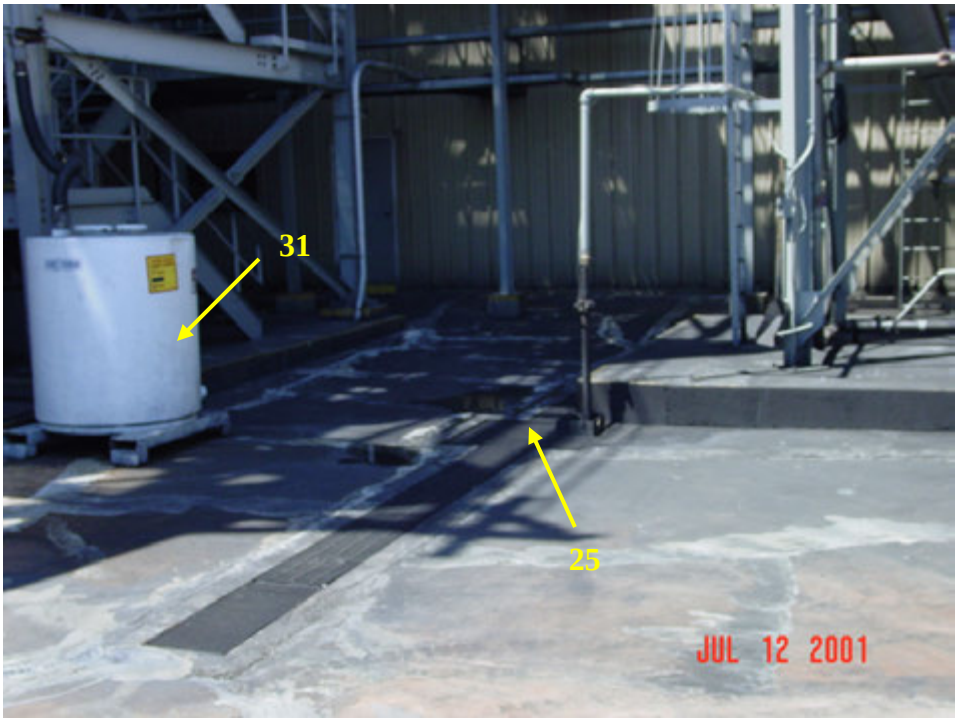
Photograph No.: F-24
Photographer: Andrea Austin
SWMU No.: 25 and 31
SWMU Name: Sump by Tank T-9 and Carbon Adsorber No. 3 (WS-3)
Date: 07/12/2001
SWMU Description: The trench and sump drain the bermed containment area (SWMU 23) of water or spills. Small pools of water were observed adjacent to trench. Rainwater also flows into trench and sump to be conveyed to Tank T-12 (SWMU 16) or T-9 (SWMU17).

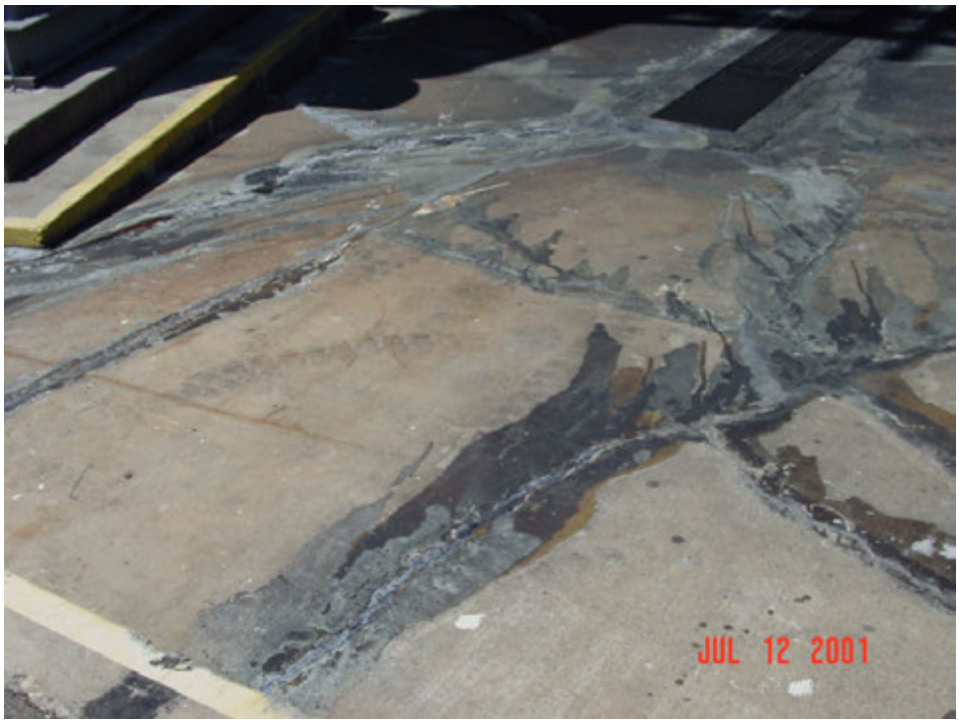
Photograph No.: F-25
Photographer: Andrea Austin
SWMU No.: 23
SWMU Name: Repaired Containment Area
Date: 07/12/2001
SWMU Description: Cracks in the Process Area have been filled in and patched with a polyresin, Sikadur 35®.

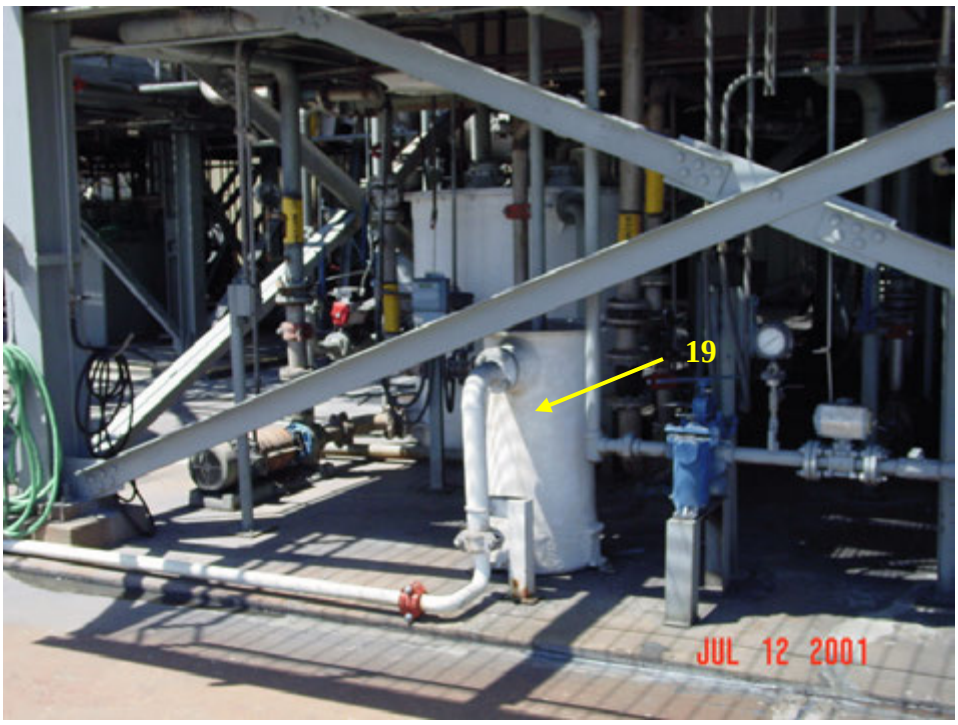
Photograph No.: F-26
Photographer: Andrea Austin
SWMU No.: 19
SWMU Name: RF-2 Scrubber Water Equalization Tank T-19
Date: 07/12/2001
SWMU Description: Treatment of scrubber water from air pollution equipment. Cracks near Tank T-19 have been sealed with a polyresin, Sikadur 35®. No evidence of a release.

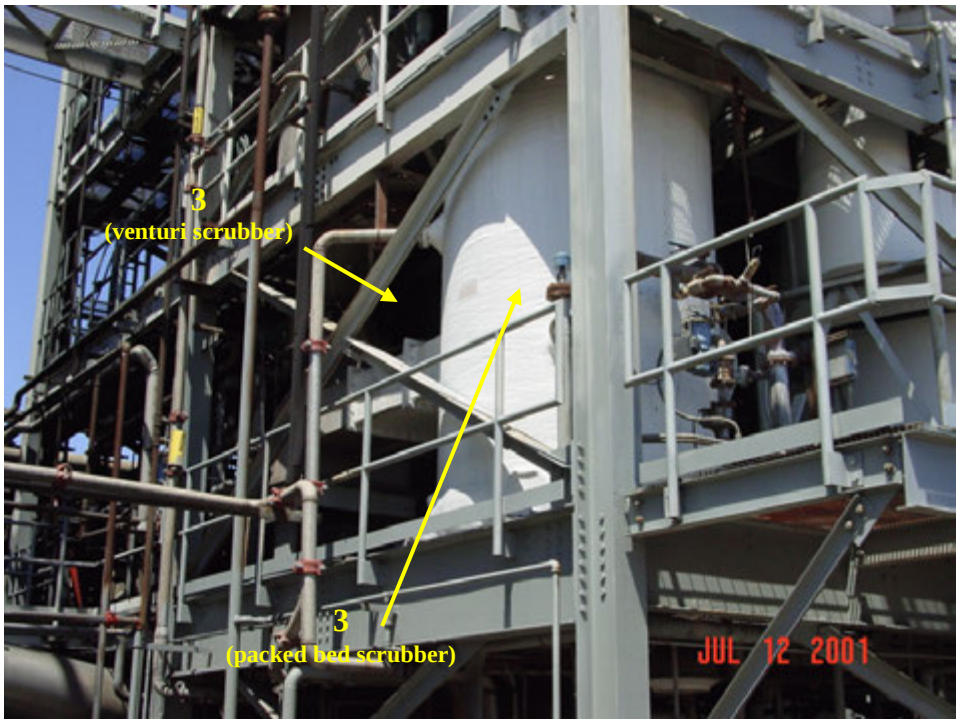
Photograph No.: F-27
Photographer: Andrea Austin
SWMU No.: 3
SWMU Name: Air Pollution Control Equipment (RF-2)
Date: 07/12/2001
SWMU Description: Left vessel (brown/gray) is the venturi scrubber. White vessel on the right is the packed bed scrubber. The venturi scrubber is designed to remove particulates, and the packed bed scrubber is designed to remove acid gases from the gases leaving the afterburner. Equipment in excellent condition. No evidence of leaks in the air pollution control equipment.

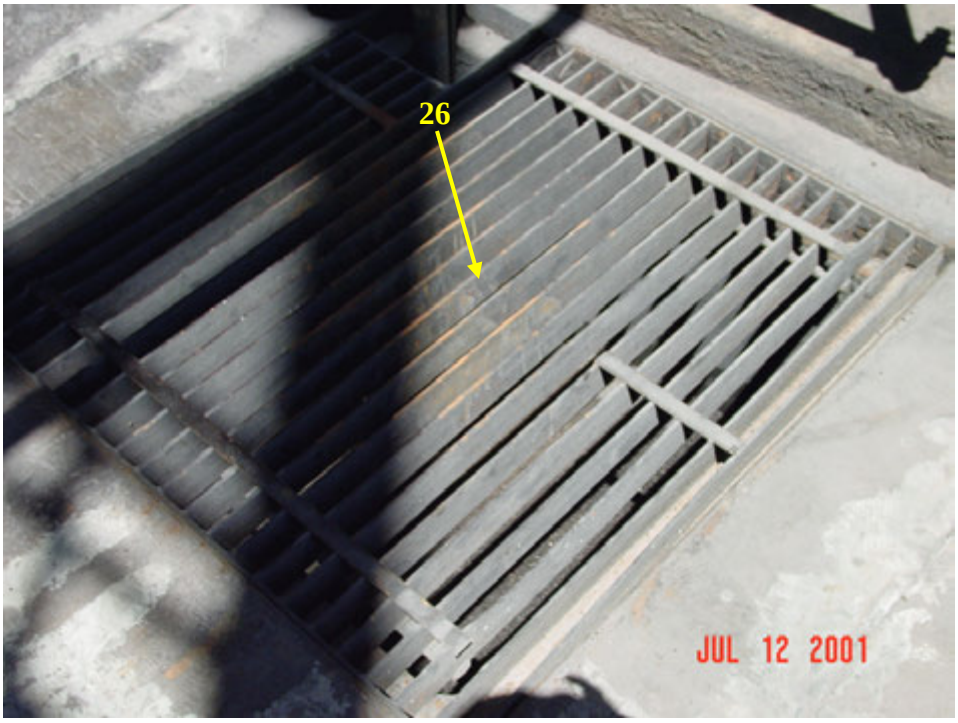
Photograph No.: F-28
Photographer: Andrea Austin
SWMU No.: 26
SWMU Name: Sump under the Venturi Scrubber by cooling screw
Date: 07/12/2001
SWMU Description: Collects spilled process water and rain water from the process containment area. Water is recycled via piping back to Tank T-9 (SWMU 16) or T-12 (SWMU 17). No evidence of overflow from the sump.

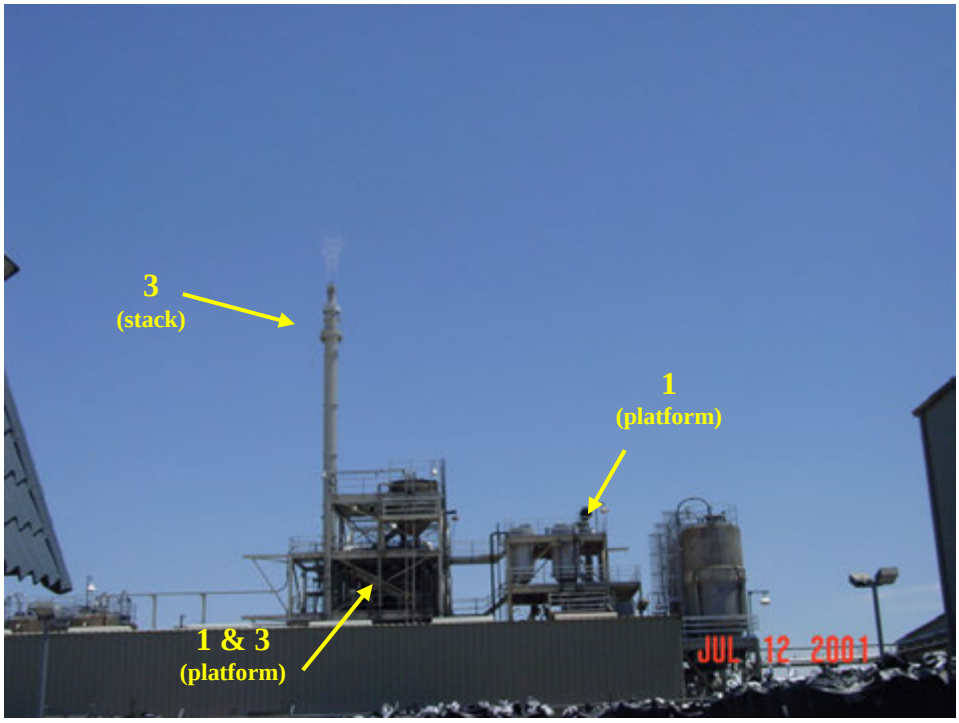
Photograph No.: F-36
Photographer: Andrea Austin
SWMU No.: 1, 2, 3
SWMU Name: Air Pollution Control Equipment
Date: 07/12/2001
SWMU Description: Facing Northwest, platform structures for RF-1 and RF-2 and air pollution control equipment. (SWMUs 1, 2, and 3 not clearly visible.) Exhaust from the stack is barely visible. Tanks to the right of RF-1 platform hold reactivated carbon. Black Bags of reactivated carbon visible in foreground.
