Hull & associates, inc.

April 27, 2009

RE: RCRA 2020 Corrective Action Universe at RPM – Carboline Facility, 125 Fairgrounds Road, Xenia, Ohio, EPA ID NO. OHD030963615; BRG001.300.0005

Site Photographs of SWMU-2, SWMU-3, SWMU-6 and AOC-1

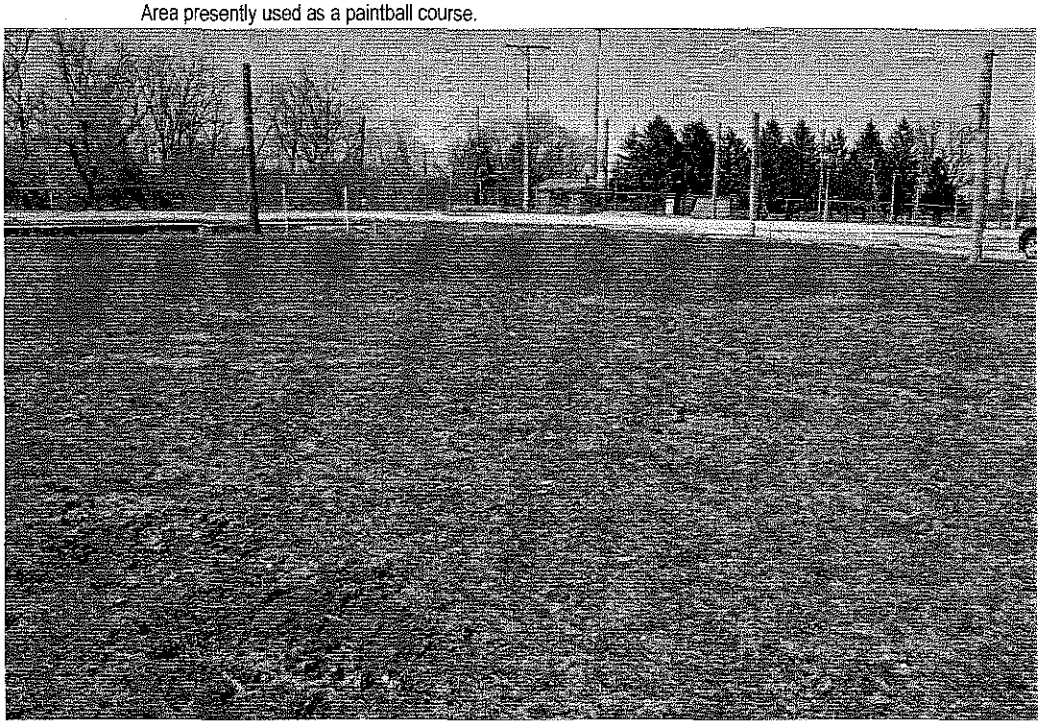
During the Site walkover by Hull in January and April 2009, no distressed vegetation, stained soil, or evidence of the former storage areas was observed.

PHOTO 1: View looking southwest at area where 6,000 gal. D-Waste AST was formerly located. Area presently used as a paintball course.

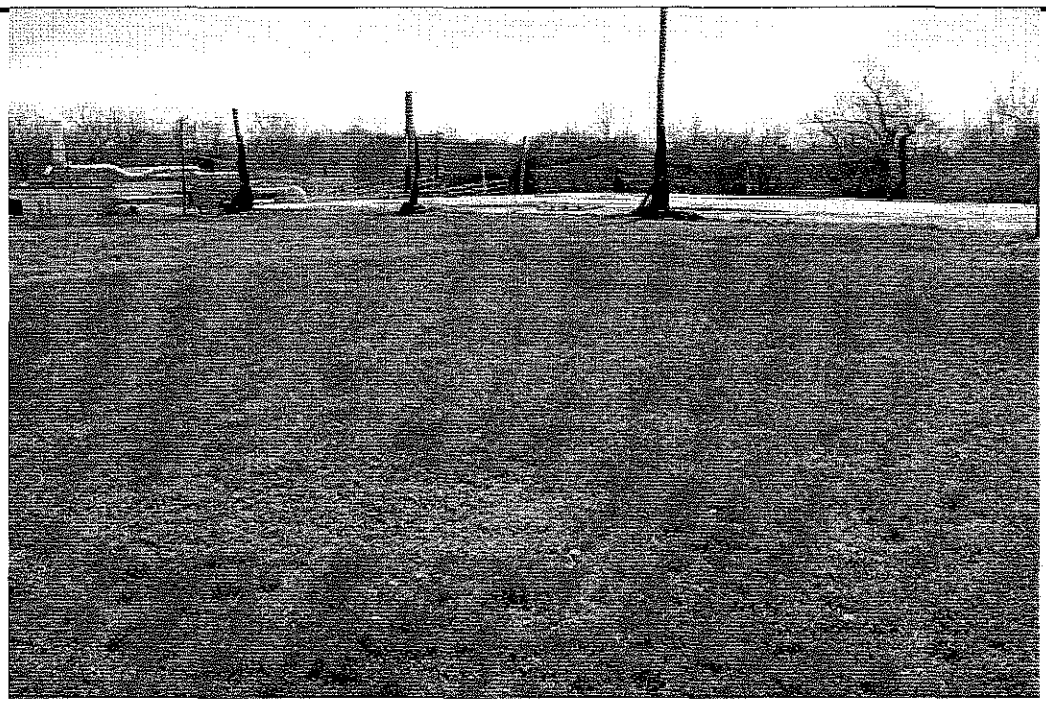
PHOTO 2: View looking west-northwest at area where 6,000-gal D-Waste AST was former located. Area presently used as a paintball course.

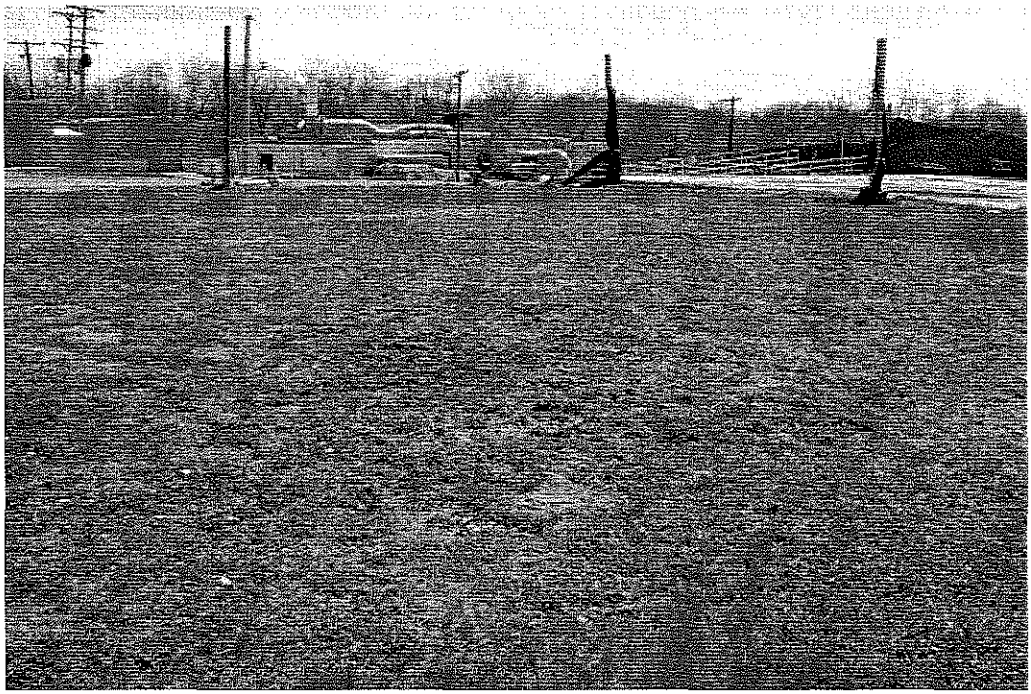
During the Site walkover by Hull in January and April 2009, no distressed vegetation, stained soil, or evidence of the former storage areas was observed.

PHOTO 3: View looking southeast at former less than 90-day hazardous waste storage area. Area presently used as a paintball course.

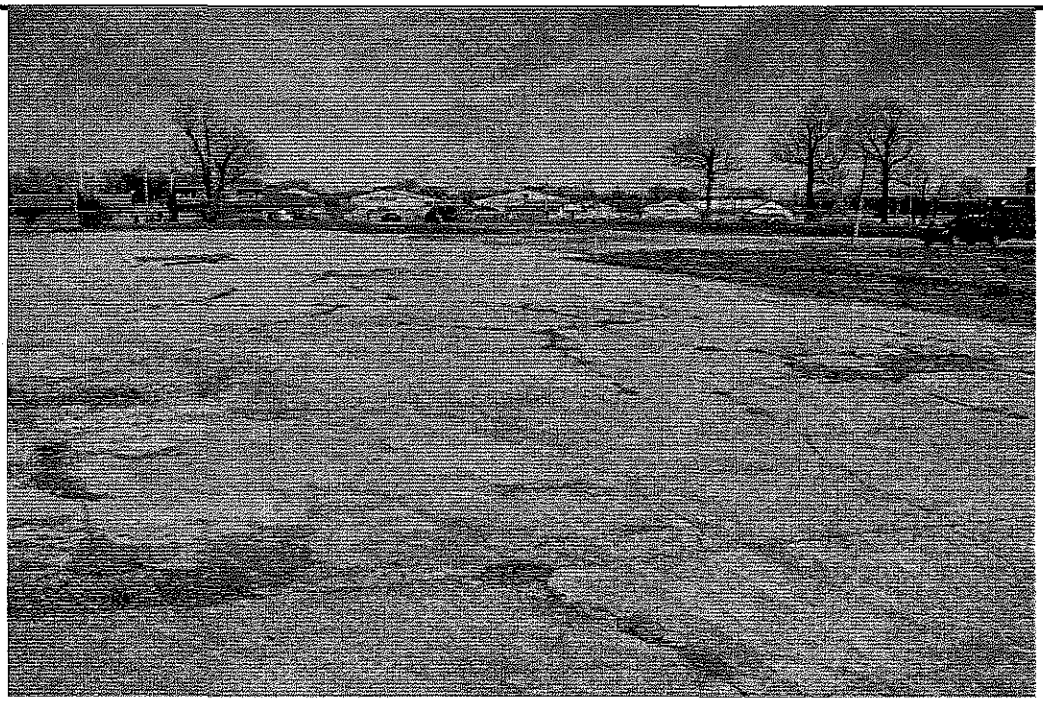
PHOTO 4: Another view looking southeast at less than 90 day former hazardous waste storage area. Area presently used as a paintball course.

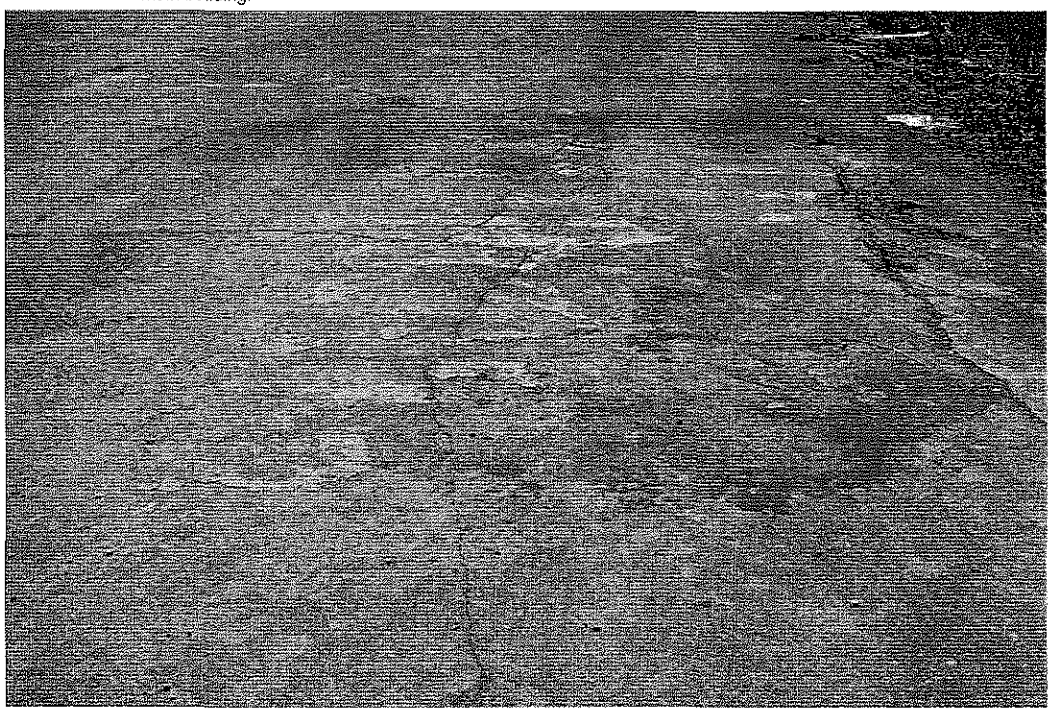
As indicated previously, cracks were observed in the concrete pad during the Site visits conducted by Hull. Many of the cracks appeared surficial, but some likely penetrated the concrete pad based on the presence of vegetation growing in the cracks. Dried paint residue was observed on the concrete pad, but was generally limited in extent to small isolated areas. No staining or dried paint was observed around the perimeter of the concrete pad. Based on observations, it appears that any spills in this area were likely minor and restricted to small localized areas on the concrete surface.

PHOTO 5: View looking northeast at backpad area. Some minor dried paint observed on concrete. main building.

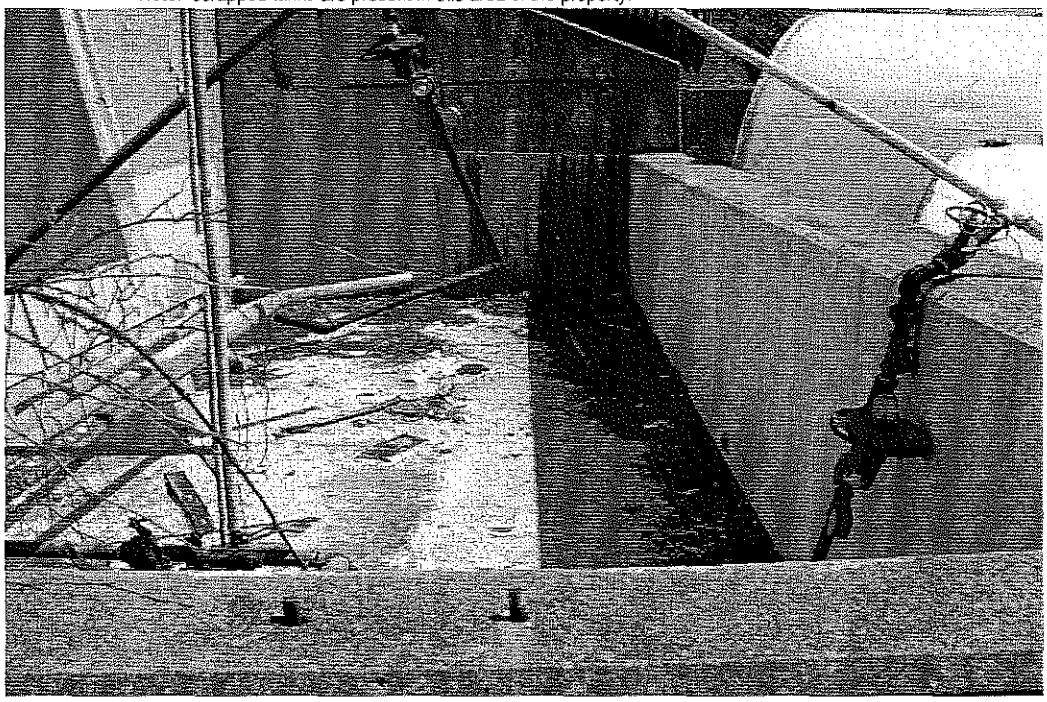
Three solvent blending tanks (AOC-1) formerly occupied an area near the southeast corner of the manufacturing building. The concrete secondary containment surrounding the three former solvent blending tanks was intact and appeared to be in good condition. The three solvent above ground storage tanks had been previously removed. No cracks were observed within the interior of the containment structure. The northern portion of the secondary containment butted against a portion of the manufacturing building. Soil, debris piles and clean, emptied above ground storage tanks were present adjacent to the containment area to the south. Inspection of the ground surface in this area was limited due to the debris covering the ground and snow and

Photo 7: View looking northeast at concrete containment that surrounding former solvent tanks. Note: scrapped tanks are present in this area of the property.

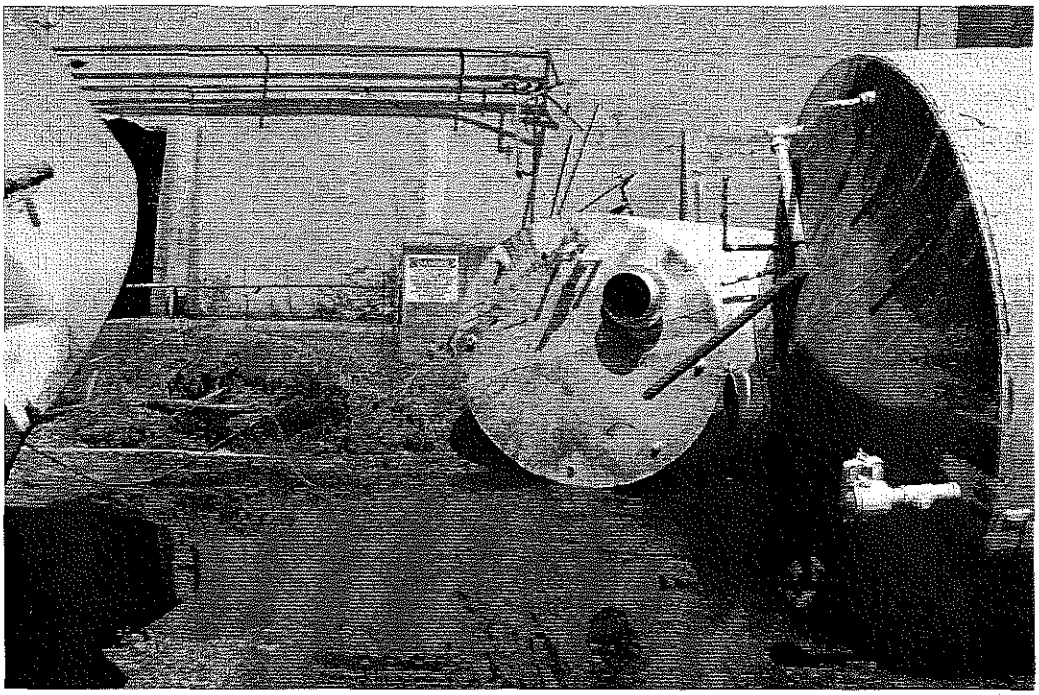
Photo 8: View looking at former solvent ASTs concrete containment structure.

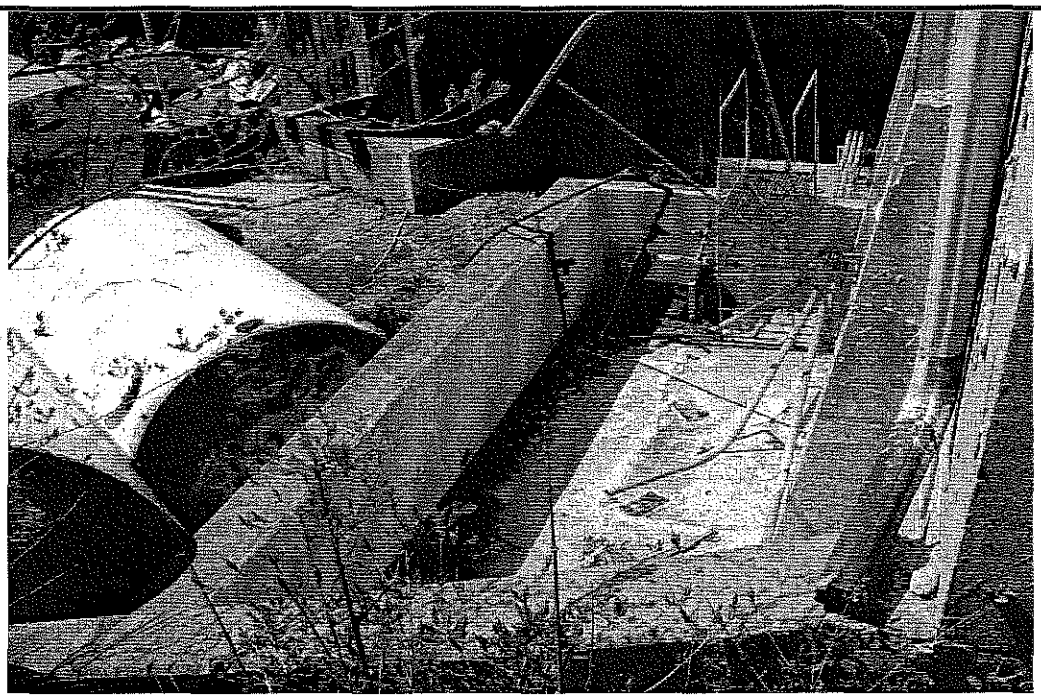
ice. In April, the debris was still observed and standing water with algae was present. No sheen was observed on the standing water and no staining or distressed vegetation was observed on the ground surface where visible.

Photo 10 Standing water, and steel tanks being stagged in the area of the former solvent tanks. AOC-1
