RE: Plan for Addressing Recommendations in the Site Assessment Report Electric Energy, Inc., Joppa Power Station.

GLOBAL STABILITY EVALUATION
EAST ASH POND
EEI JOPPA POWER GENERATING FACILITY
JOPPA, ILLINOIS

Geotechnology Project No. J017150.02

November 10, 2010

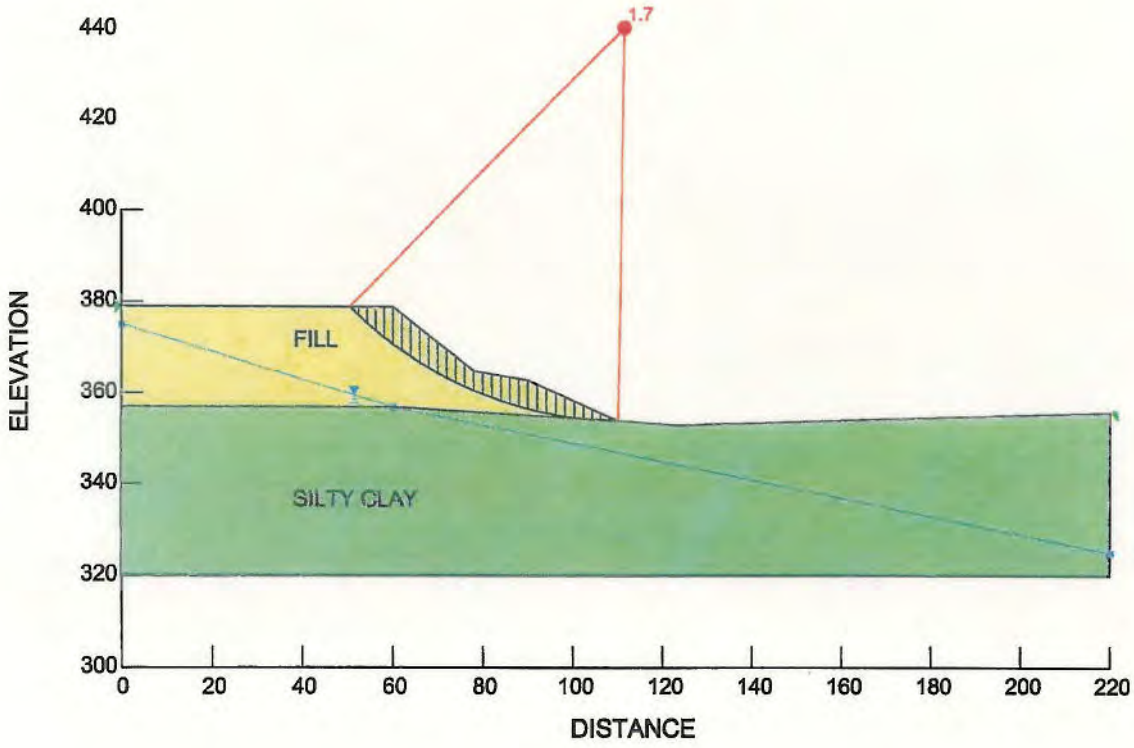
PLATE 3

SLOPE STABILITY ANALYSIS RESULTS			
Analysis Condition	**Calculated Factor of Safety**	**Target Factor of Safety**	**Reference Plate No.**
Existing Conditions, Steady State Seepage	1.7	1.5	3
Partially Saturated Slope, Steady State Seepage	1.5	1.5	4
Slope with Seismic Forces Mean Return Time 2,500 Years	0.5	1.0	5
Slope with Seismic Forces Mean Return Time 500 Years	1.0	1.0	6

We recommend a minimum factor of safety of 1.5 for long-term stability. Based on the analyses, the embankment has a factor of safety greater than the IDNR recommended factor of safety of 1.5. During an extreme event, such as an earthquake, a factor of safety of 1.0 or more is recommended. However, for a horizontal acceleration of 0.65g (mean return time 2,500 years) the resulting factor of safety was less than 1. But a factor of safety of 1.0 was calculated for a horizontal acceleration of 0.22g (mean return time 500 years).

SLOPE STABILITY CROSS SECTION A-A'
STEADY STATE SEEPAGE A - A'

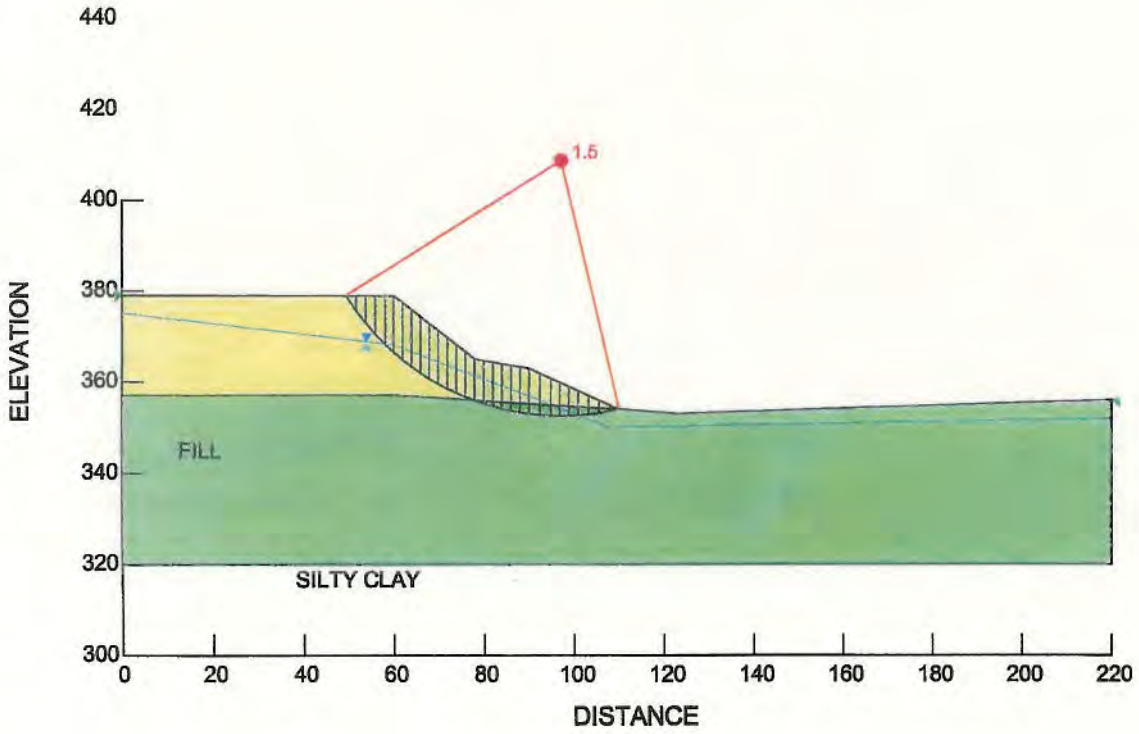
Project Number	
J017150.02	PLATE 4

2. Analysis is a parametric study of piezometric surface for a corresponding FOS=1.5. The piezometric surface shown does not represent observed conditions but represents an upper limit below which the FOS is equal to or greater than the target FOS 1.5.

SLOPE STABILITY CROSS SECTION A-A'
STEADY STATE SEEPAGE
SLOPE PARTIALLY SATURATED
