Coal Combustion Waste Impoundment

Round 7 - Dam Assessment Report

Ottumwa Generating Station (Site 012)

Fly Ash Impoundment Dikes
Alliant Energy
Ottumwa, Iowa

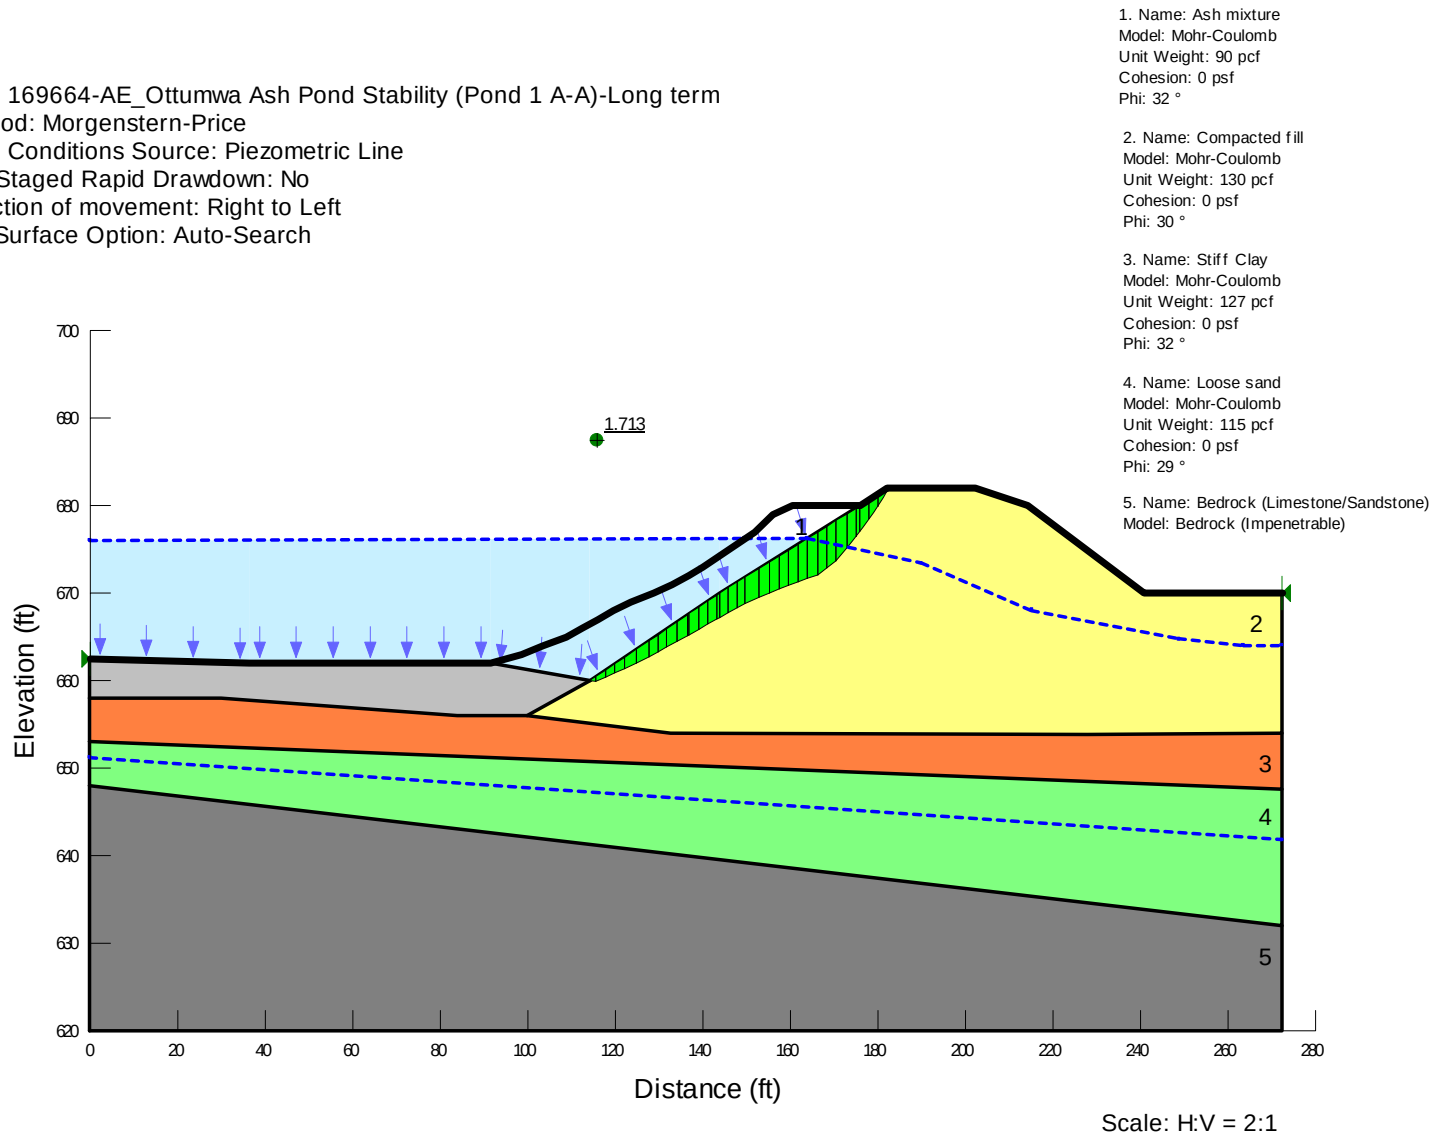
Figure 5-2
Ash Pond 1 – Long-Term Stability Evaluation Results

Based on the results of the analyses, the report concludes that the embankments have stability safety factors at or above the minimum recommended values.

Loading Condition	Required Safety Factor (U.S. Army Corps of Engineers)[1]	Main Ash Pond	Zero Liquid Discharge Pond
Long-Term Stability	1.5	1.71	2.14
Rapid Drawdown Stability	1.2	2.14	2.41
Seismic Stability	1.2	2.57	1.96
