Coal Combustion Dam Inspection Checklist Form

| Site Name: Progress Energy Asheville | Date: 29 MAY 2009 |
| Unit Name: 1964 POND | Operator's Name: Progress ENERGY |

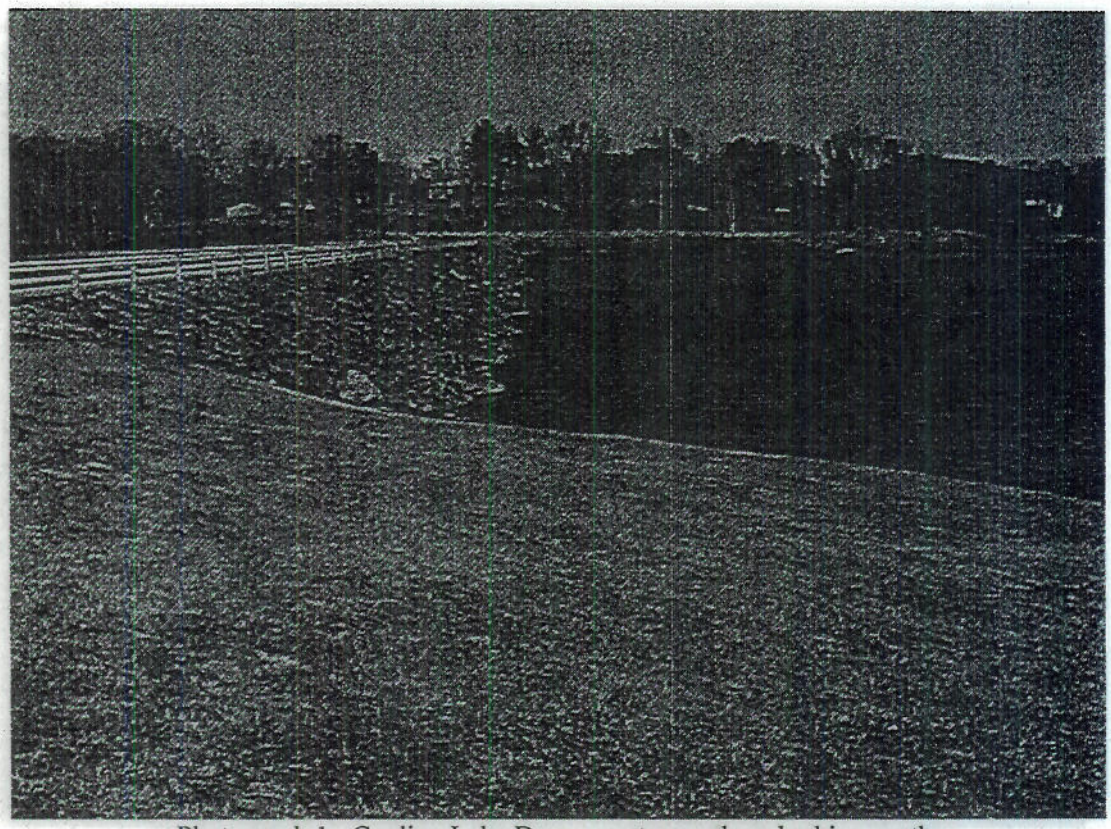
Photograph 1: Cooling Lake Dam – upstream slope looking north.

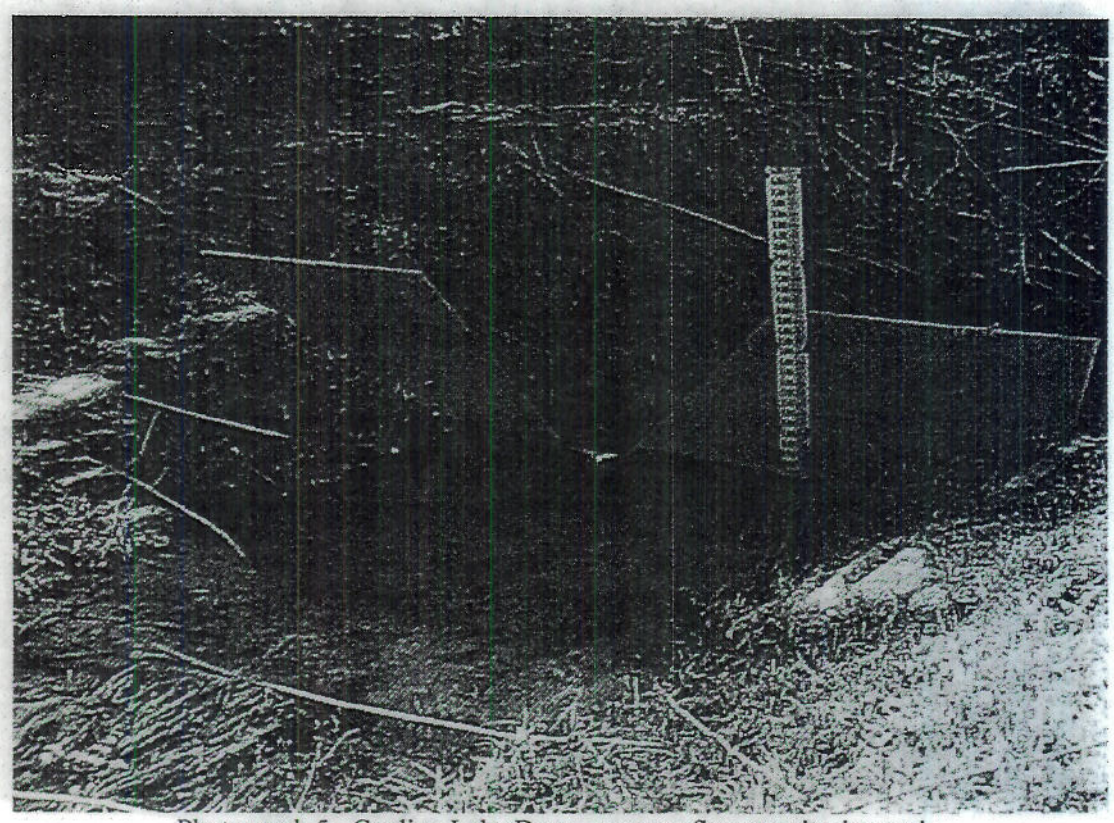
Photograph 5: Cooling Lake Dam - seepage flow monitoring weir.

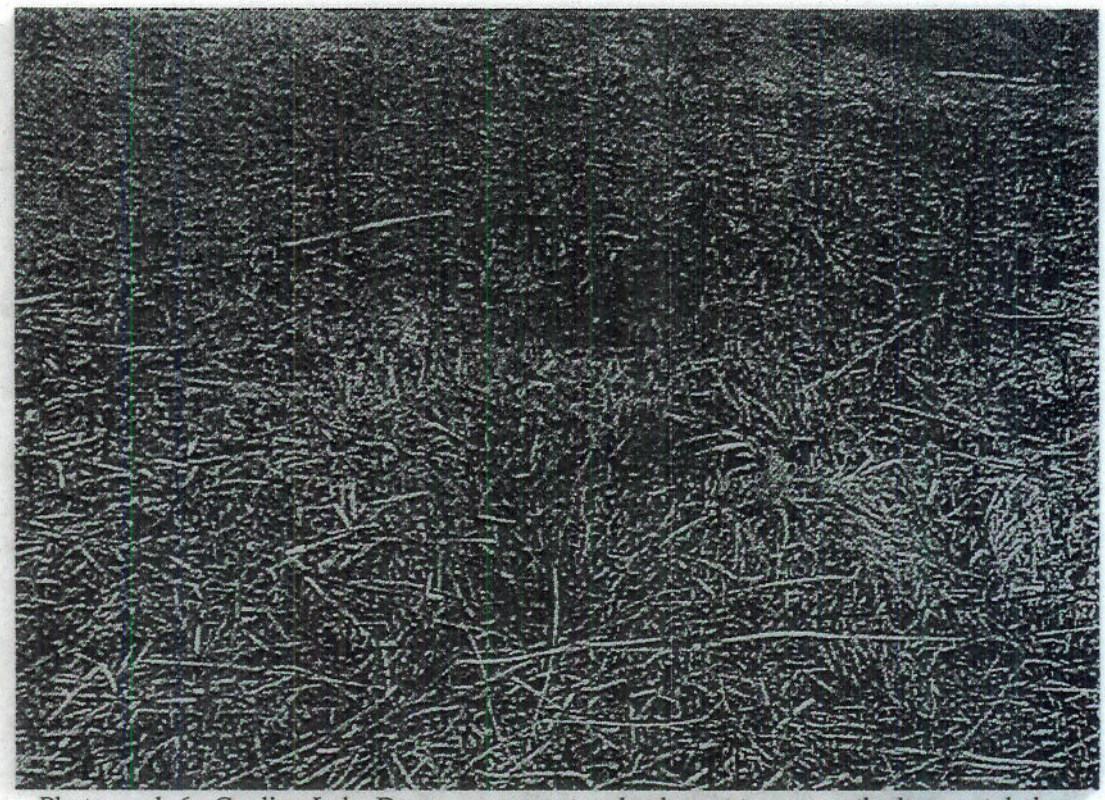
Photograph 6: Cooling Lake Dam – seepage at embankment toe on north abutment, below piezometer P-8, no soil transport noted, orange color from algae).

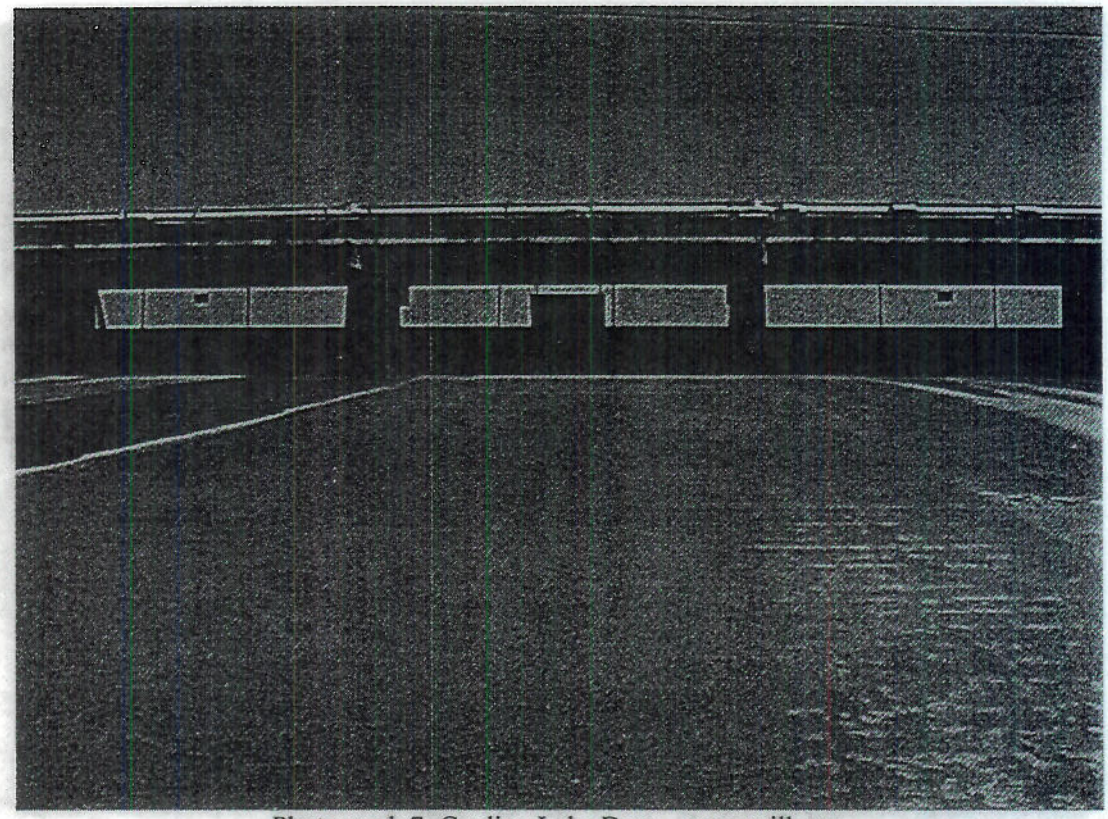
Photograph 7: Cooling Lake Dam – ogee spillway.

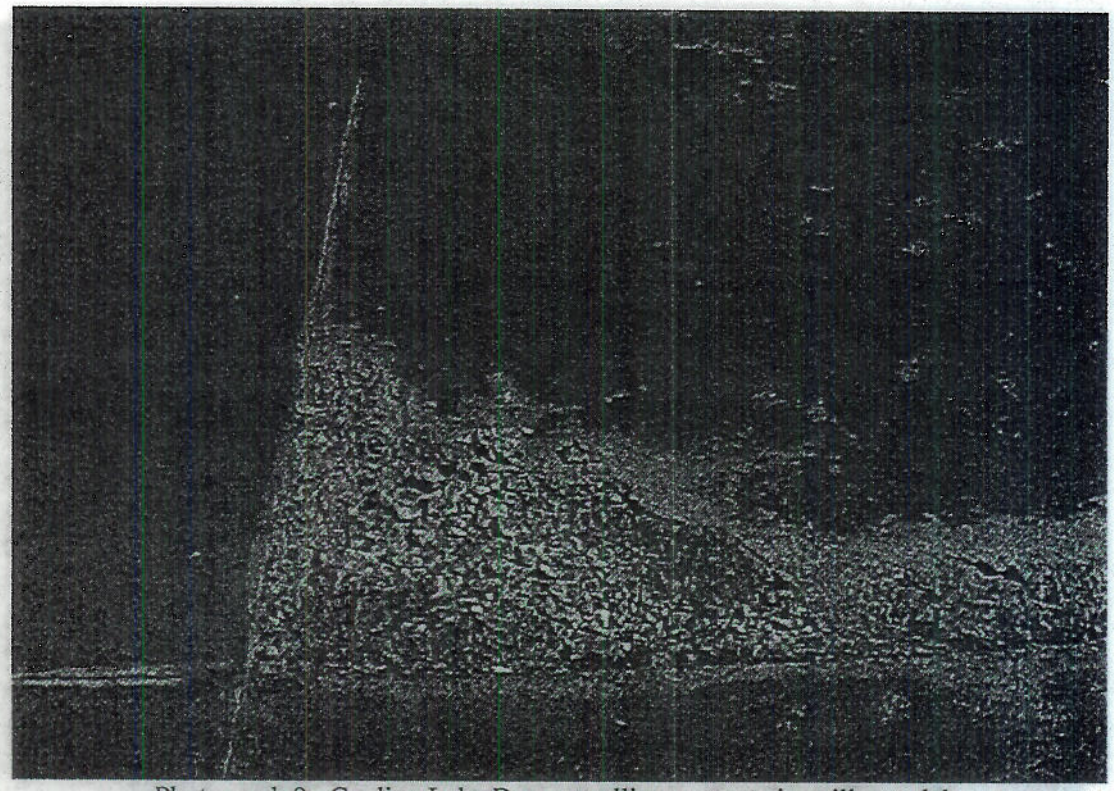
Photograph 9: Cooling Lake Dam – spalling concrete in spillway slab.

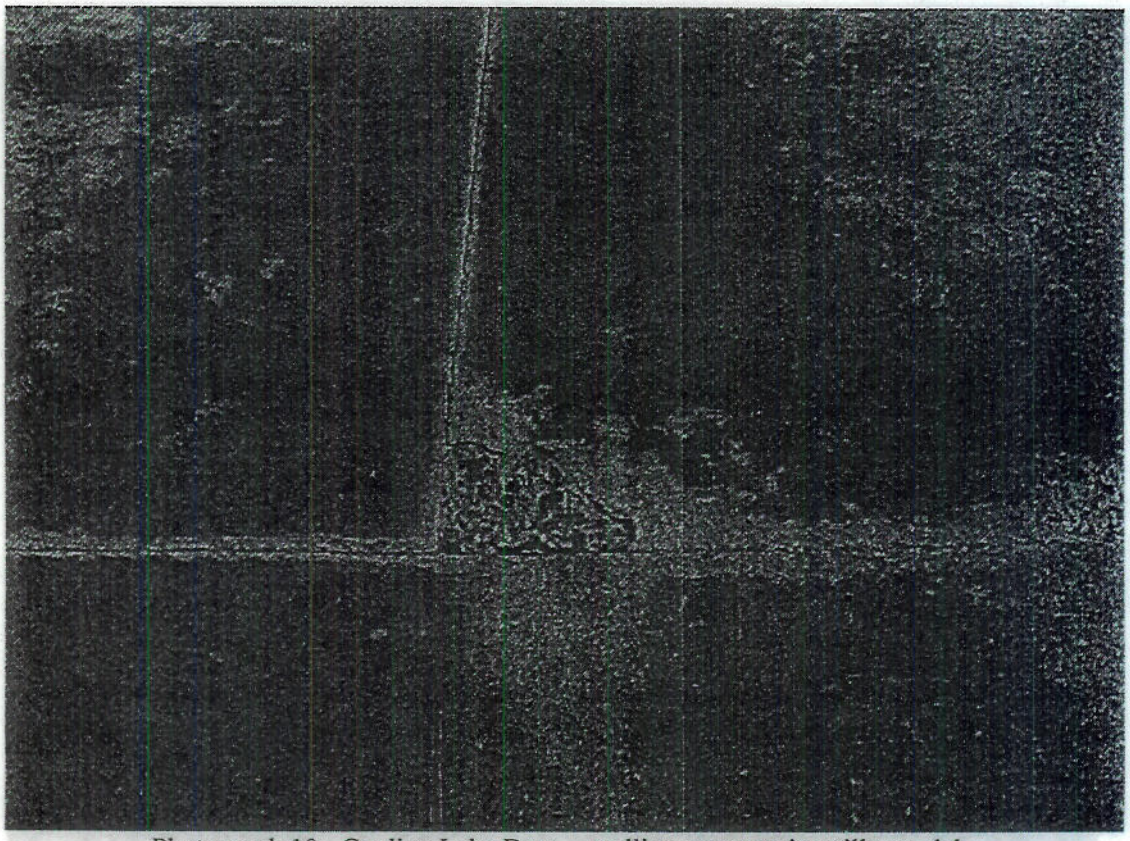
Photograph 10: Cooling Lake Dam – spalling concrete in spillway slab.

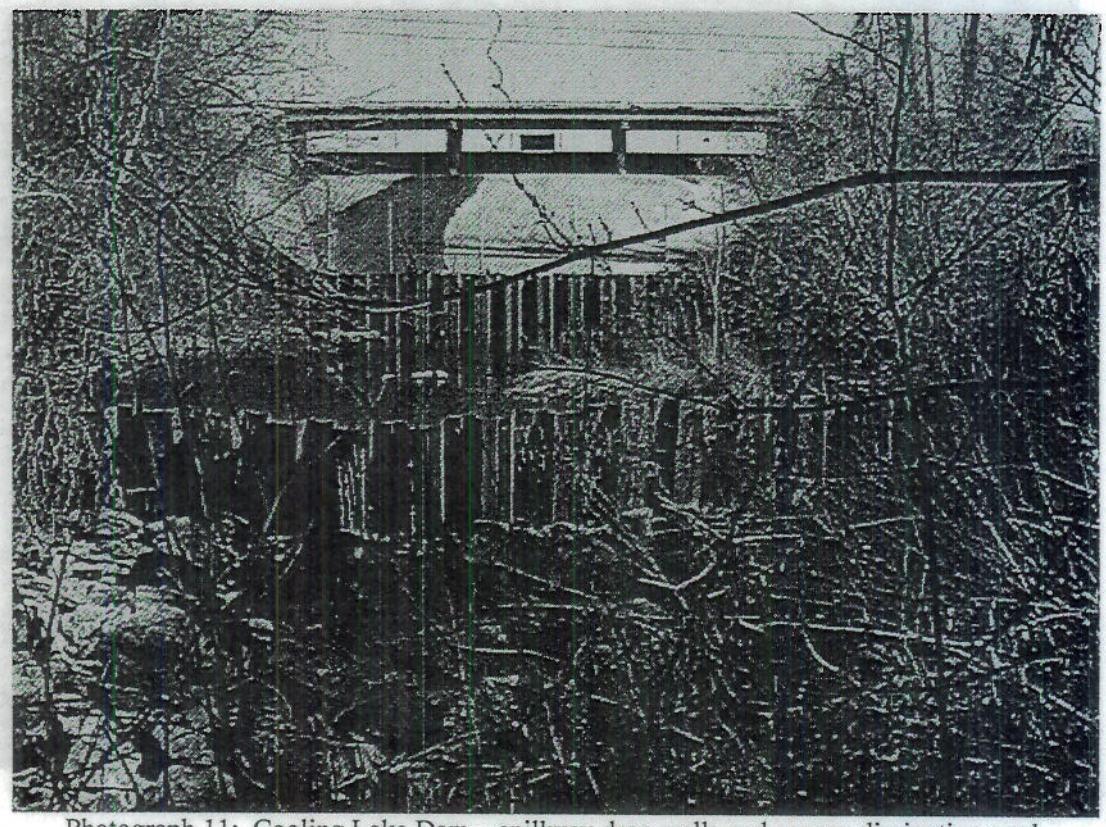
Photograph 11: Cooling Lake Dam – spillway drop walls and energy dissipation pool.

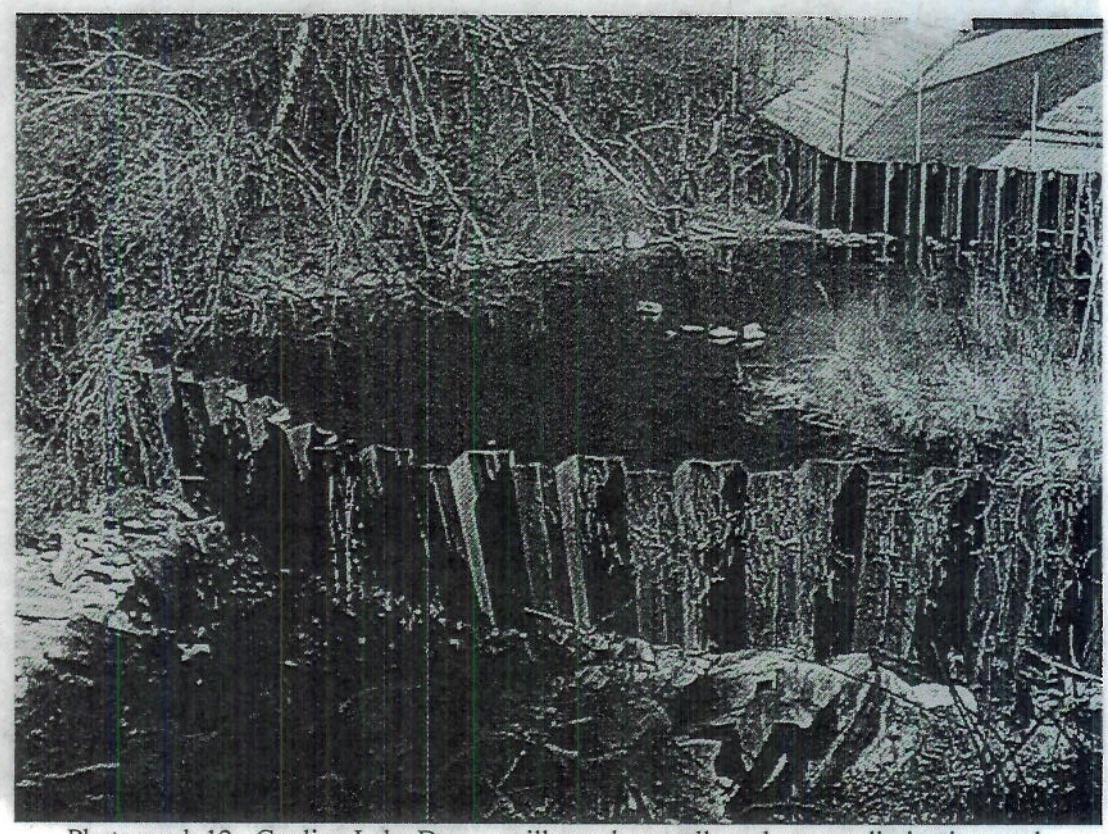
Photograph 12: Cooling Lake Dam – spillway drop walls and energy dissipation pool.

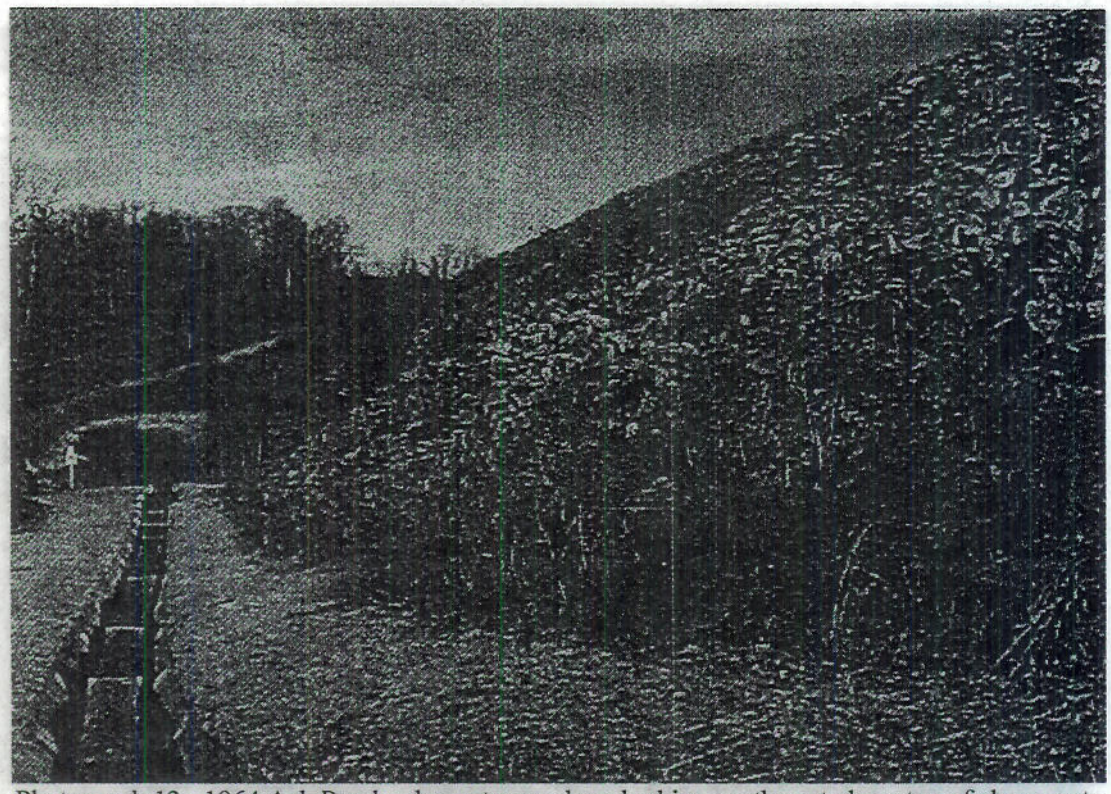
Photograph 13: 1964 Ash Pond – downstream slope looking northwest along toe of slope, note bushes growing in riprap.

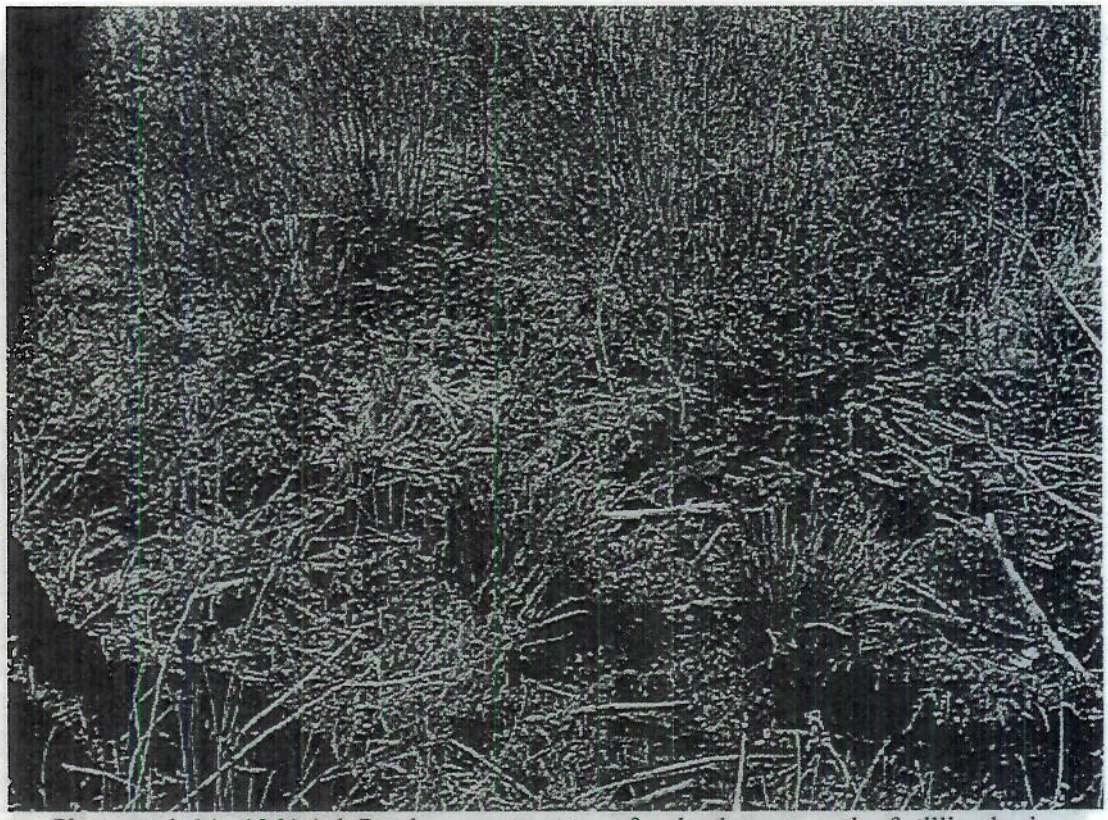
Photograph 14: 1964 Ash Pond – seepage at toe of embankment, north of stilling basin.

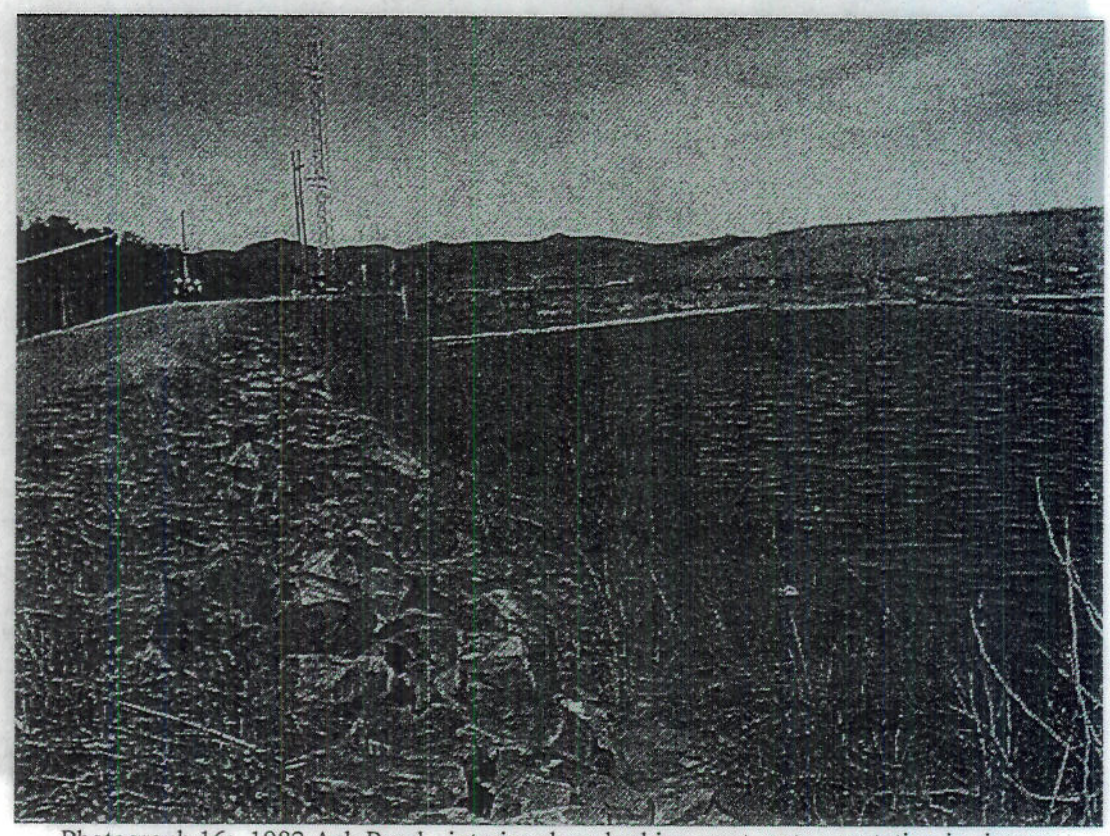
Photograph 16: 1982 Ash Pond - interior slope looking west, note vegetation in rip rap.

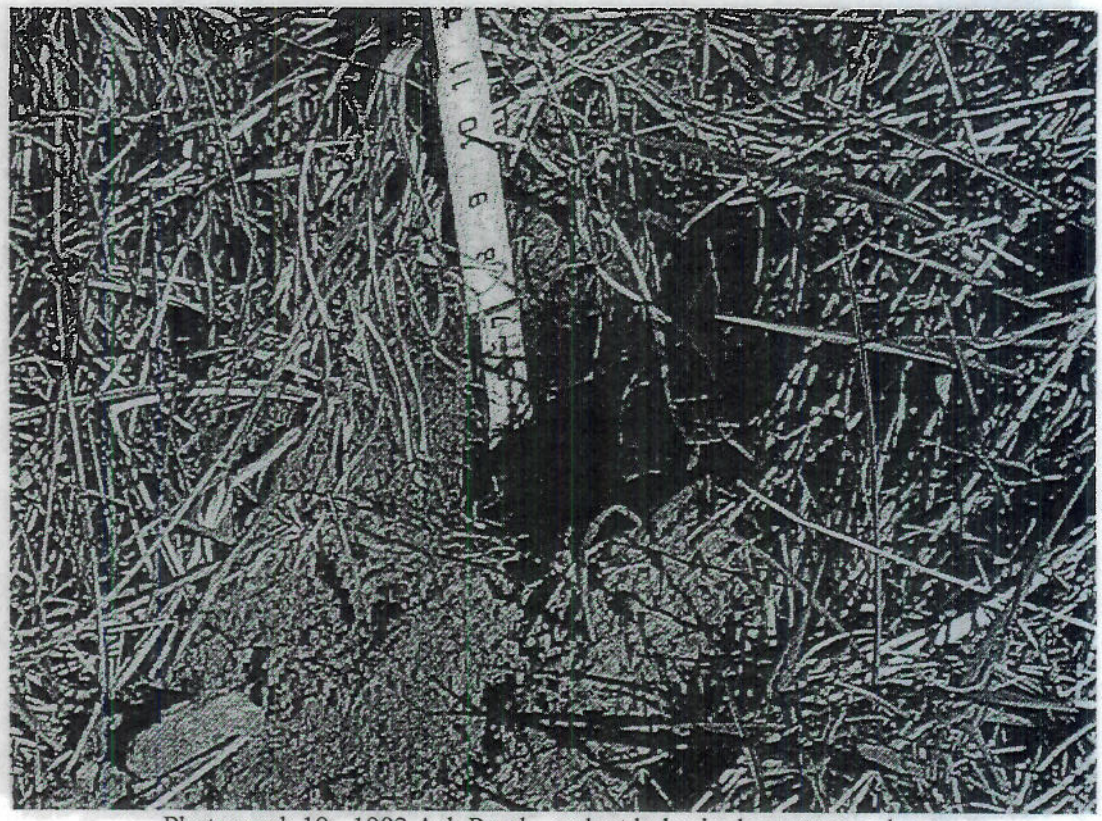
Photograph 19: 1982 Ash Pond – rodent holes in downstream slope.

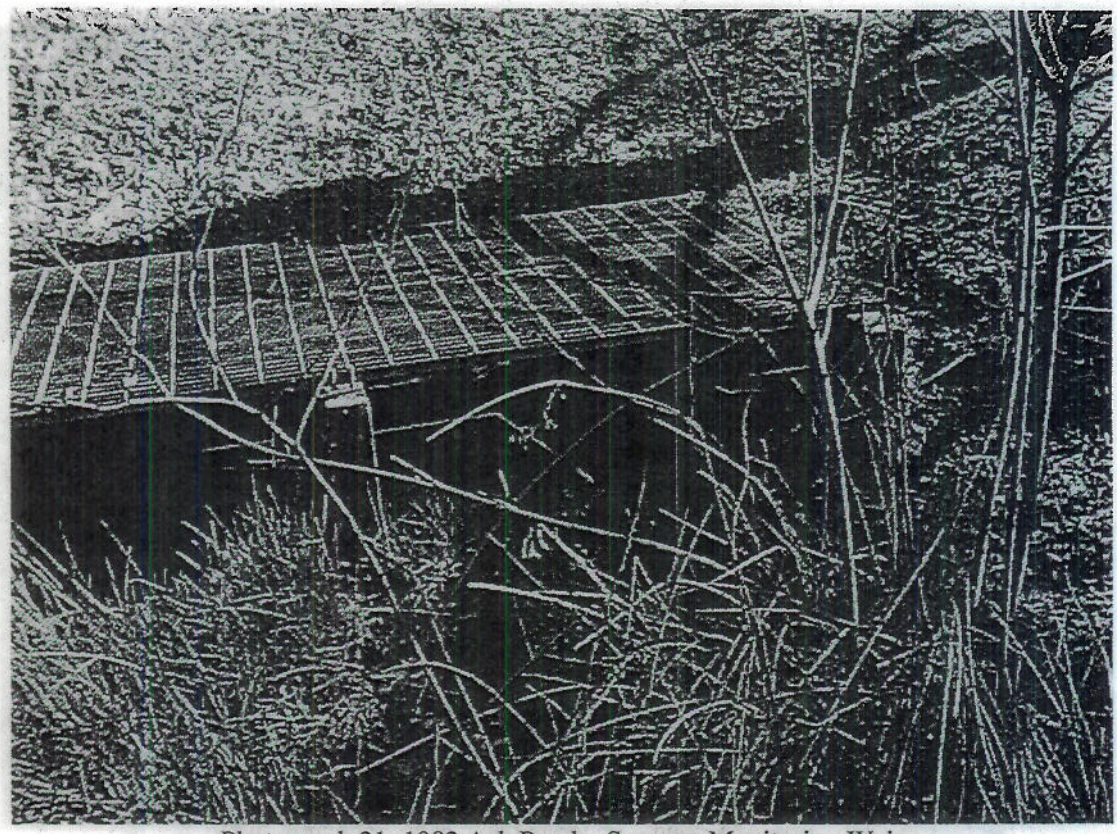
Photograph 21: 1982 Ash Pond – Seepage Monitoring Weir

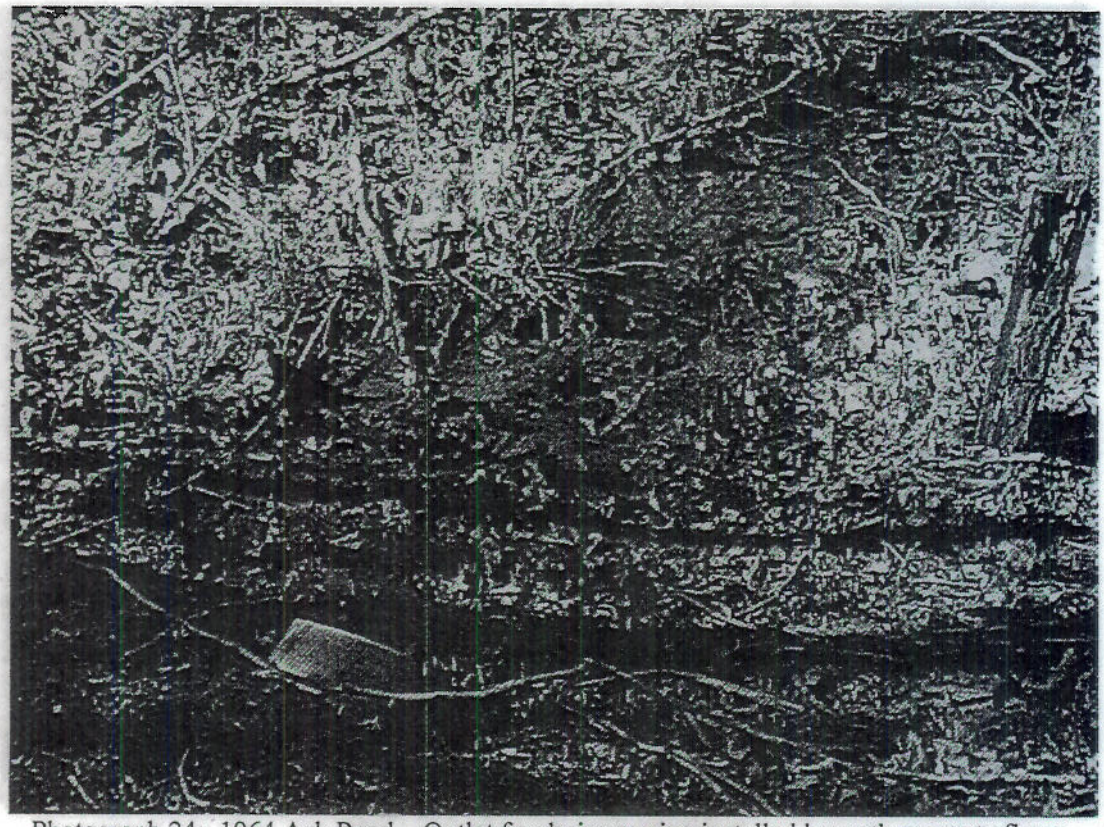
Photograph 24: 1964 Ash Pond – Outlet for drainage pipe installed beneath concrete flume.

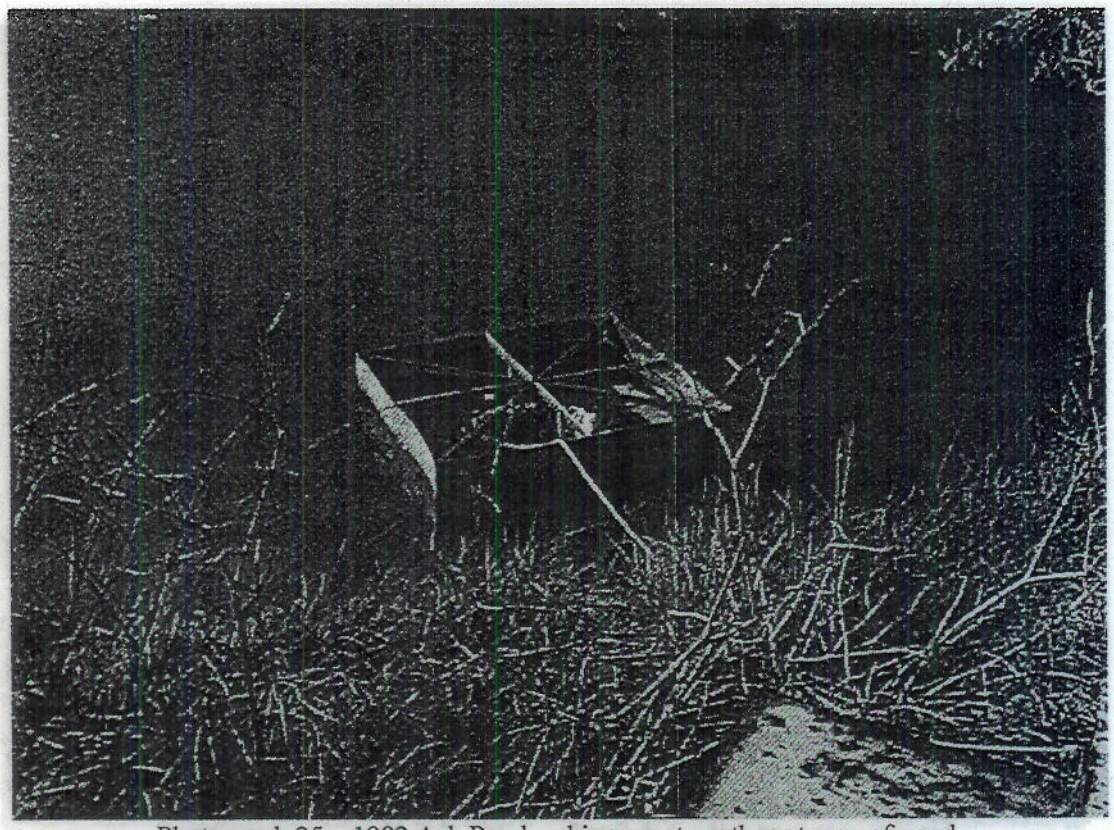
Photograph 25 – 1982 Ash Pond – skimmer at southwest area of pond.

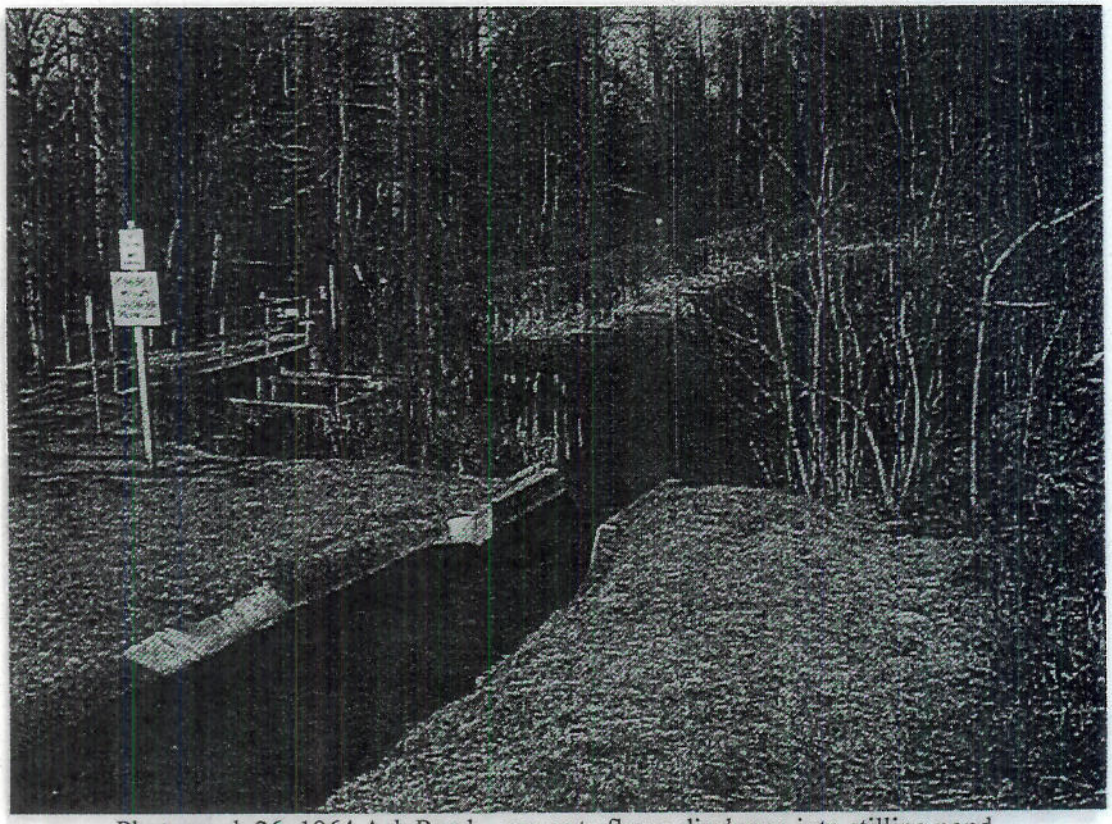
Photograph 26: 1964 Ash Pond – concrete flume discharge into stilling pond.

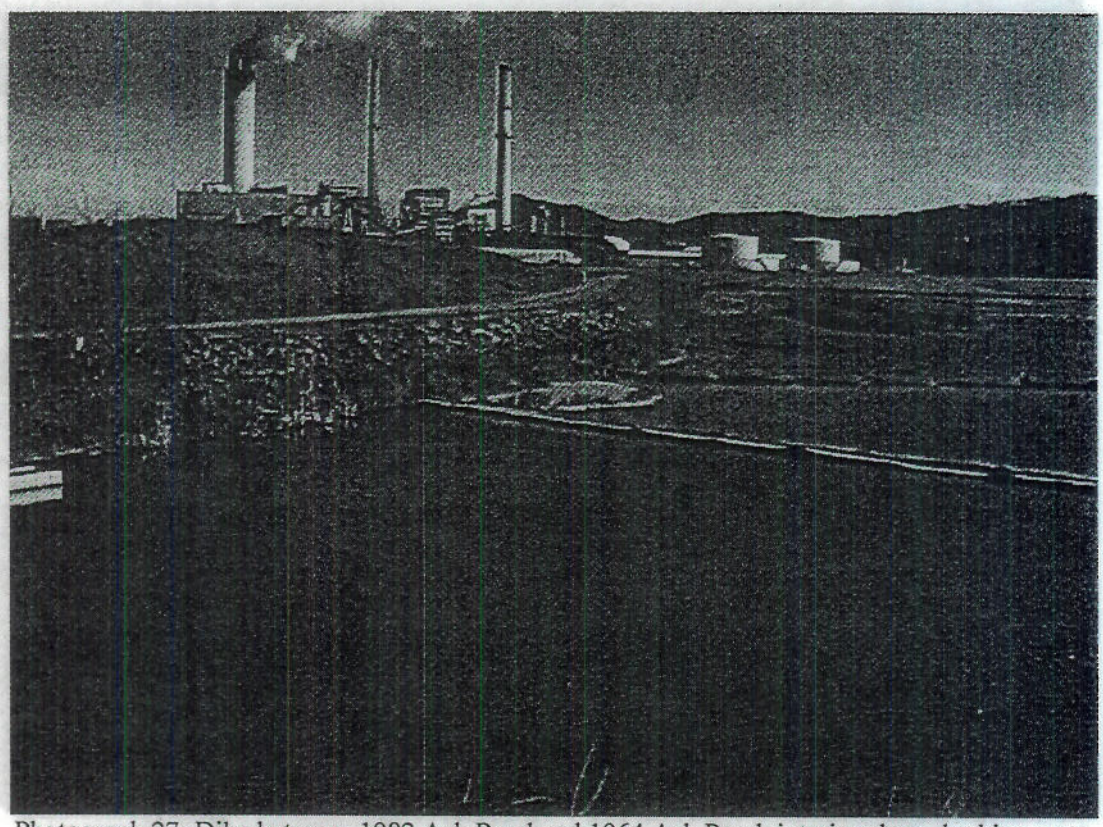
Photograph 27: Dike between 1982 Ash Pond and 1964 Ash Pond, interior slope, looking west.

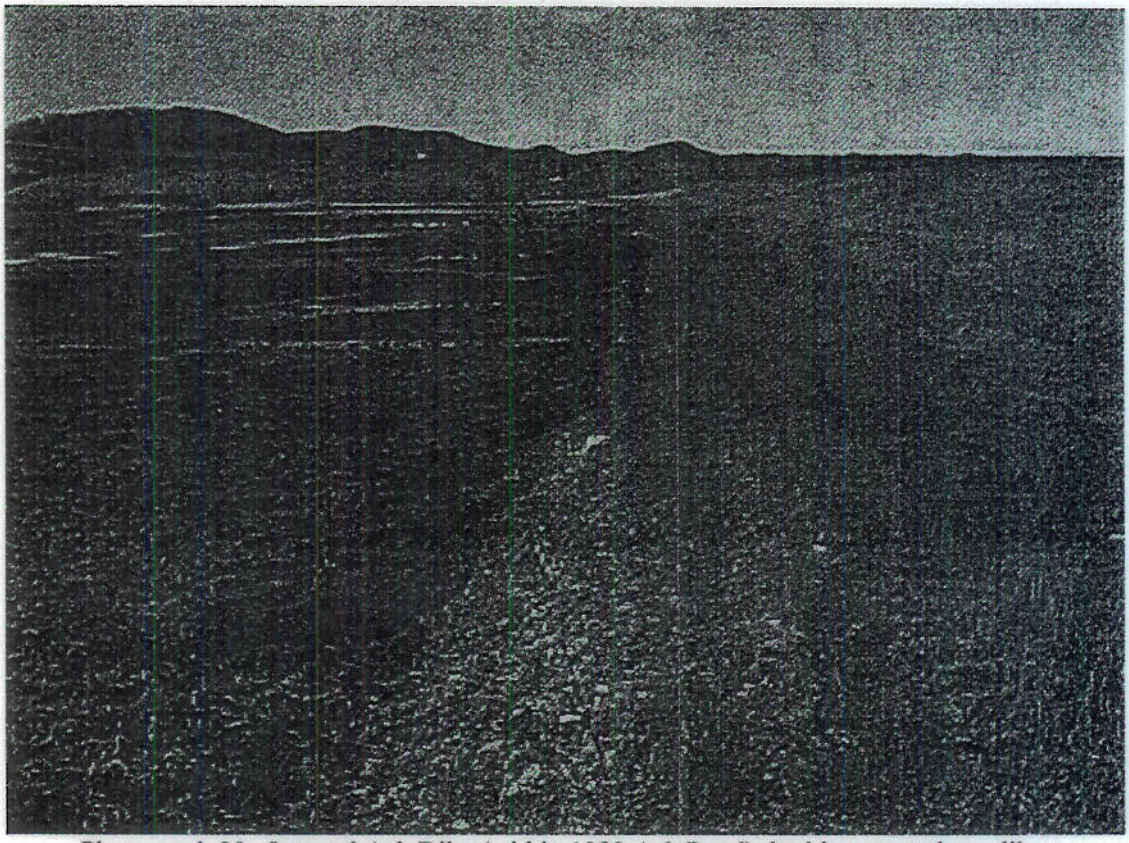
Photograph 29: Internal Ash Dike (within 1982 Ash Pond), looking west along dike.

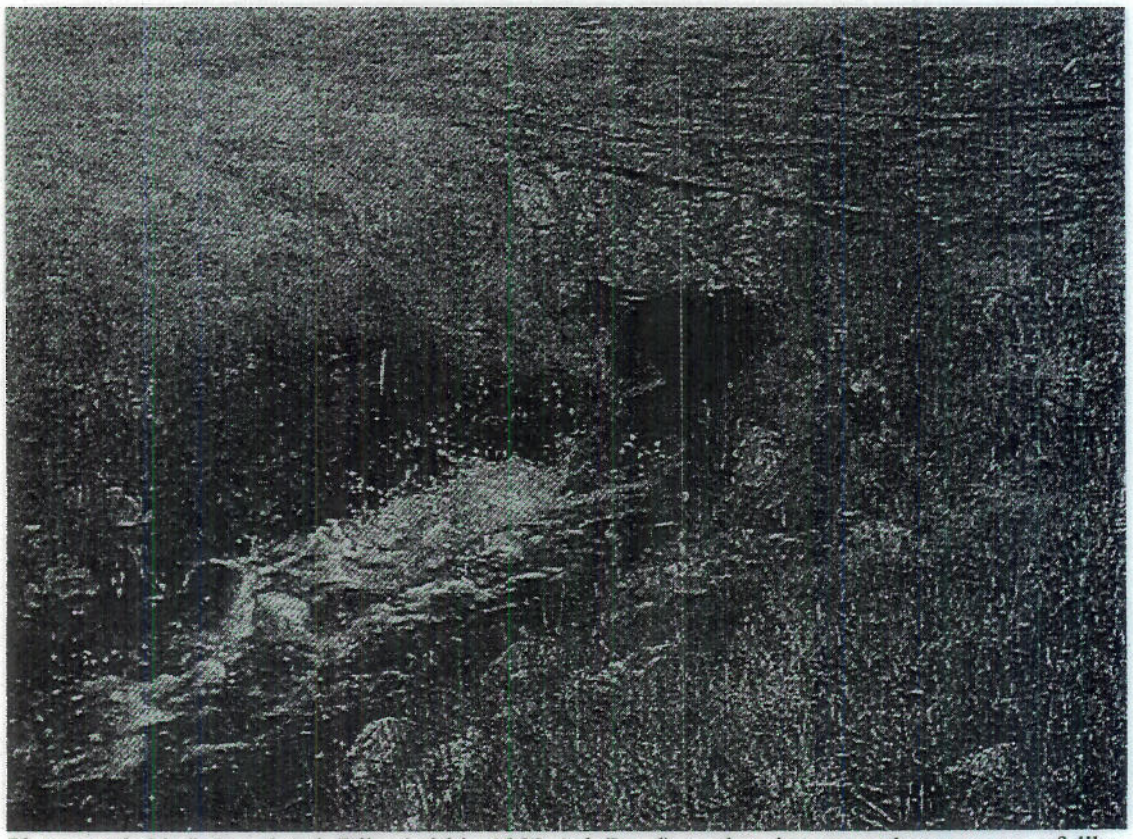
Photograph 30: Internal Ash Dike (within 1982 Ash Pond), outlet pipe at southeast corner of dike.

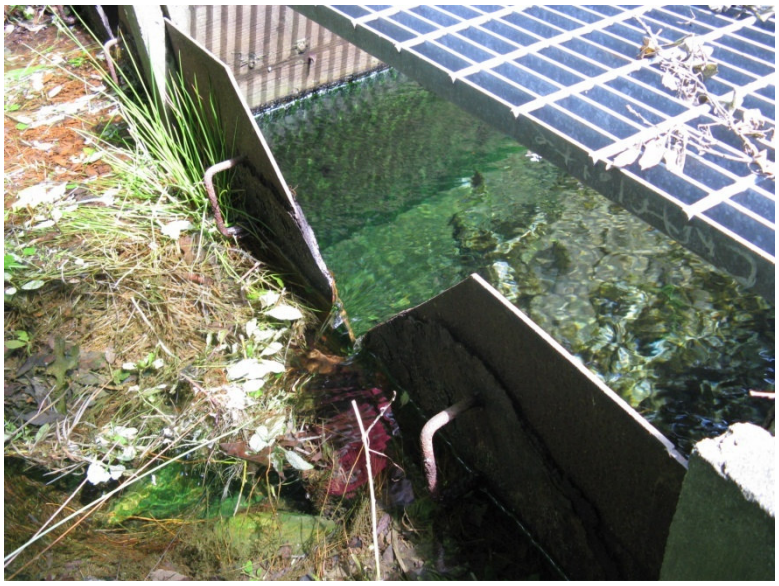
Photo 11: 1982 Dam - Crest and Downstream Embankment, Crest (Right Side), Photo: 021, 5/29/09
(note: right and left are based on the observer facing downstream)
