CCW IMPOUNDMENTS INSPECTION REPORT

BRUCE MANSFIELD POWER PLANT
BEAVER COUNTY, PENNSYLVANIA

PROJECT NO. 09-4157
OCTOBER 2009

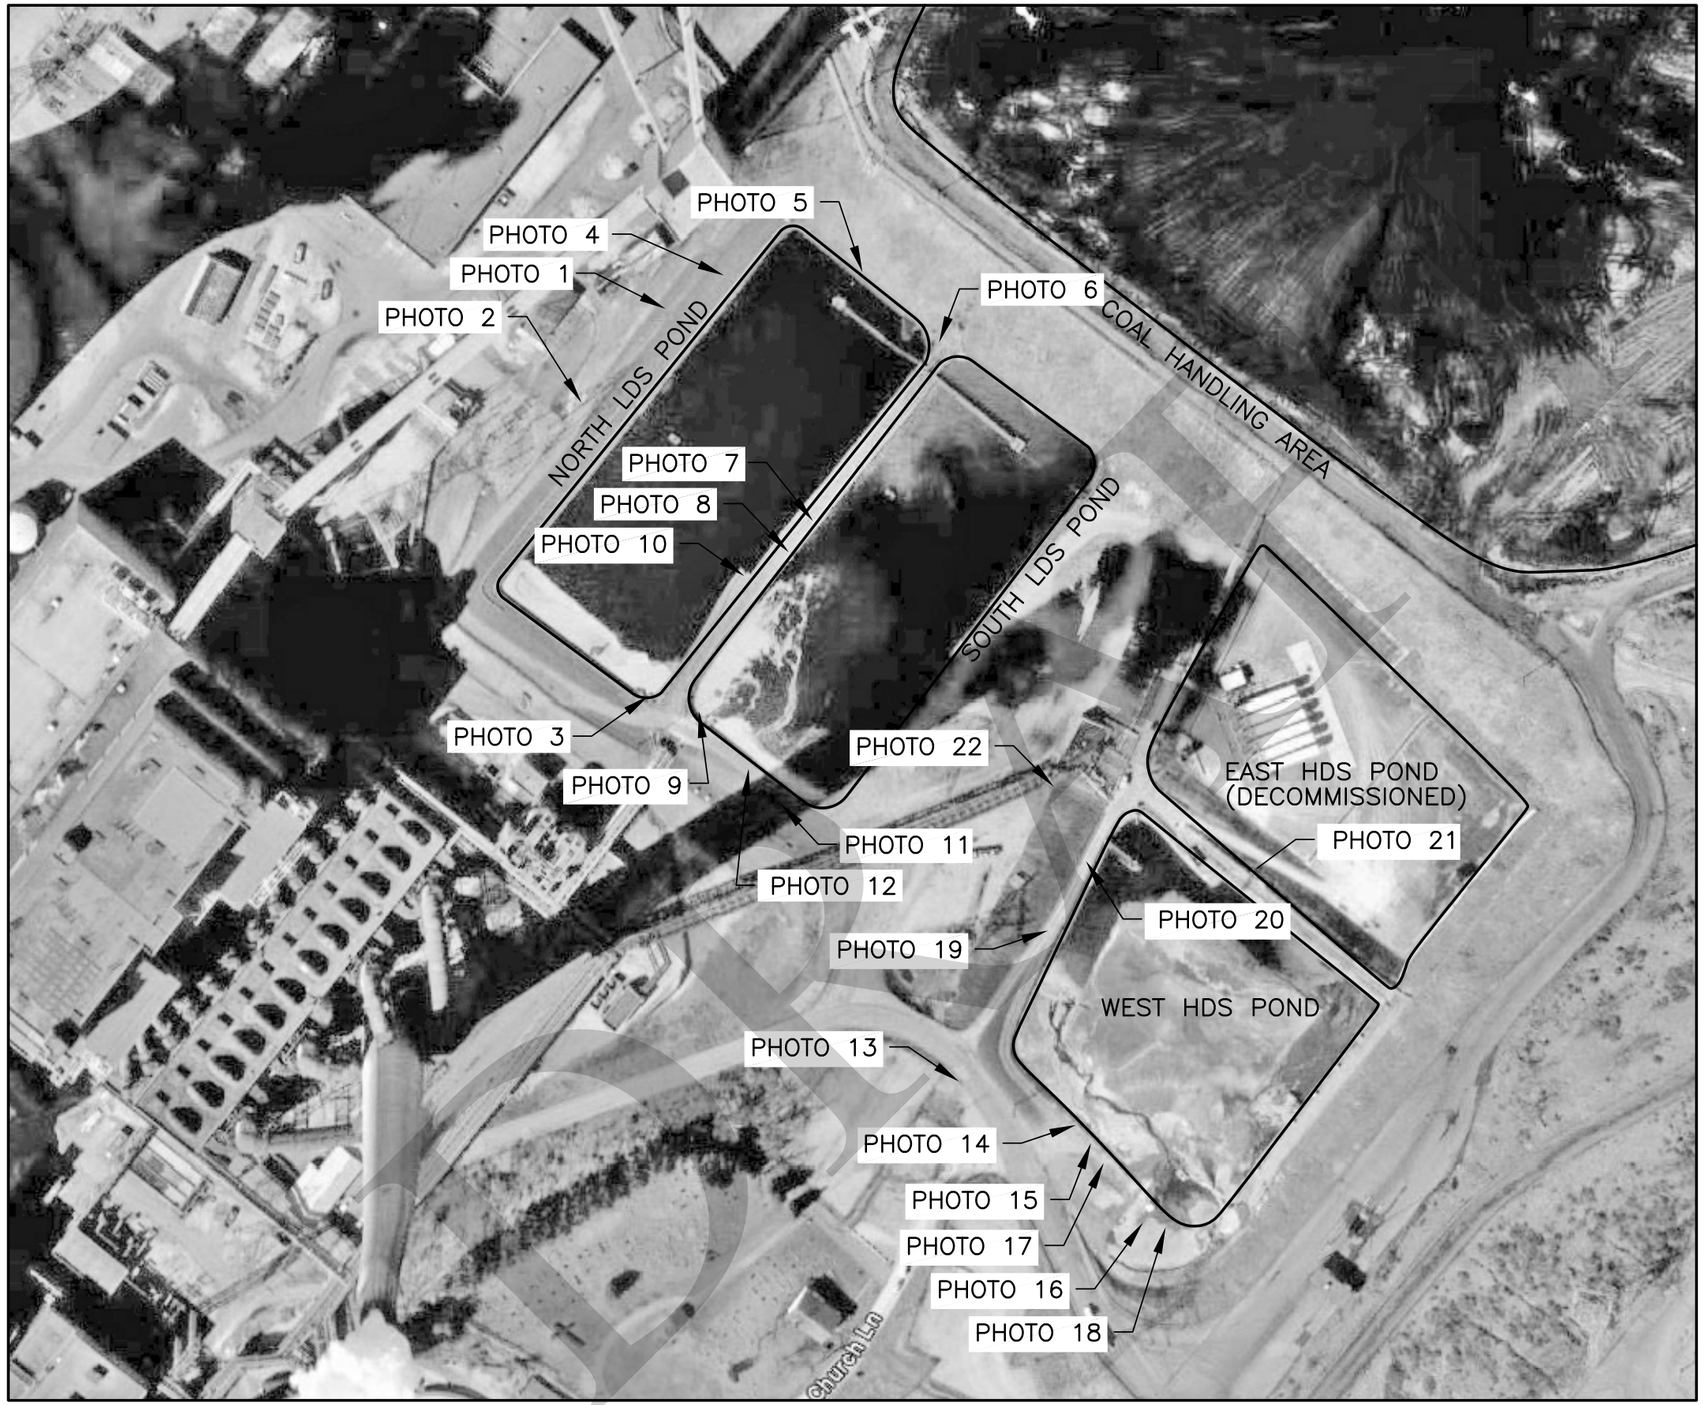
FIGURE 3-1

The Site inspection was conducted on September 1, 2009. The inspection team consisted of representatives from First Energy, GAI, the PADEP, the USEPA, and RIZZO. The team stopped at each of the Project features to inspect the structures and the surrounding area. Particular attention was paid to Site features that may contribute to typical failure modes of embankment structures, such as settlement, seepage, and slope stability. Photographs taken during the site inspection are provided in ***Appendix B***, and their locations are shown on ***Figure 3-1***.

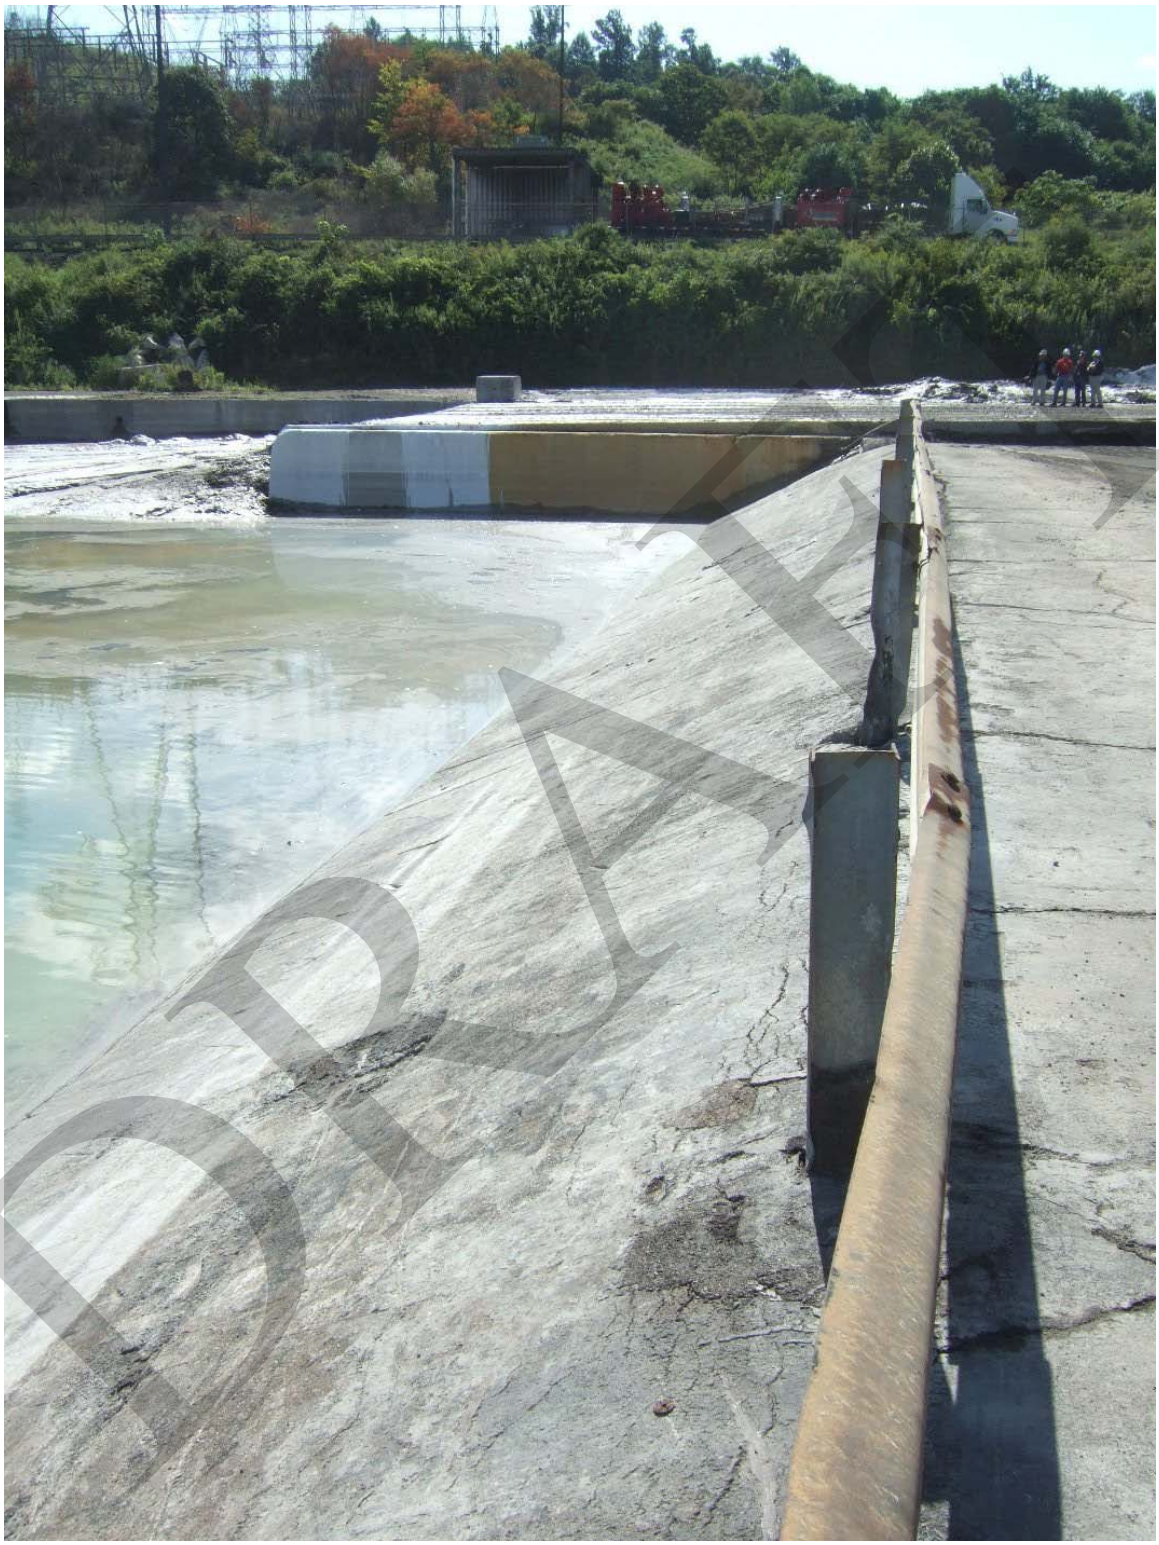
PHOTO 16: CLOSEUP OF SOUTH WALL OF WEST HDS POND

PHOTO 17: TRUCK DUMP AREA OF WEST HDS POND

PHOTO 18: WEST HDS POND LOOKING EAST

PHOTO 19: ALONG NORTH CREST OF WEST HDS POND

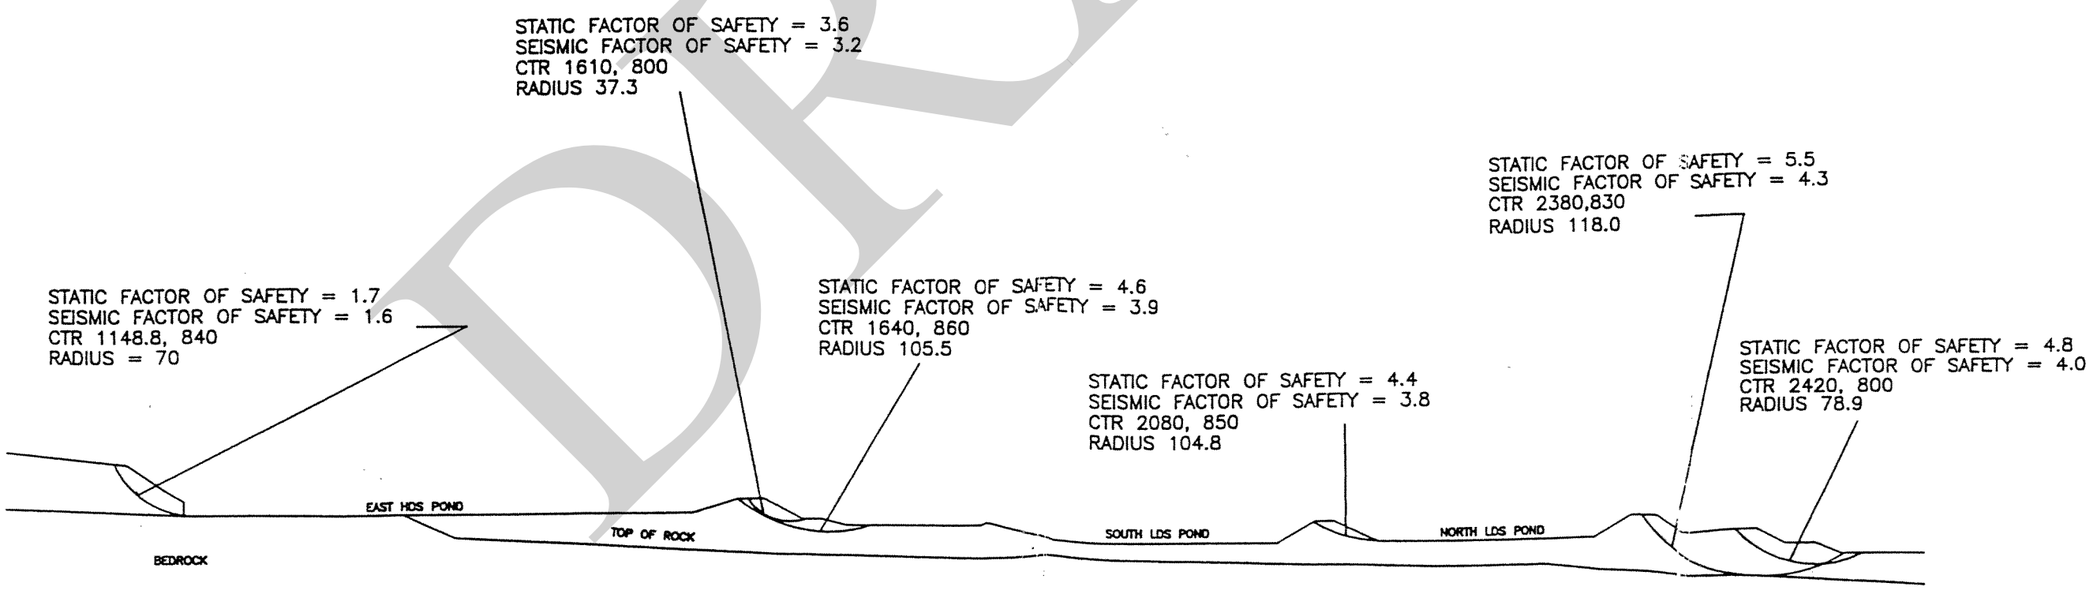
SOIL PARAMETERS:	MINIMUM FACTOR OF SAFETY:
UNIT WEIGHT = 120 pcf	STATIC = 1.7
COHESION = 500 psf	SEISMIC = 1.6
FRICTION ANGLE = 30 degrees	⊕CTR 1148.75, 840
	RADIUS = 70
