COAL ASH IMPOUNDMENT SITE ASSESSMENT FINAL REPORT

LAKE ROAD GENERATING STATION
KCP&L Greater Missouri Operations Company
ST. JOSEPH, MISSOURI

COAL ASH IMPOUNDMENT
SITE ASSESSMENT REPORT

KLEINFELDER PROJECT NUMBER 116664-2

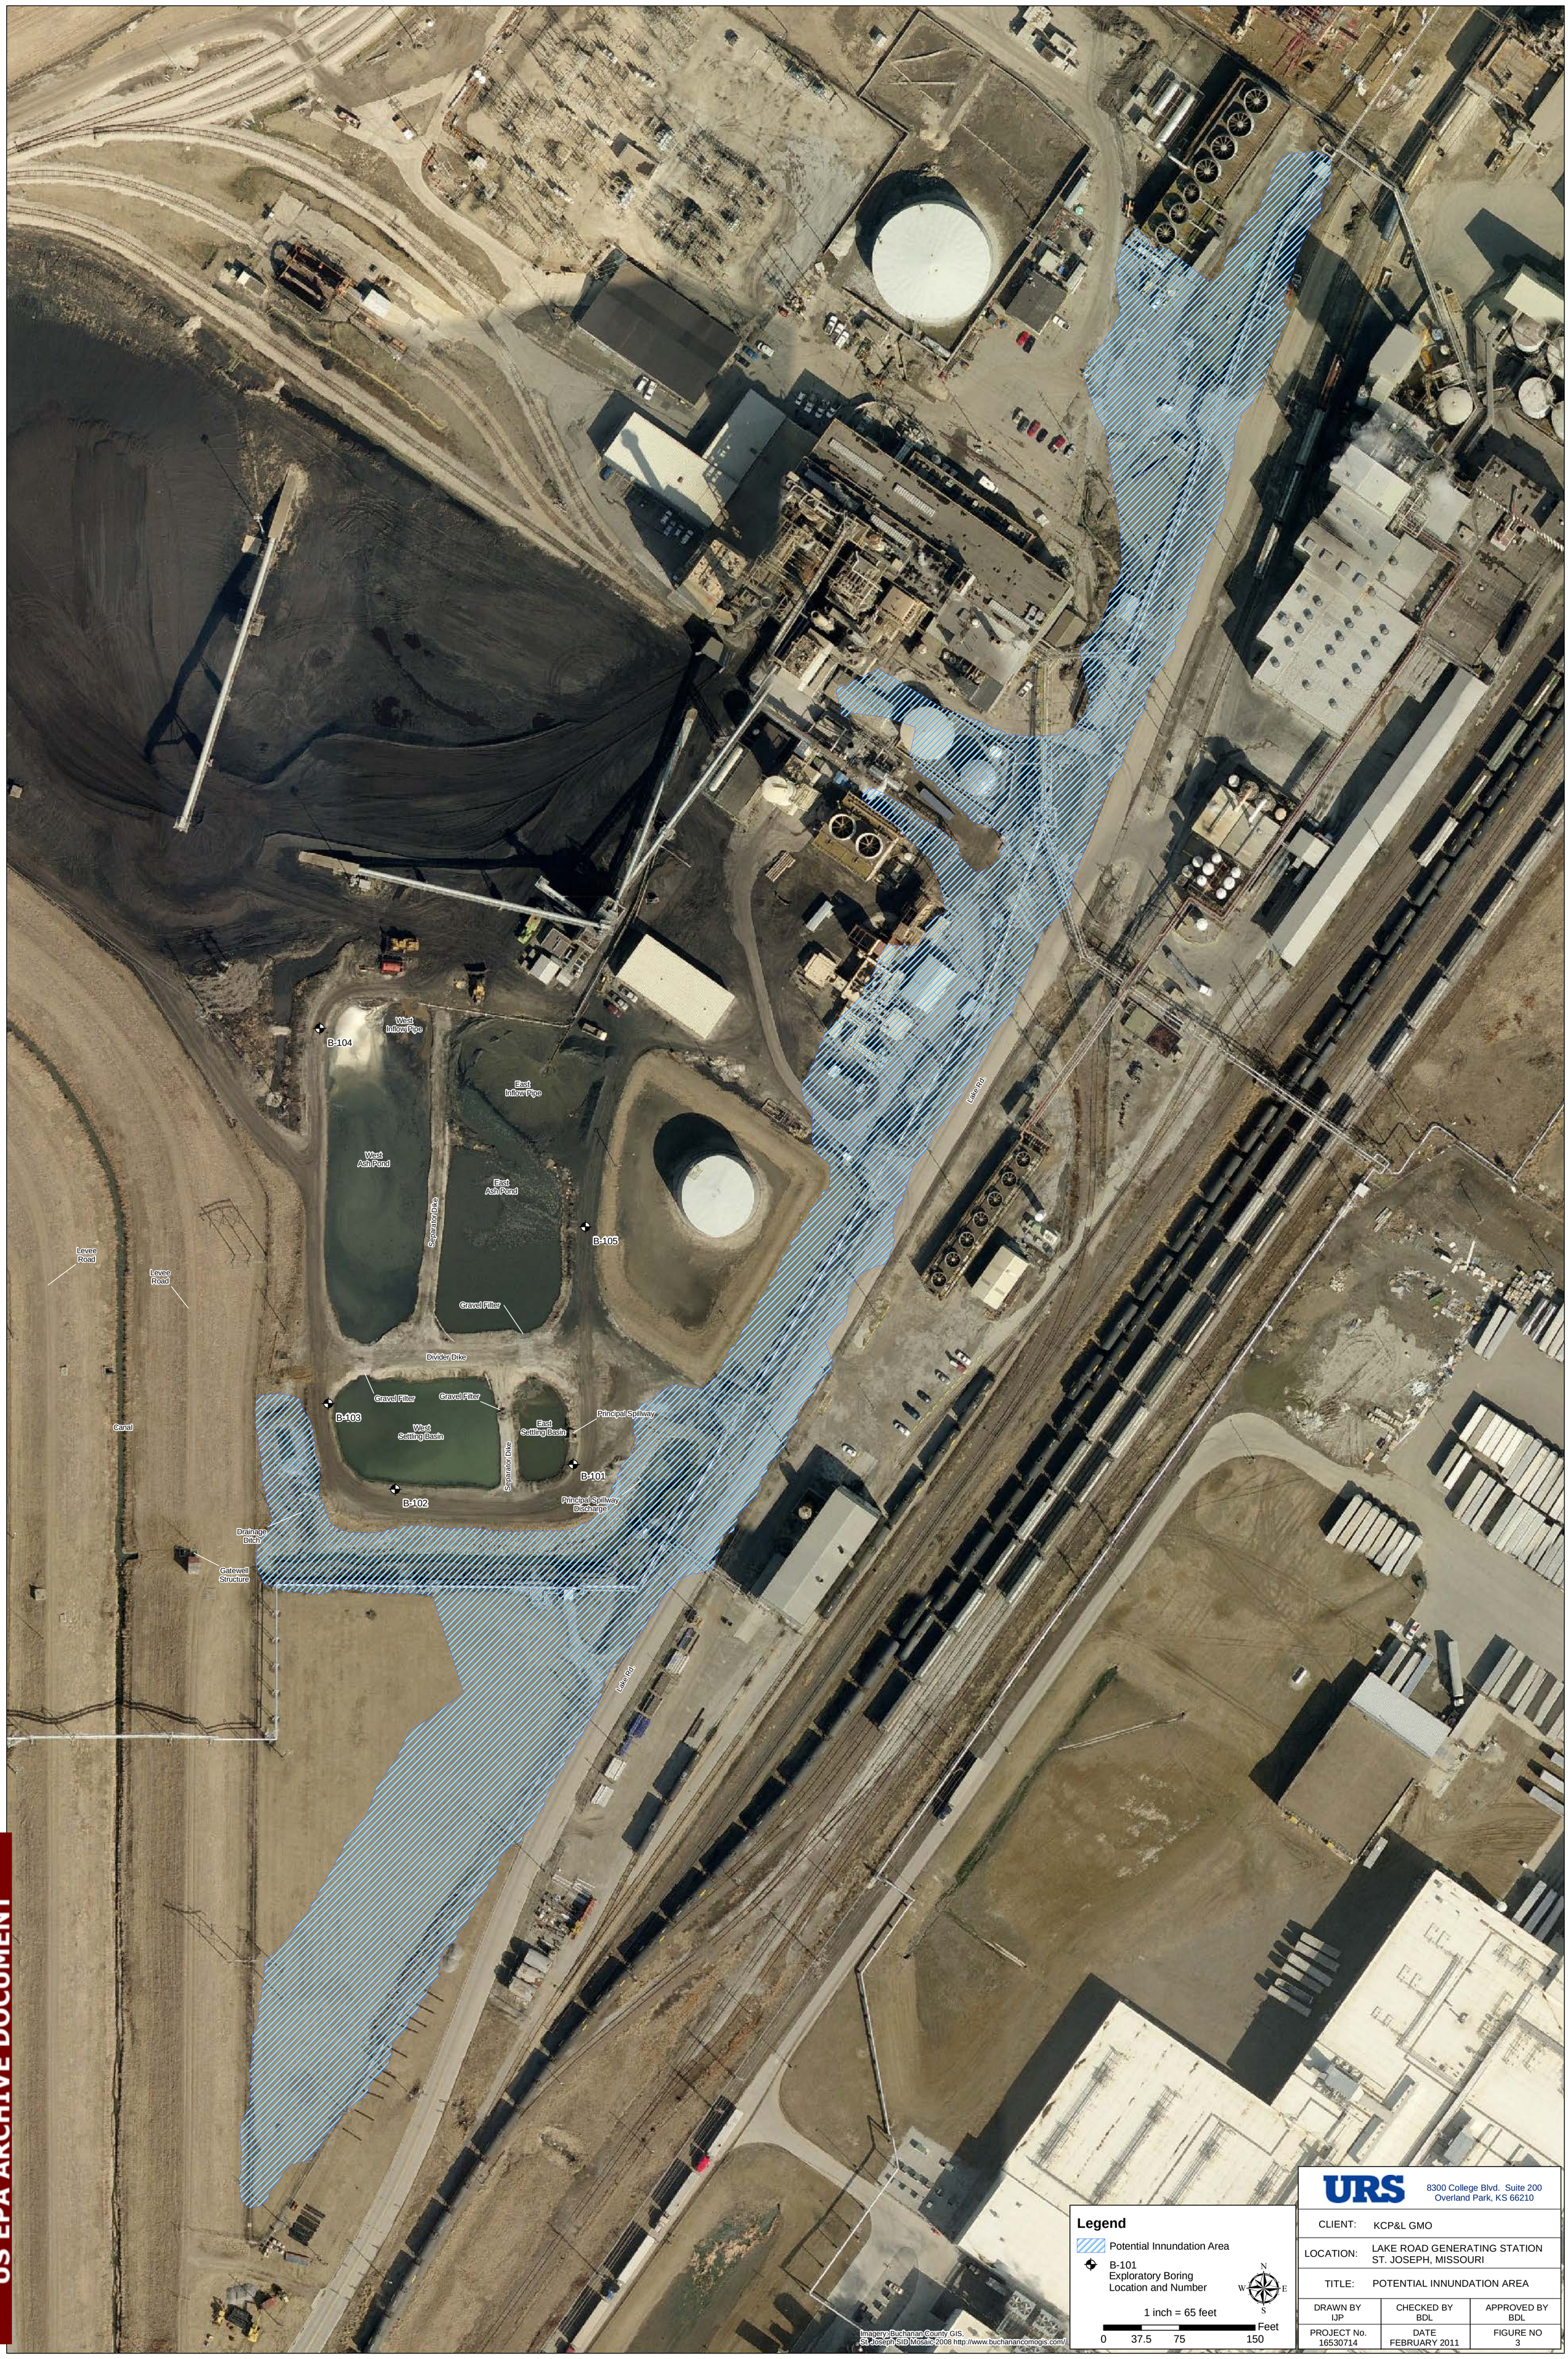
DRAWN BY	CHECKED BY	APPROVED BY
IJP	BDL	BDL
PROJECT No.	DATE	FIGURE NO
16530714	FEBRUARY 2011	3

- Potential inundation area was analyzed by URS in the the February 2011 Geotechnical Evaluation Report and most of the flooded area would remain on KCP&L property, with some water reaching Lake Road. Report shows "depth of water in the operational areas of the facility will not exceed a foot."
- Loss of human life is not anticipated since inundated area is mostly on KCP&L property.
- A Slide gate at the discharge under the levee can stop contaminated flow to the canal and river.
