Assessment of Dam Safety
Coal Combustion Surface Impoundments (Task 3)
Draft Report

PacifiCorp

Naughton Power Station

Kemmerer, Wyoming

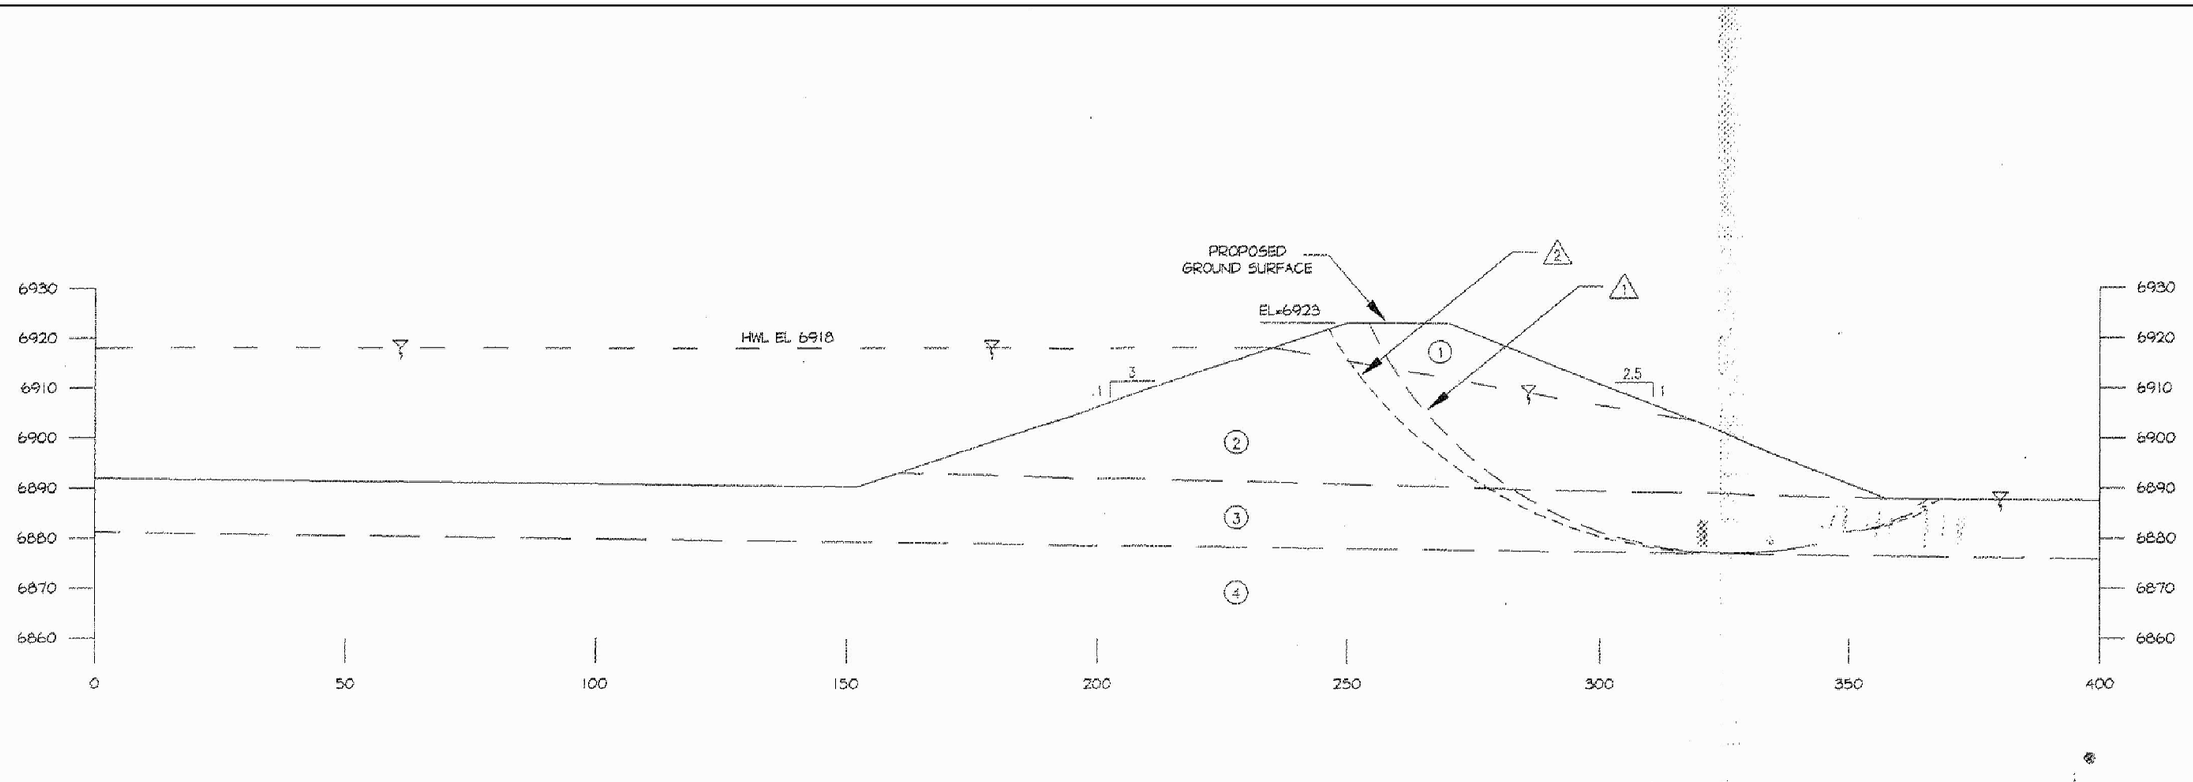
FIGURE 6

SOIL LAYER	WET UNIT WEIGHT (pcf)	COHESION (psf)	FRICTION ANGLE (°)
① FILL ABOVE GWL	122.0	600	26
② FILL BELOW GWL	122.0	600	26
③ LEAN CLAY	119.5	200	25
④ CLAYSTONE BEDROCK	130.2	4000	0

CASE		①	②
CONDITIONS		STATIC	PSEUDO-STATIC
MINIMUM FACTOR OF SAFETY		1.5	1.1
REQUIRED FACTOR OF SAFETY		1.5	1.0
RADIUS		79 ft	92 ft
CENTER	HOR. POINT	326	325
	VERT. POINT	6956	6969
SEISMIC COEFFICIENT		0.00 g	0.10 g

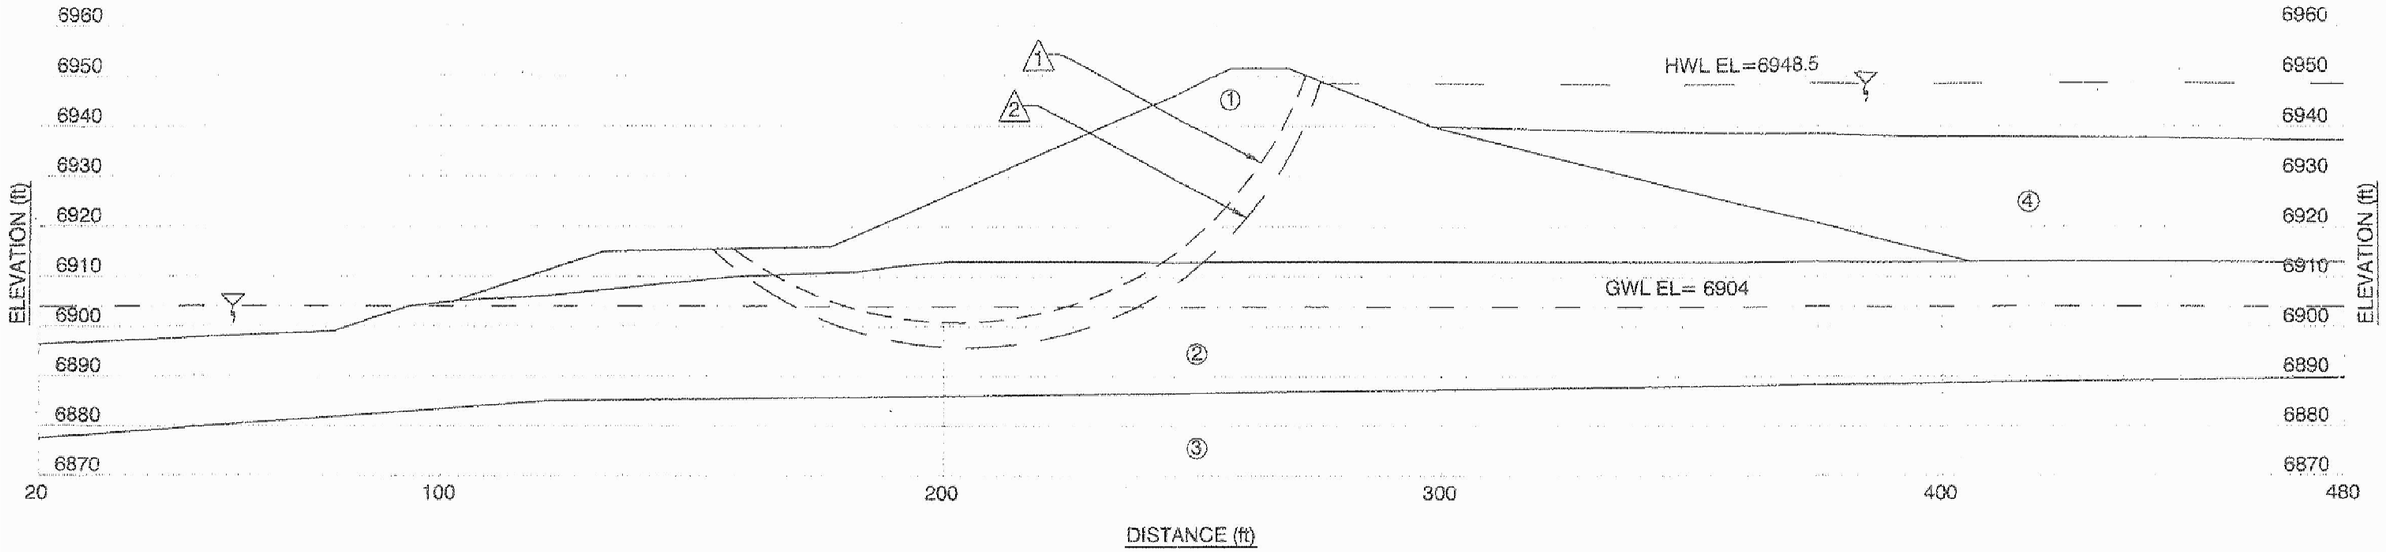
SOIL LAYER	WET UNIT WEIGHT (pcf)	COHESION (psf)	FRICTION ANGLE (°)
① FILL	122.0	600	26
② LEAN CLAY	119.5	200	25
③ CLAYSTONE	130.2	4000	0
④ SOLIDS	80.0	0	0

CASE	1	2
CONDITIONS	STATIC	PSEUDO-STATIC
MINIMUM FACTOR OF SAFETY	2.02	1.56
REQUIRED FACTOR OF SAFETY	1.5	1.0
SEISMIC COEFFICIENT	0.00 g	0.10 g
