Coal Combustion Residue Impoundment

Round 11 - Dam Assessment Report

Gallatin Fossil Plant

Ash Pond / Stilling Pond Complex
TVA
Gallatin, Tennessee

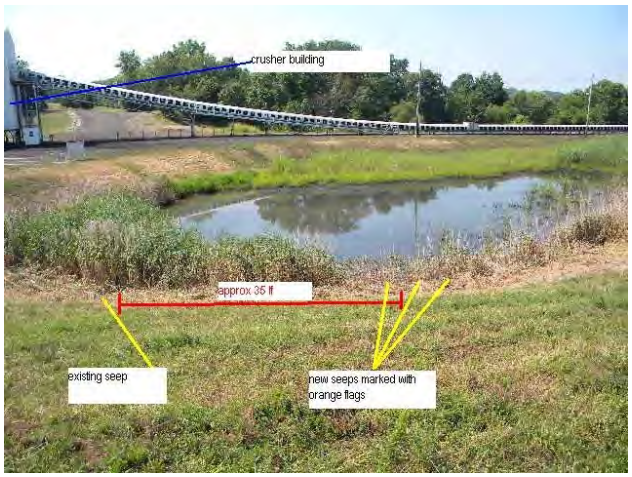
Area of Concern 10

6/22/2010
Seep Initially observed by TVA on 6/22/2010 approximately 35 feet west of existing seep on Pond E dike. Observed to have clear discharge. SAP Level 1.
