Section P - Master List

Container Storage Area Certification

Drum Storage Building #1

Prepared for: Romic Environmental Technologies Corp,
6760 West Allison Road
Chandler, AZ 85226

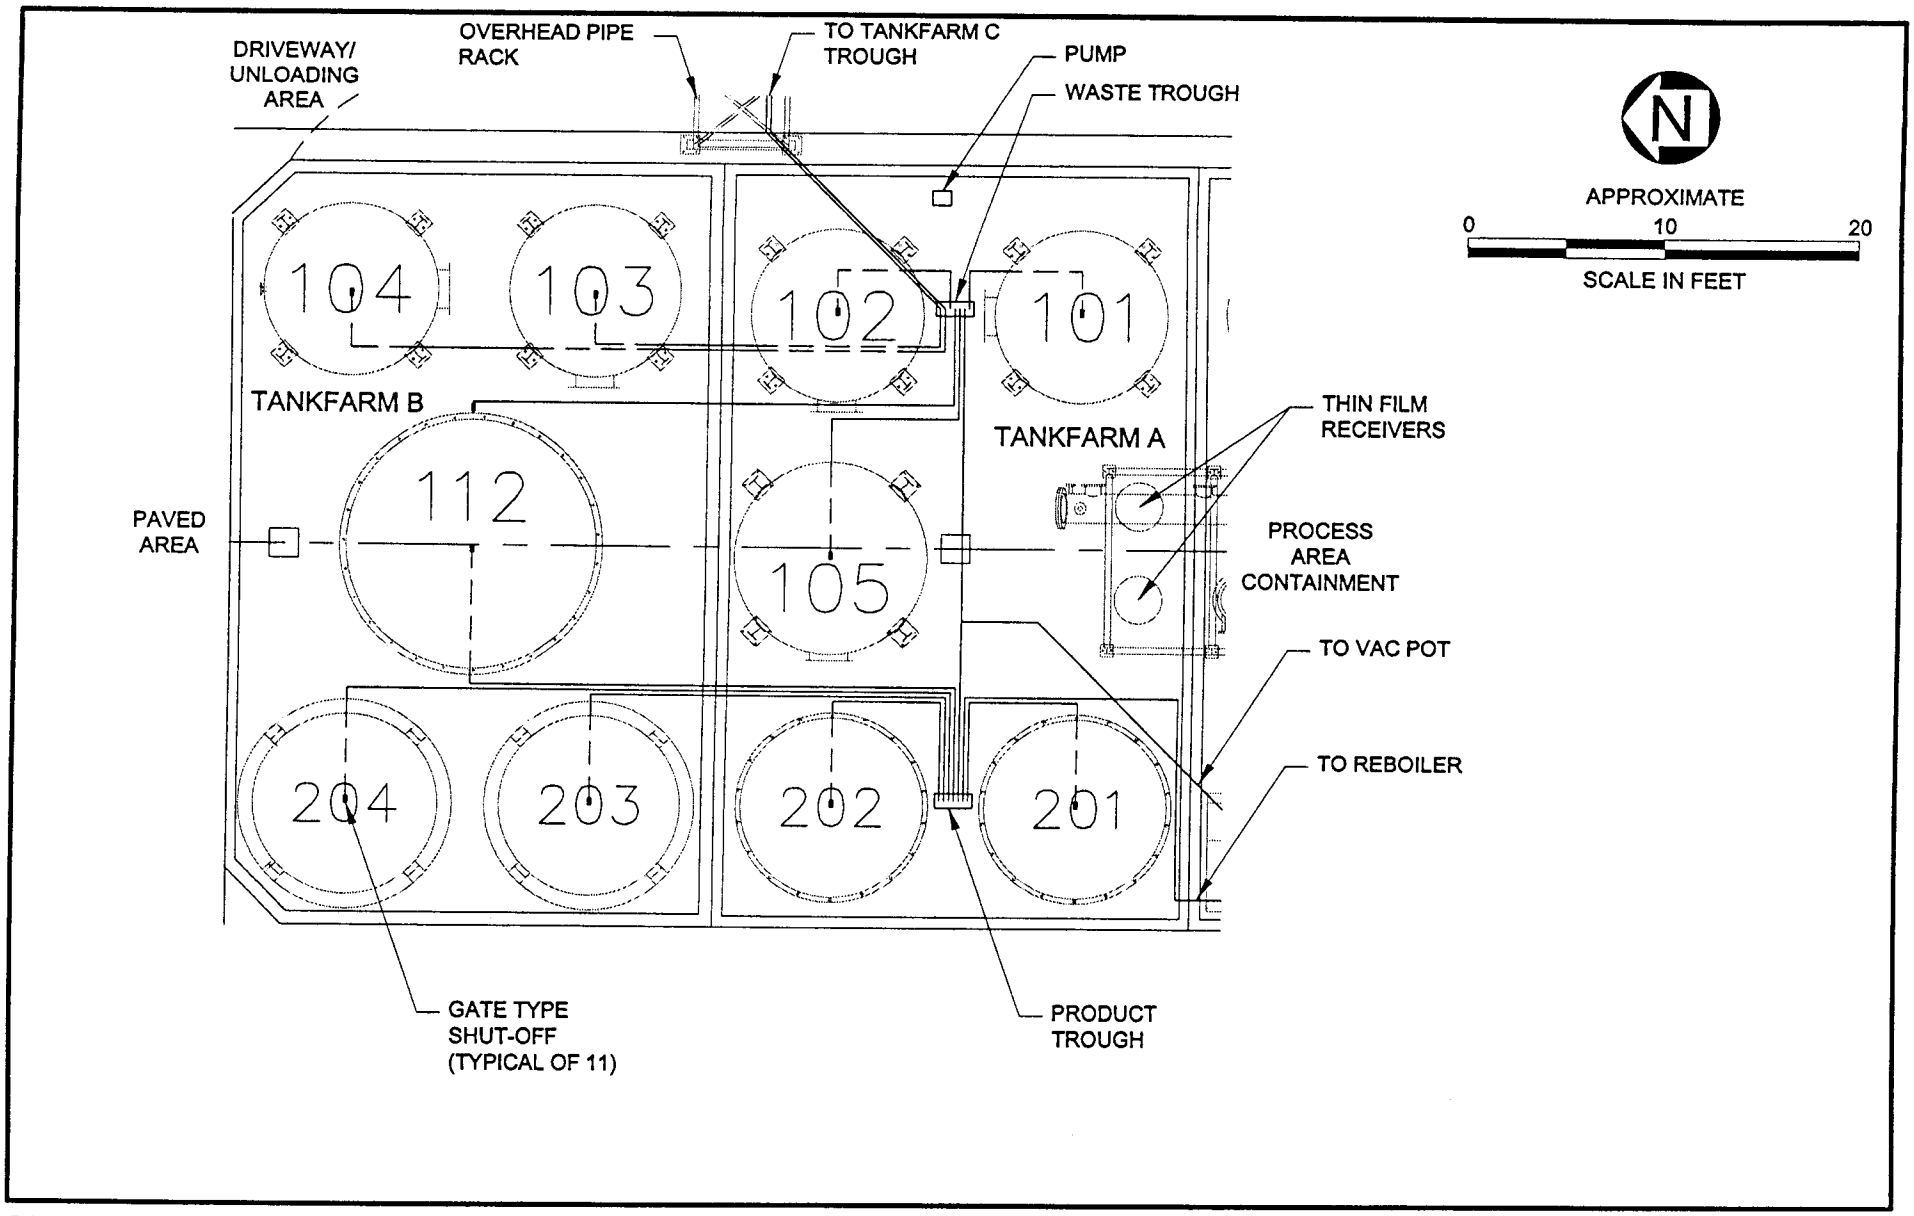
Existing (4) W8x31 columns w/(2) 7/8" dia. Anchors bolts with 1x12x12 base plate is adequate to resist the overturning moment.

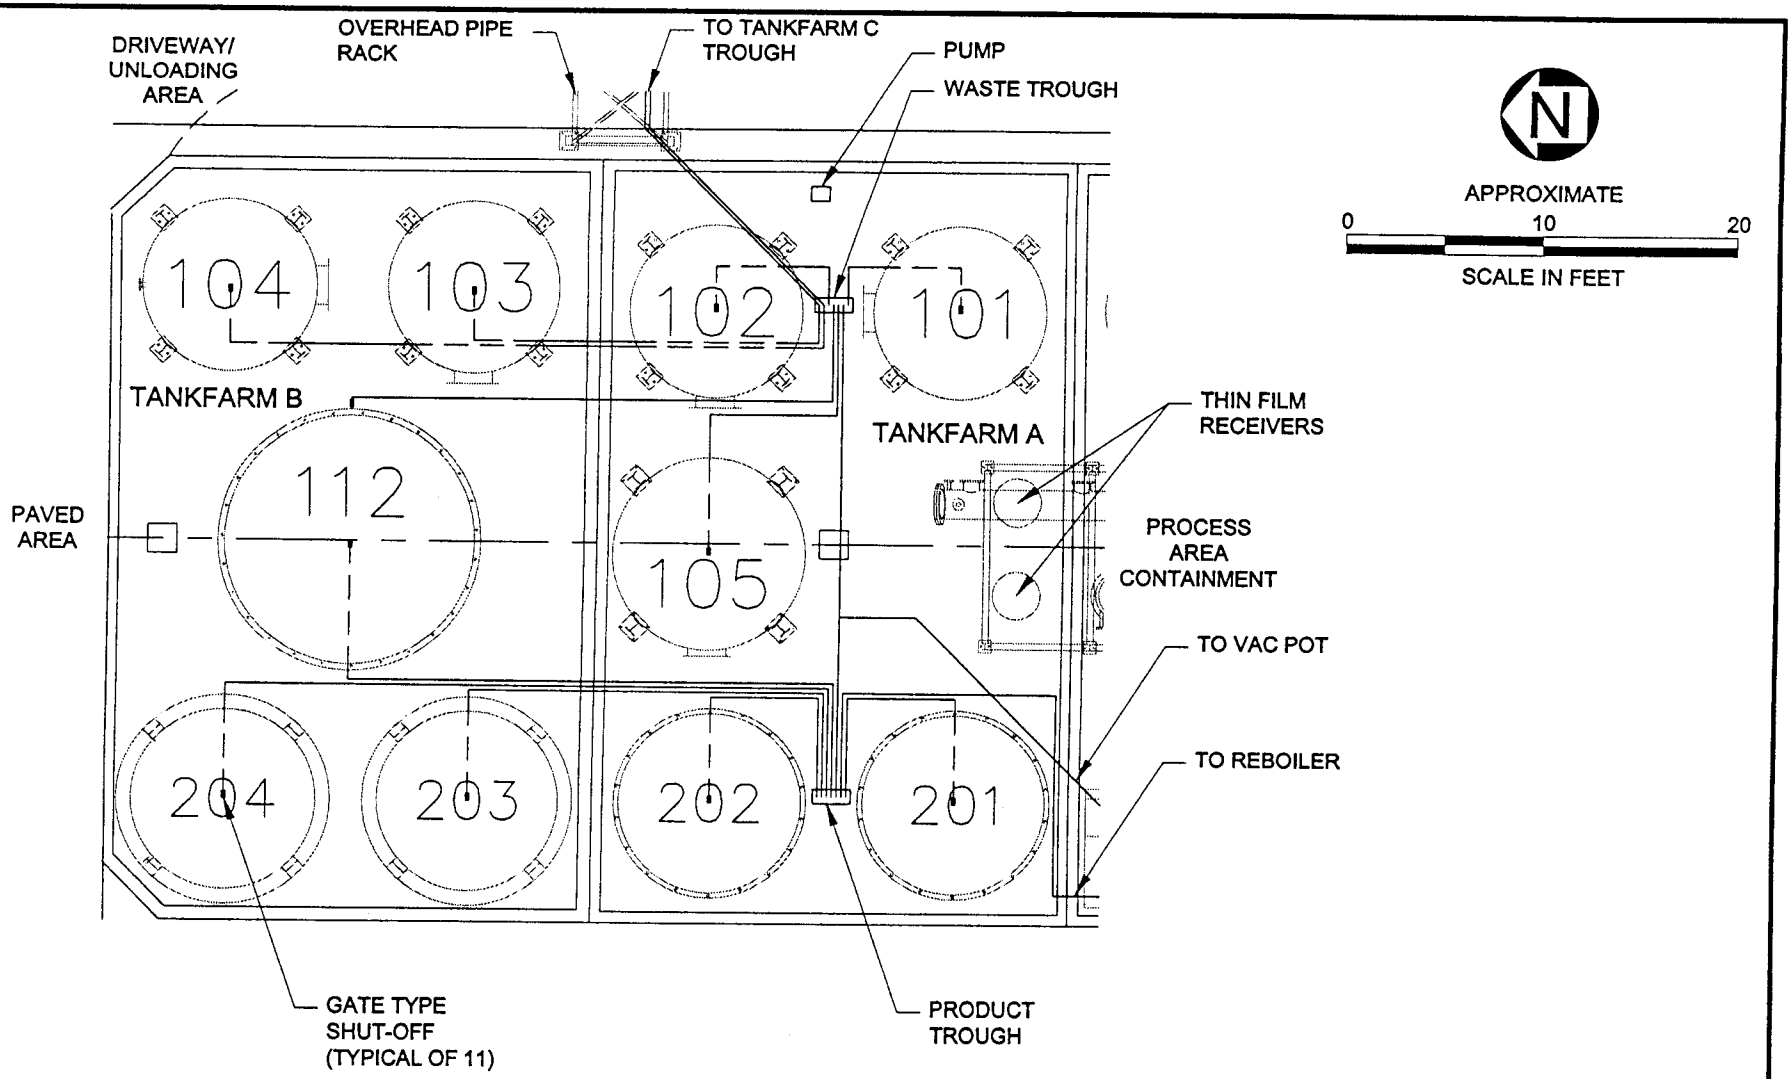
Therefore the existing (4) W8x31 support columns with 1"x12"x12" + (4) 1/2" diameter anchor bolts are still adequate to resist the overturning moment.

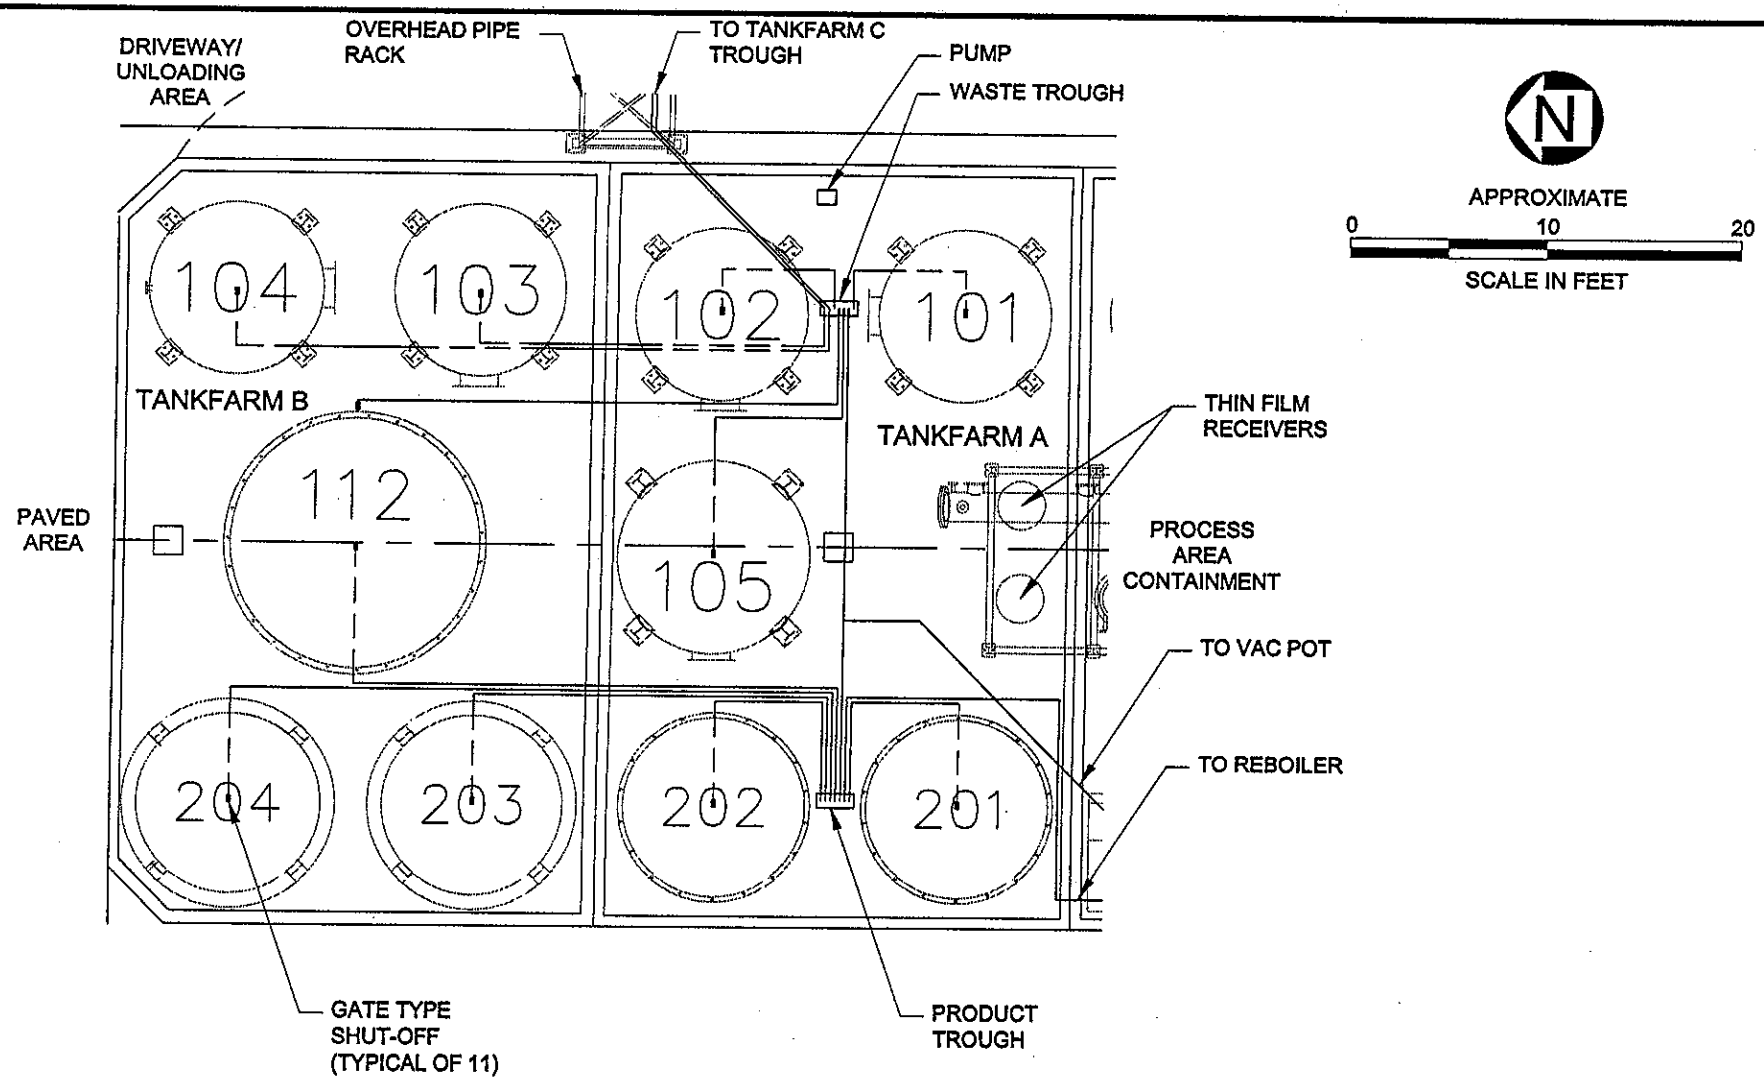
Therefore the existing 9' diameter flat bottom tank with (9) 3/4" diameter bolt is still adequate to resist the overturning moment.

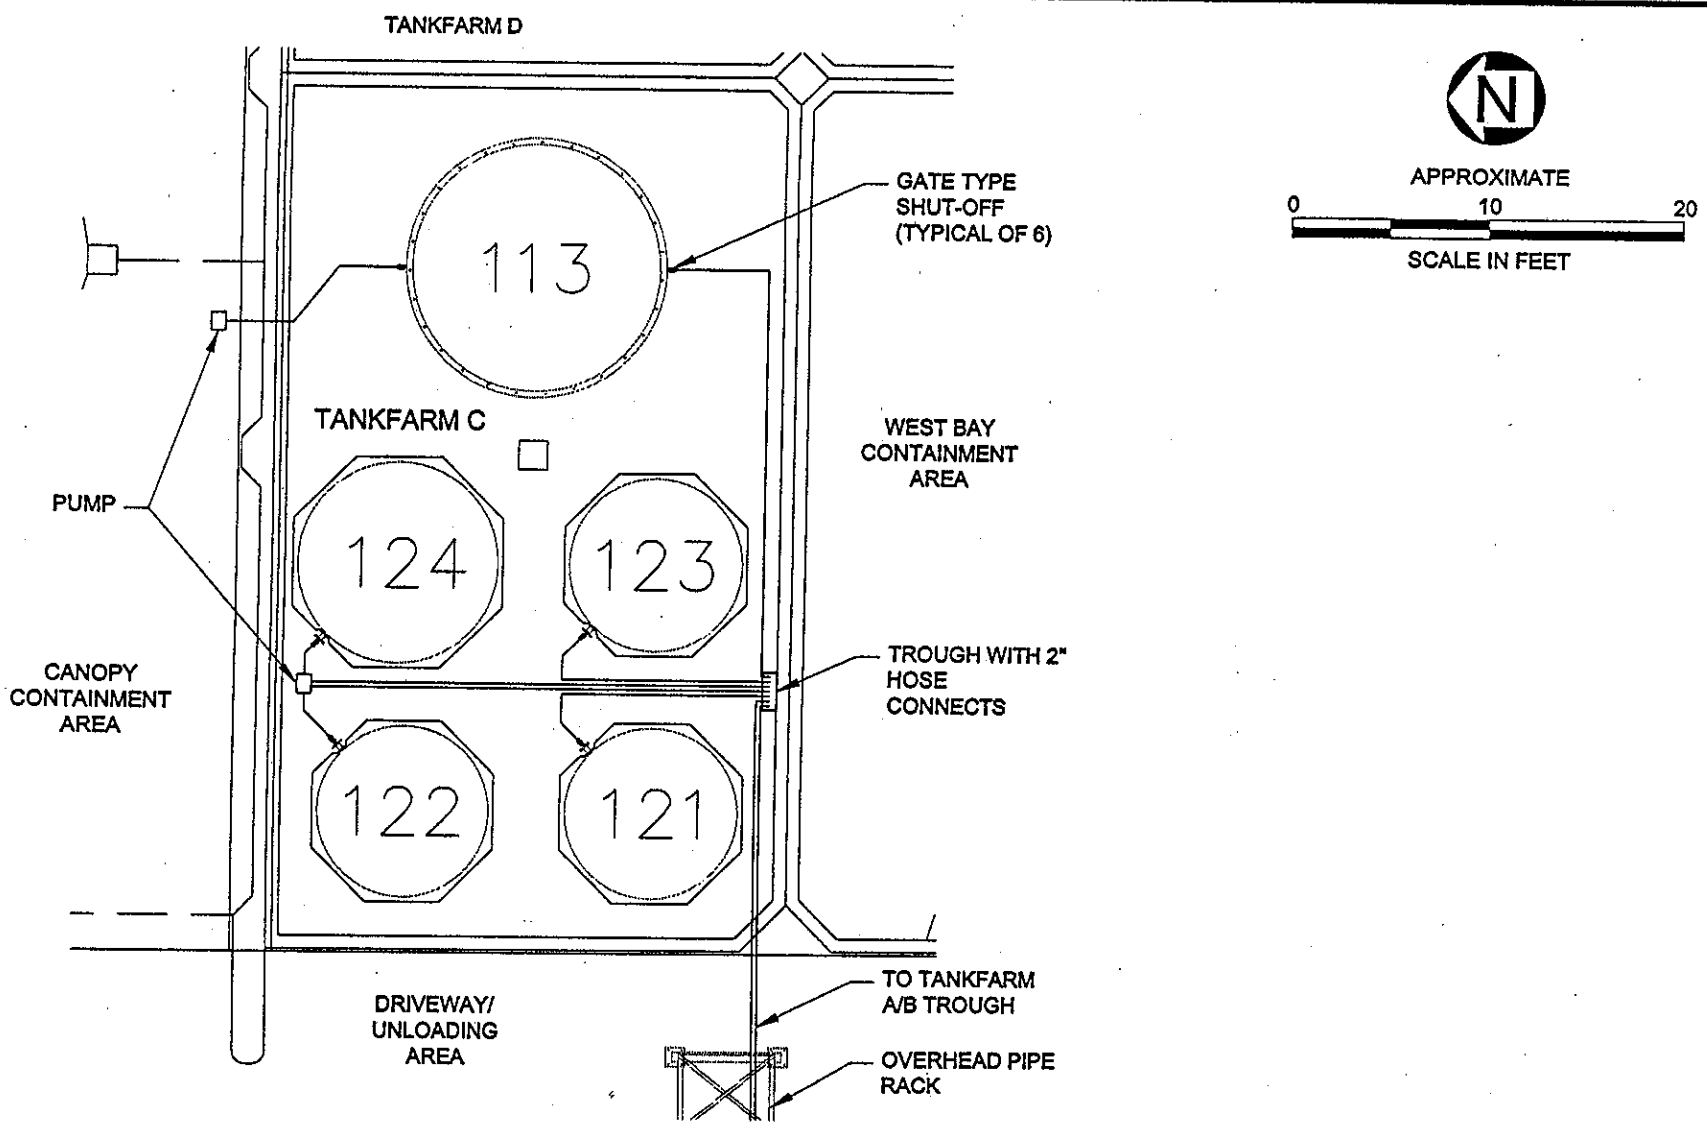
Therefore the existing 9' diameter flat bottom tank with (9) 3/4" diameter bolt is still adequate to resist the overturning moment.
