FIVE-YEAR REVIEW REPORT FOR WELLS G&H SUPERFUND SITE MIDDLESEX COUNTY, MASSACHUSETTS

U.S. Environmental Protection Agency
Region 1
BOSTON, MASSACHUSETTS

9/29/14
Date

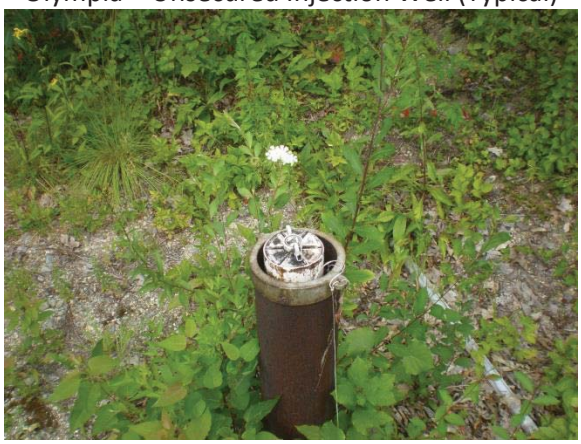
Olympia – Unsecured Injection Well (Typical)

Olympia – Unsecured Monitoring Well Inside Fenceline (Typical)
