**TECHNICAL MEMORANDUM
BROWNFIELDS SUSTAINABILITY PILOT
ALLEN-MORRISON SITE, LYNCHBURG, VIRGINIA**

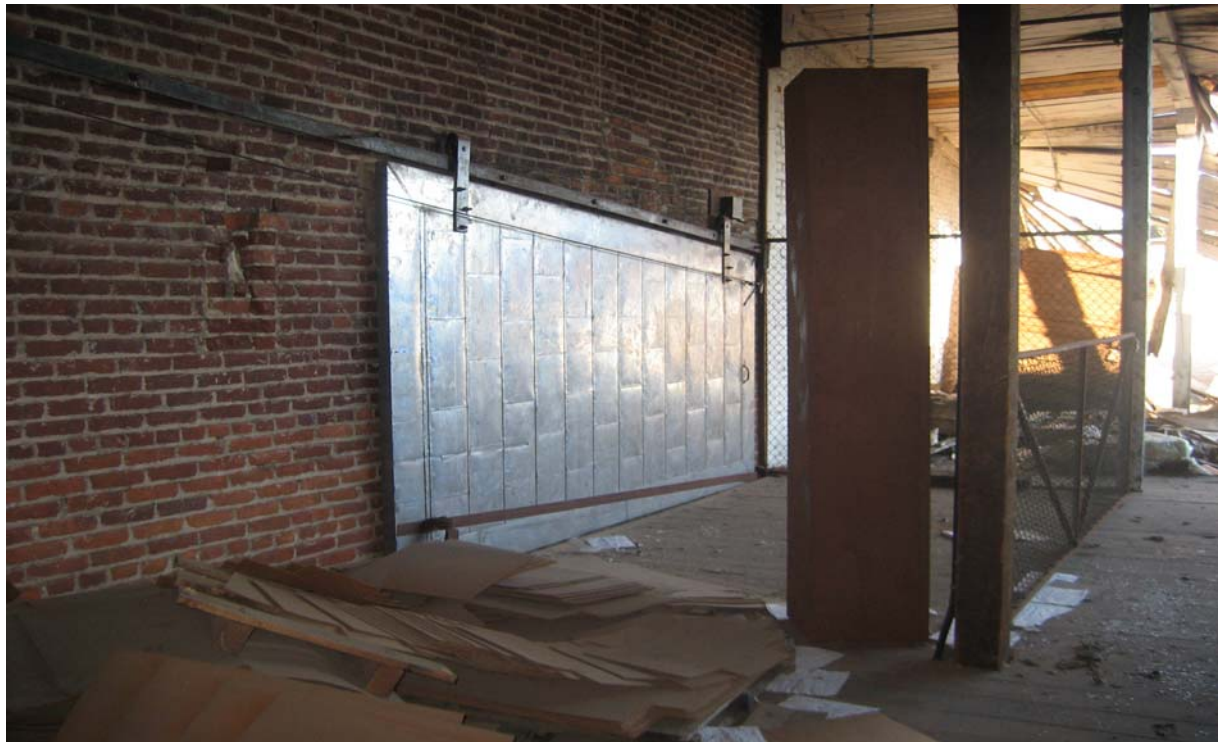
Photograph No. 2: Sliding door upstairs in Thornhill 7A

- Sliding Doors: Several large sliding tracked, wooden doors—some with a counterweight or a visually interesting pressed metal (likely tin) finish—could be reused in the redevelopment rather than salvaged for lumber and metal of relatively little value (see Photograph No. 2). Sliding doors and their approximate dimensions and locations are as follows:

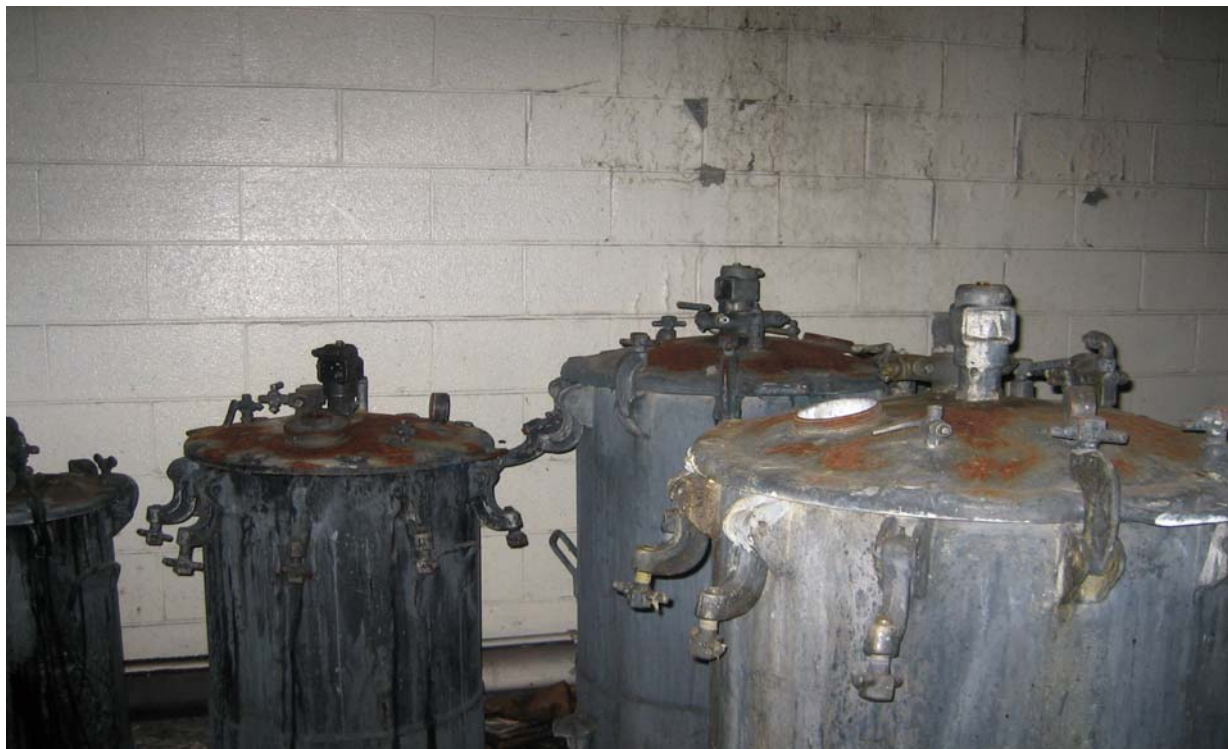
Photograph No. 3: Paint mixing canisters in Thornhill 7D

- Tanks and Paint Mixing Vessels: Several large, steel, boiler tanks and paint mixing vessels could be sold as scrap metal (see Photographs No. 3 and 4). However, the tanks could also be reused on site as cisterns to collect rainwater for irrigating a community garden at the site, irrigating general site landscaping, or supplying water for other gray water applications. This reuse would allow for more sustainable operation of the facility, reduce site operating costs, and provide an opportunity for public interpretation of these sustainable practices. The tanks could also be used by local artists as material for sculptures or other artwork. Properly cleaning the tanks, particularly the paint mixing vessels, would be required before reuse.

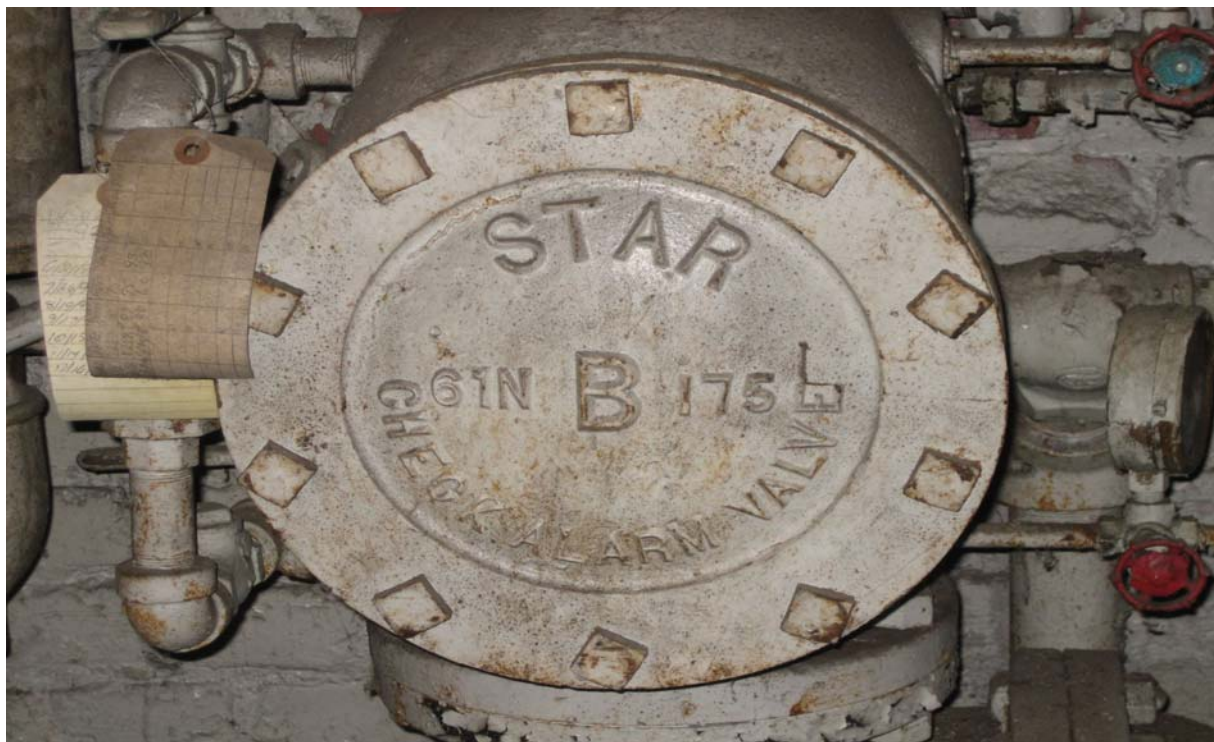
Photograph No. 6: Sprinkler system plating in Thornhill 7C

- Sprinkler System and Plates: The sprinkler or fire suppression system piping in both the Thornhill and Allen-Morrison facilities can be salvaged for scrap metal value. However, certain interesting features such as valves and manufacturer or other system identification plates (see Photograph No. 6) could be refinished and reused decoratively in the redevelopment project and to interpret the site history. Of particular interest could be a circa 1911 plate in Thornhill Building 7C.

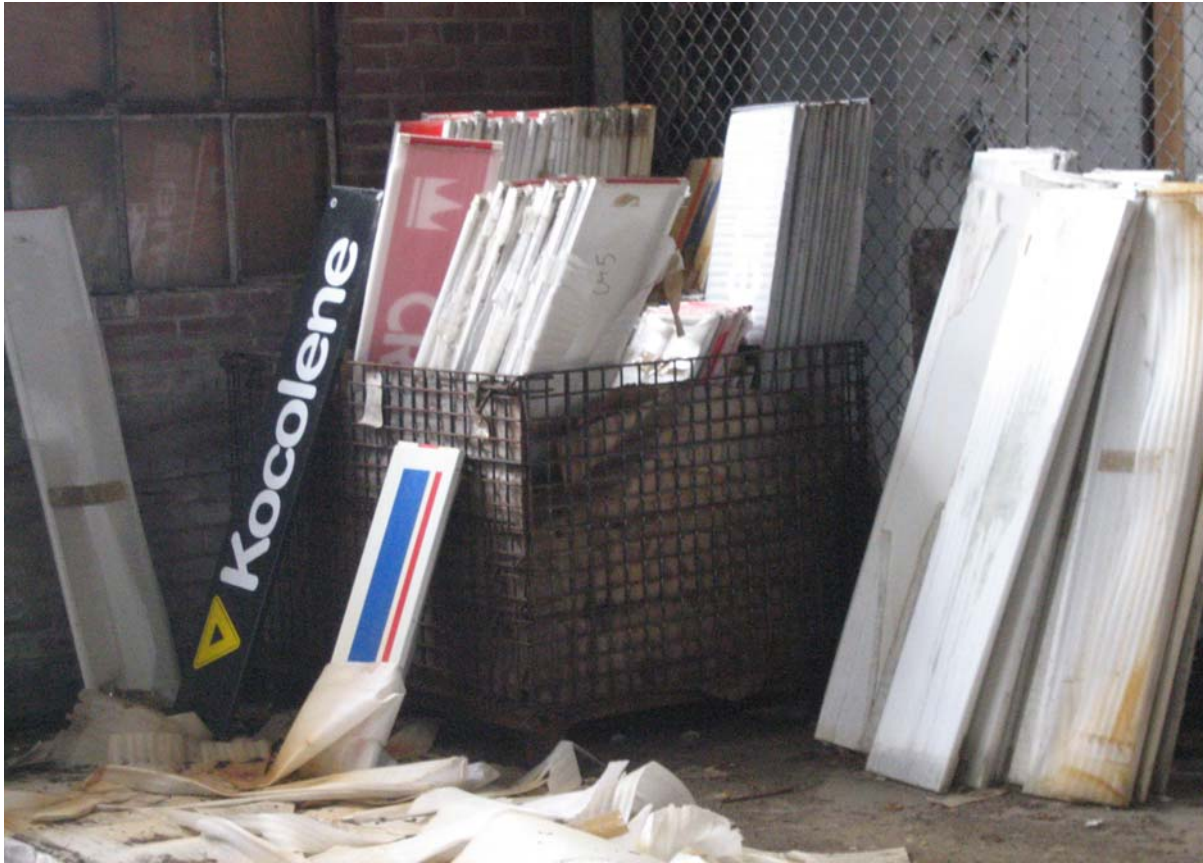
Photograph No. 8: Sheet metal signs in Allen-Morrison 1E

- Sheet Metal Signs: Sheet metal signs apparently manufactured by Allen-Morrison were located in Thornhill Building 7C and Allen-Morrison Building 1E (see Photograph No. 8). These signs could be displayed in the redevelopment to highlight the industrial heritage of the site.

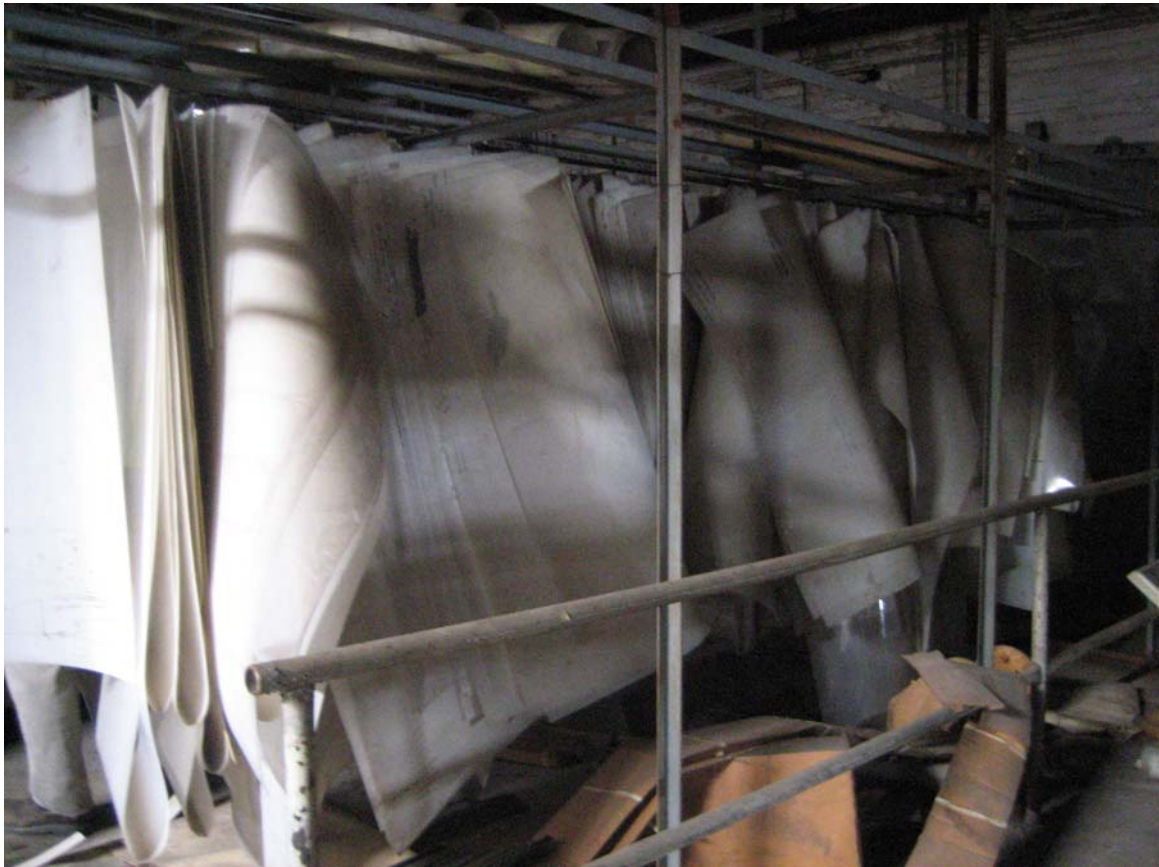
Photograph No. 9: Sign design drawings on rack in Allen-Morrison 1C

- Mylar Sign Design Drawings: A rack containing dozens of mylar sign design drawings was located in Allen-Morrison Building 1C (see Photograph No. 9). These drawings could be restored and framed for reuse as artwork or other display in the redevelopment to highlight the industrial heritage of the site.

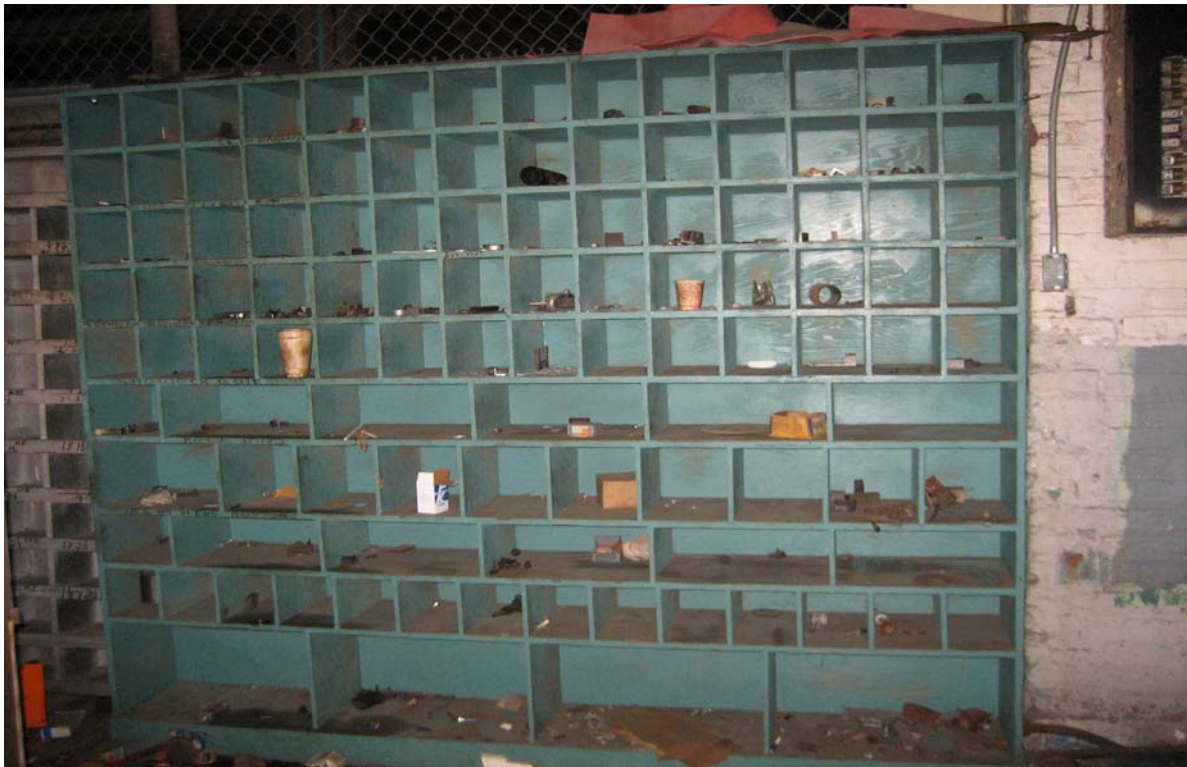
Photograph No. 10: Shelving unit in Allen-Morrison 1C

- Shelving Units, Tables, and Drying Rack: Several wooden or steel shelving racks and tables located throughout the site could be refurbished, if necessary, for reuse by Lynchburg Grows or other local businesses or volunteer organizations (see Photographs No. 10 and 11). Of particular interest may be the wooden mailbox and parts storage shelving units in Thornhill Building 7E and Allen-Morrison Building 7C. Larger, heavier duty steel shelving or drying racks, such as those located in Thornhill Buildings 7A and 7E, could be used at the site to store lumber (or other materials) prior to reuse.
