## **WHEN LOW TECHNOLOGY IS THE ANSWER: RESPONSE TO A REMOTE OIL SEEP:**

**Robert M. Mandel**

Federal On-Scene Coordinator  
United States Environmental Protection Agency  
75 Hawthorne St.  
San Francisco, CA 94105 USA

IOSC 2001-306 Mandel

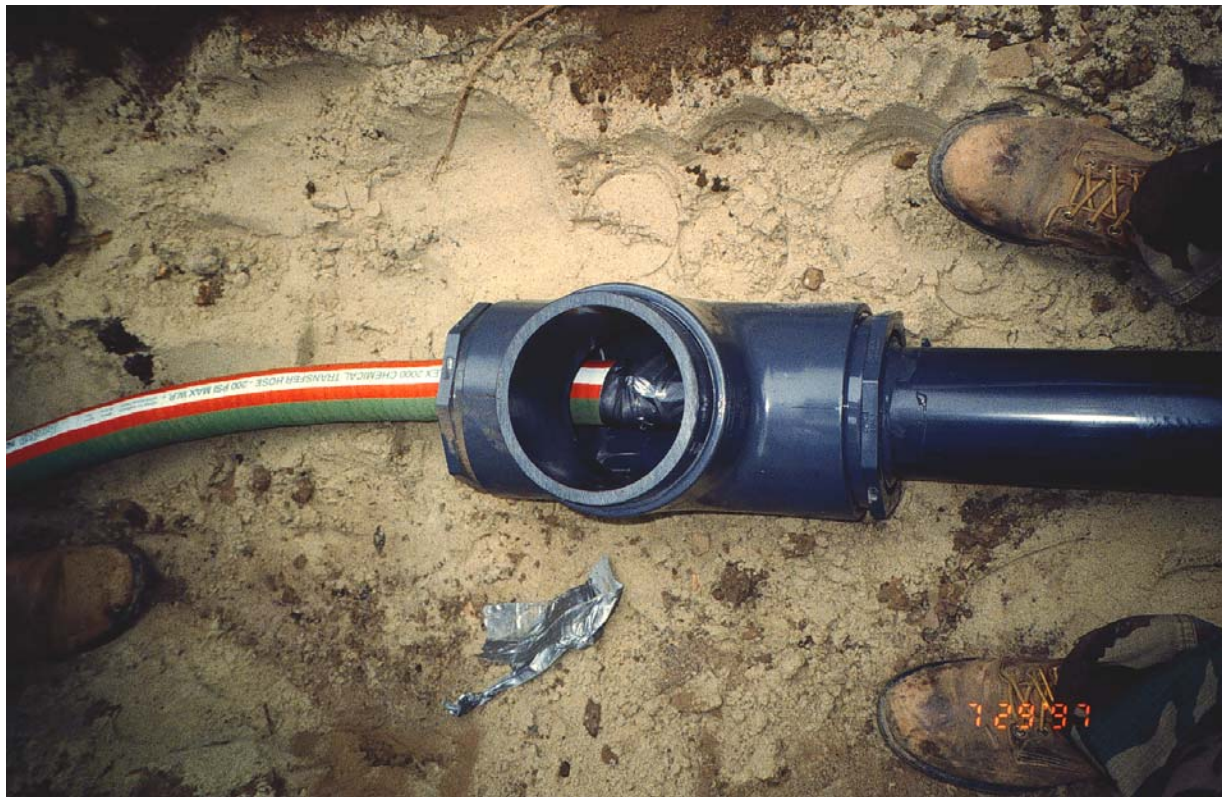
Figure 2

- Fig 1: A heavily oiled portion of upper Toro Creek during July 1997.
- Fig 2: Workers set the 3-chambered OWS clarifier in position.
- Fig 3: The chemical hose holding the oil is enclosed within the PVC pipe to provide secondary containment.

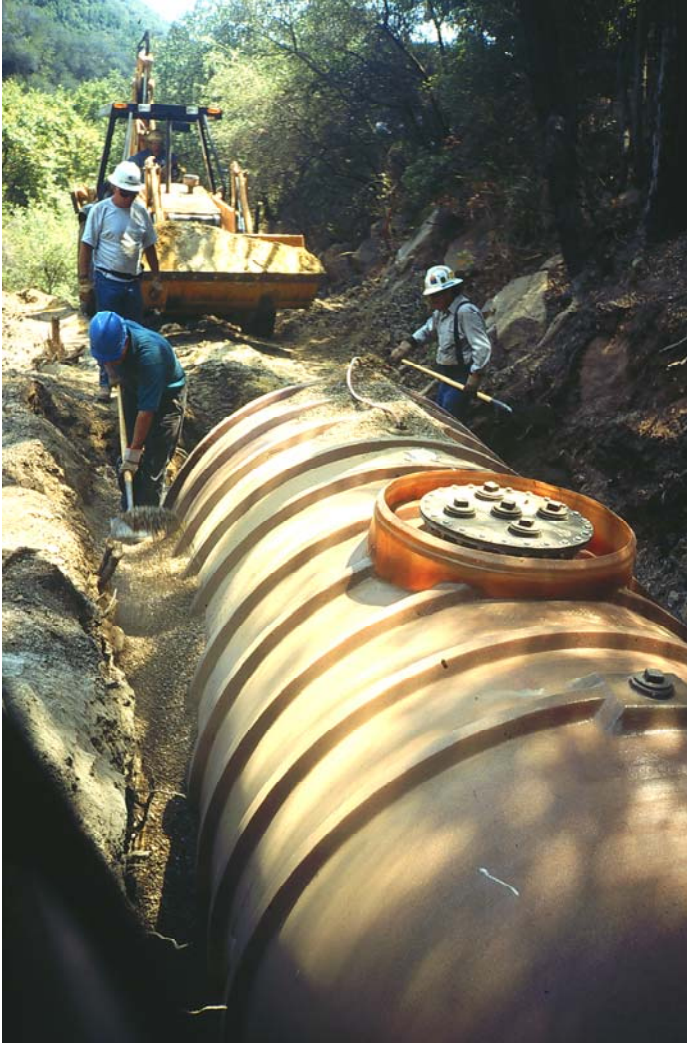
Figure 4

- Fig 4: Pipeline trench containing the secondary containment hose and electrical wiring for the high level alarm.
- Fig 5: The UST is installed.
- Fig 6: Here is the thick oil layer that accumulates in the primary separation chamber.

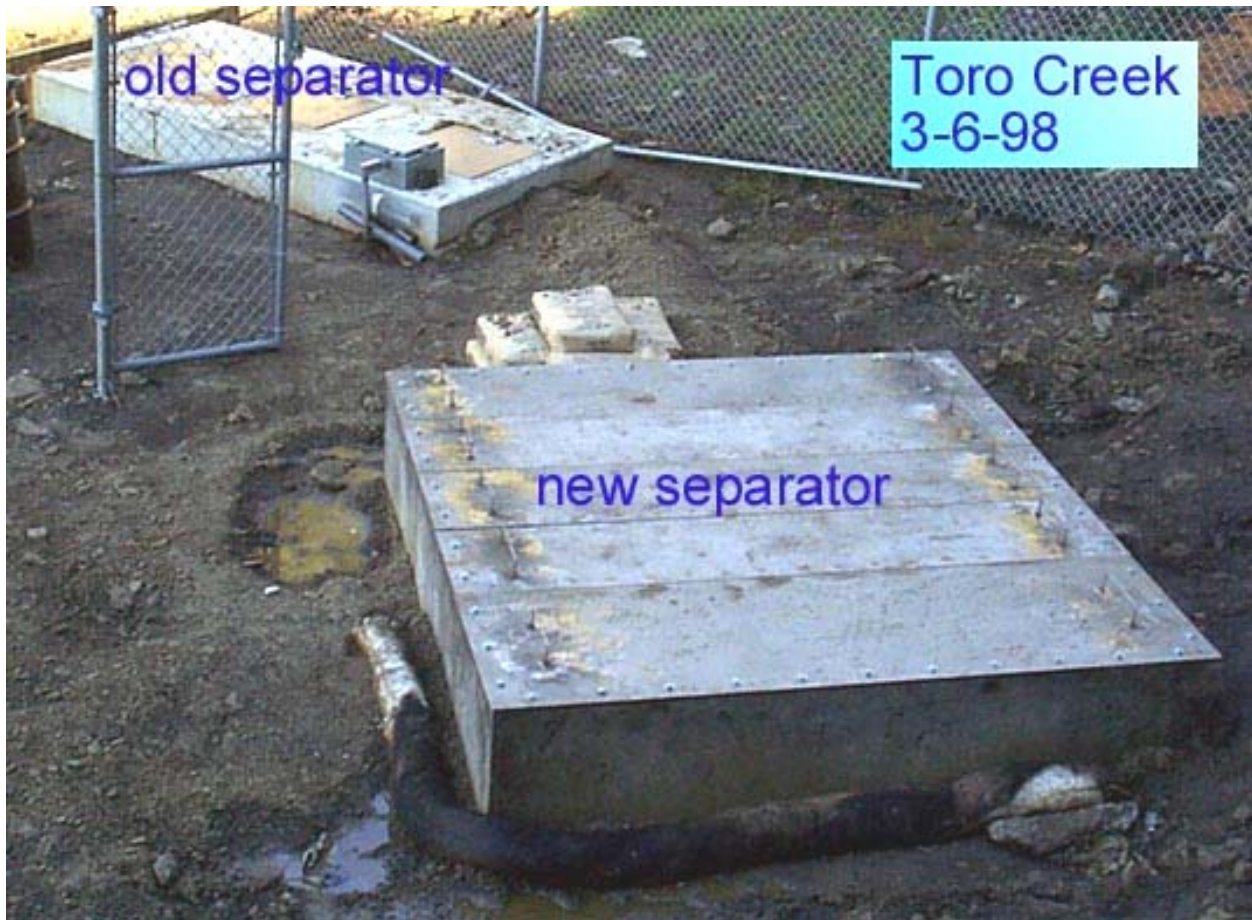
Figure 12

- Fig 12: New primary clarifier in place directly over the seep.
- Fig 13: Current OWS system configuration.
- Fig 14: Diagram of final as-built for the OWS system at Toro Creek.
