Region 7  
Emergency Response and Removal Branch  
Kansas City, KS

# CHEMICAL ACCIDENT INVESTIGATION REPORT

## TERRA INDUSTRIES, INC. NITROGEN FERTILIZER FACILITY PORT NEAL, IOWA

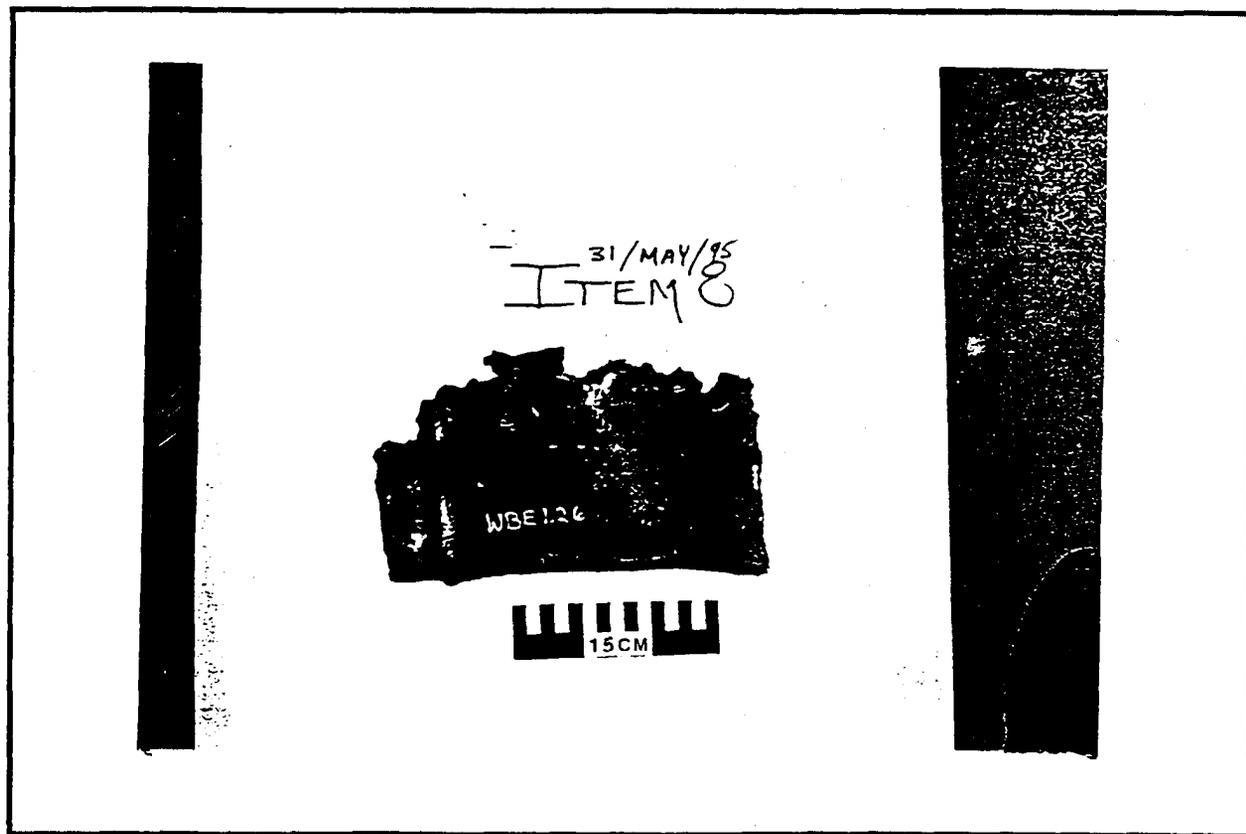
Photo 7 - 3  
Neutralizer Fragment

Metallurgical analytical results indicated that the fragment displayed a high-temperature discolored surface and severe erosion in one direction (*Photo 7-2*). The adjacent area showed little discoloration. The opposite surface exhibited severe tearing and fracturing with evidence of high-temperature discoloration (*Photo 7-3*). Unetched cross sections exhibited high-temperature oxidation on the inside diameter with severe surface tearing/seams or laps. The etched cross-sections displayed evidence of severe surface movement and cold working with a one-directional heavy force. Of the fragments analyzed, metalographic analysis suggests that the highest temperature, internal pressure and velocity was located in the area of Item #8. This sample exhibited the most severe surface distortion and high-temperature grain structure change.

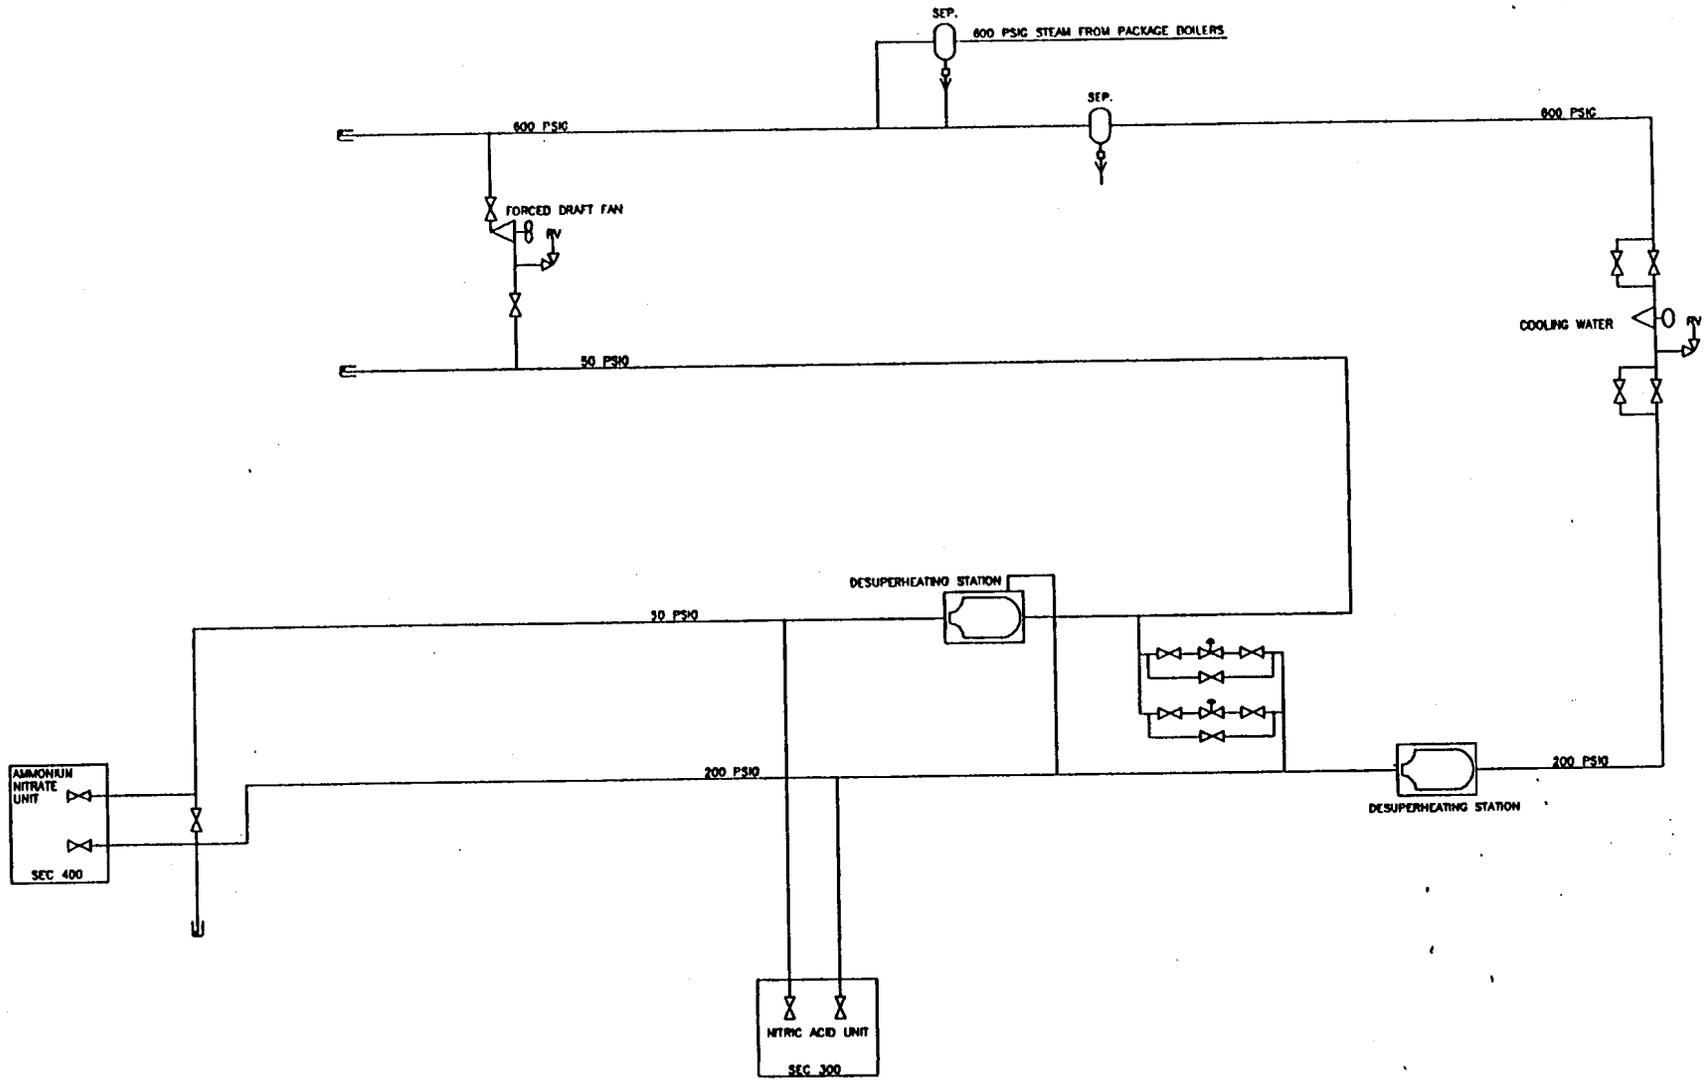
FIGURE 7 - 4  
STEAM DISTRIBUTION SYSTEM (PARTIAL)

The investigation team concluded that the steam distribution system had the potential to supply superheat during high demand events such as the slow roll of the nitric acid compressor.

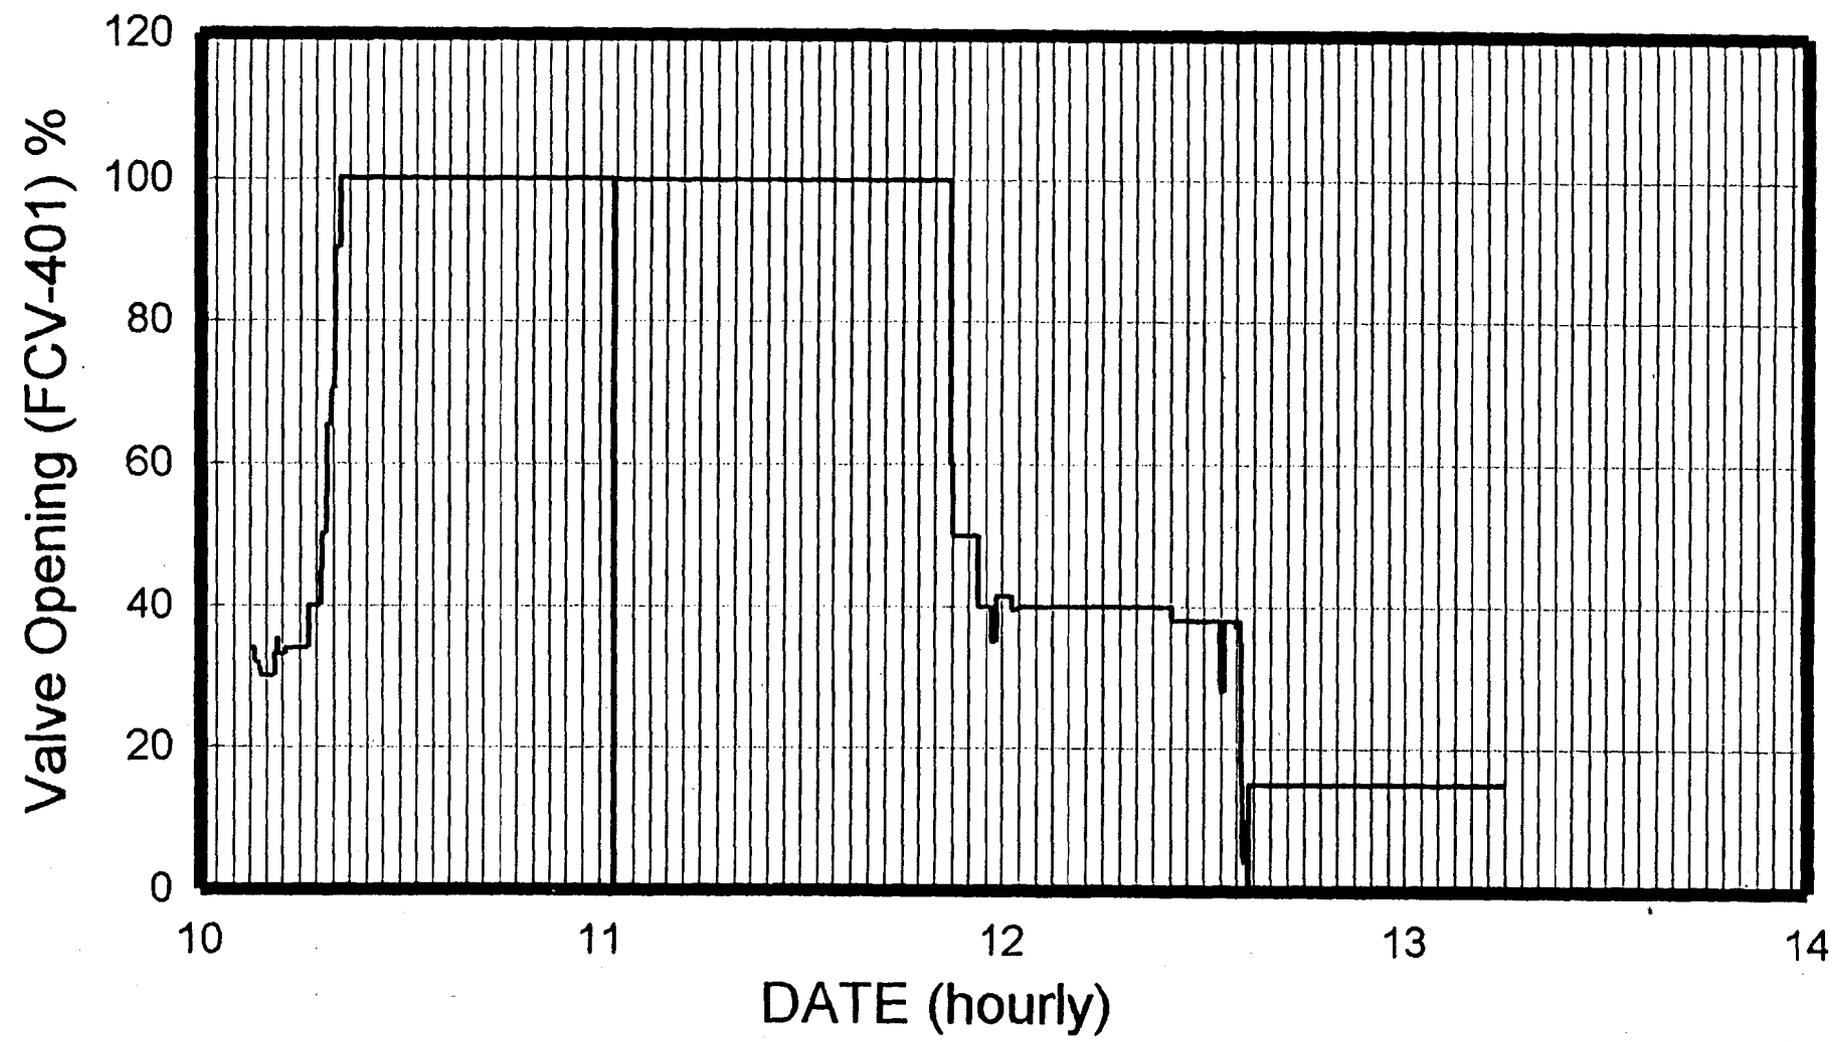
Figure 7-5

The investigation team graphed AN plant DCS data provided by Terra to document conditions in the AN plant for three days preceding the explosion. DCS data indicated that from 0903 hours on December 10 through 2050 hours on December 11, the neutralizer nitric acid control valve (FCV-401) was 100% open (*Figure 7-5*). Outside operator grab sample analyses for these periods indicate a rundown pH in the 7.0 range, heavily on the free ammonia side of the AN pH curve (*Figure 7-6*). Urea offgas flow during this period ranged from 70-85%. It appeared to the investigation team that when the urea plants were operating efficiently, the supply of nitric acid to the AN plant was limited and would not maintain the specified pH range of 5.5-6.5.

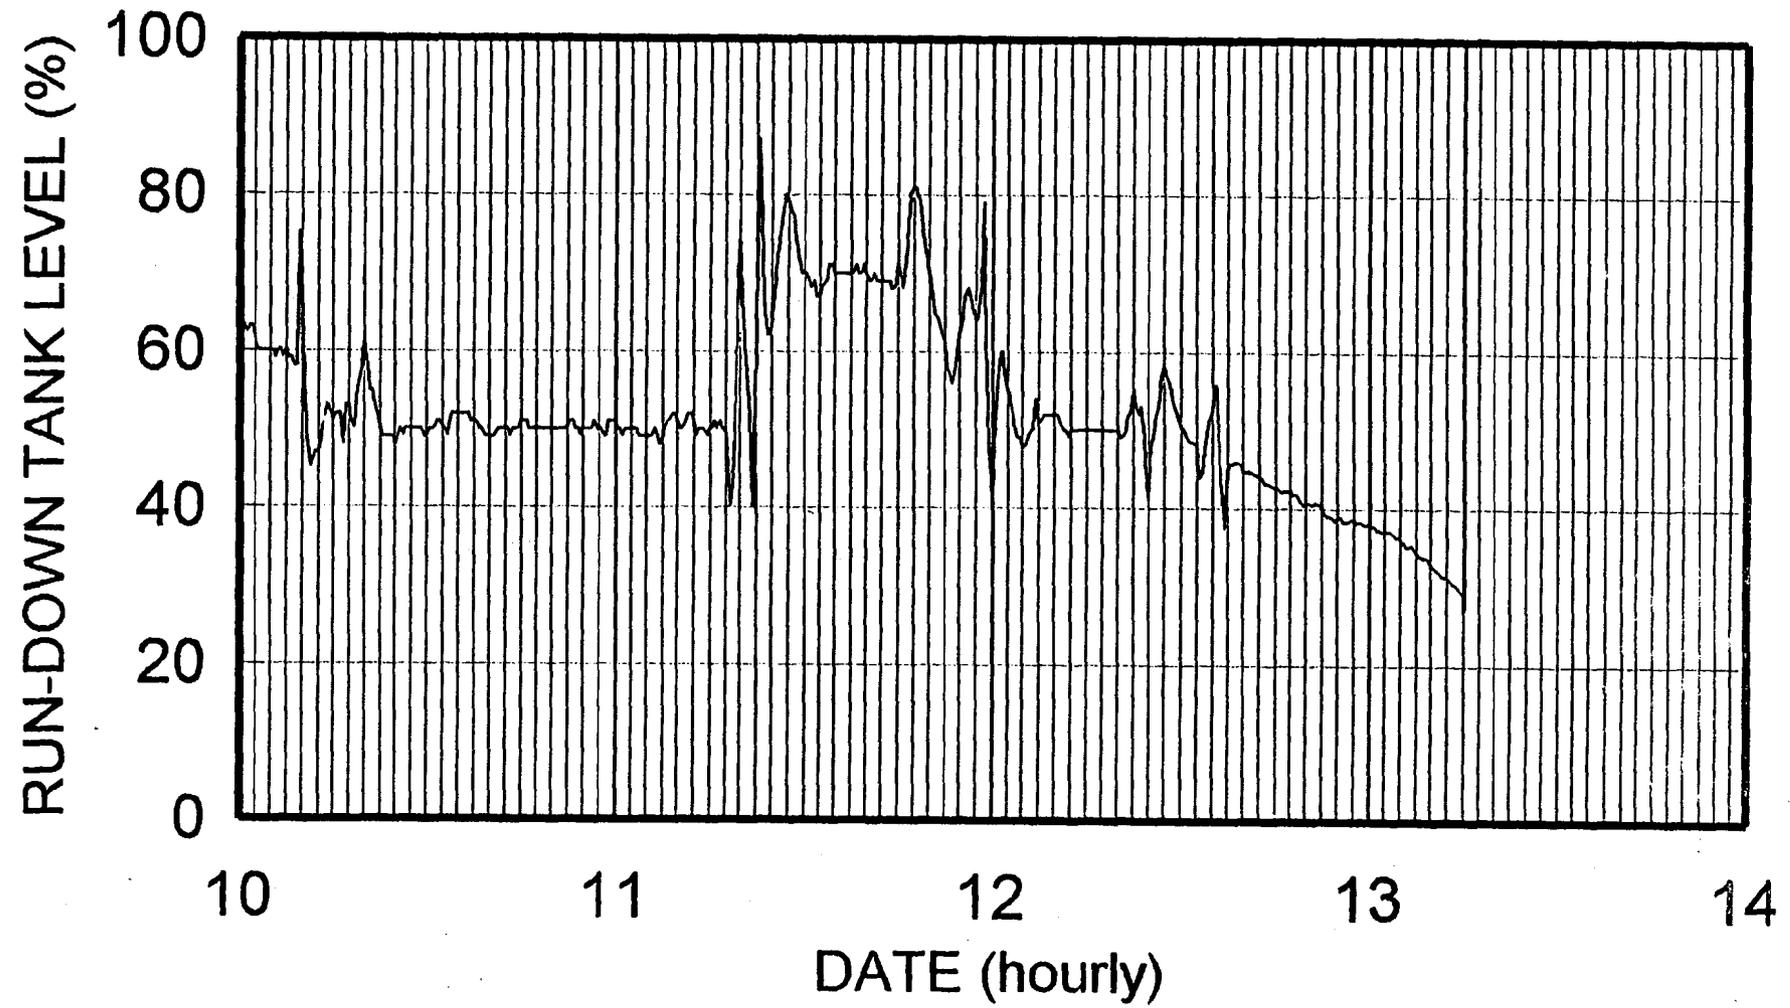
FIGURE 8-1

2. The indicated level in the rundown tank (DCS data) steadily declined at a rate of approximately 50 gallons per hour from the time that the AN plant was shut down until the explosion. The rate of decline of the DCS indicated rundown tank level remained constant over this time period. (*Figure 8-1*)

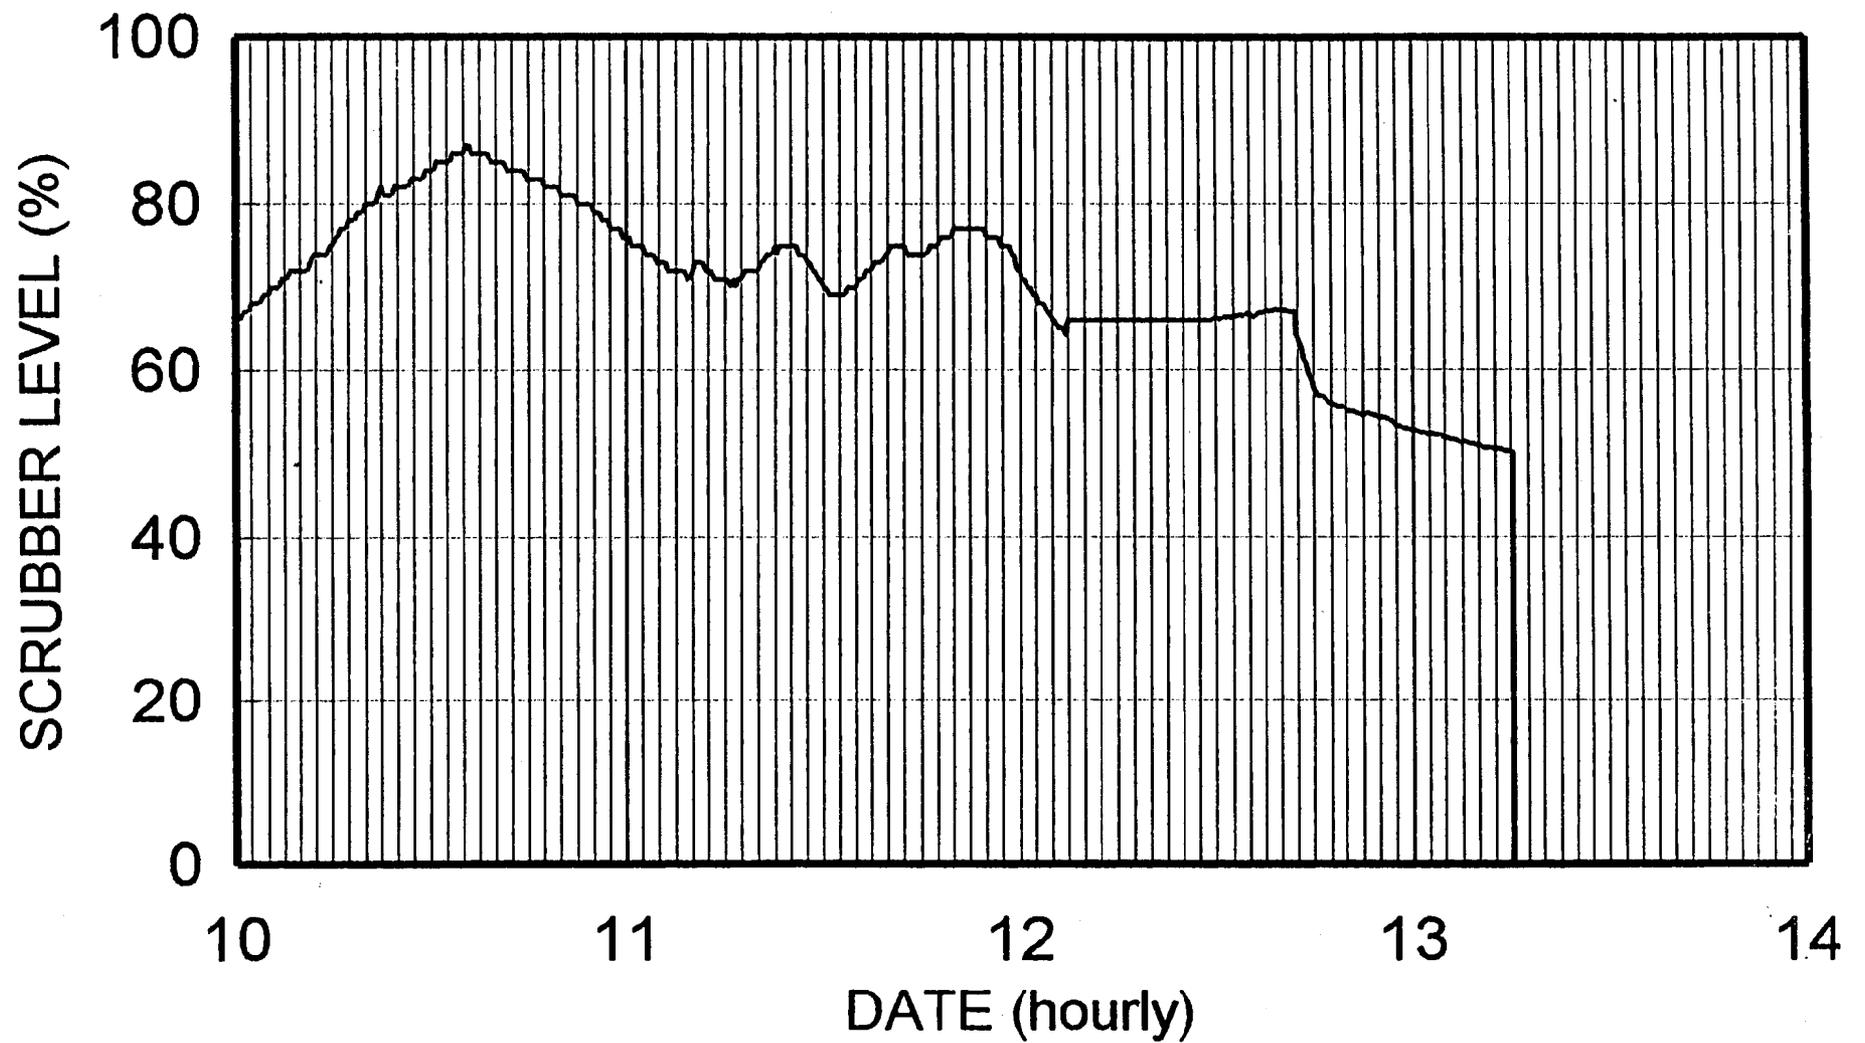
FIGURE 8-2

The investigation team reviewed DCS data pertaining to the AN scrubber. The data indicated that the scrubber level declined at a steady rate following the blowdown event occurring on December 12 through the time of the explosion (*Figure 8-2*). The investigation team determined that two plausible scenarios for this decline were:

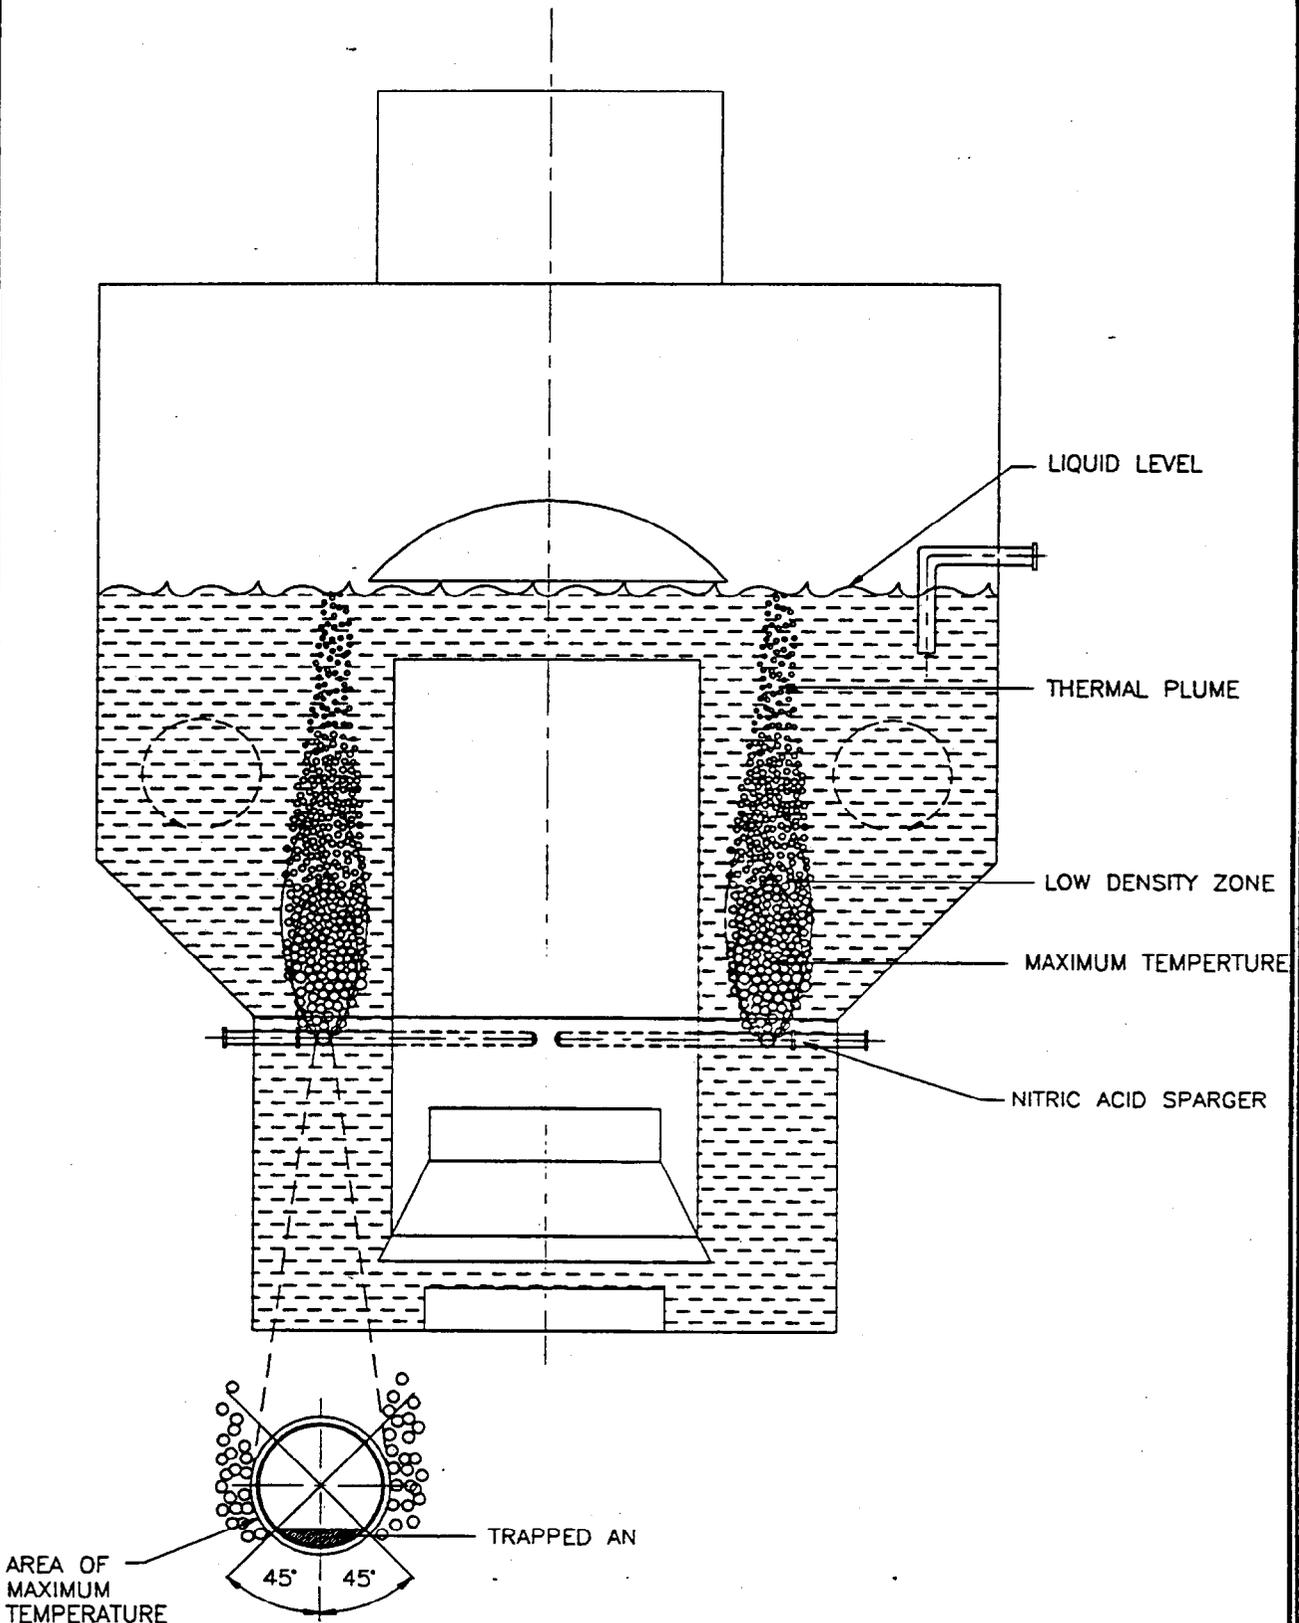
CUT CROSS SECTION OF NEUTRALIZER

Calculations indicated that continued steam heating would have resulted in a high temperature (near the temperature of the steam) and a low-density zone to develop directly around or above the sparger. Sensitizing factors lowered the thermal decomposition activation energy of the AN. The combination of energy in the input steam and the addition of superheat (possibly due to high steam demands in the nitric acid plant) exceeded the activation energy of the AN, resulting in the onset of thermal decomposition. The initial dissociation reaction was endothermic, and would have been quickly overcome due to its close proximity to the heating source. As heat continued to be transferred into this zone, the reaction became exothermic and self-sustaining [ 13]. At this point, large volumes of gases would have been formed. The effect of the rapidly expanding gas would have been twofold:

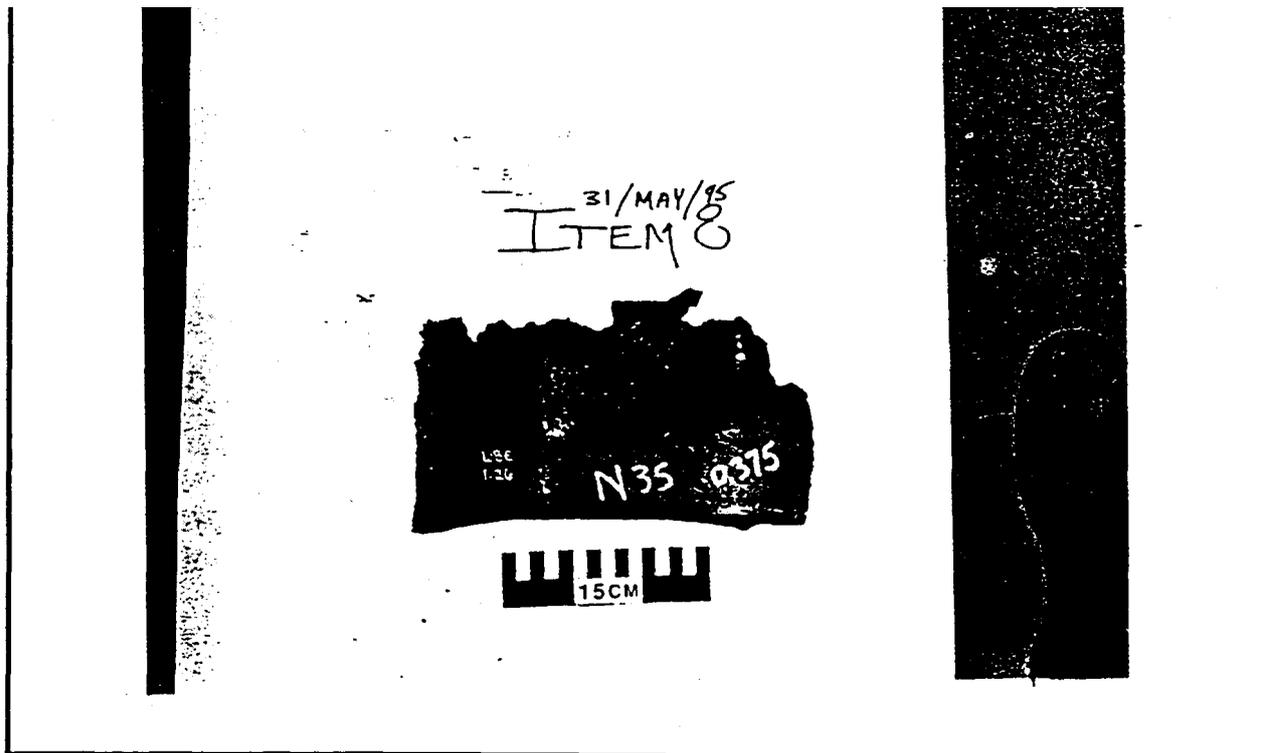
Photo 8-17  
EPA Item #8 (Neutralizer)

2. Pitting of some neutralizer fragments that were located near the spargers exhibits characteristics of cavitation, which implies that the process causing the deformation involved high velocity bubbles (*photo 8-17*).

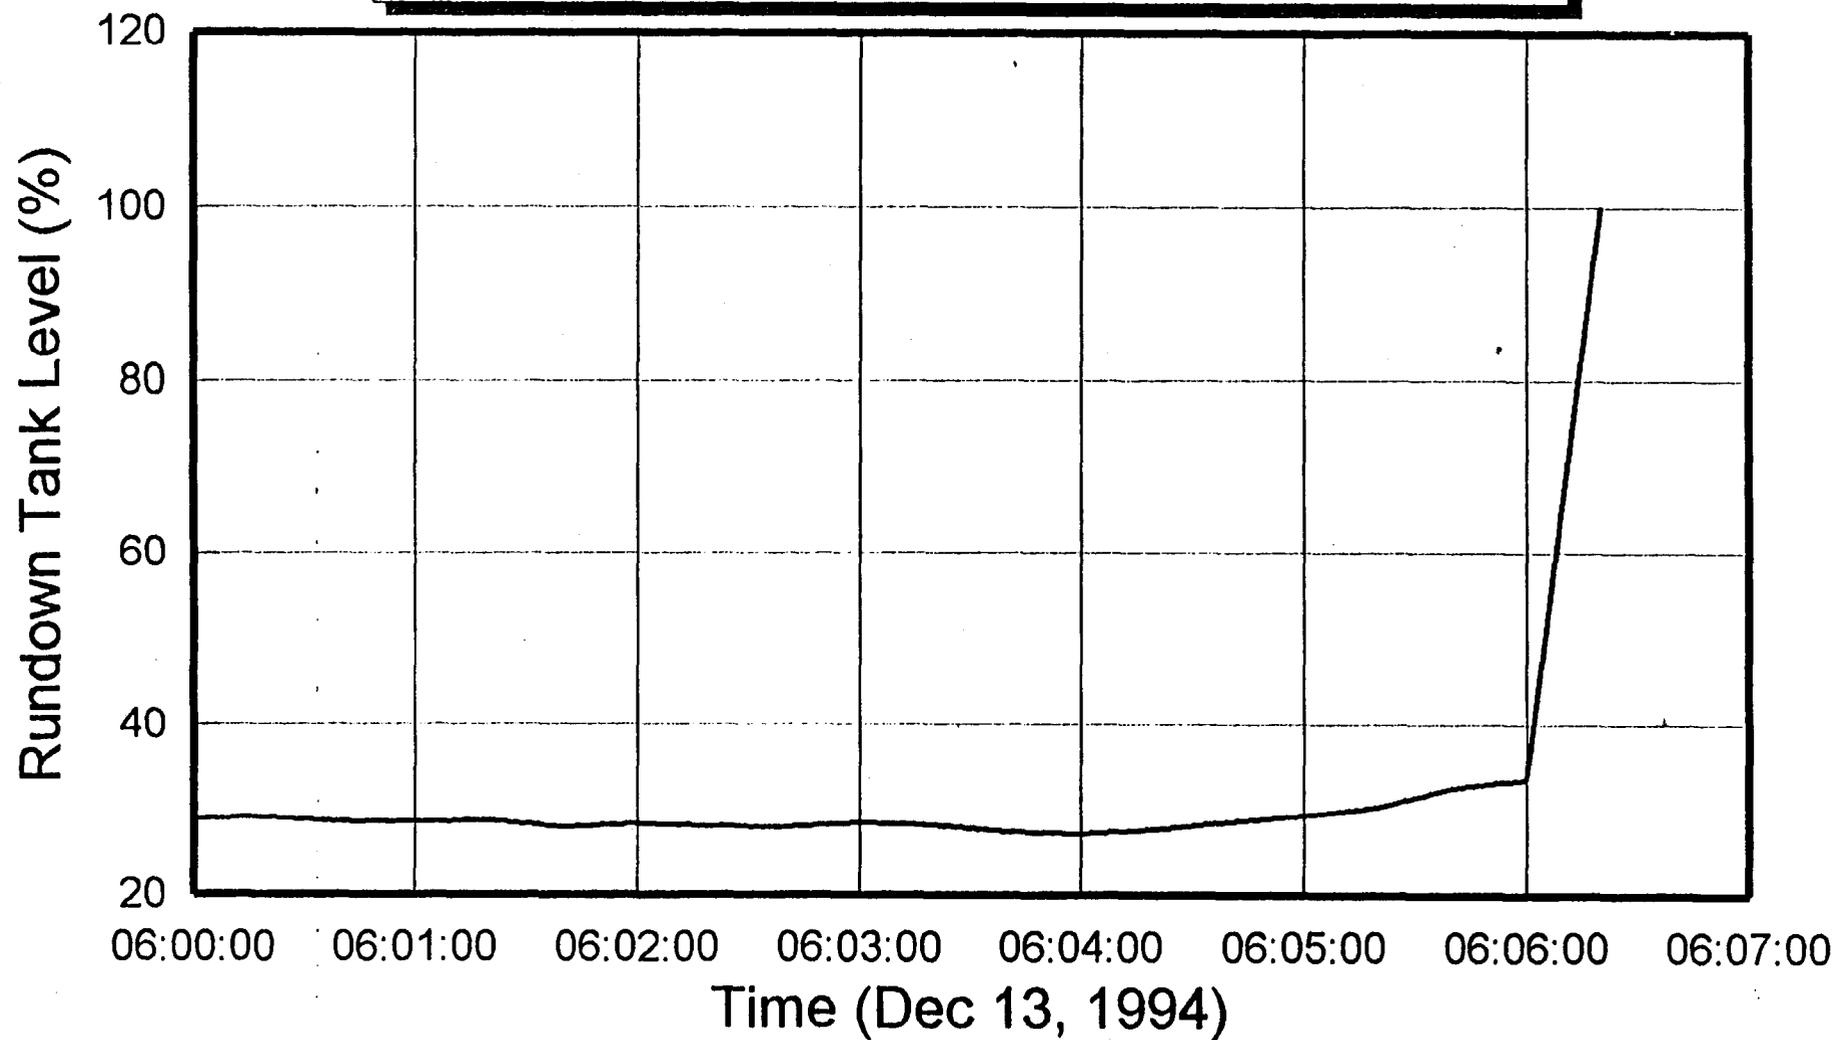
FIGURE 8-5

3. The rundown tank was equipped with steam coils that were attached to a steam header, but steam was not applied because of problems with the coils.
4. The pH of the rundown tank solution was determined to be approximately 1.0 and analytical data indicated the presence of chlorides.
5. Approximately 2 minutes before the explosion (DCS time), the level indication showed an exponential increase to an indicated level of 100% at the approximate time of the explosion (*Figure 8-5*).
