United States  
Environmental Protection  
Agency

## CHEMICAL ACCIDENT INVESTIGATION REPORT

### TERRA INDUSTRIES, INC. NITROGEN FERTILIZER FACILITY PORT NEAL, IOWA

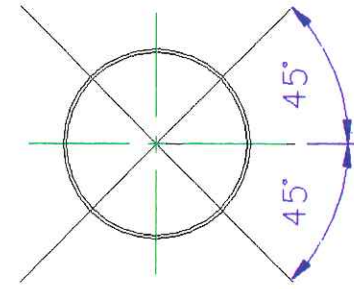
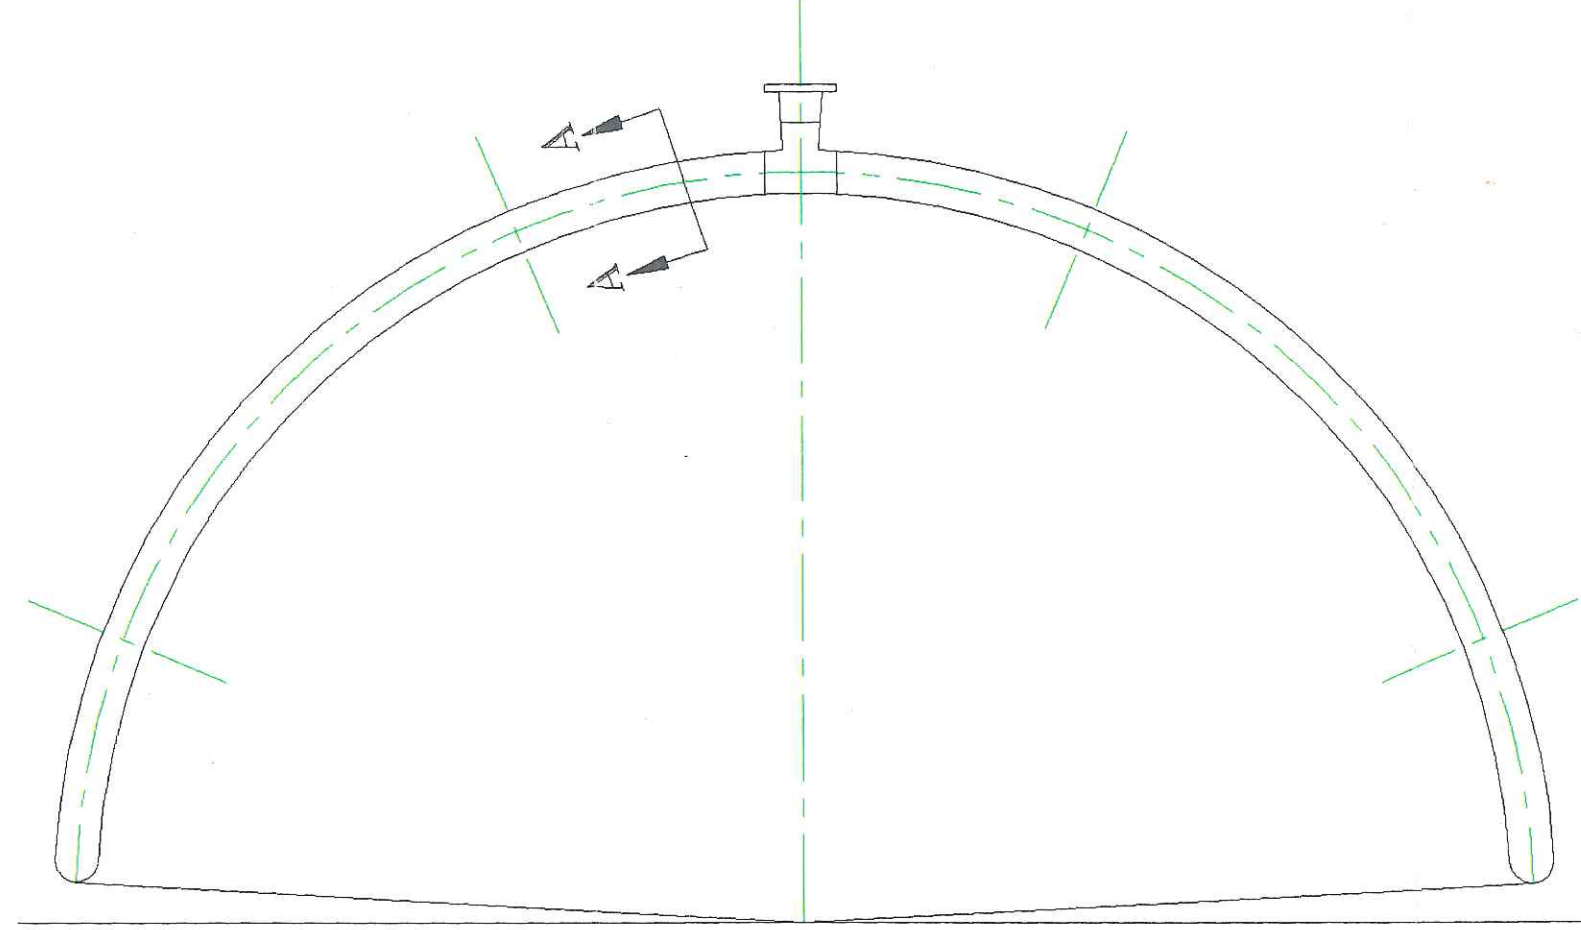
## NITRIC ACID SPARGER DETAIL

The neutralizer and the nitric acid spargers were inspected during the September, 1994 facility turnaround. Interviews and depositions of Terra employees vary in reference to the description of the neutralizer and spargers, but all agree that the neutralizer and the nitric acid spargers visibly appeared to be in good condition when inspected during turnaround.

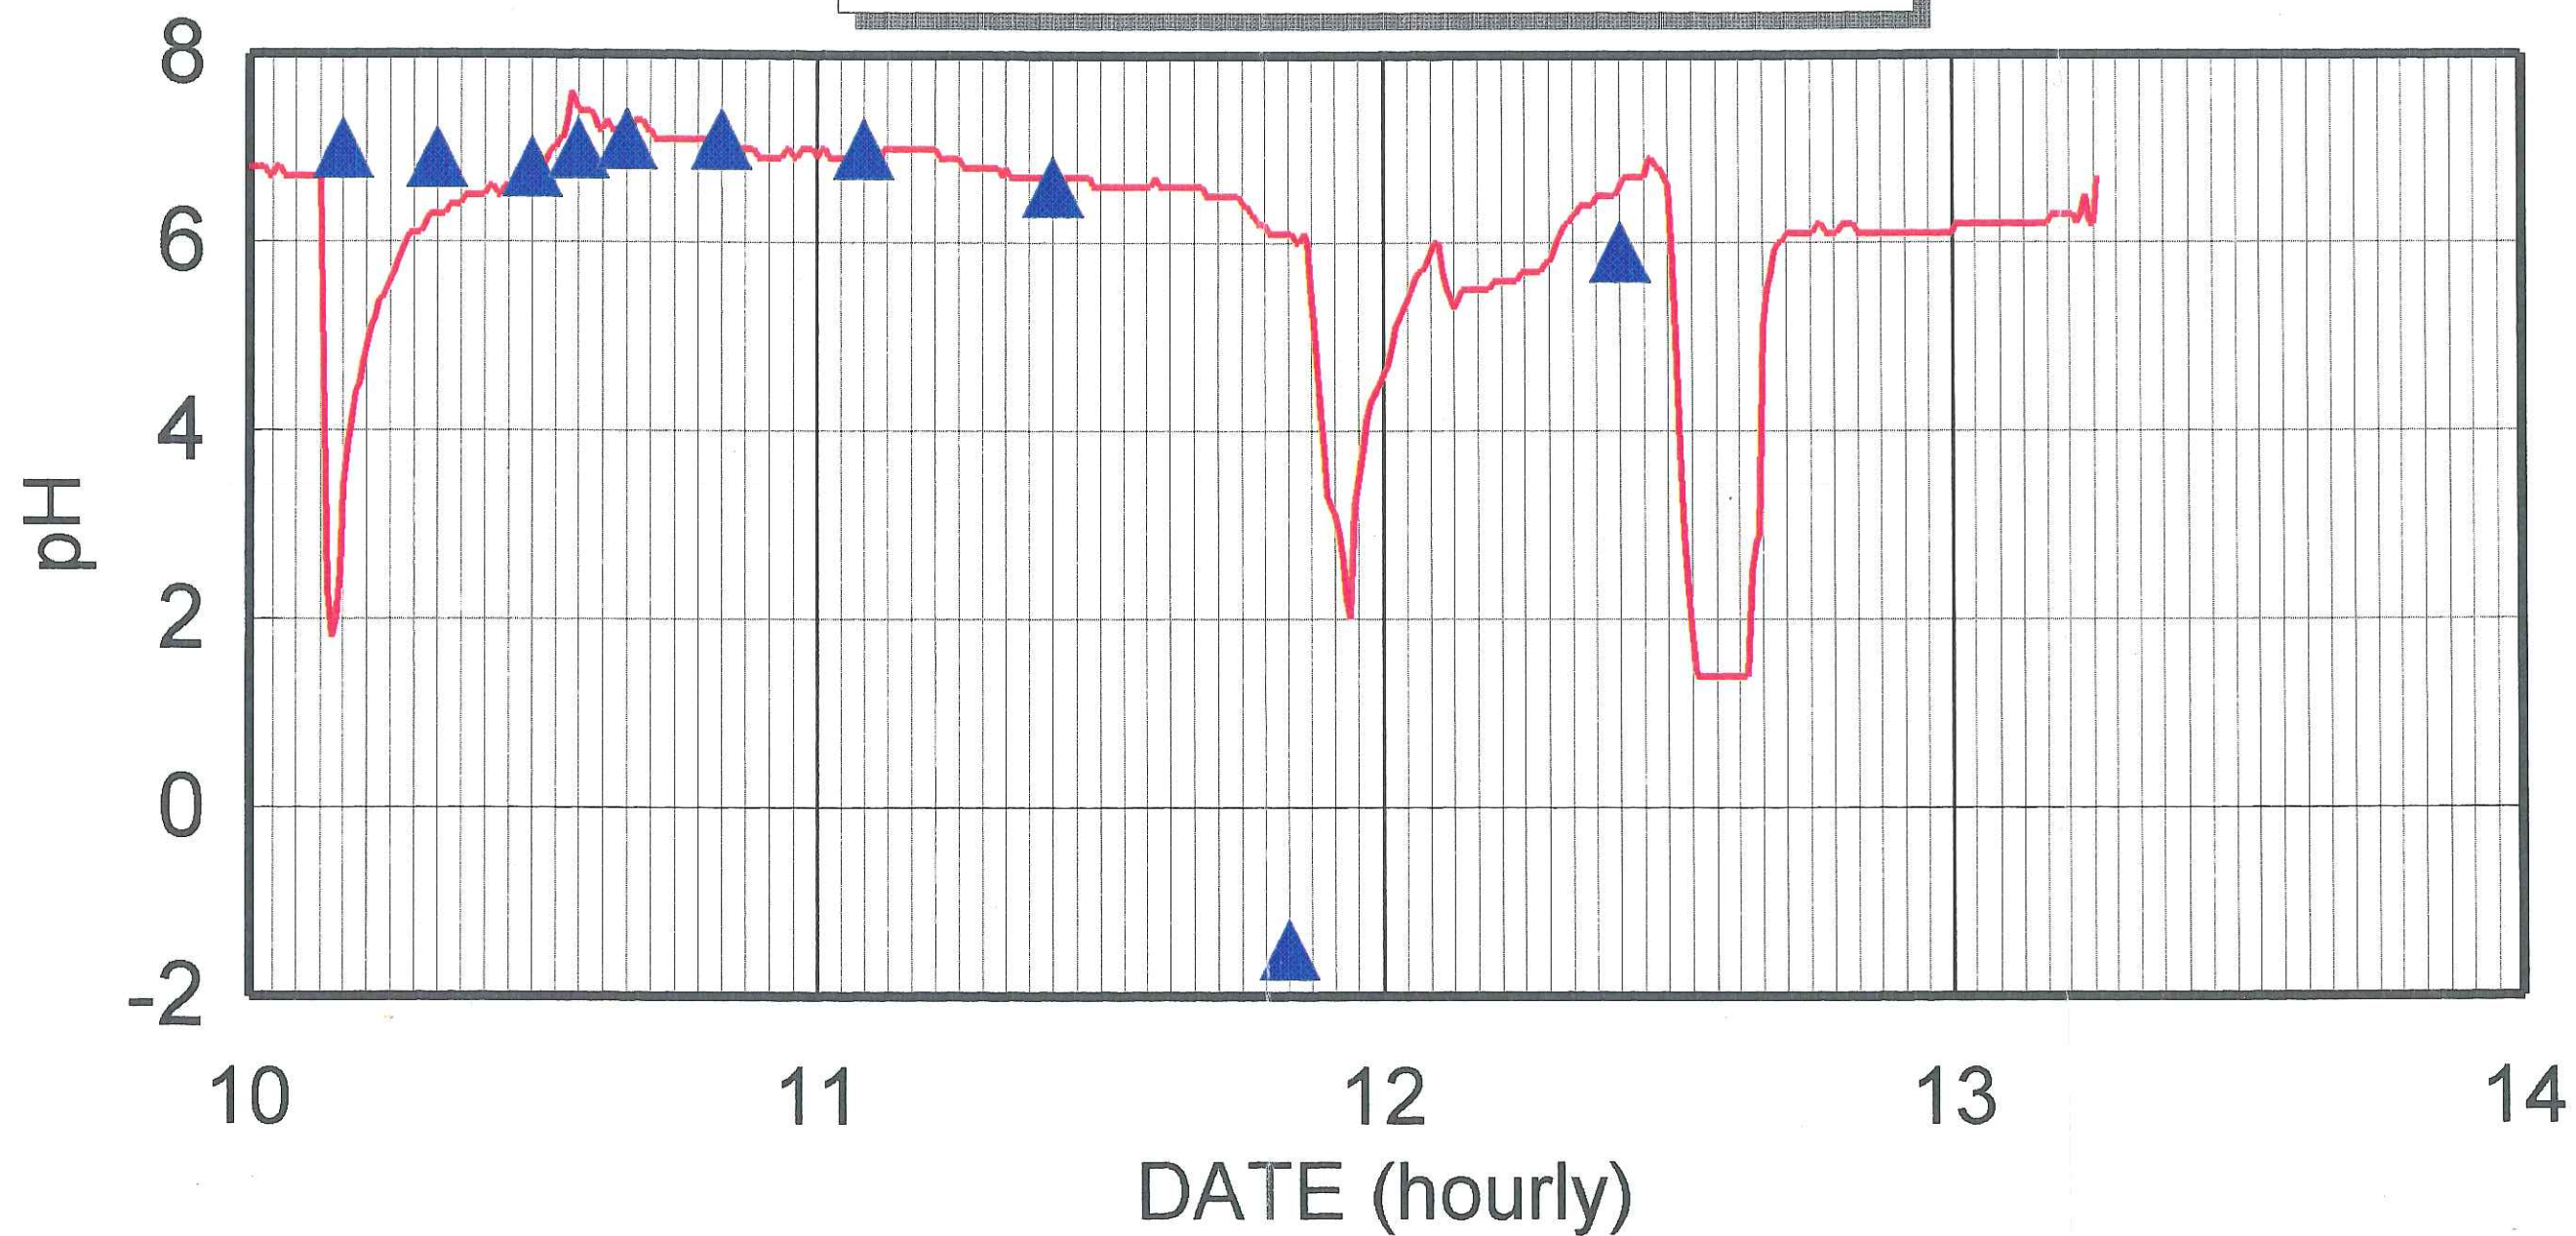
# NEUTRALIZER pH PROBE vs GRAB

In the days and weeks just prior to the explosion, the equipment failures and maintenance problems were chronic. The pH probe in the neutralizer rundown line appeared to be malfunctioning and there were no spares in stock. Both the ammonium nitrate product pumps which transports ammonium nitrate to storage were leaking or otherwise malfunctioning. There were numerous problems in the nitric acid plant, and maintenance was having a hard time keeping up with the repair requests.

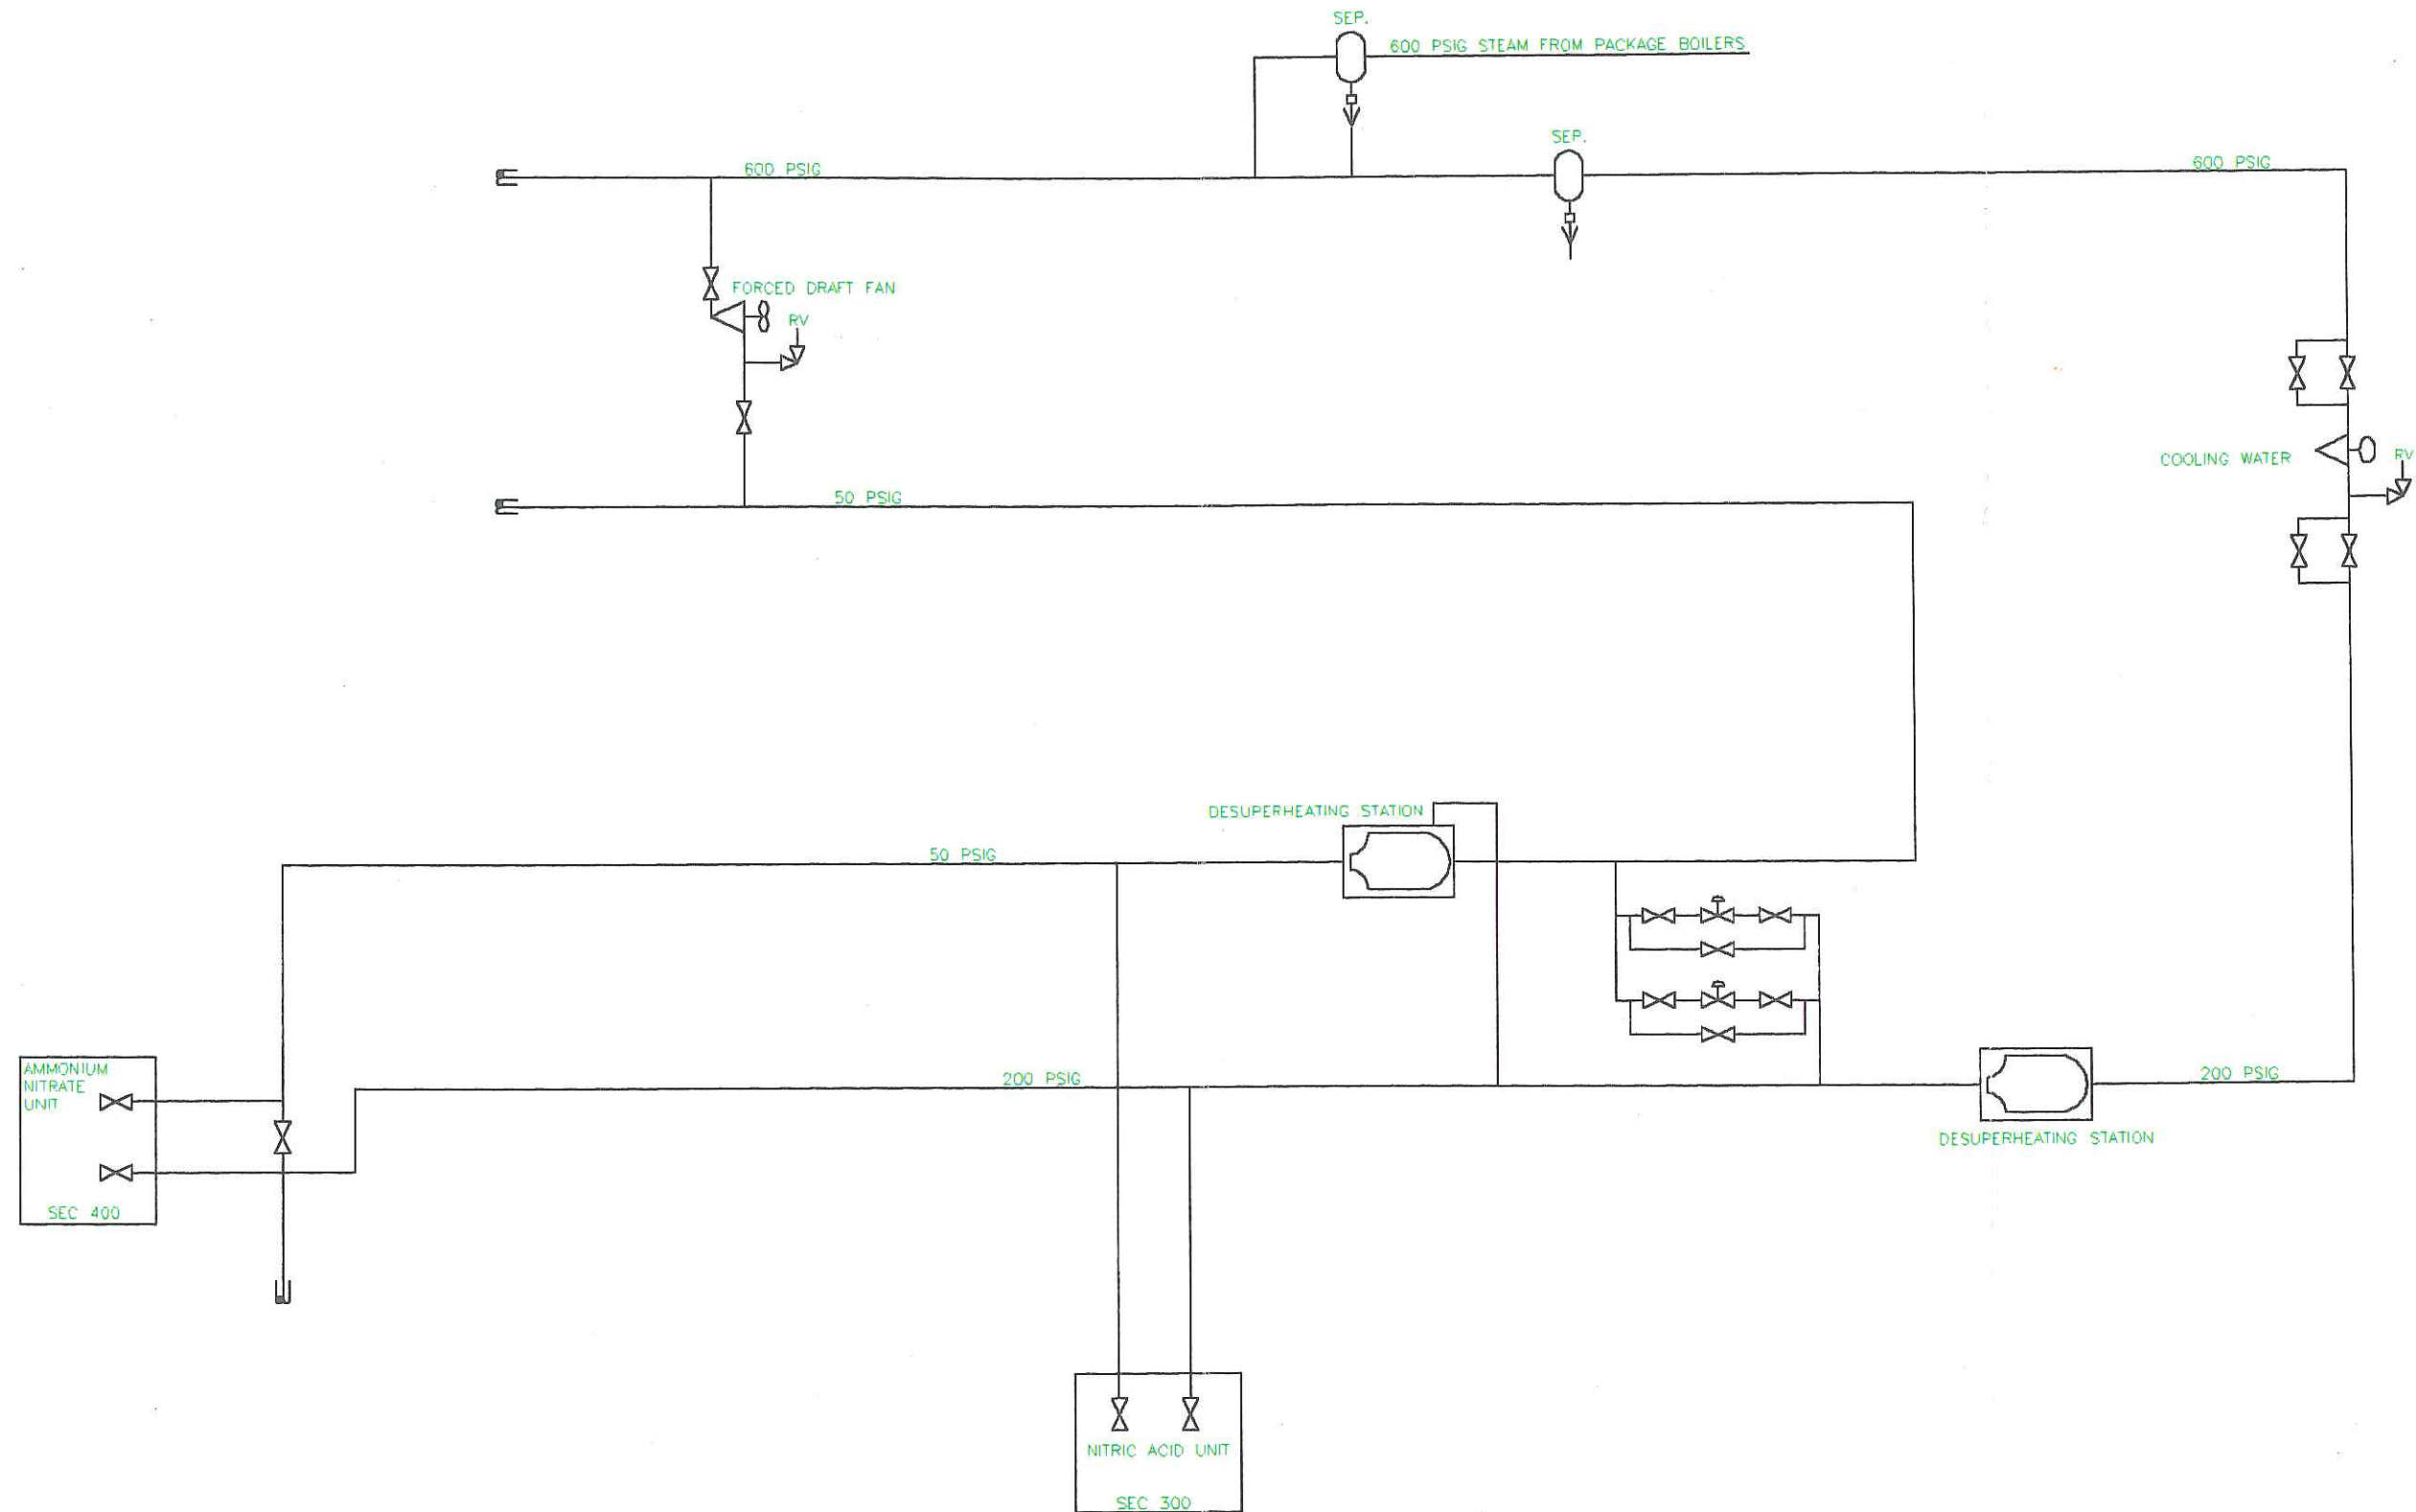
FIGURE 7 - 4  
STEAM DISTRIBUTION SYSTEM (PARTIAL)

The investigation team concluded that the steam distribution system had the potential to supply superheat during high demand events such as the slow roll of the nitric acid compressor.

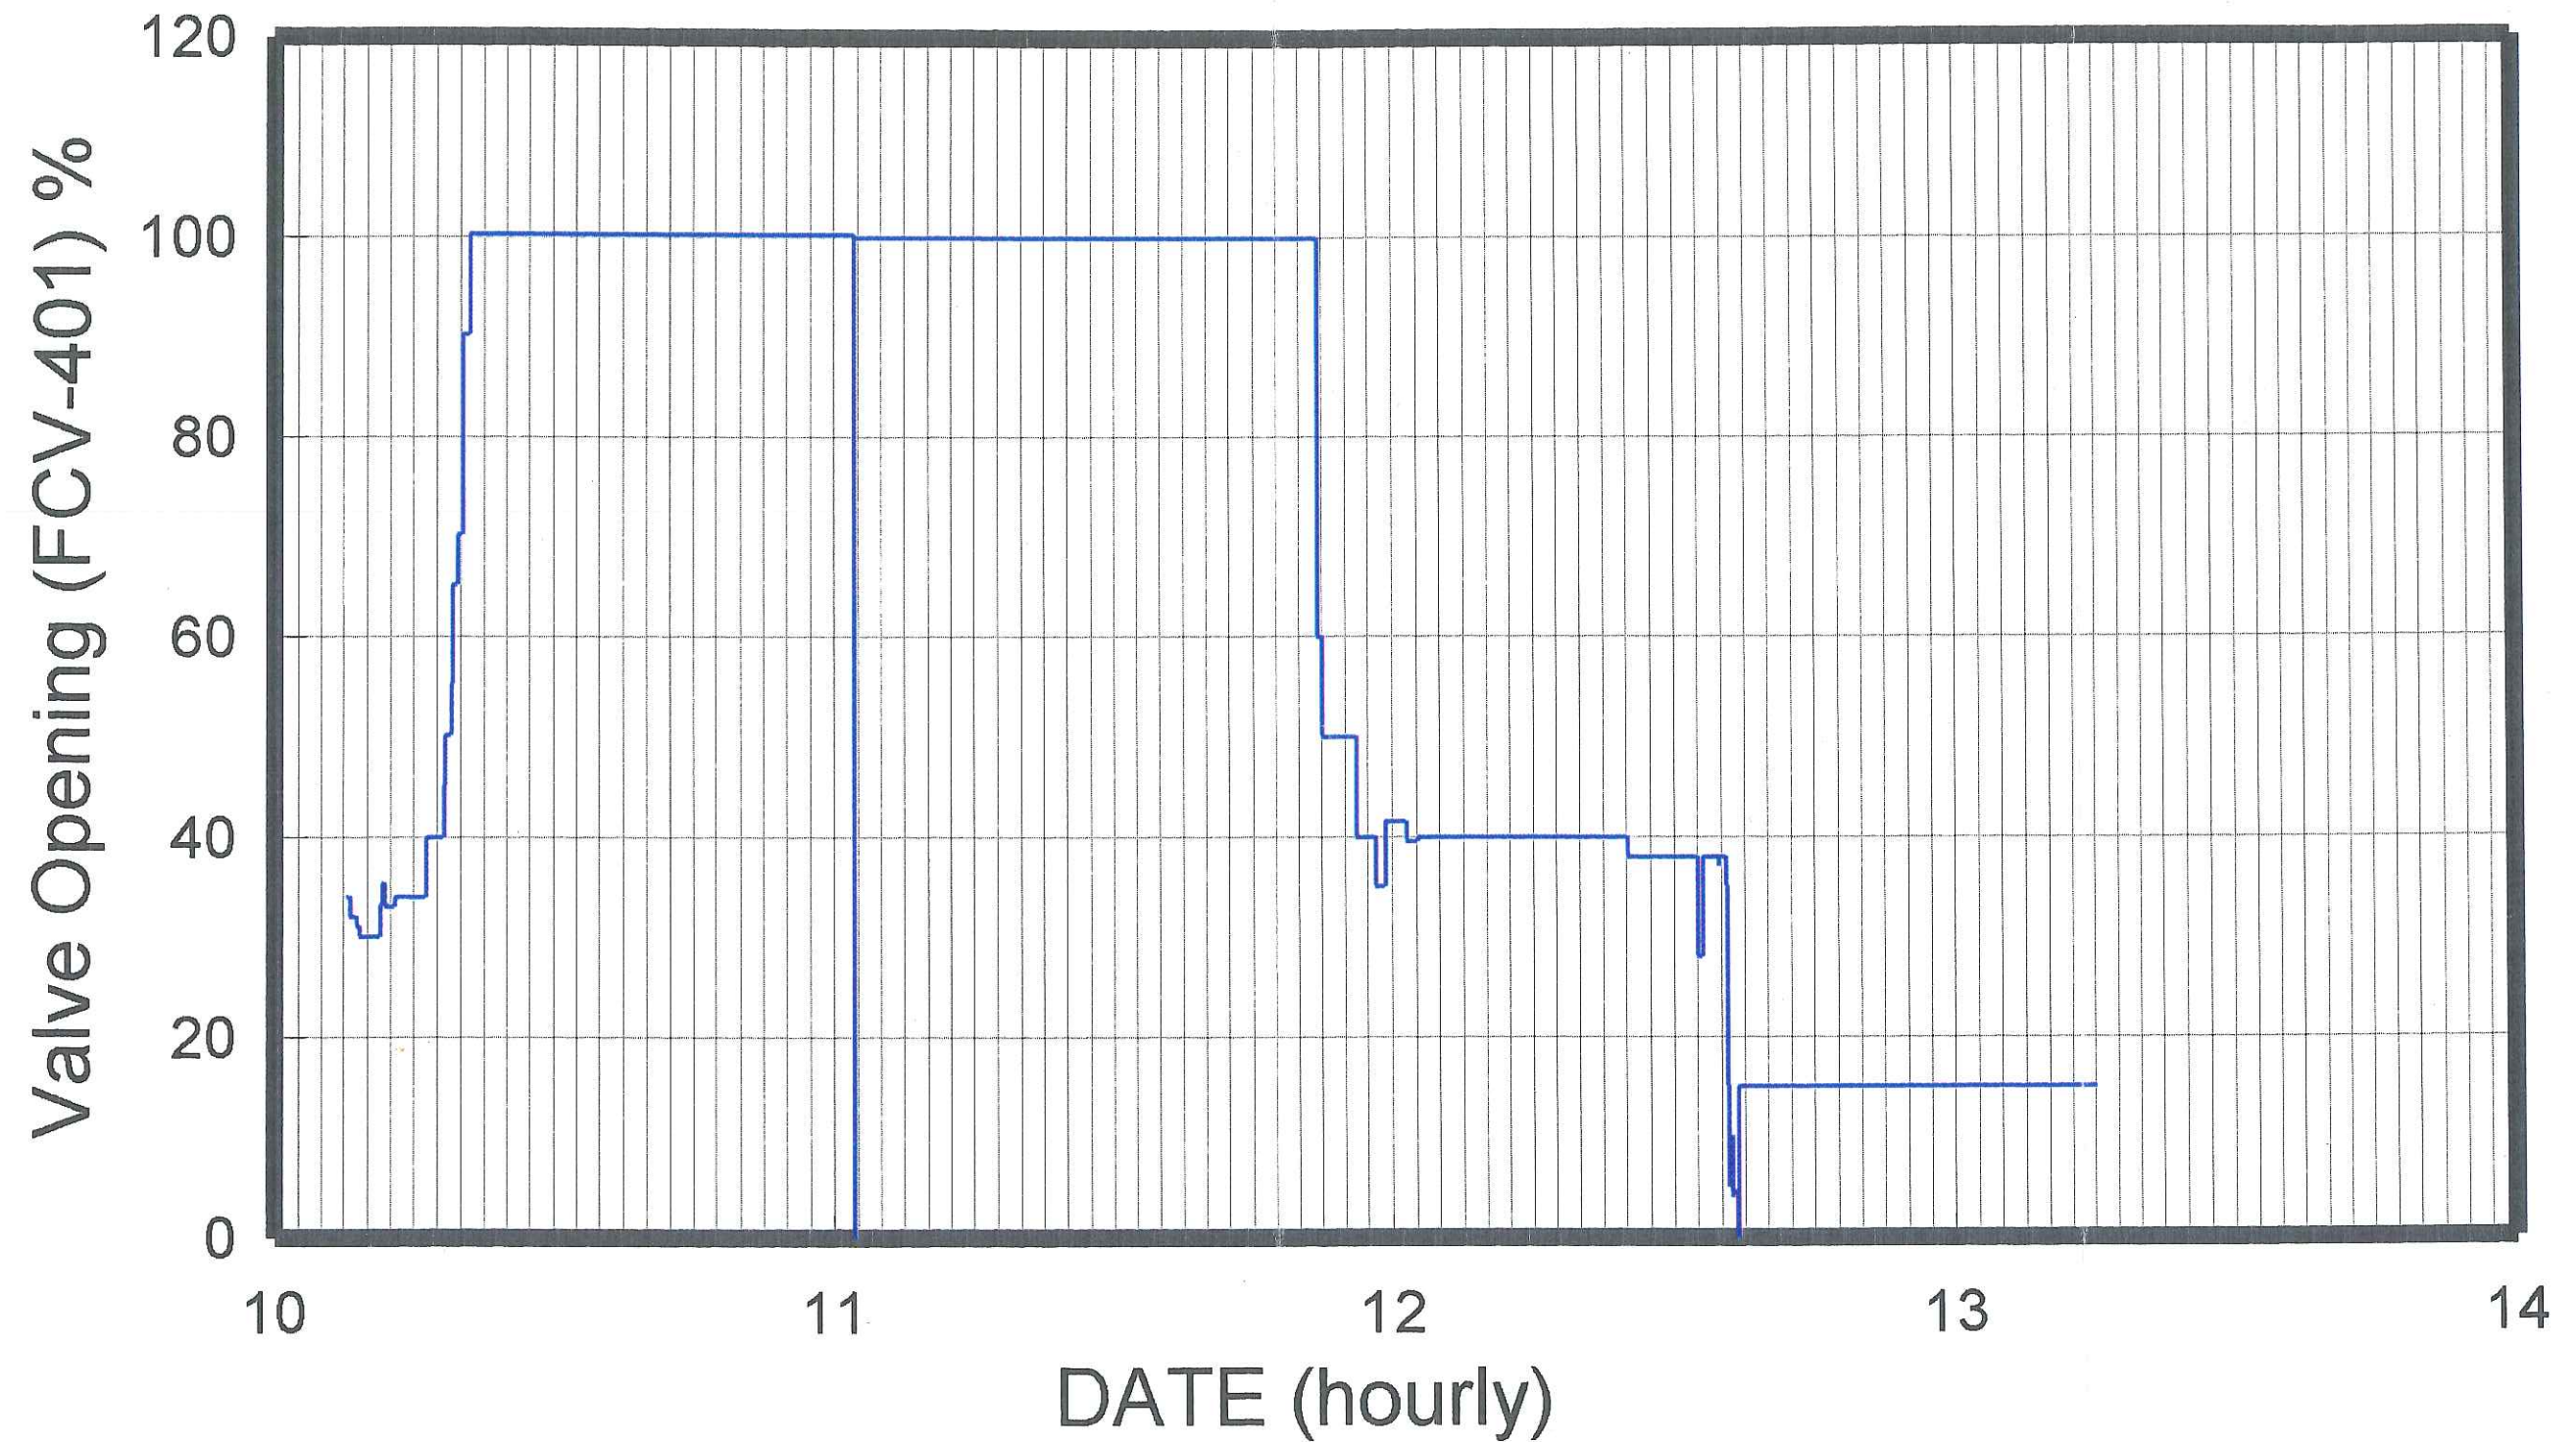
FIGURE 7 - 5

Interviews with Terra employees indicated that acid supply to the AN plant had been a periodic problem for a few years prior to the installation of the scrubber [ID-14, ID-23]. Terra increased the nitric acid pump capacity to overcome the problem, but periodic shortages still occurred in the AN plant, apparently due to losses in the piping resulting from a combination of pipe diameter and length. The investigation team determined that when the AN scrubber was installed, the nitric acid supply for the scrubber was taken from the same nitric acid line that supplied the neutralizer without increasing the capability to supply nitric acid to the AN plant.

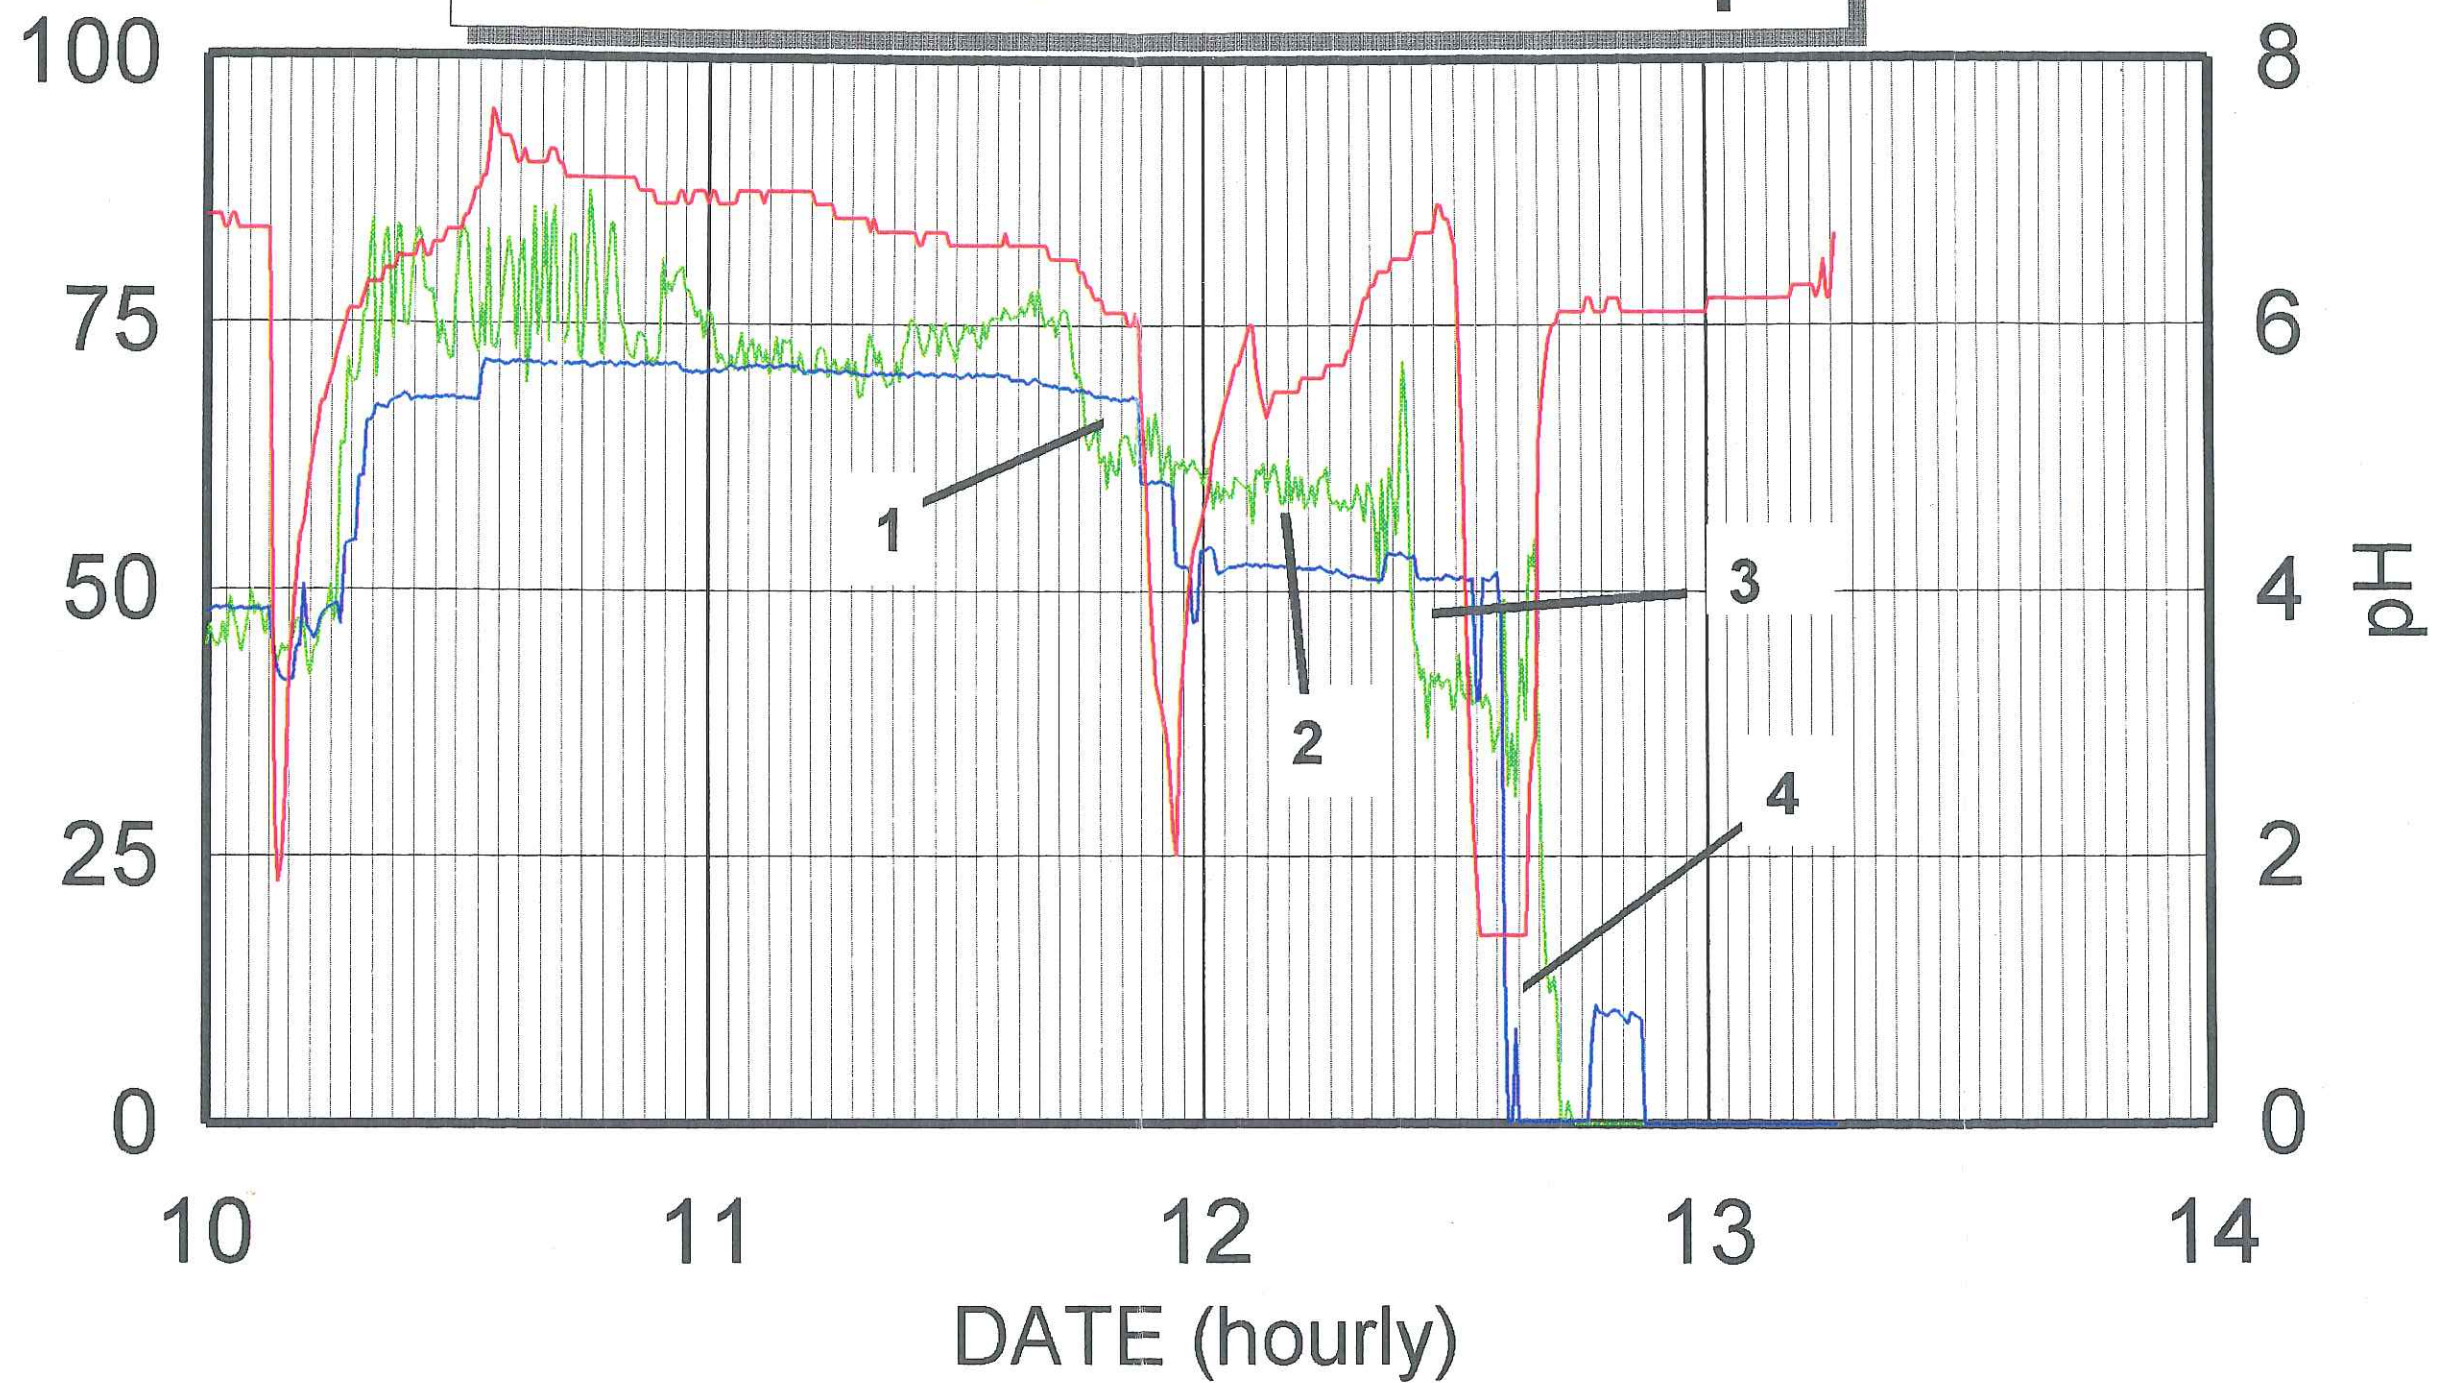
## NEUTRALIZER FEEDS vs. pH

When operated in the automatic mode, the AN DCS monitors urea offgas flows and the ratio controller adjusts the nitric acid flow rate to follow the offgas fluctuations. This feed-forward control loop anticipates pH changes and adjusts nitric acid flow accordingly. In cascade mode, the pH control loop, a feed-back loop, monitors the pH of the neutralizer output and fine tunes the nitric acid valve to maintain the selected pH (set point). However, the DCS was operating in the manual mode for the duration of the graphed data, with one short attempt to put the DCS in cascade mode that occurred at 0431 hours on December 10. The DCS data indicates that nitric acid control adjustments significantly lagged behind urea offgas fluctuations (reductions) on December 10, December 11, and during shutdown on December 12 (*Figure 7-7*). The DCS was in manual mode, and operator adjustments of the acid valve position lagged changes in the offgas flow rate. This caused an acid condition in the neutralizer each time. The ratio controller monitored the offgas changes, but was not engaged in either the automatic or cascade mode.

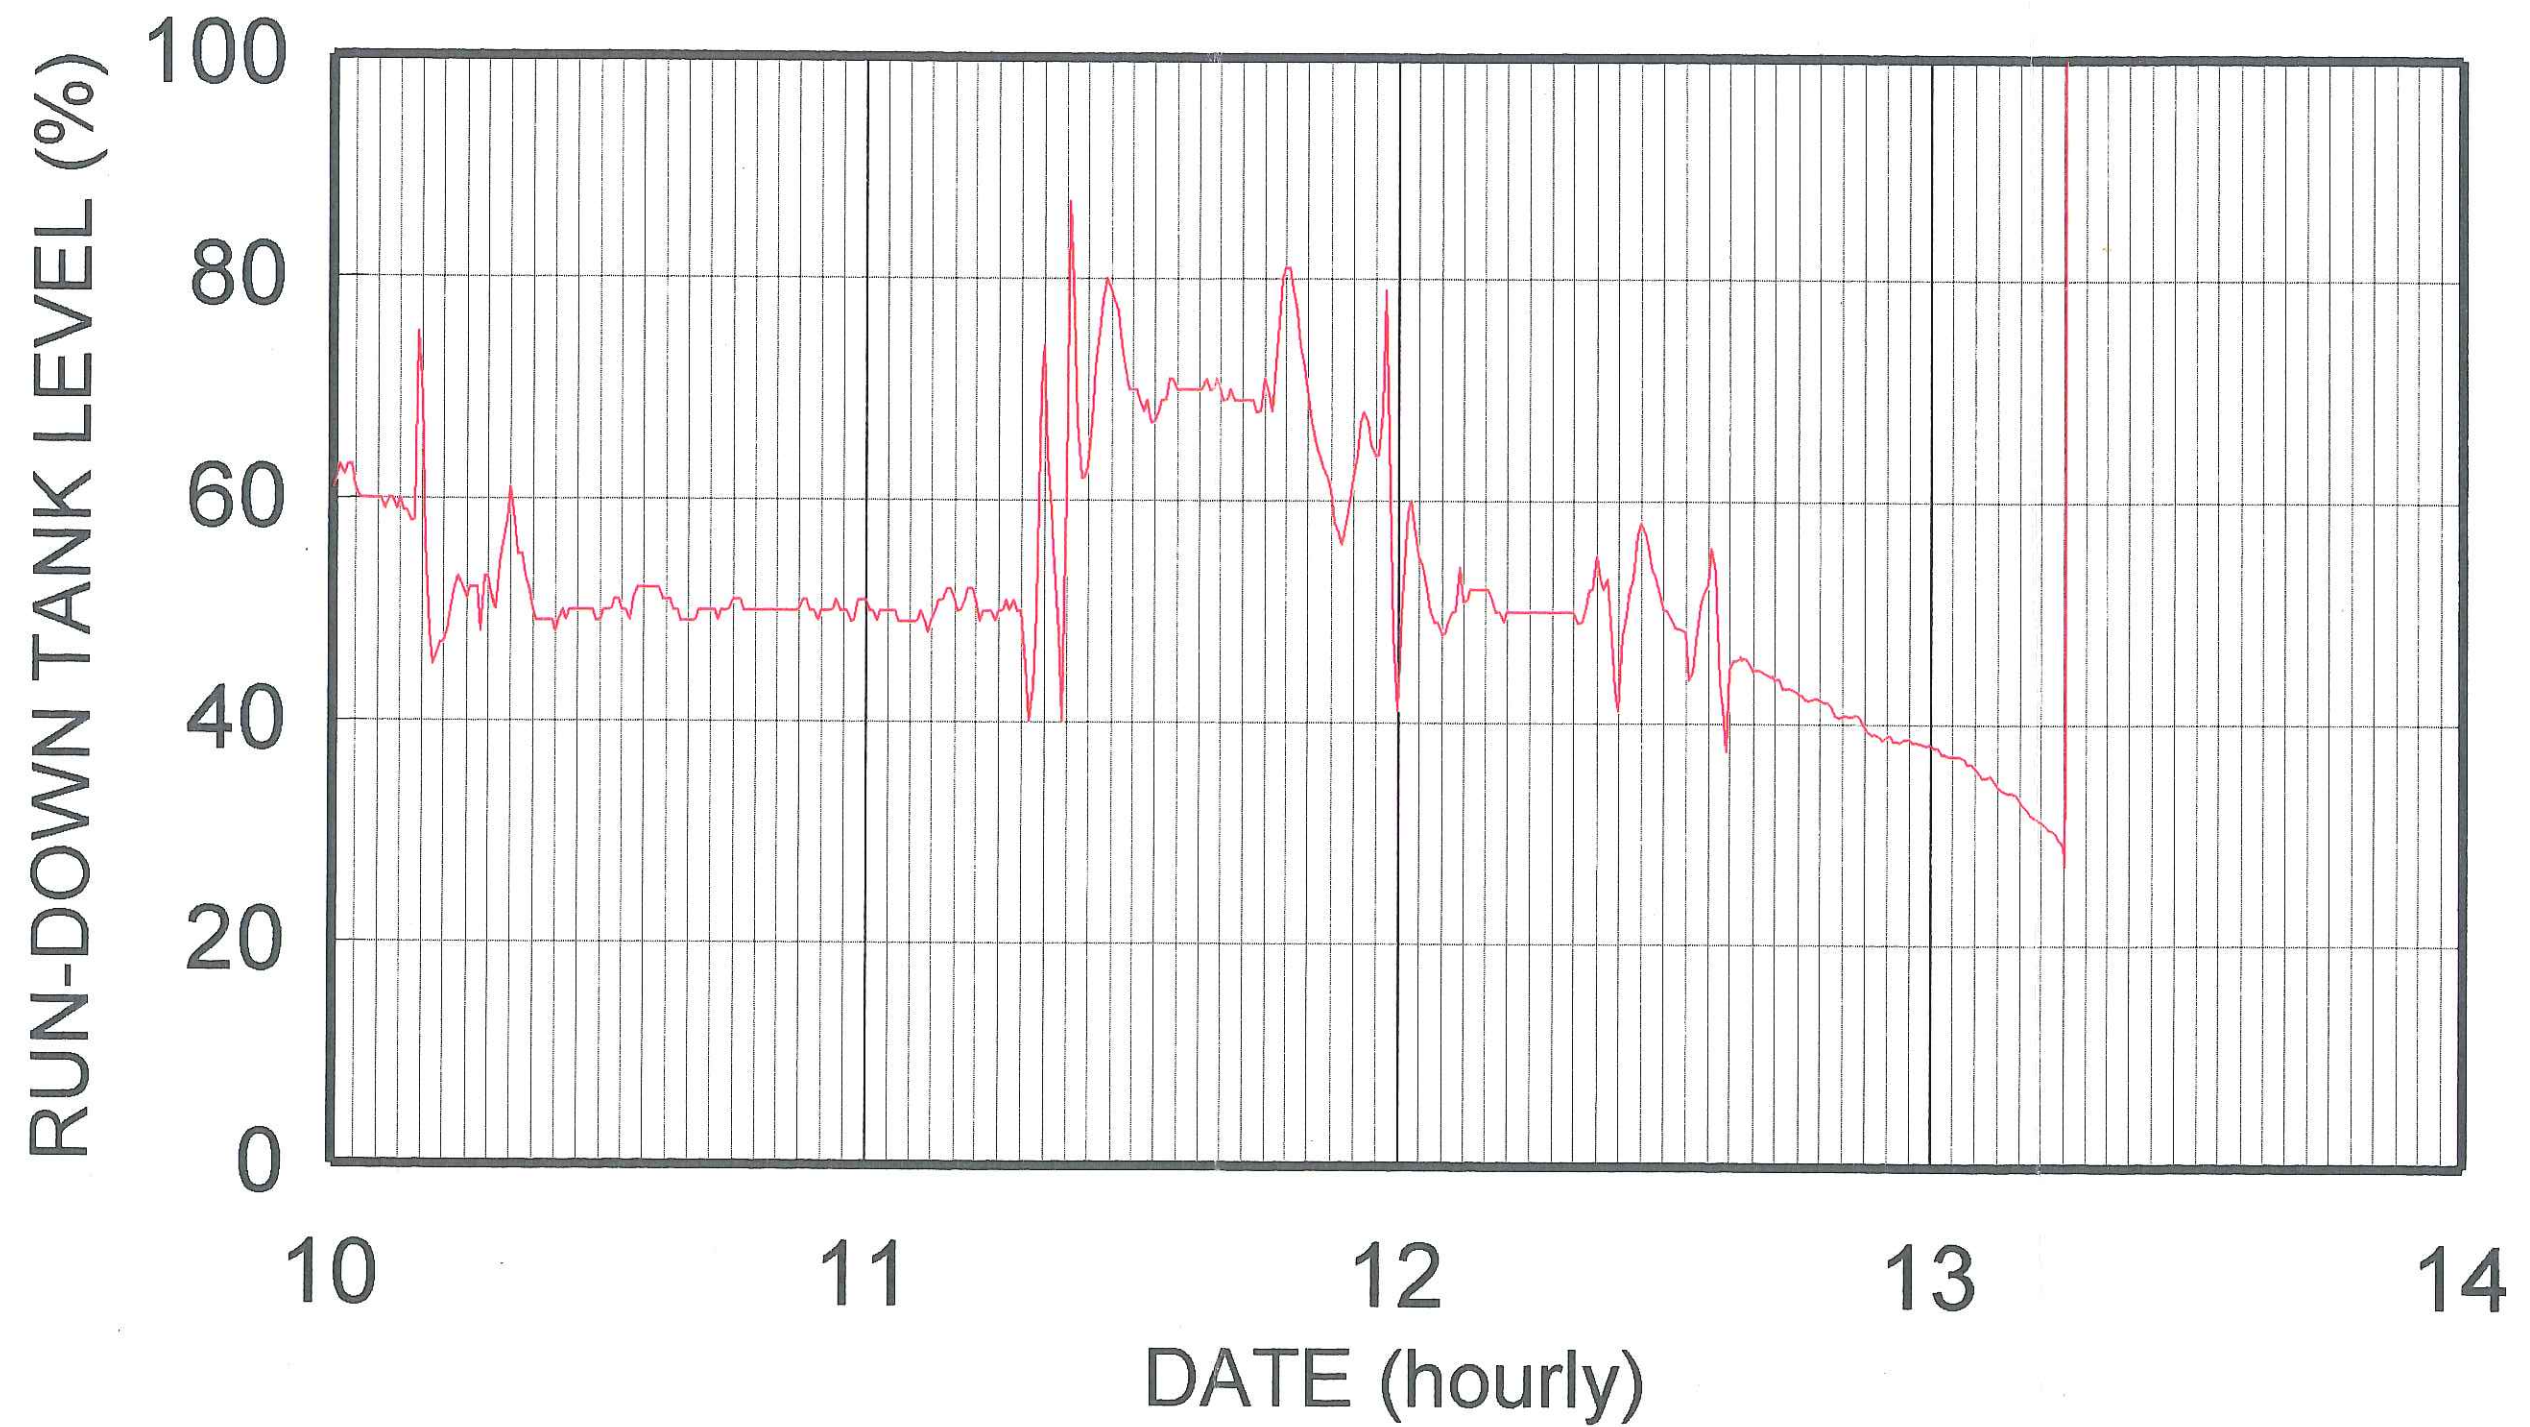
FIGURE 8 - 1

1. A process pump was operating. The investigation team determined that both process pumps had been shut down and blocked in and steam had been applied to the AN product lines from the process pumps to storage.
2. The rundown tank was leaking. The investigation team was unable to totally disprove this possibility, but ambient temperatures would contraindicate that ammonium nitrate would continue to release from the rundown tank at the low rate indicated without crystallizing.
3. Impact of cold weather on the rundown tank level sensors and associated piping. The investigation team determined that work orders had been issued requesting that these sensors be insulated, but they had not been insulated prior to the explosion. The investigation team determined that this was the most likely cause of the declining level.
