United States  
Environmental Protection  
Agency

## CHEMICAL ACCIDENT INVESTIGATION REPORT

### TERRA INDUSTRIES, INC. NITROGEN FERTILIZER FACILITY PORT NEAL, IOWA

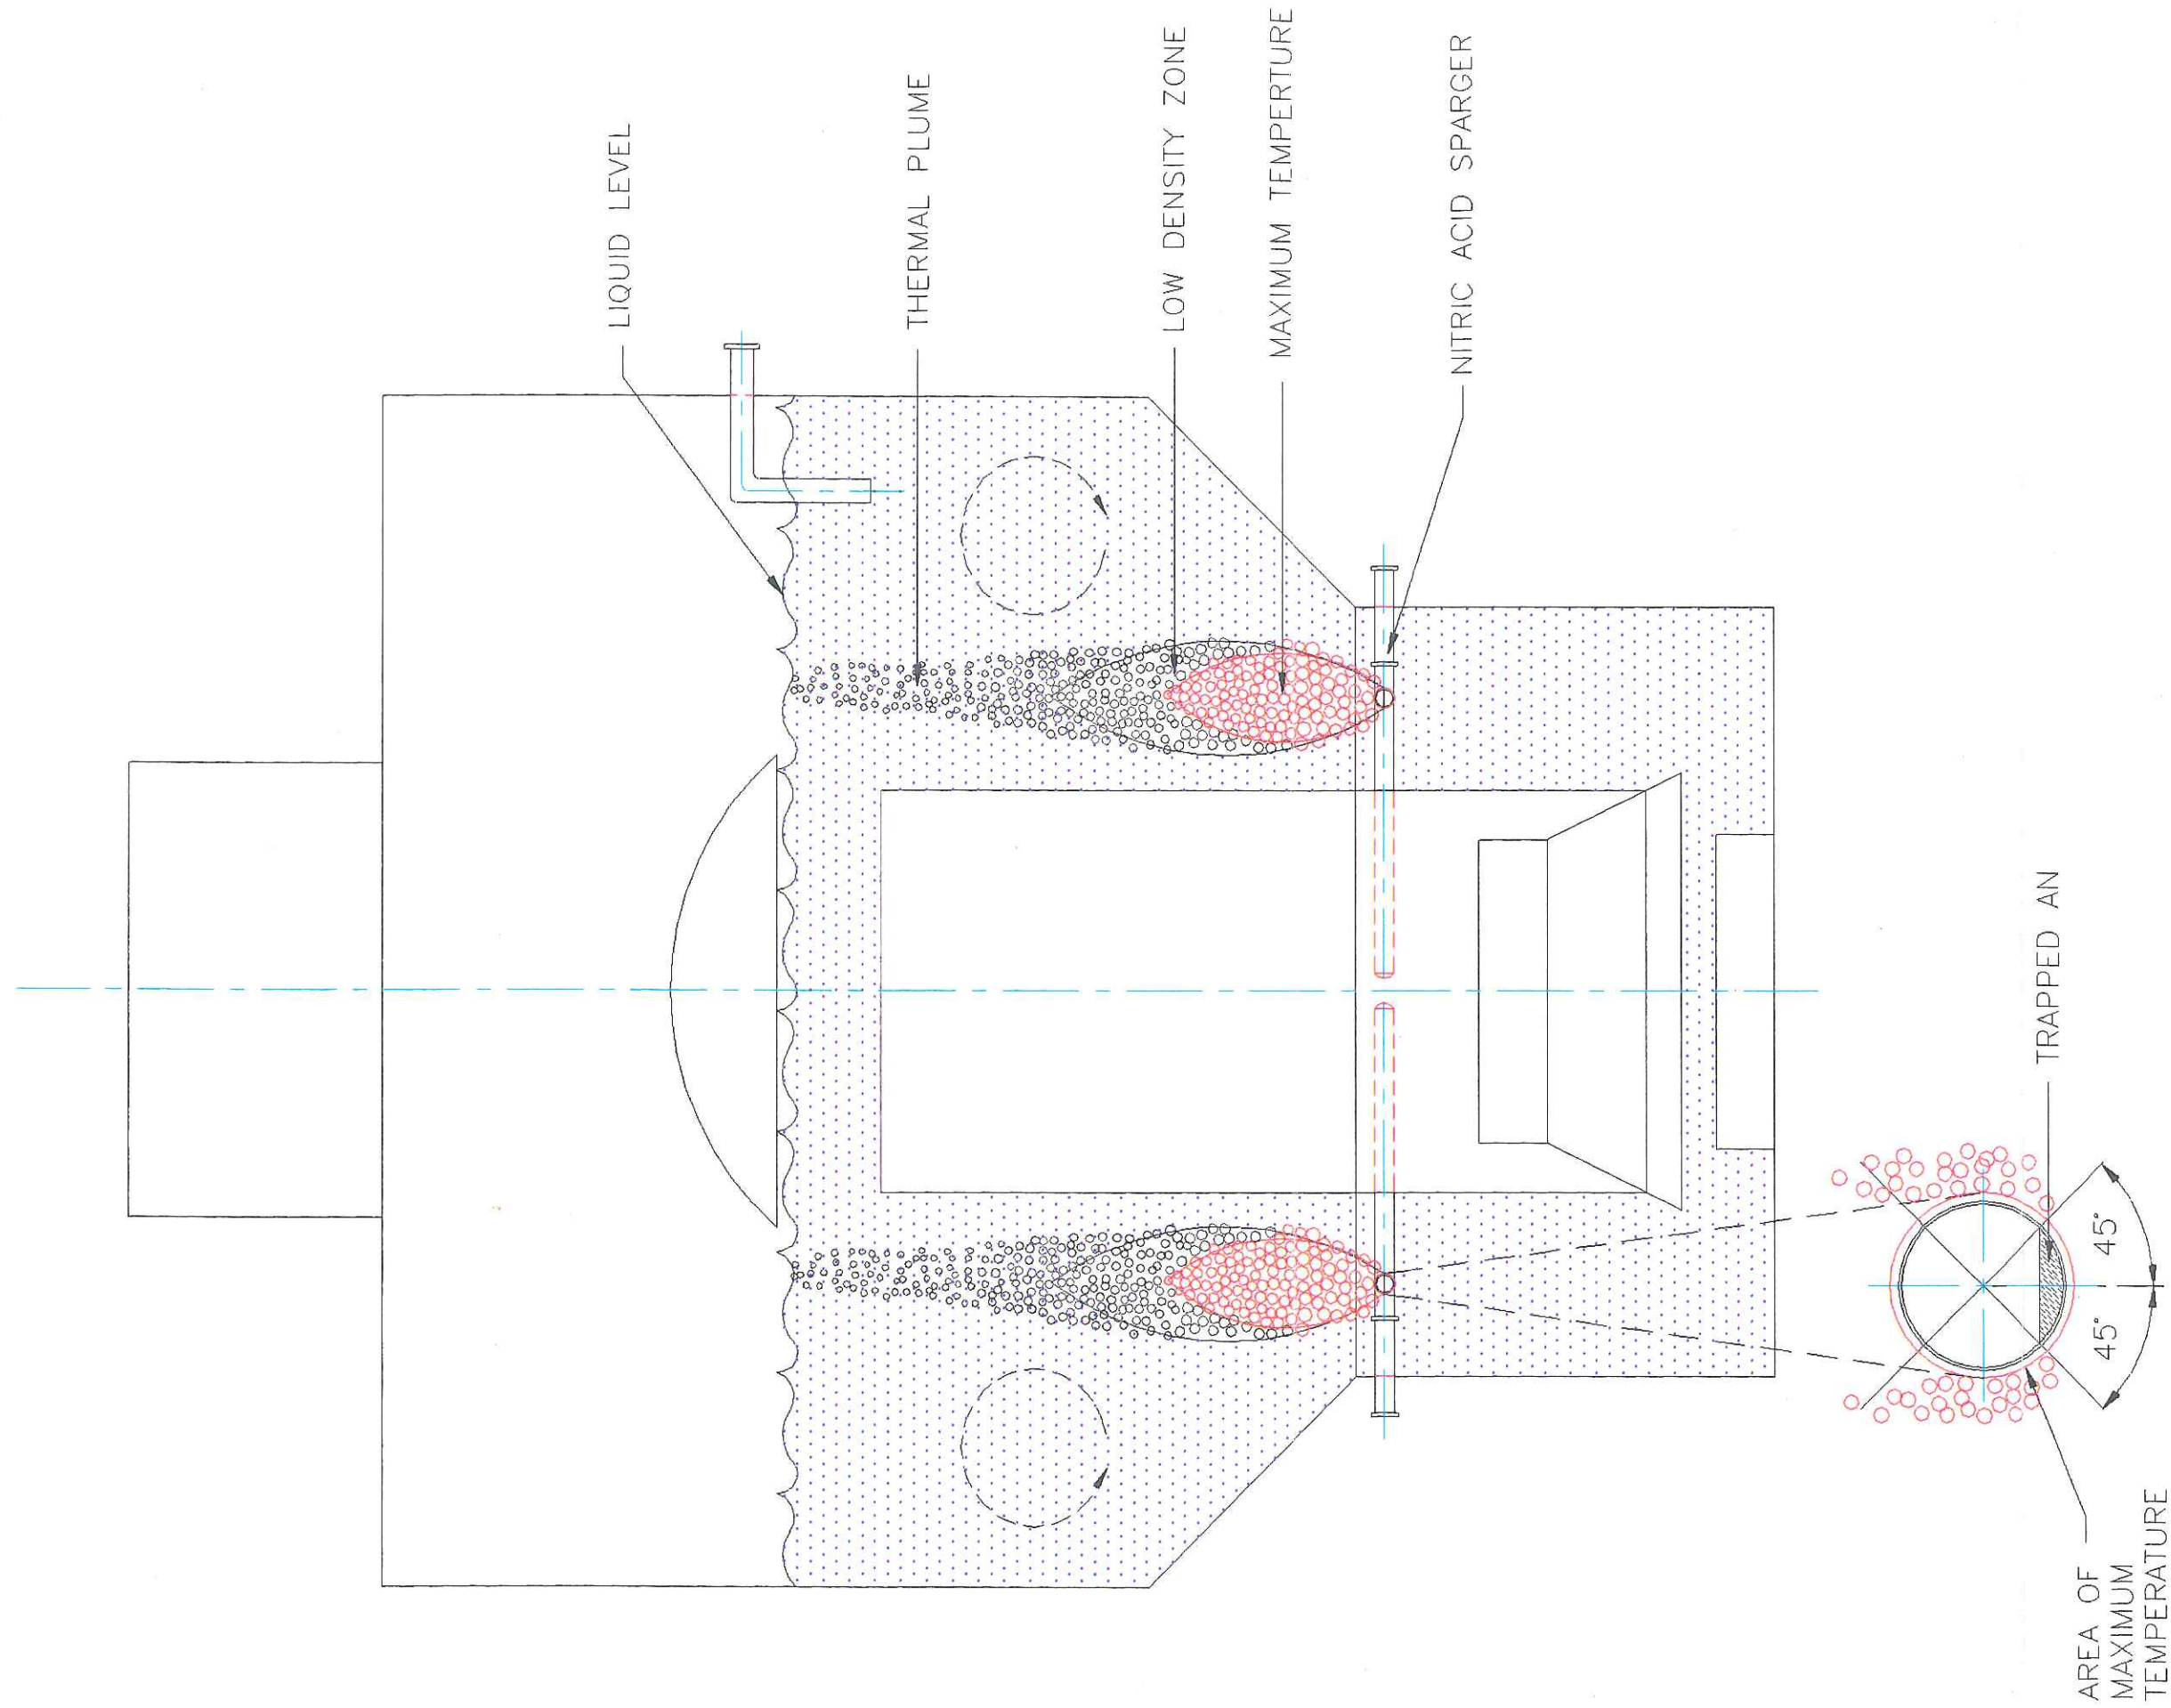
CUT CROSS SECTION OF NEUTRALIZER

Calculations indicated that continued steam heating would have resulted in a high temperature (near the temperature of the steam) and a low-density zone to develop directly around or above the sparger. Sensitizing factors lowered the thermal decomposition activation energy of the AN. The combination of energy in the input steam and the addition of superheat (possibly due to high steam demands in the nitric acid plant) exceeded the activation energy of the AN, resulting in the onset of thermal decomposition. The initial dissociation reaction was endothermic, and would have been quickly overcome due to its close proximity to the heating source. As heat continued to be transferred into this zone, the reaction became exothermic and self-sustaining [13]. At this point, large volumes of gases would have been formed. The effect of the rapidly expanding gas would have been twofold:

1. Adiabatic compression of the bubbles in the AN solution resulted in a more rapidly expanding wave front (deflagration propagation) [1]; and
2. Overcoming the vent capacity of the neutralizer, rundown tank, and scrubber system that, in turn, resulted in additional confinement until the vessels failed [21].

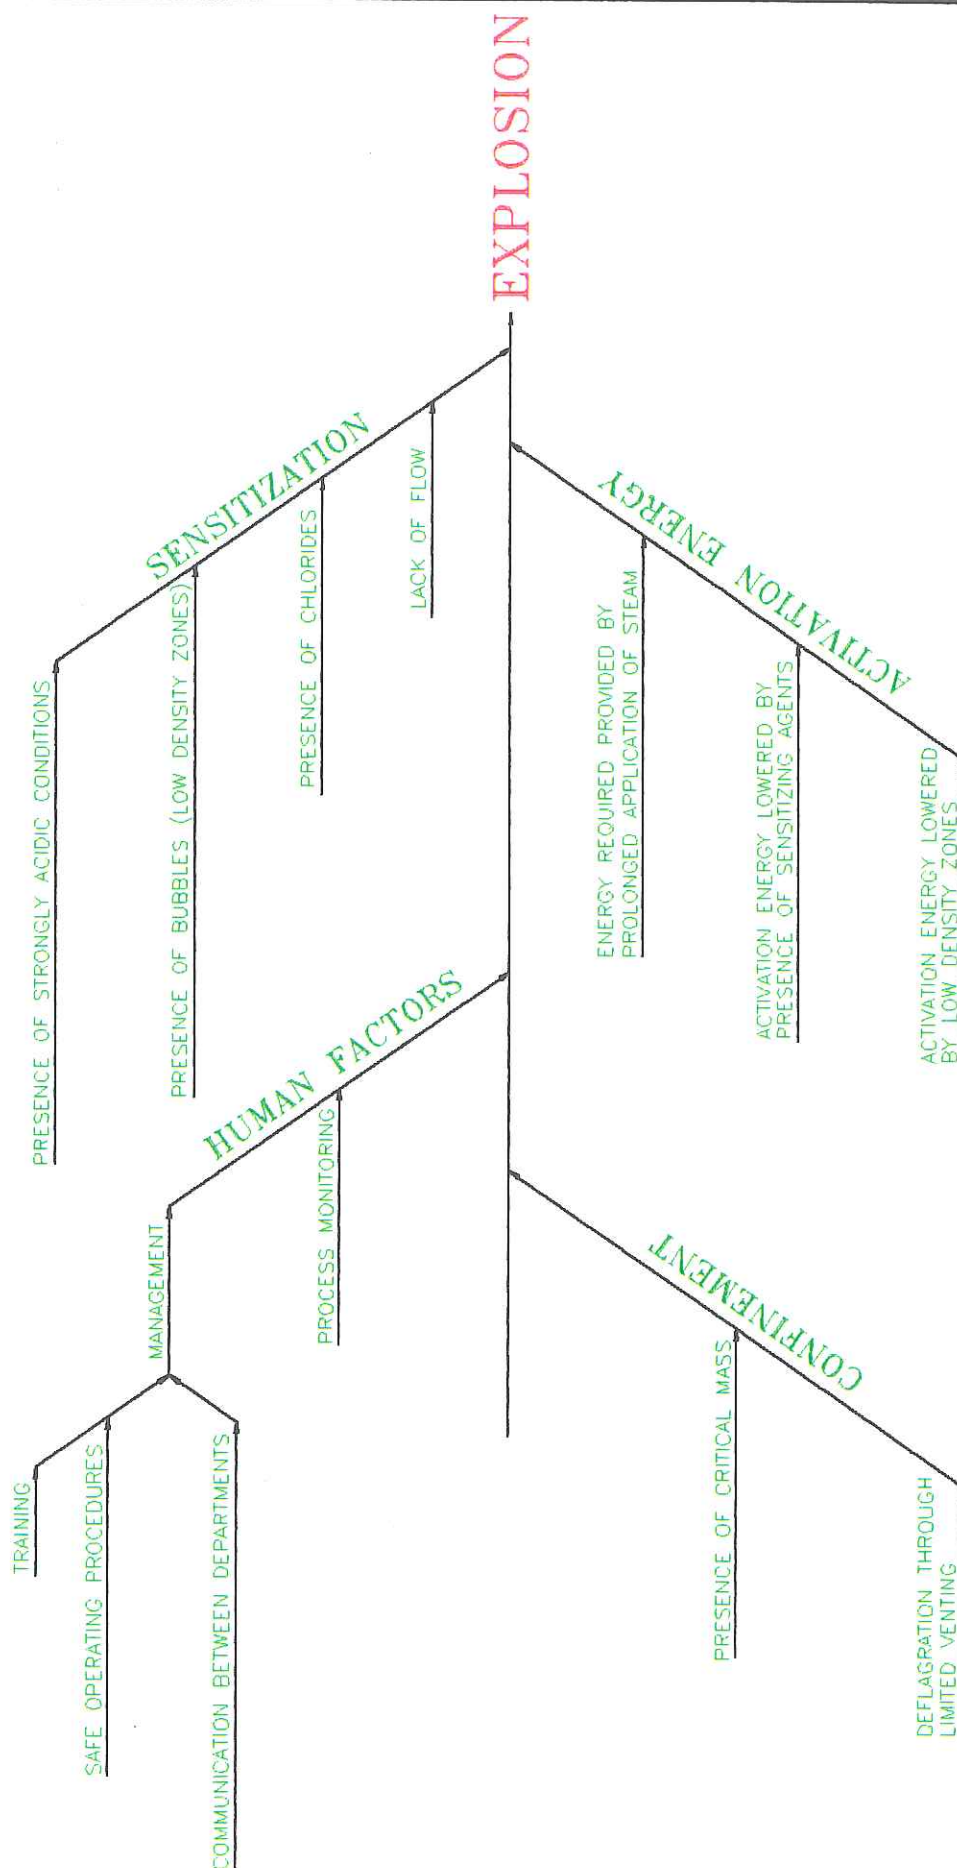
FIGURE 10 - 1  
EXPLOSION FACTOR FLOW CHART

operation procedures at the Terra Port Neal ammonium nitrate plant. The lack of safe operating procedures resulted in conditions in the plant that were necessary for the explosion to occur. The significant conditions that caused the explosion were:

1. Strongly acidic conditions in the neutralizer and rundown tank;
2. Prolonged application of 200 psig steam to the neutralizer nitric acid spargers;
3. The creation of bubbles and low density zones in the neutralizer;
4. Lack of flow in the neutralizer and rundown tank;
5. The presence of chlorides in the neutralizer and rundown tank; and
6. Lack of monitoring of the ammonium nitrate plant after the plant was shut down with the process vessels charged.
