# EPA/OSHA JOINT CHEMICAL ACCIDENT INVESTIGATION REPORT

Napp Technologies, Inc.  
Lodi, New Jersey

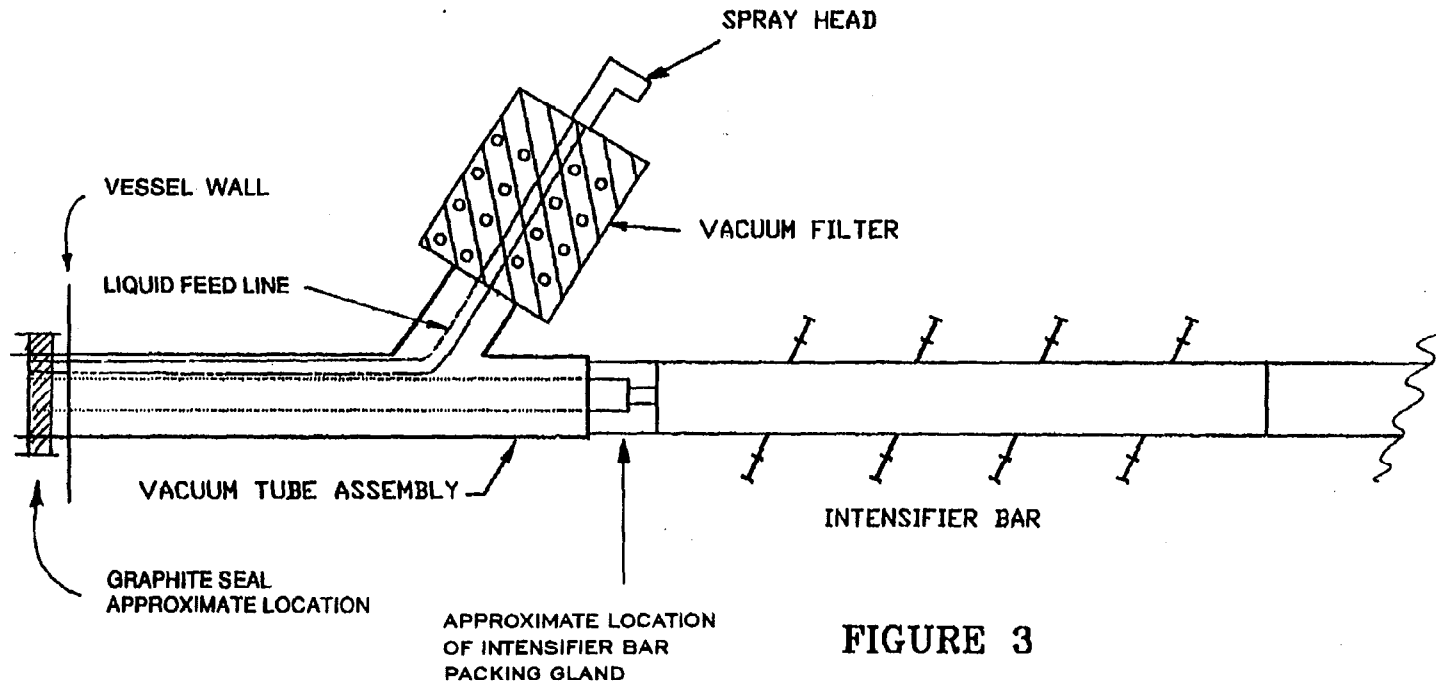
FIGURE 3

At 3:30 am. on April 20, as part of the precharging verification, operators made a final check to assure the blender was ready (i.e., clean and dry) to be loaded. The two operators and a foreman discovered that the vacuum head area, inside the blender, was wet. They also observed water on the internal walls of the blender. Another employee saw a wet spot also described as “droplets of water on the stainless steel” at the intensifier bar shaft seal (connection). They believed this moisture was

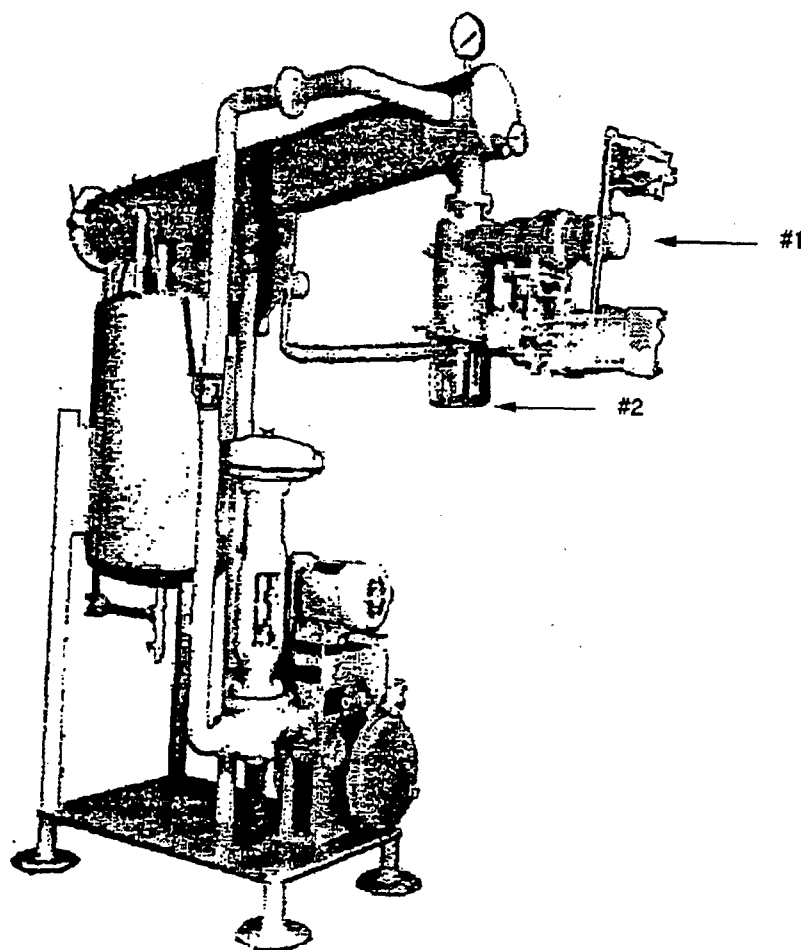
FIGURE 3A: TYPICAL VACUUM COLLECTION SYSTEM As SUPPLIED BY PATTERSON-KELLEY. # 1 SHOWS APPROXIMATE LOCATION OF INLET FROM BLENDER VACUUM LINE; # 2 SHOWS VACUUM SEPARATOR BOWL.

Between midnight and 4:30 a.m. on April 21, 1995, the third shift attempted to inject benzaldehyde into the batch on two occasions; each attempt failed. Operators observed the benzaldehyde running back into the vacuum separator. During each attempt to add the liquid, the blender was rotated for about two minutes with the intensifier bar running. Suspecting that product was blocking the spray tip of the nozzle and preventing the injection of the liquid, operators opened the blender twice and removed and washed the spray nozzle. Operators reportedly observed a slight dusty powder wafting within the head space of the blender. This was reported to the shift supervisor, who then checked the inside of the blender and directed the operators to remove and clean the nozzle. After the final attempt to charge benzaldehyde into the vessel it was determined that no fresh benzaldehyde remained. It was by then approximately 5:00 a.m. and coming to the end of the third shift. The shift supervisor told the operators to perform a lock and tagout of the blender.

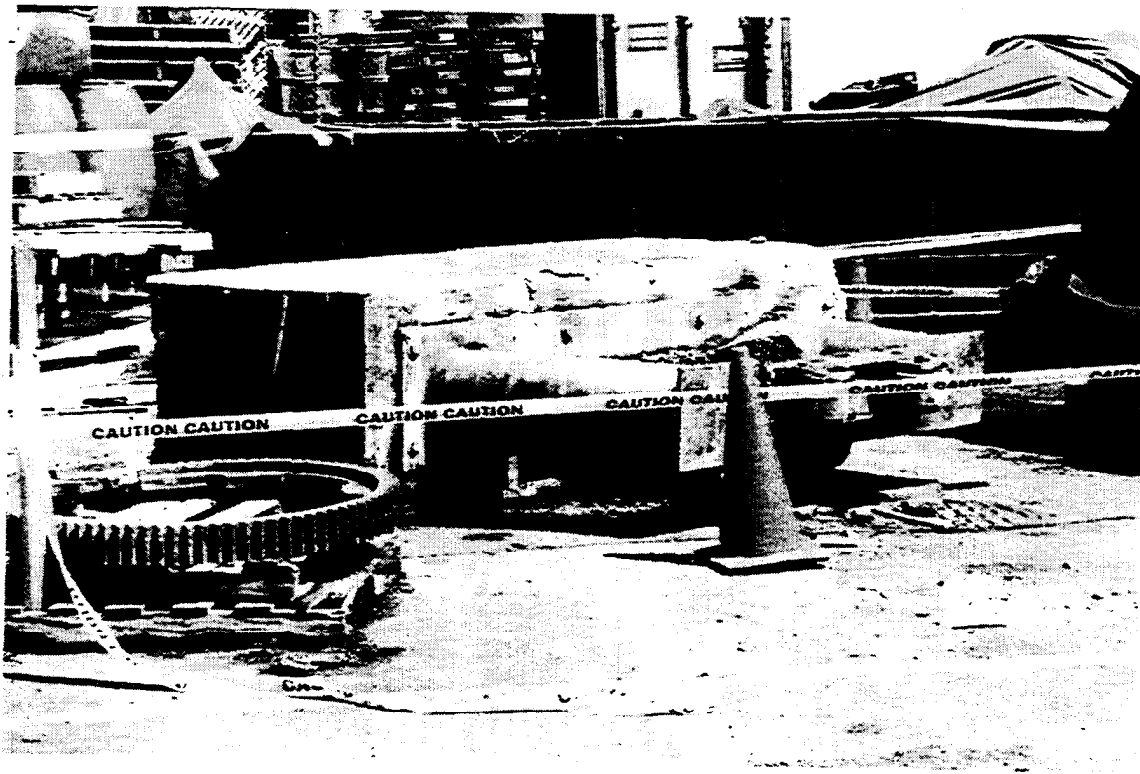
Figure 18: The concrete support and rollers that supported the belt drive side of the blender.
