# **EPA CHEMICAL ACCIDENT INVESTIGATION REPORT**

**Powell Duffryn  
Terminals, Inc.  
Savannah, Georgia**

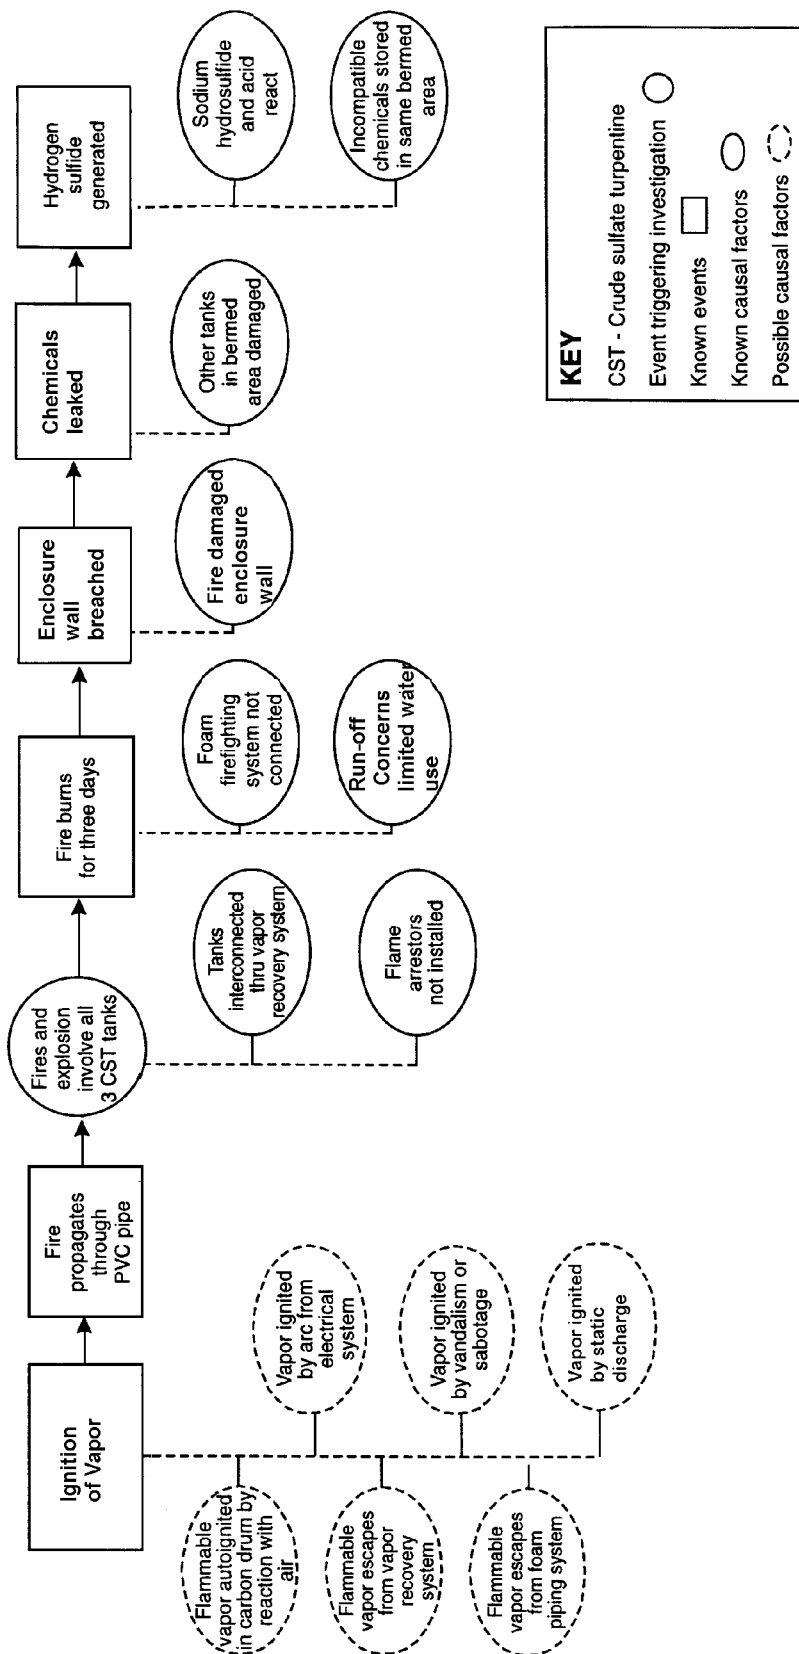
Prior to accident:

- \* CST stored for three months.
- \* Vapor recovery system, including drums of activated carbon, in place for one month.
- \* Fixed foam fire protection system partially installed on day of accident.
- \* Seals installed on foamers on day of accident.

The eyewitness' accounts of the accident are consistent with this scenario.
