EPA/OSHA JOINT CHEMICAL ACCIDENT INVESTIGATION REPORT

Shell Chemical Company Deer Park, Texas

Accident Investigation Report Shell Chemical Company, Deer Park, TX, June 22, 1997

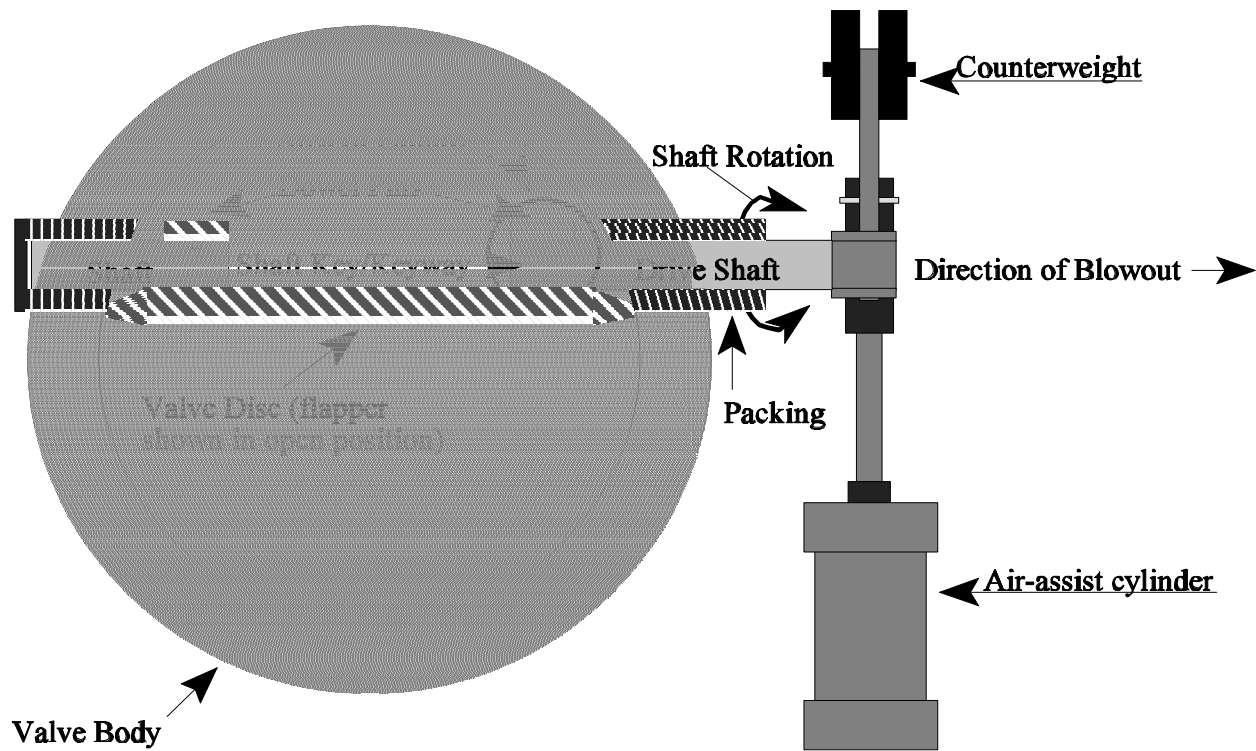
Figure 2: Clow Model GMZ Pneumatically-Assisted Check Valve

Clow Model GMZ check valves (see Figure 2) contain a two-piece stem in which one

stem piece functions as a drive shaft and connects the internal valve disk to an external air-assist cylinder and flapper counterweight assembly. The other stem piece, or idler shaft, simply functions as a hinge for one side of the flapper. The drive shaft penetrates the pressure boundary through a stuffing box. The exterior portion of the drive shaft is connected to the pneumatic piston and counterweight, and the interior portion of the shaft is coupled directly to the valve disk using a cylindrical hardened steel dowel pin and a steel rectangular bar key (see Figure 3). This arrangement provides a counter weight to partially balance the weight of the valve disk, and provides the pneumatic power assist to maintain the valve closed as described above.

The Clow Model GMZ check valve installed as the PGC fifth stage suction check valve had an internal diameter of 36 inches and weighed 3.2 tons. The valve had a design limit pressure of 480 psig, and a design limit temperature of 115 degrees Fahrenheit. The JCAIT found no evidence that these limits were exceeded at any time prior to or during the accident.

- Prior to restarting OP-III, Shell Chemical Company should replace all Clow Model GMZ check valves installed in the unit with valves not susceptible to shaft blow-out. Other Shell facilities and other companies as appropriate should review their process systems to determine if they have valves installed that may be subject to this hazard, and modify or replace those valves as necessary to prevent shaft blow-out. Companies should consult valve manufacturers or other appropriate design authorities to ensure any modifications made are safe. [Editor's note: Prior to this report being published, Shell Chemical Company replaced all Clow Model GMZ check valves installed in OP-III with valves not susceptible to shaft blow-out.]

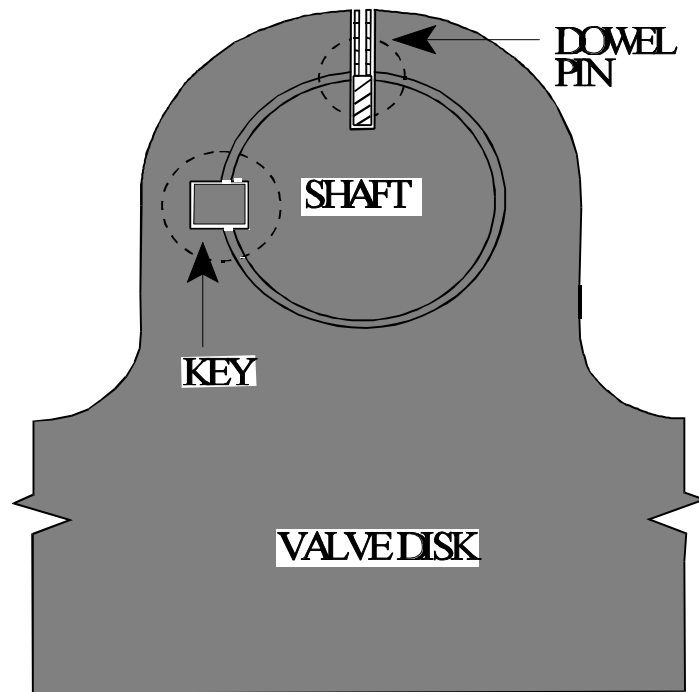
Figure 3: Expanded View of Check Valve Disk/Shaft/Key/Dowel Pin Arrangement

Analysis of sample number 5, the 36-inch diameter Clow Model GMZ check valve (and its internal components), revealed that it had suffered little or no heat damage. Analysis also indicated the following (see Figures 2 and 3 on pages 25-26 for an illustration of the valve):
