EPA/OSHA JOINT CHEMICAL ACCIDENT INVESTIGATION REPORT

**Surpass Chemical Co., Inc.
Albany, NY**

Accident Investigation Report
Surpass Chemical Company, Inc., Albany, New York, April 8, 1997

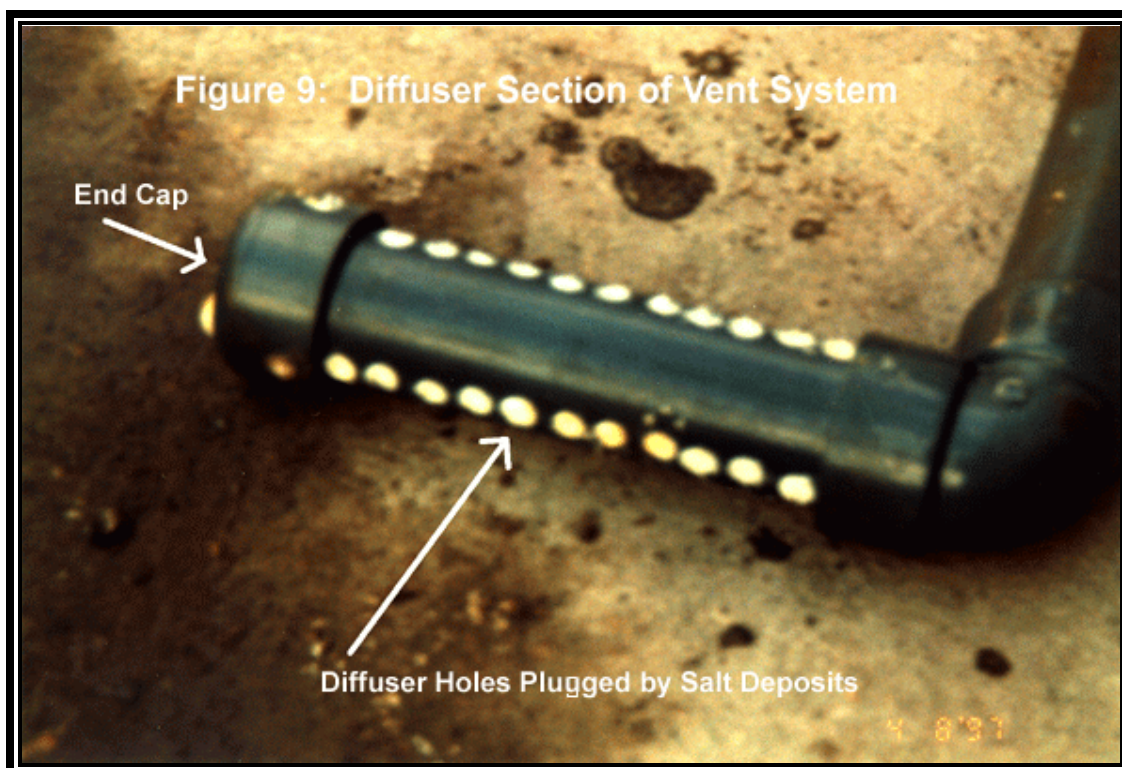
- The scrubber tank was not affected by the tank failure; it was found intact in its original position after the incident. (See **Figure 8**.)
- After the incident, the diffuser in the scrubbing tank was removed by disconnecting the vent line quick connect and removing the lid from the scrubber tank. The holes in the diffuser were found to be clogged with a white crystalline substance, as shown in **Figure 9**. This substance was sodium chloride, according to laboratory analysis.
