# Assessment of Dam Safety

## Coal Combustion Surface Impoundments (Task 3)

Allegheny Energy

R. Paul Smith Station

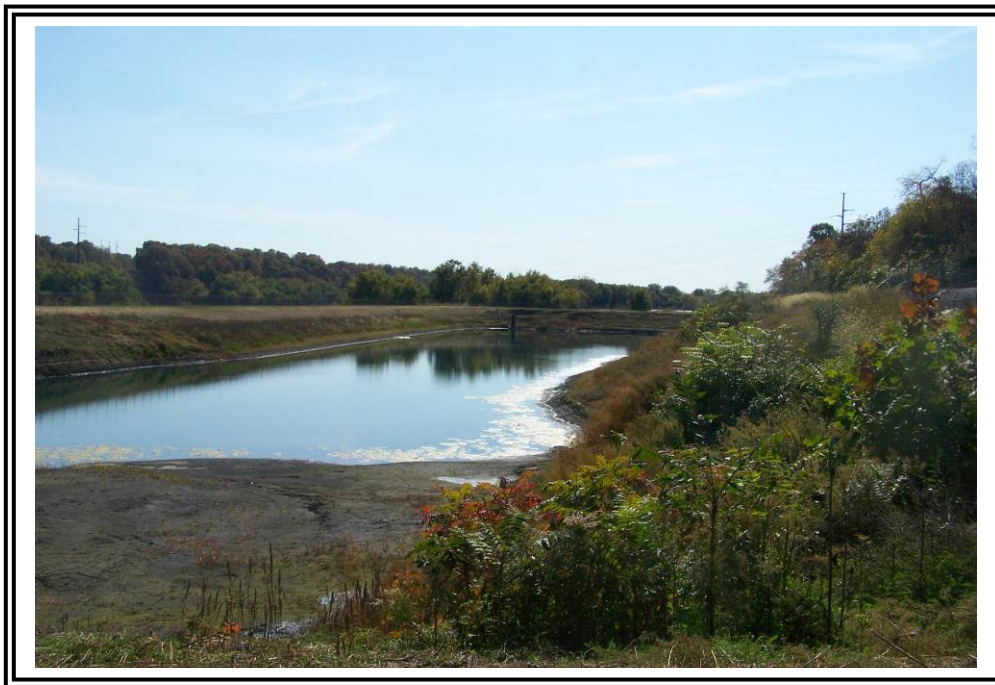
1

Pond #3, looking southeast from the north abutment. West side of pond (right side of photo) is in natural ground.

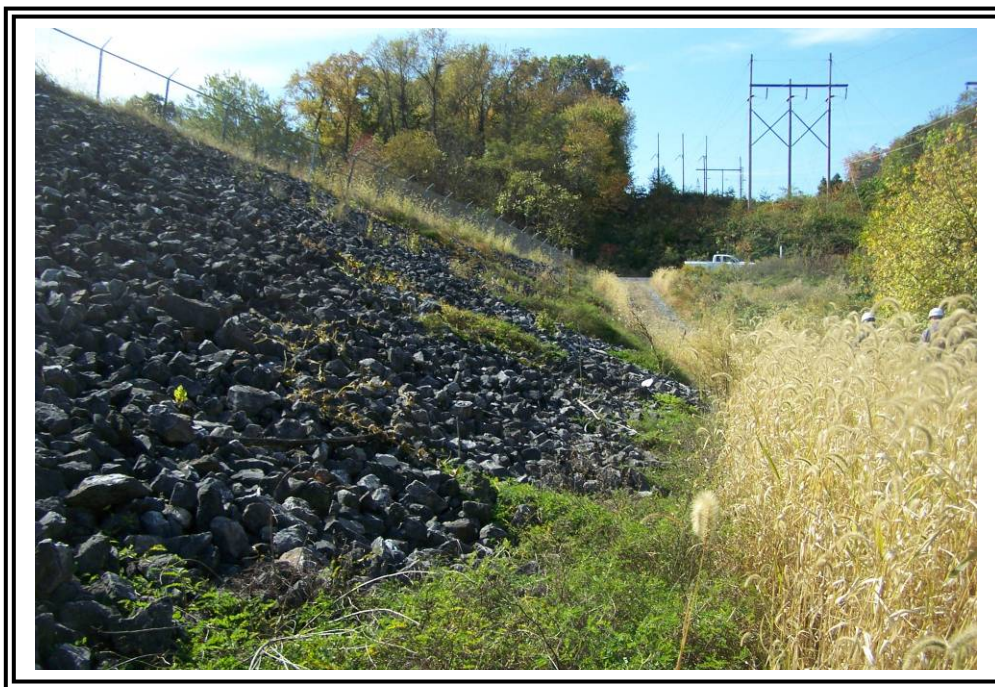
5

Downstream slope of north dike at Pond #3, looking west towards north abutment.

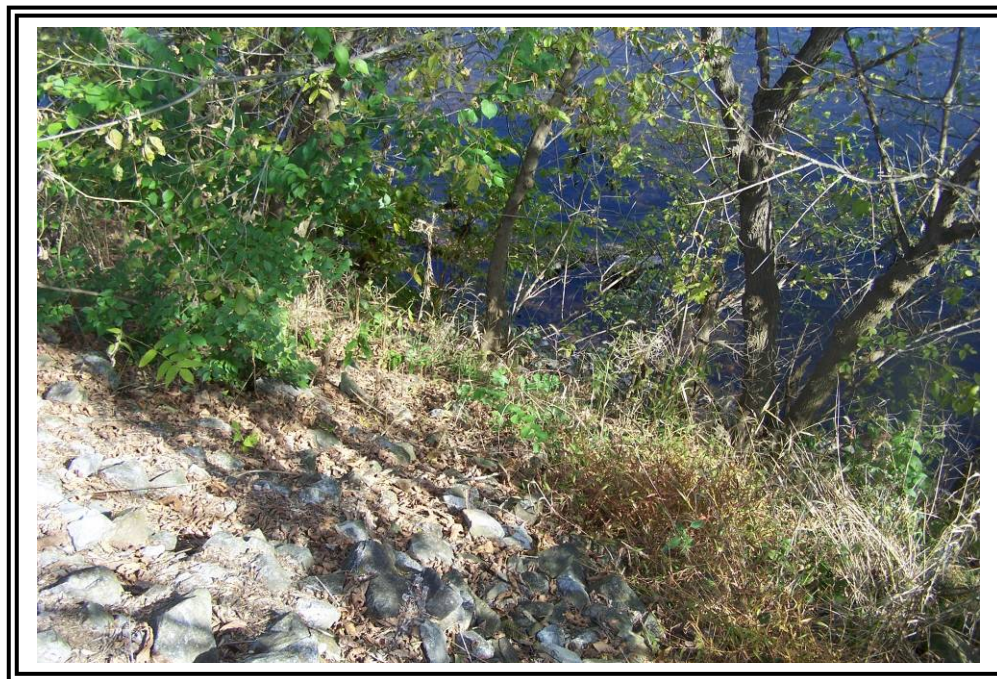
10

Stone buttress on east dike of Pond #3 extends to the edge of the Potomac River.

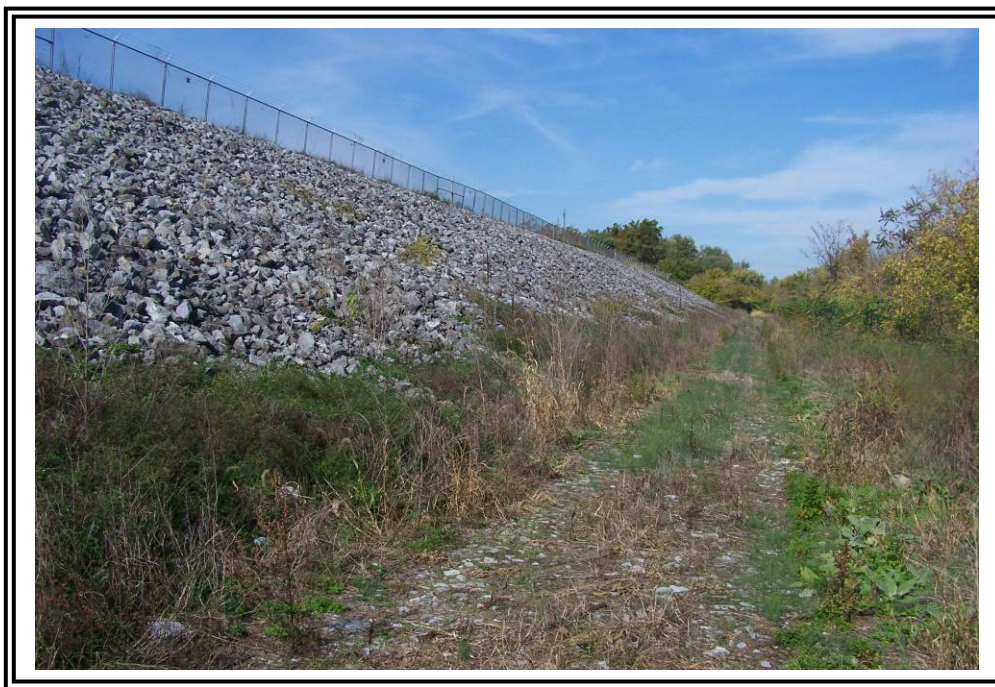
11

Downstream slope of east dike at Pond #3, looking north.

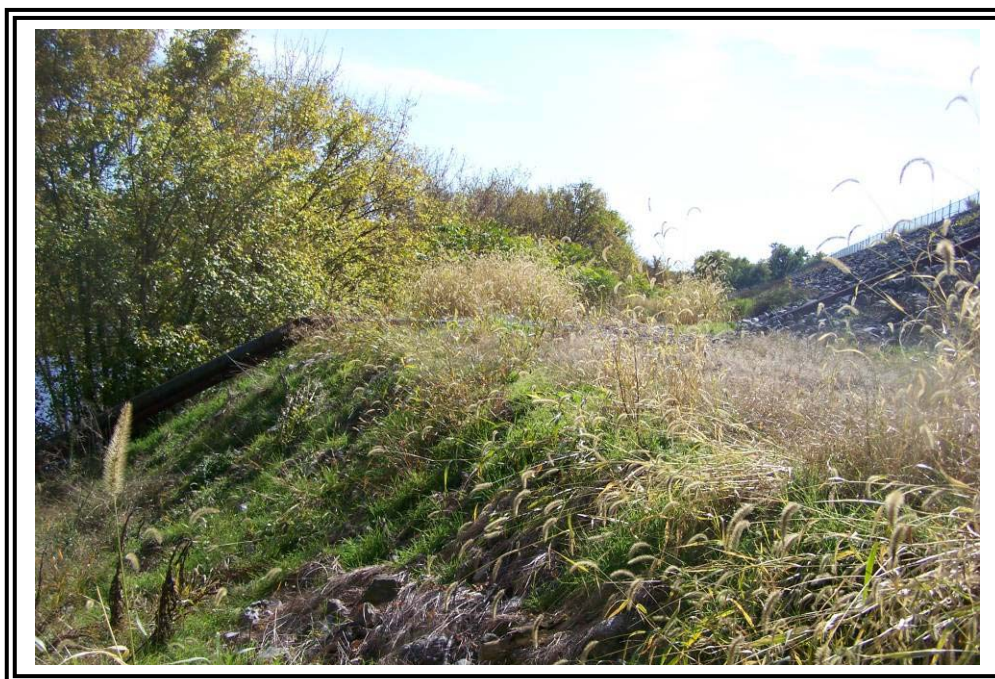
14

Stone buttress at looking south from northeast corner of Pond #3.

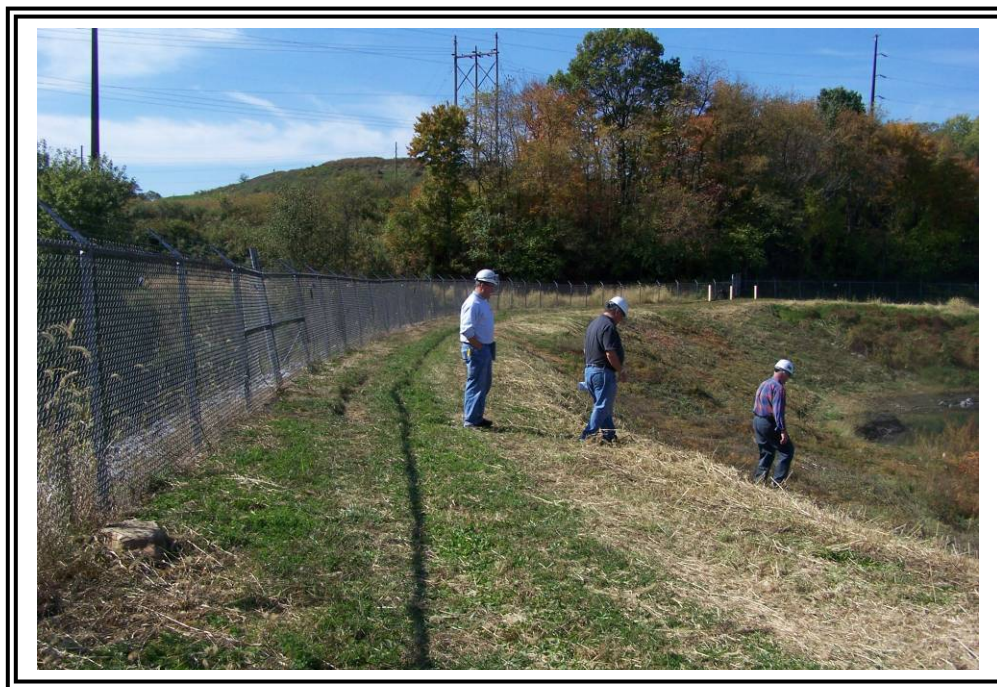
15

In general, the alignments of the crest of Ash Pond #3 dikes do not show signs of change in horizontal alignment. The crest is typically about 12 feet wide and is grass covered as shown in Photos 2, 6, and 15. The crest is slightly wider at the west end of the north dike because of ash left against the upstream slope during past dredging operations.

Crest of south dike at Pond #3, looking west toward south abutment.

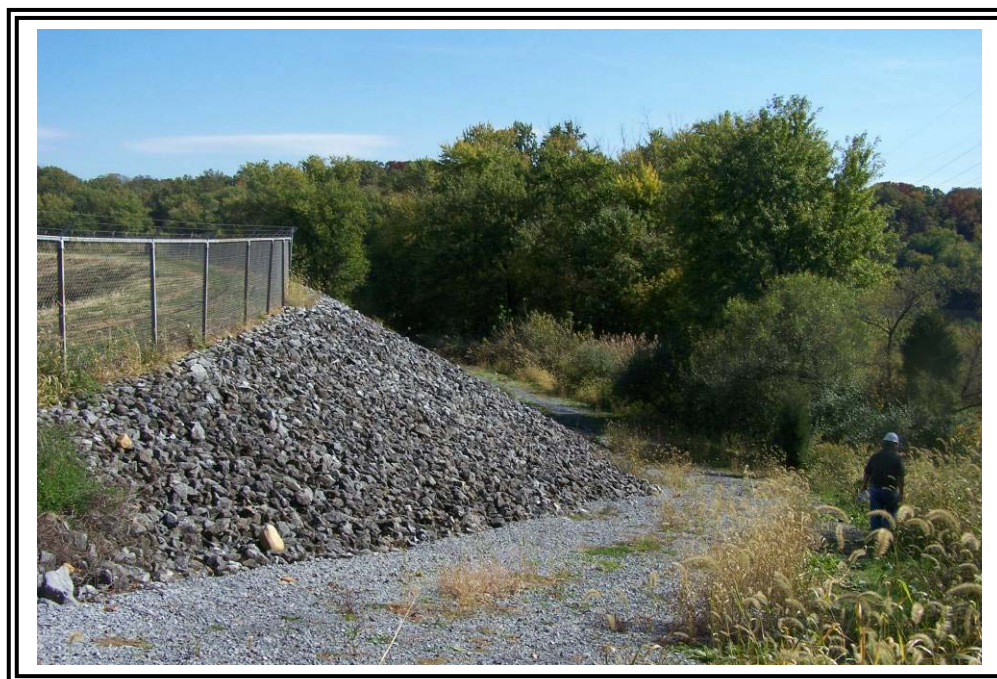
18

Downstream slope of south dike of Pond #3, looking east.

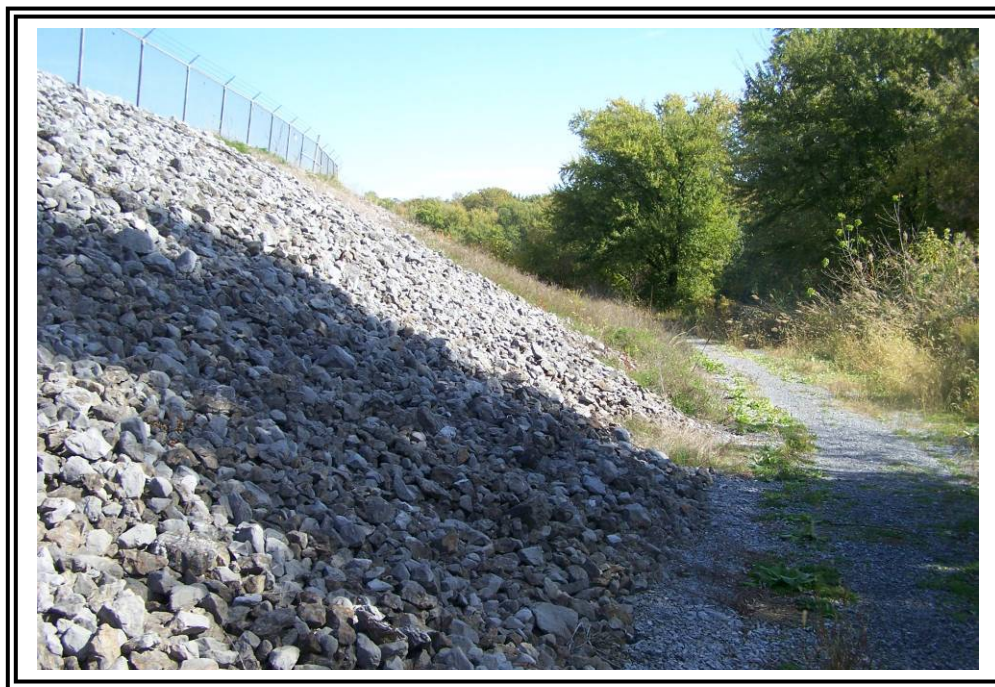
19

Downstream slope of south dike of Pond #3, looking east.

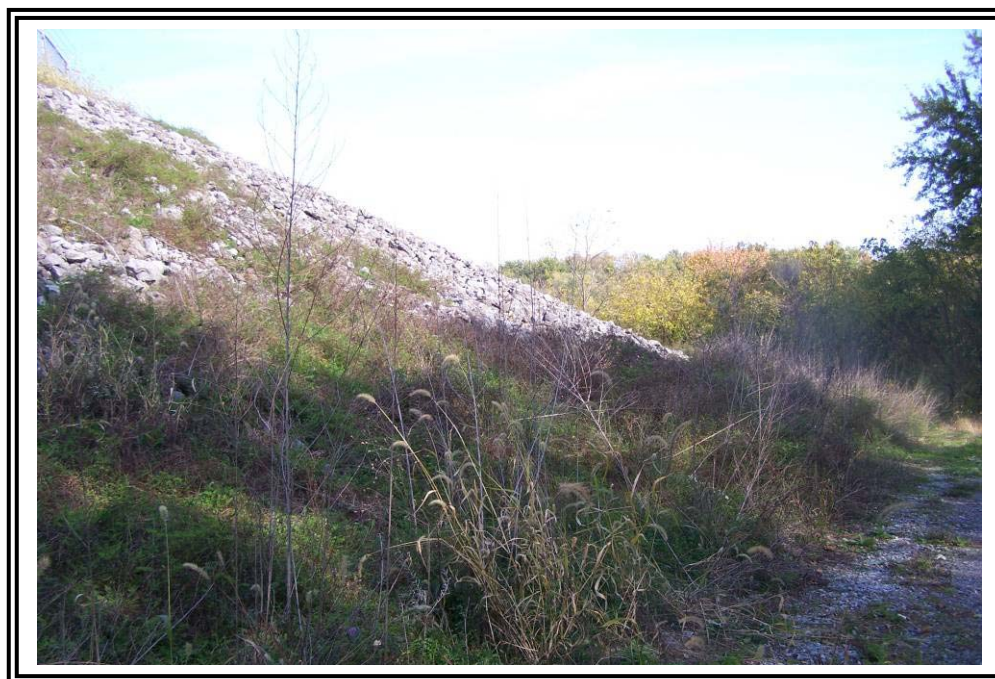
20

Typical patchy vegetation on rip rap armor of downstream slopes of Pond #3. Mostly grasses, occasional saplings.

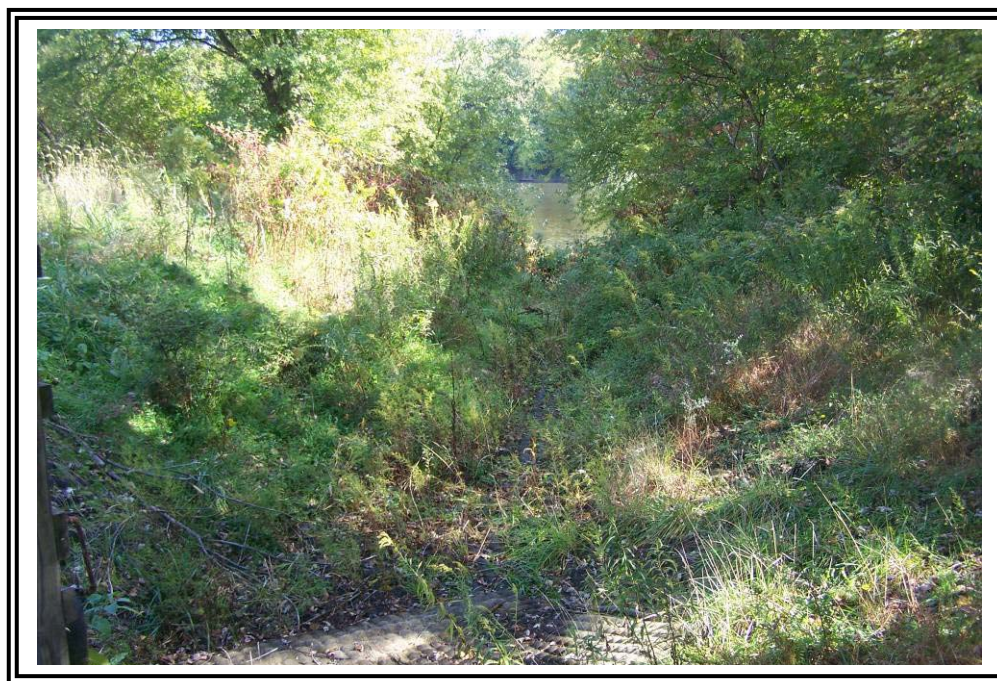
24

Fabriform lined discharge channel from Pond #3 to the Potomac River.

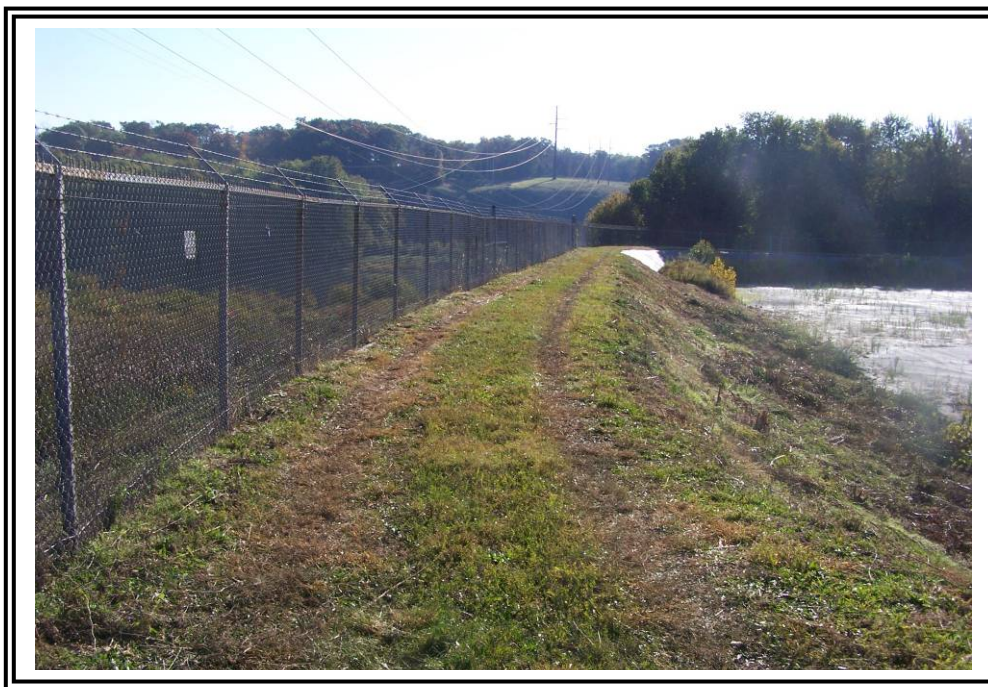
27

In general, the alignments of the crest of Ash Pond #4 dikes do not show signs of change in horizontal alignment. The crest is about 10 feet wide and is grass covered as shown in Photos 27, 33, 34 and 42. The surface has moderate rutting from vehicle traffic on the crest. An approximately 14-inch diameter, 2-inch deep depression was observed on the crest in the area where the discharge pipe passes beneath the east dike. The discharge pipe was slip-lined in 1997, as described in Section 1.3.2.

Crest of the north dike at Pond #4, looking east.

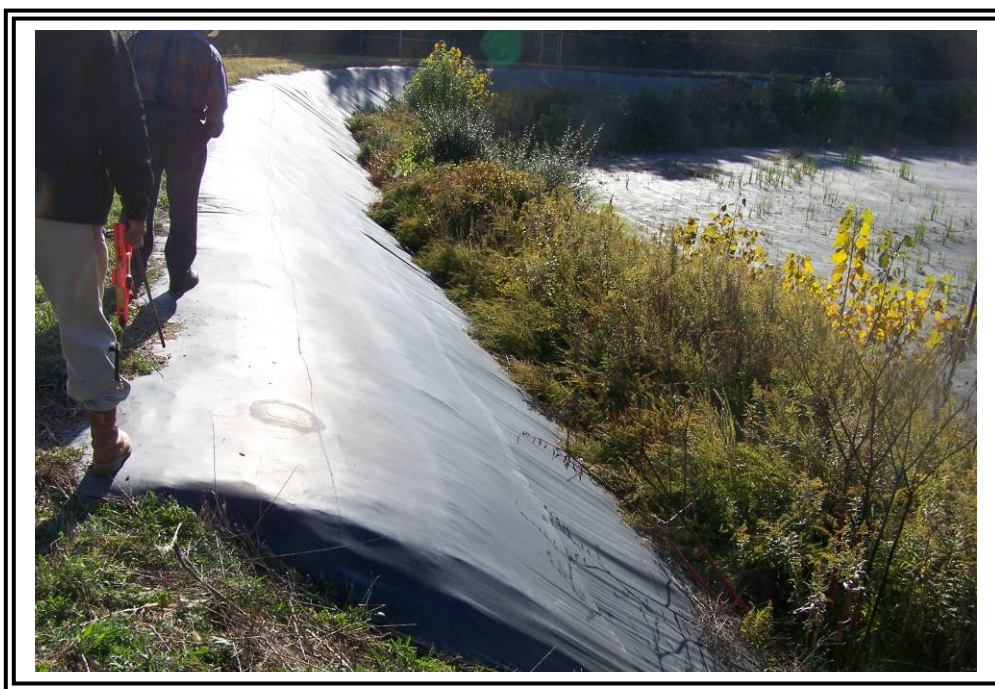
29

Hypalon liner on the upstream slope of the north dike at Pond #4.

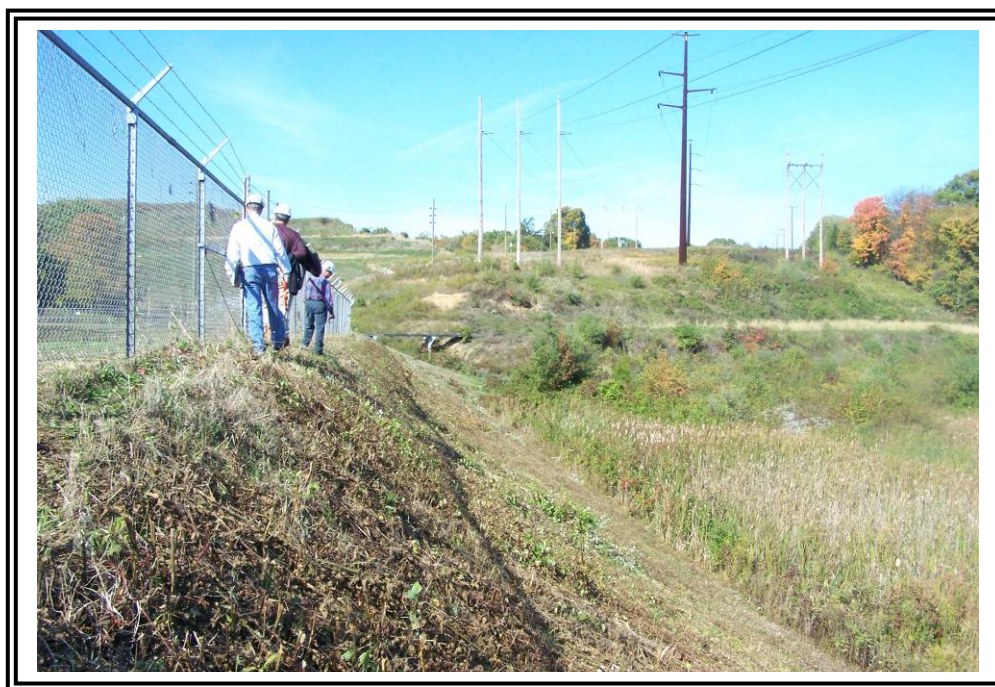
31

The downstream slopes are weed covered which was freshly cut at the time of our site visit. Photo Nos. 31, 35, and 46 show the general condition of the downstream slope. Many features of deterioration of the downstream slopes were noted as listed below:

Downstream slope of north dike at Pond #4, looking north.

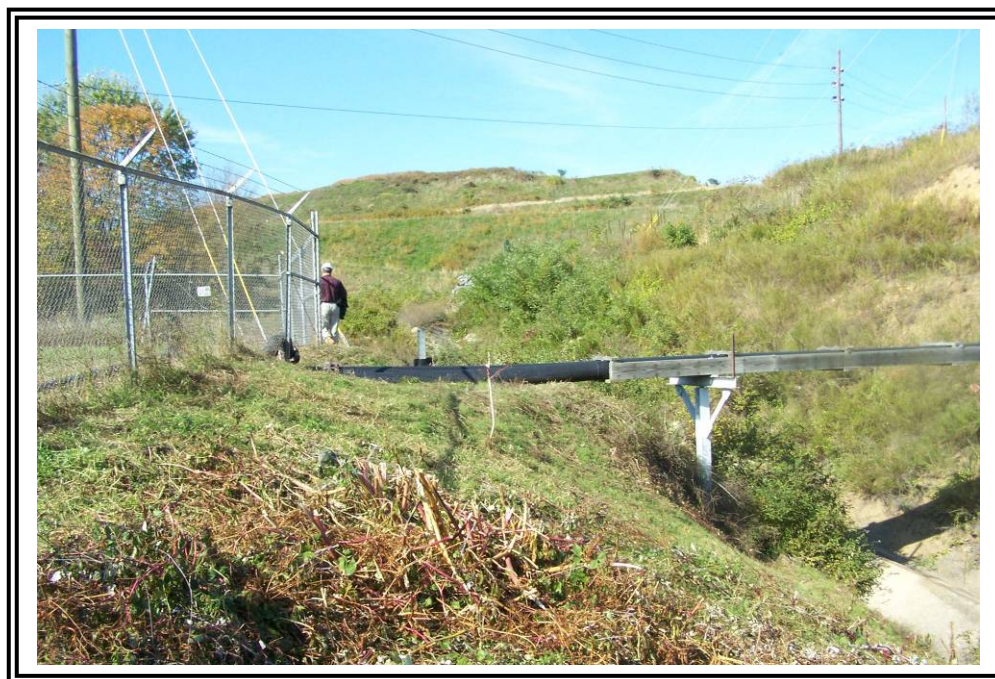
32

Sluice lines at north abutment.

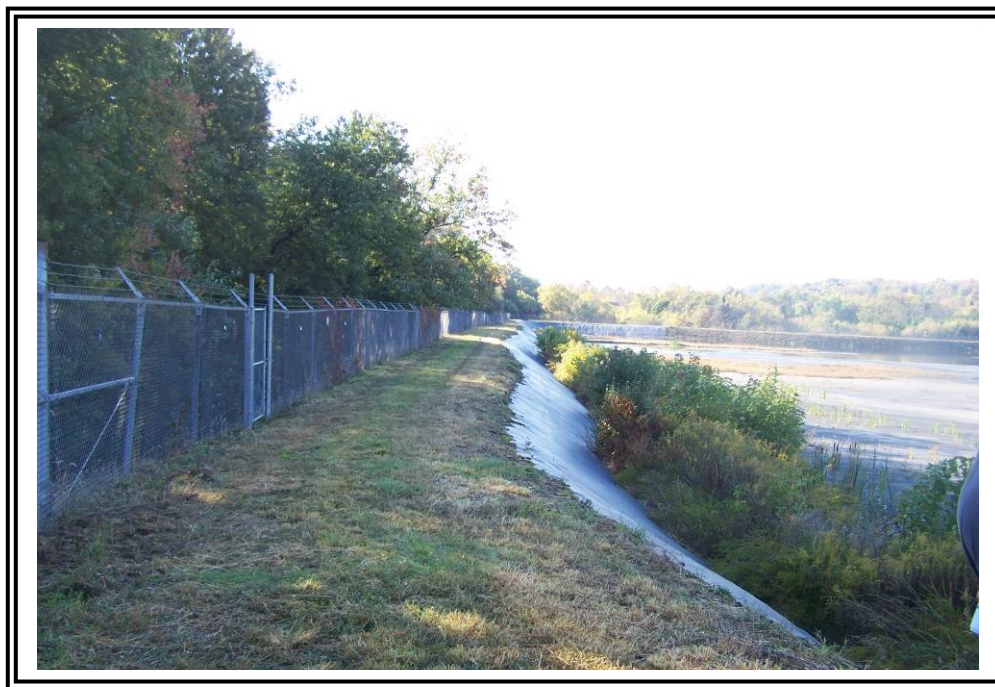
33

Crest of east dike at Pond #4, looking south.

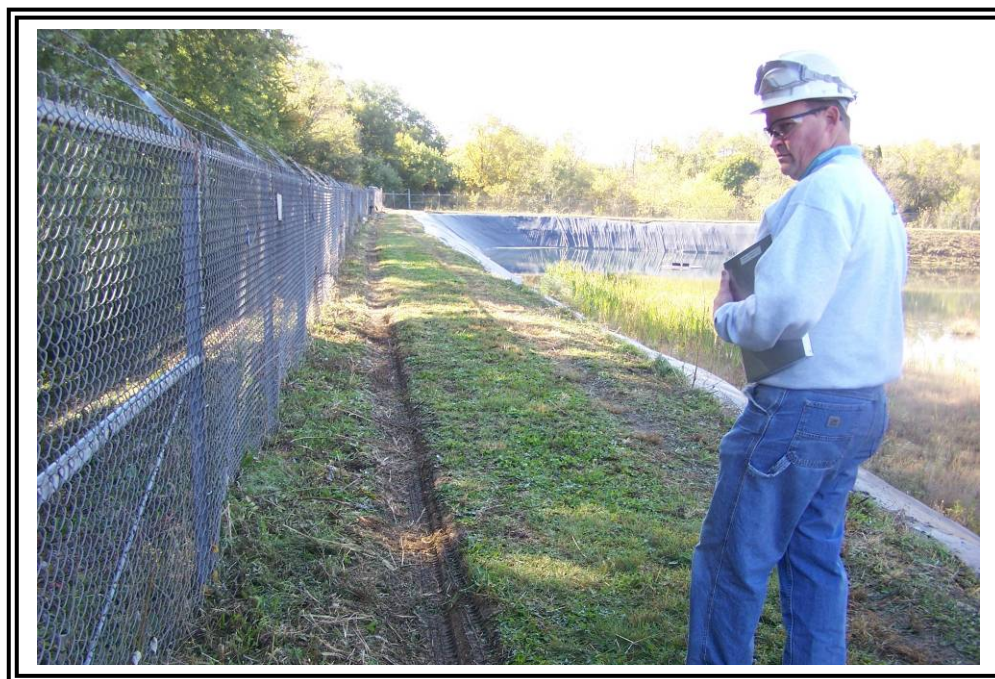
34

Crest of east dike at Pond #4, looking south.

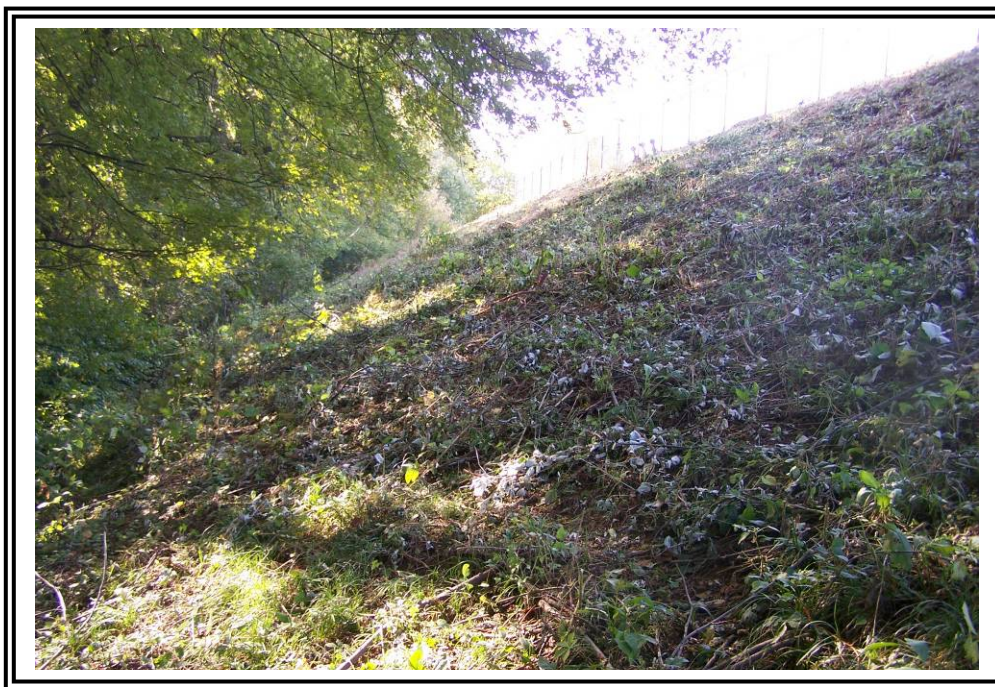
35

Downstream slope of east dike at Pond #4, looking south.

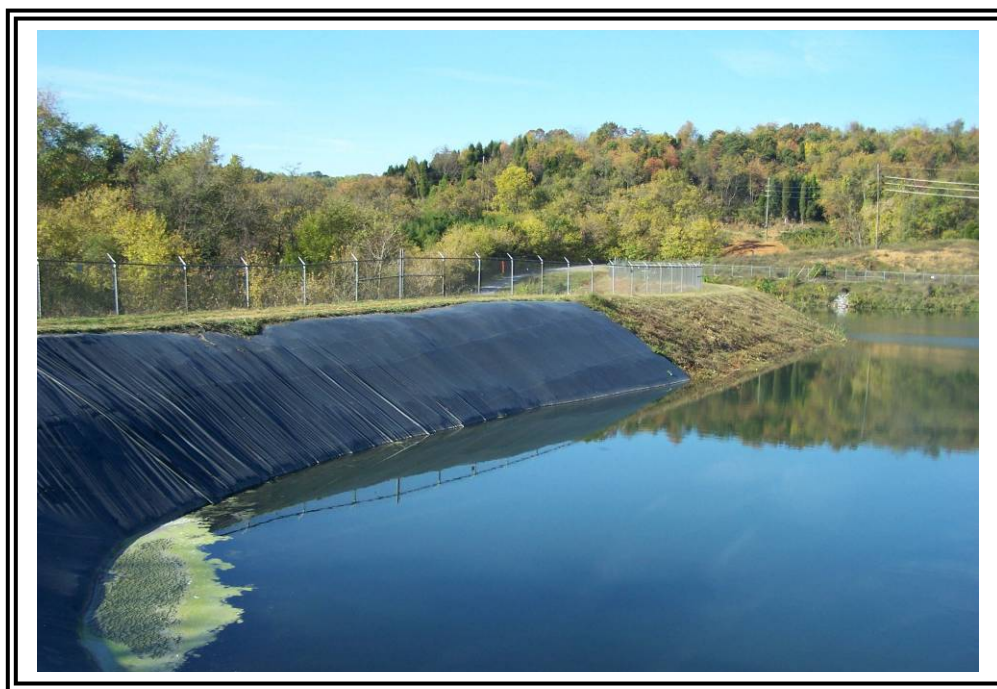
43

Upstream slope of south dike at Pond #4, looking southwest.

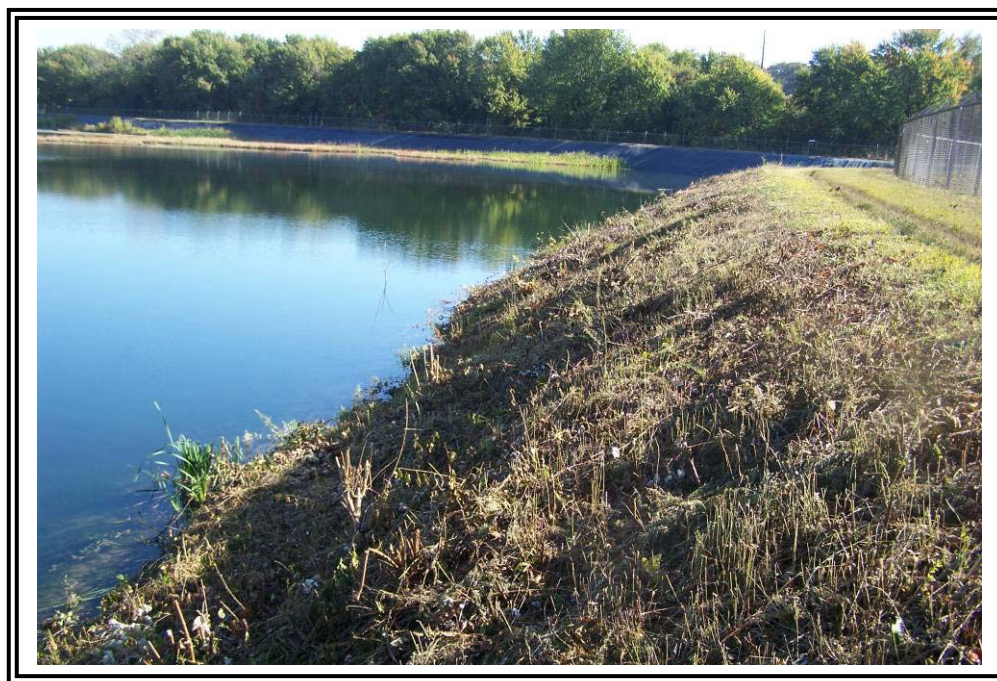
44

Upstream slope of south dike at Pond #4, looking east.

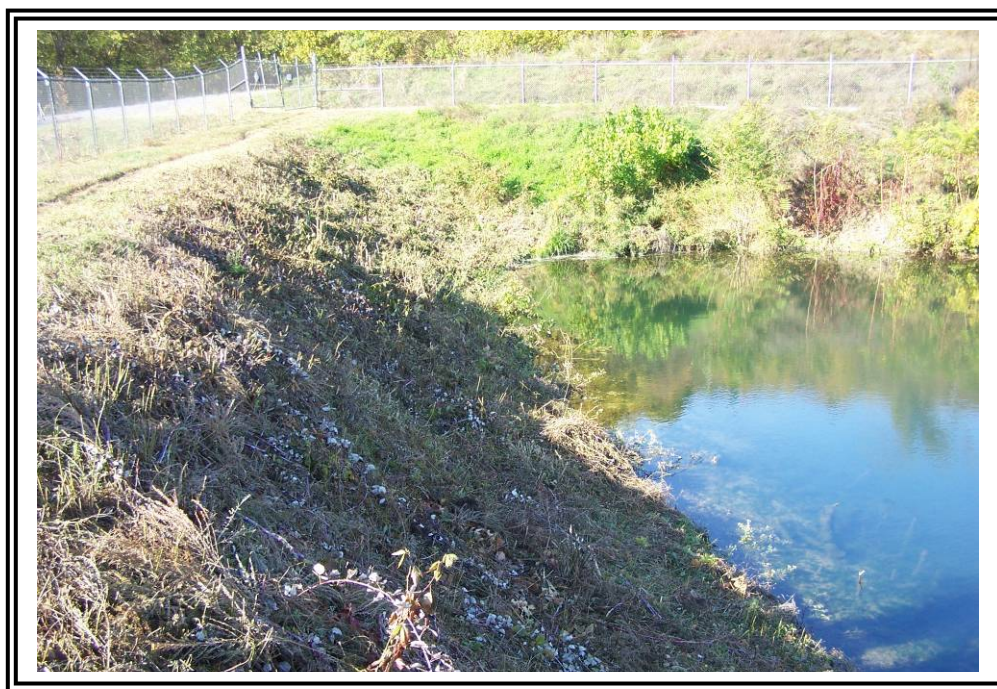
45

Upstream slope of the south dike at Pond #4, looking west toward the south abutment.

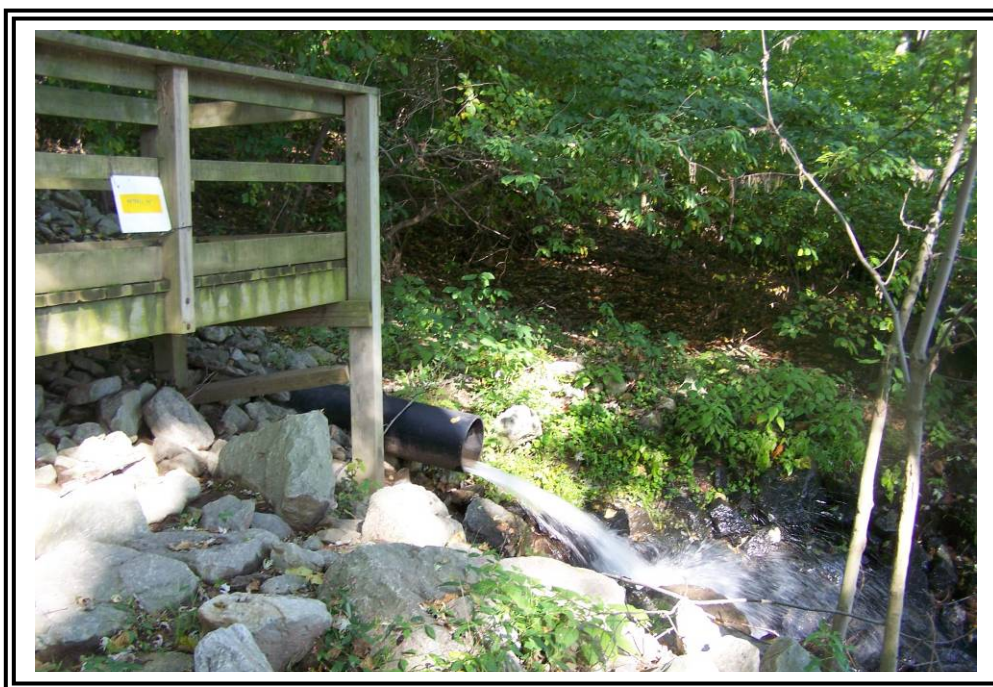
49

Discharge pipe from Pond #4.

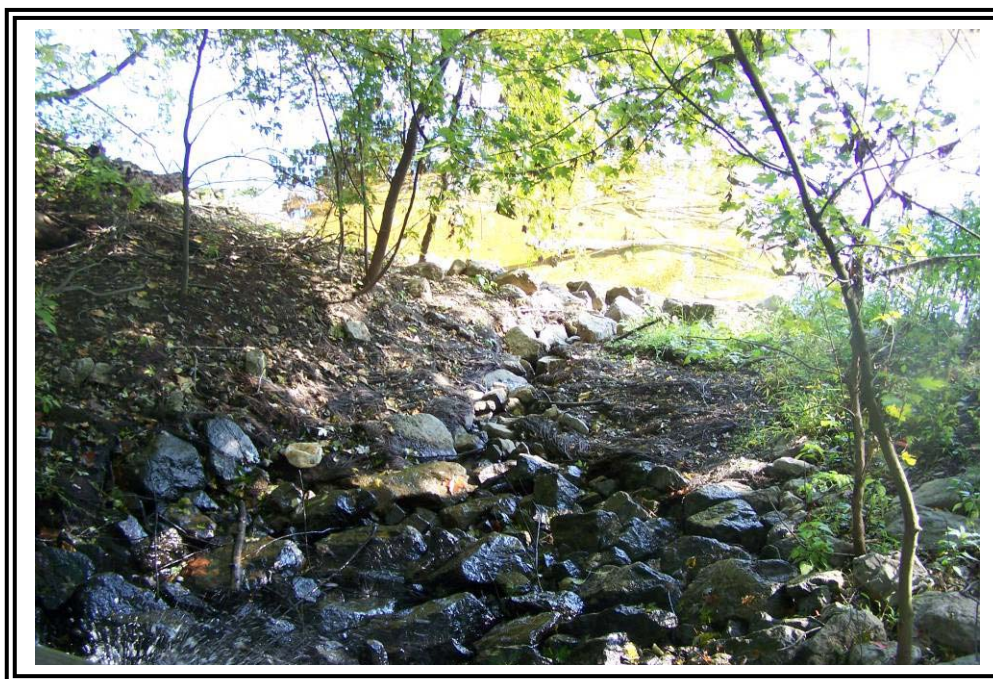
50

Rip rap channel from the Pond #4 outlet to the Potomac River.
