# **Dam Safety Assessment of CCW Impoundments**

## **Joppa Plant**

**United States Environmental Protection Agency  
Washington, DC**

May 27, 2010

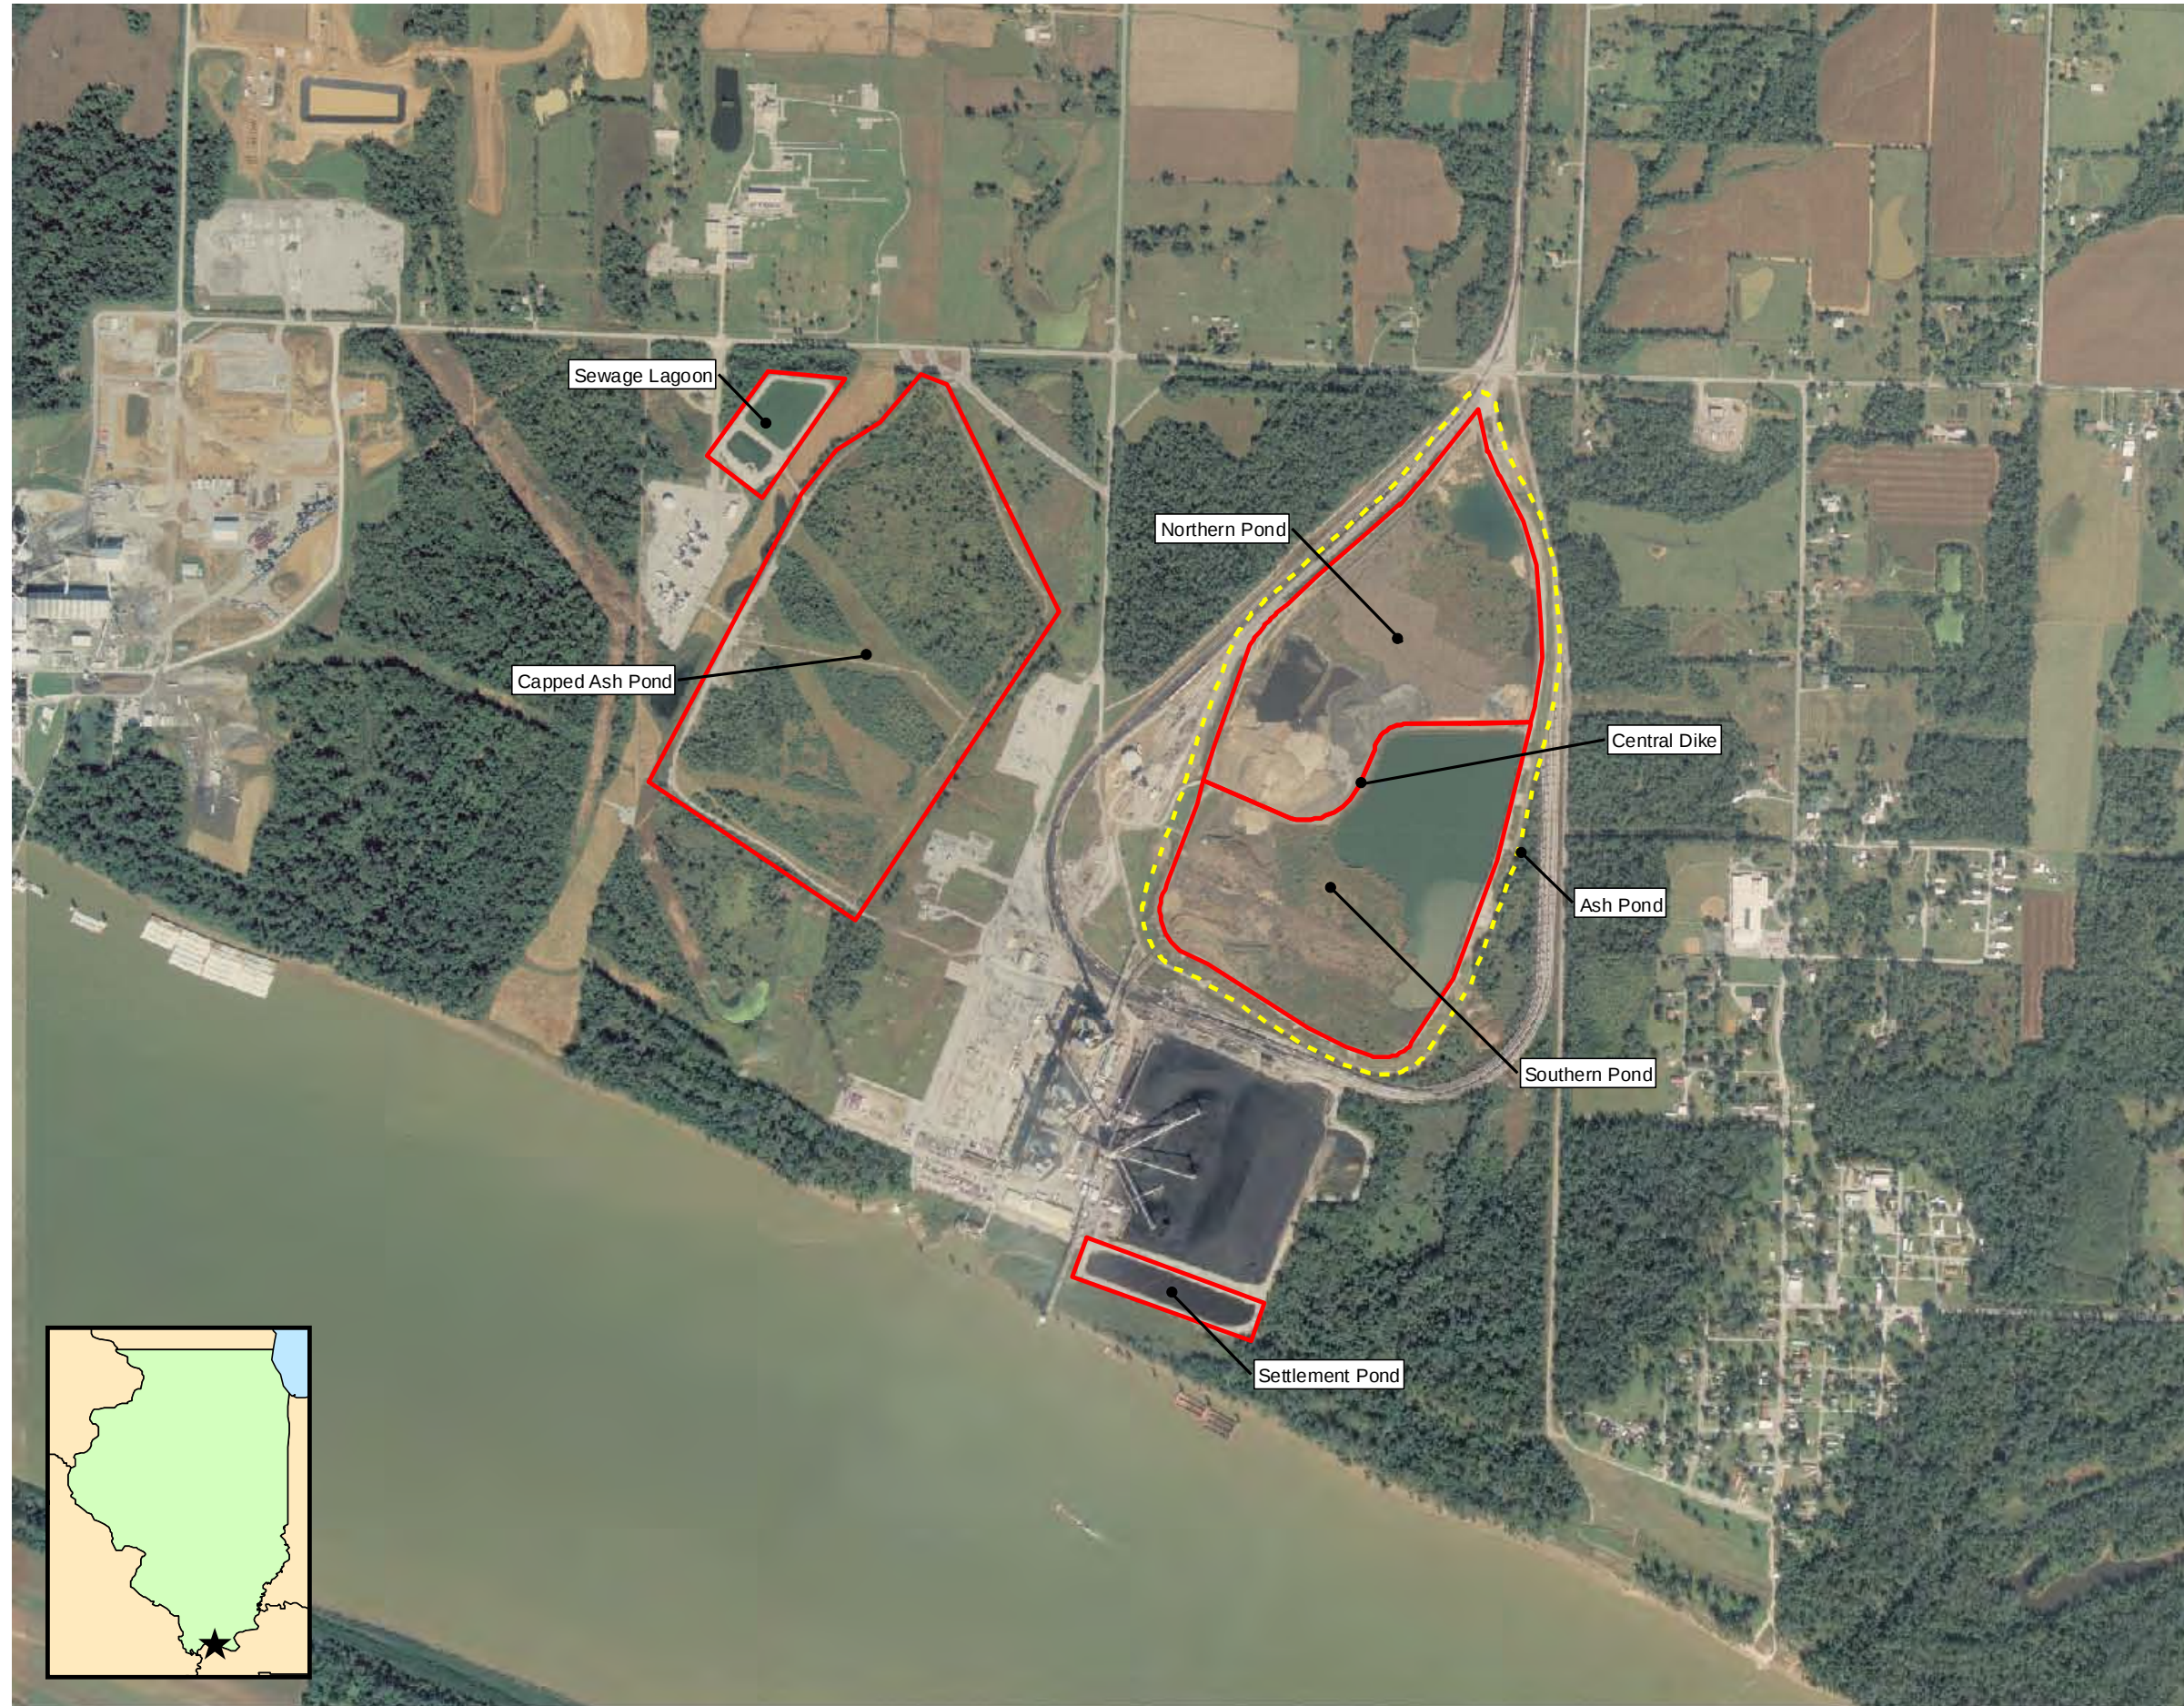
DRAFT FIGURE 2

The Facility Layout Map provided as Figure 2 shows the location of the various impoundments on the site. There are three additional impoundments at the Joppa Station, identified as follows:

- CCW has accumulated above the normal pool level over an estimated 90 percent of the pond area. Water in the pond is isolated to primarily the northeastern corner (Figures 2 & 3, Photos 4 & 5).

- CCW has accumulated above the normal pool level over an estimated 50 percent of the pond area. Water in the pond is isolated to primarily the eastern half of the pond (Figures 2 & 3, Photo 17).

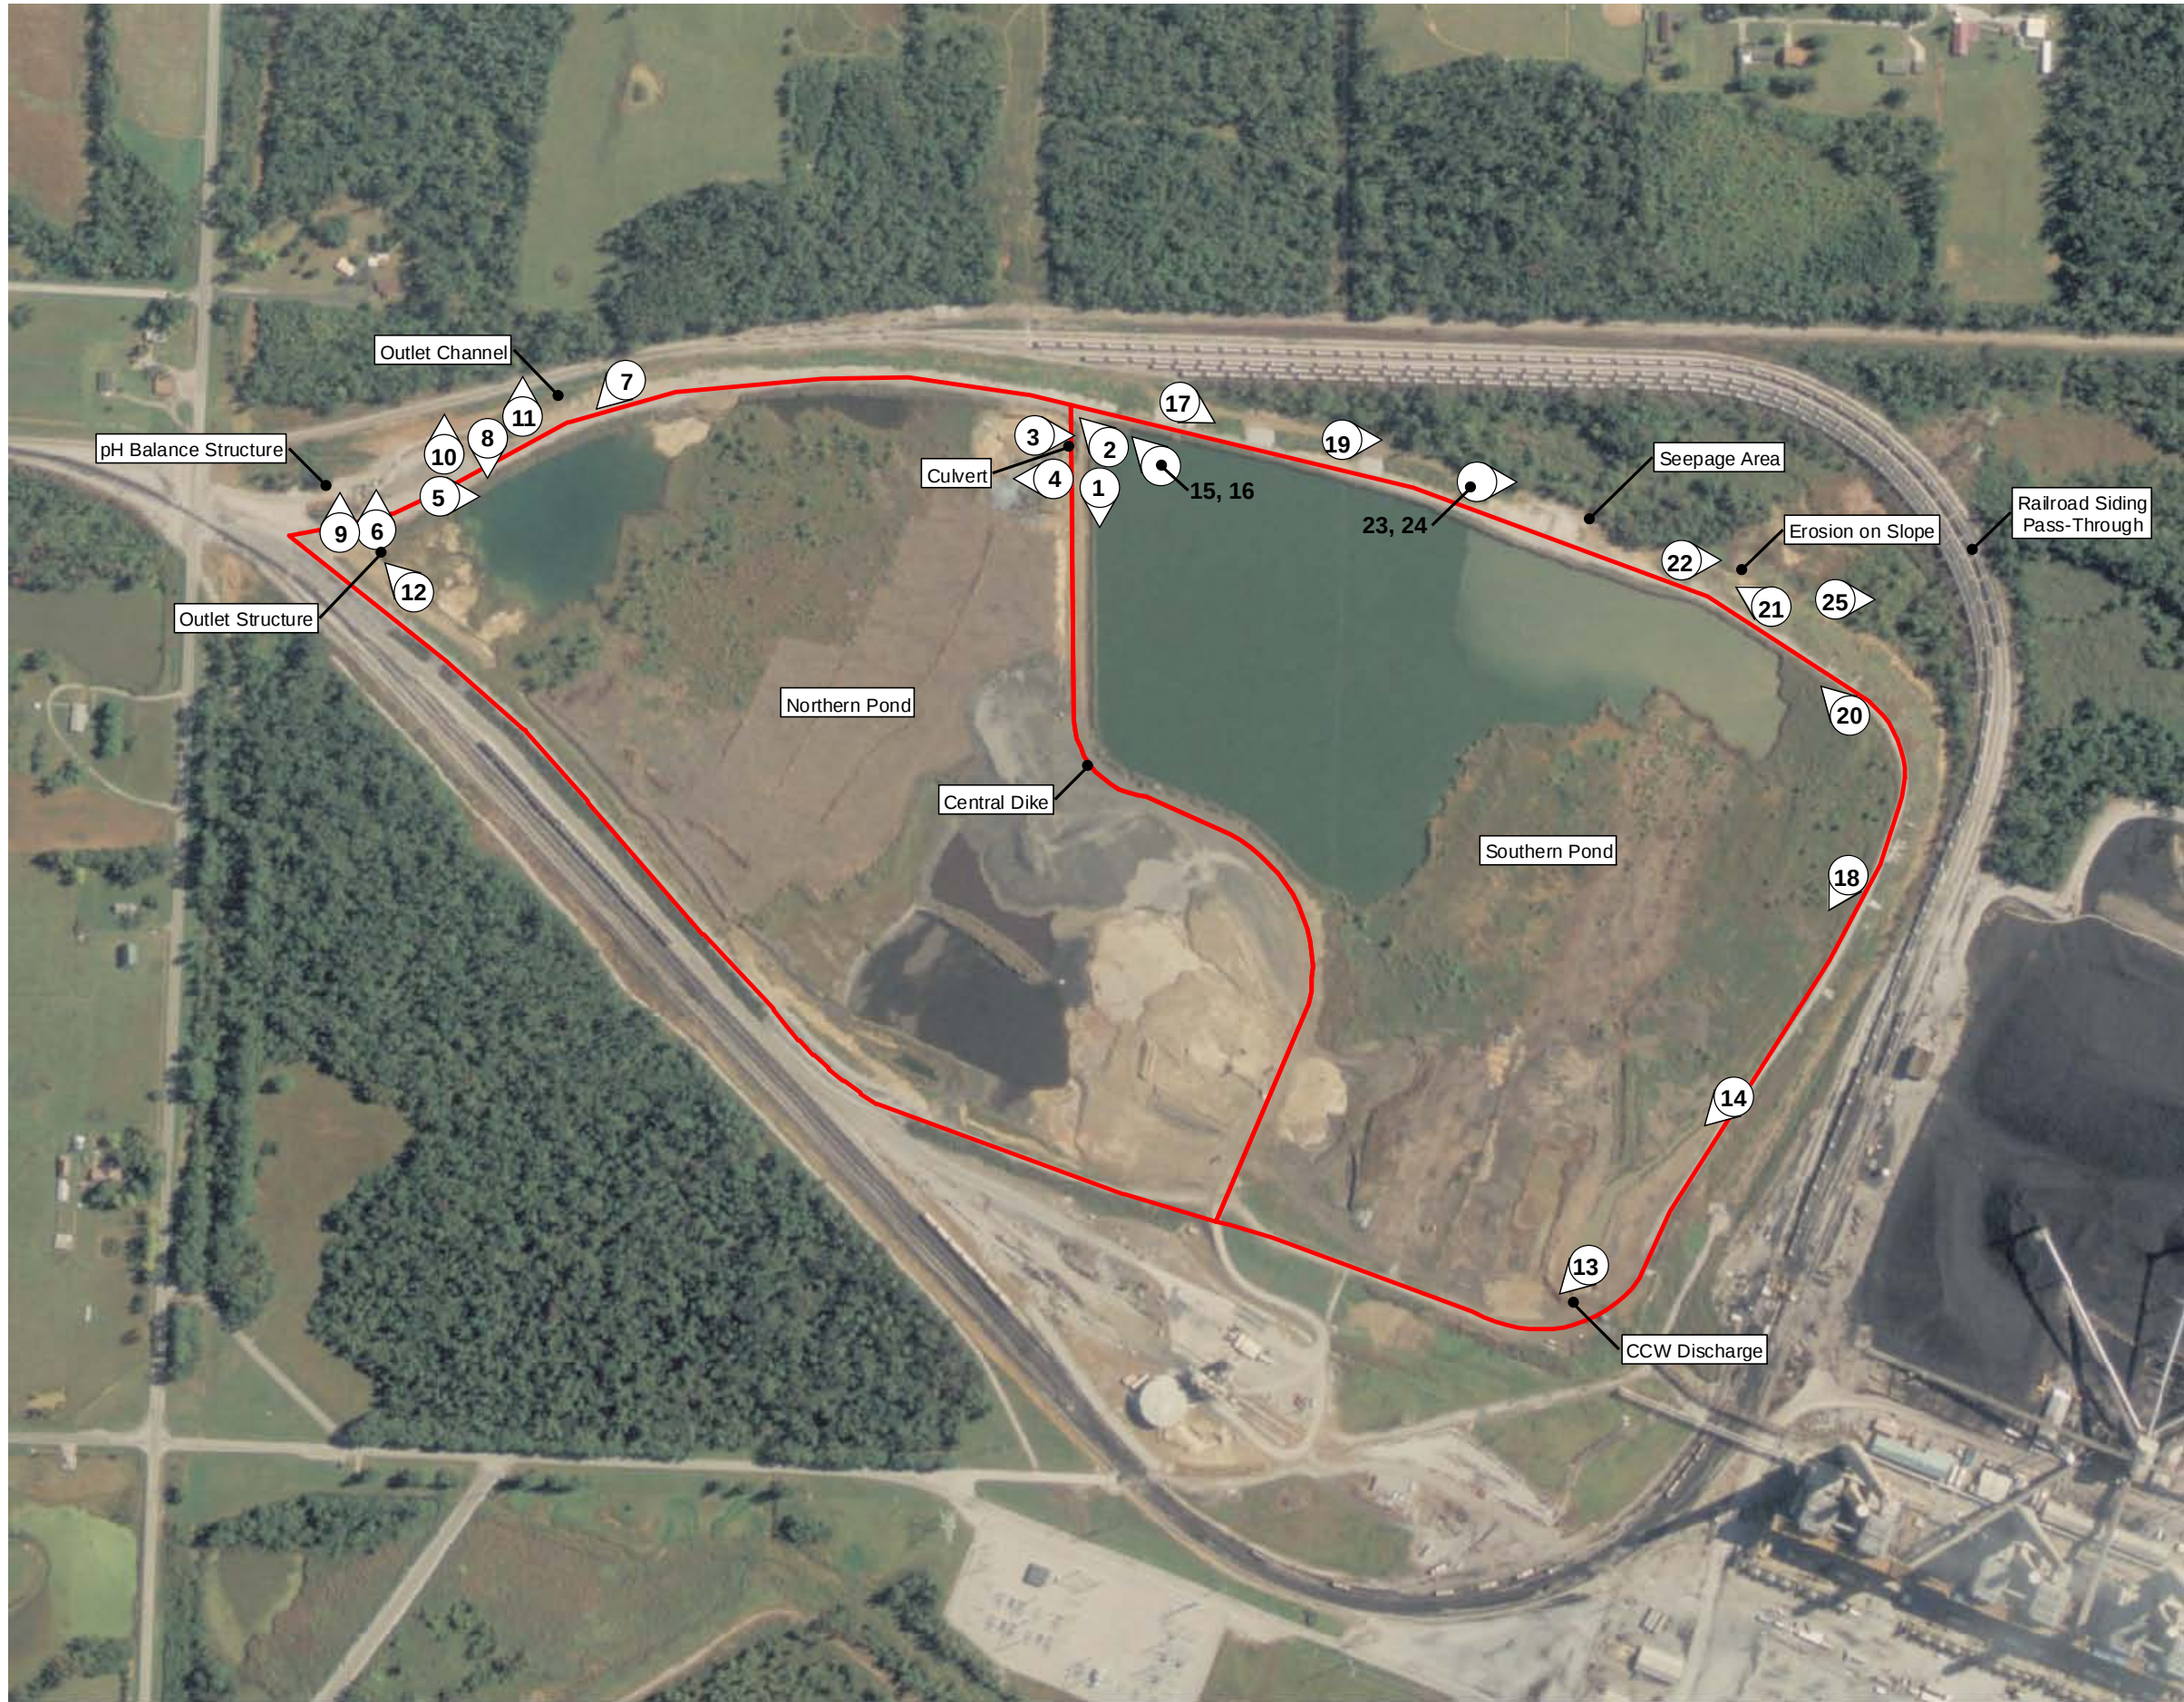
DRAFT FIGURE 3

Photos of relevant features and conditions observed during the inspection were taken by O'Brien & Gere and are provided in Appendix B. A Site Plan of the Northern and Southern Ponds is presented as Figure 3, which also provides photograph locations and directions.

- Seepage was observed in multiple locations along the outboard toe of the embankment. The most significant area of seepage is located approximately 500 feet north of the power lines (Photos 23 & 24). Other areas where seepage was observed include an area approximately 200 feet south of the power lines and along the southern embankment of the Southern Pond. The approximate locations of seepage are identified on Figure 3.
