# Dam Safety Assessment of CCW Impoundments

## Joppa Plant

September 24, 2010

**O'BRIEN & GERE**  
[www.obg.com](http://www.obg.com)

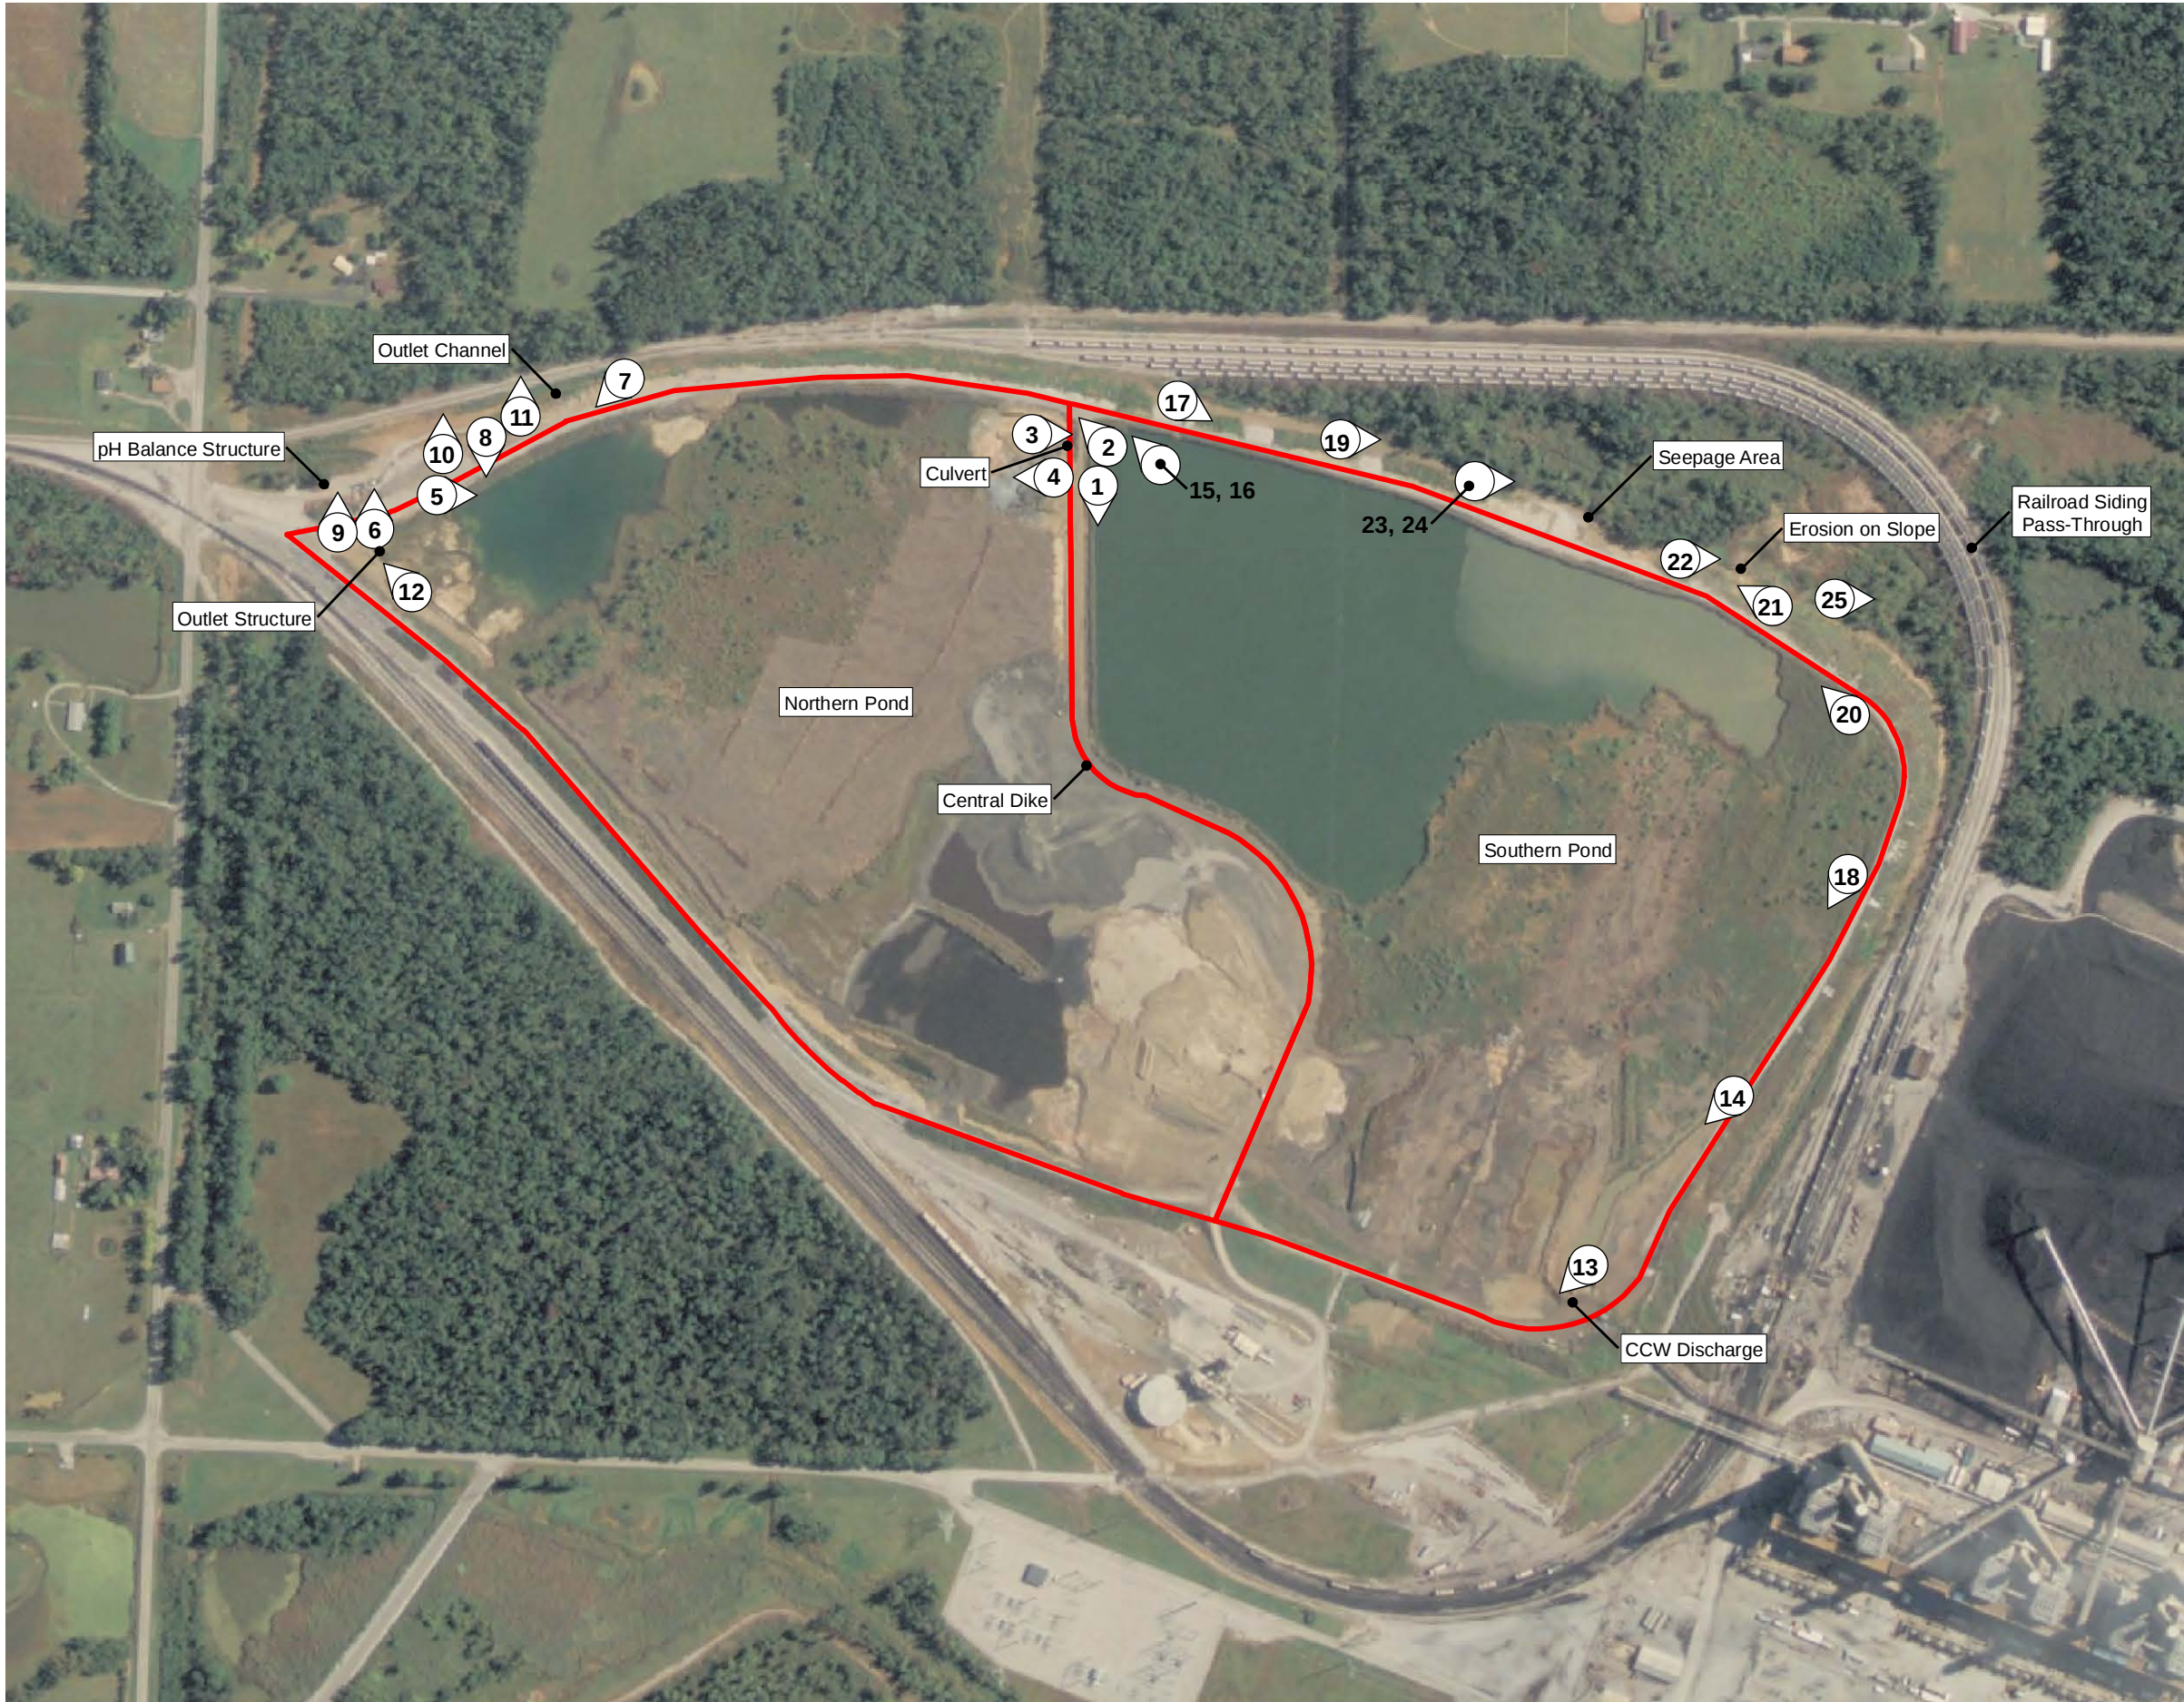
FIGURE 3

- Seepage was observed in multiple locations along the outboard toe of the embankment. The most significant area of seepage is located approximately 500 feet north of the power lines (Photos 23 & 24). Other areas where seepage was observed include an area approximately 200 feet south of the power lines and along the southern embankment of the Southern Pond. The approximate locations of seepage are identified on Figure 3.

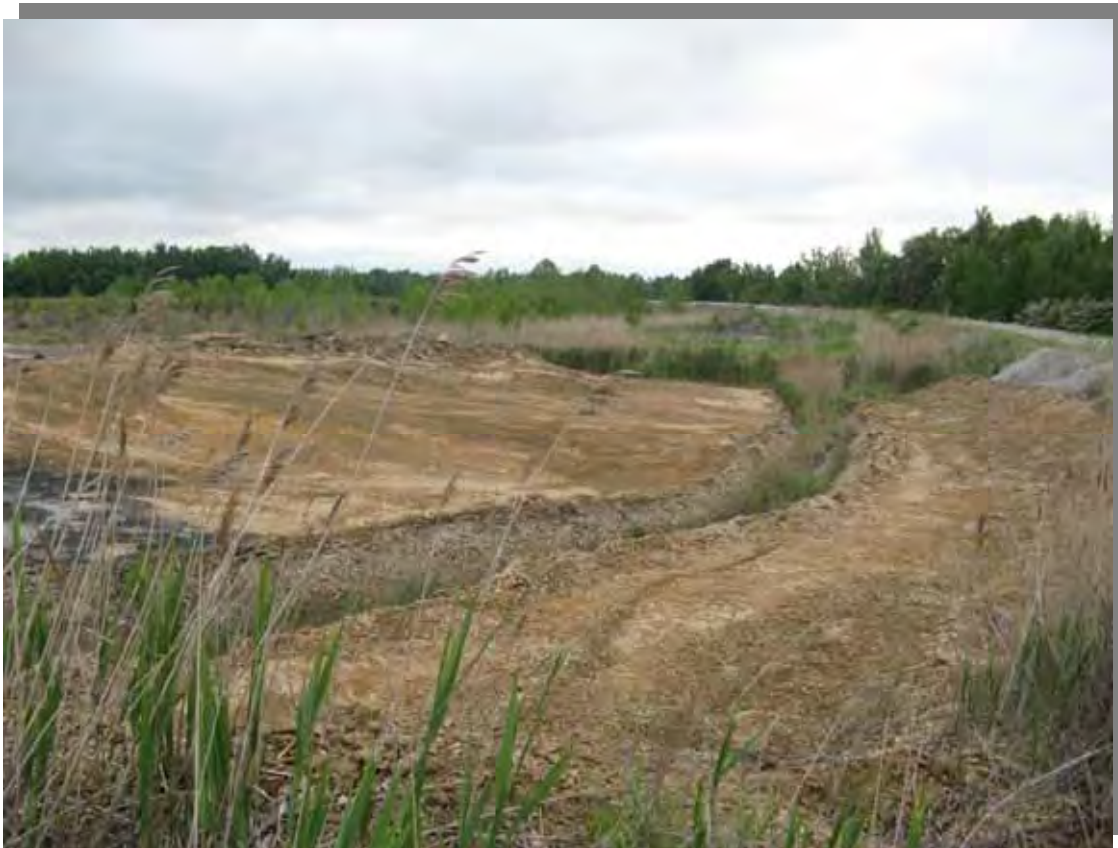
- CCW has accumulated above the normal pool level over an estimated 90 percent of the pond area. Water in the pond is isolated to primarily the northeastern corner (Figures 2 & 3, Photos 4 & 5).

Photo 4 – Interior of Northern Pond, looking north from Central Dike.  
Channel to direct flow from Culvert to Pond outlet structure.

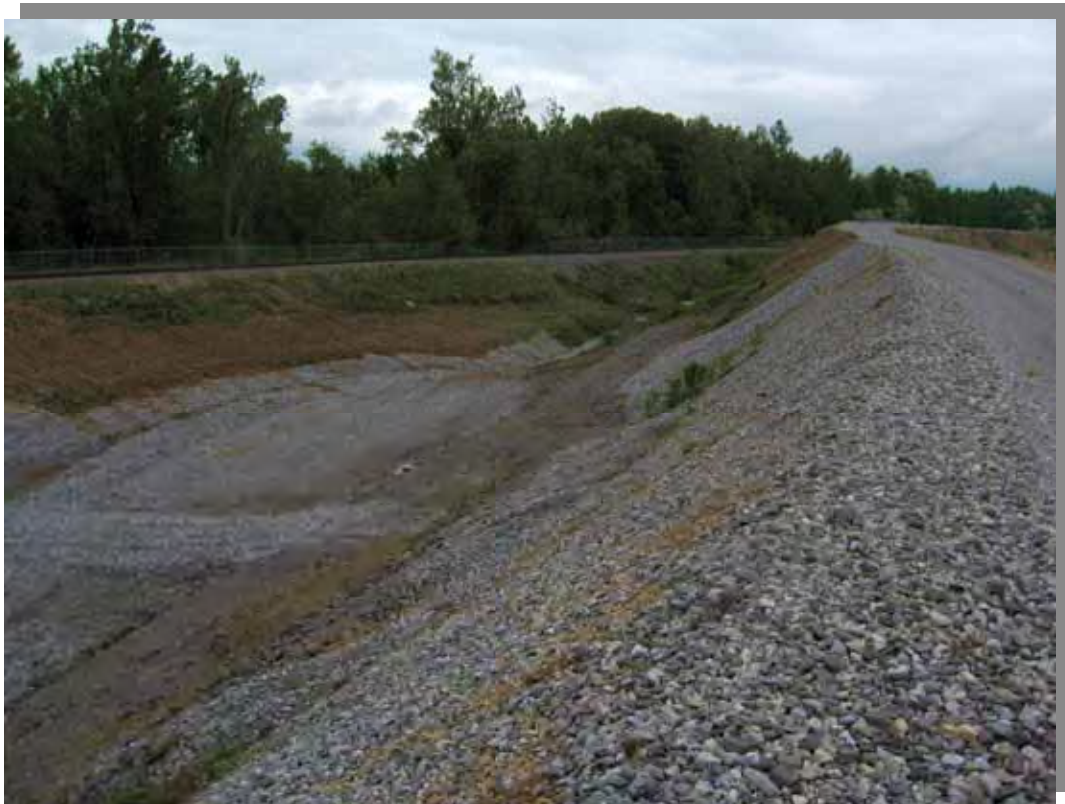
- Portions of the outboard slopes of the embankments are covered with rock fill and small riprap. The majority of the outboard slopes are overgrown with vegetation such as grasses, and small shrubs (Photos 6 - 8).

Photo 6 – Outboard slope of Northern Pond near the northern end.

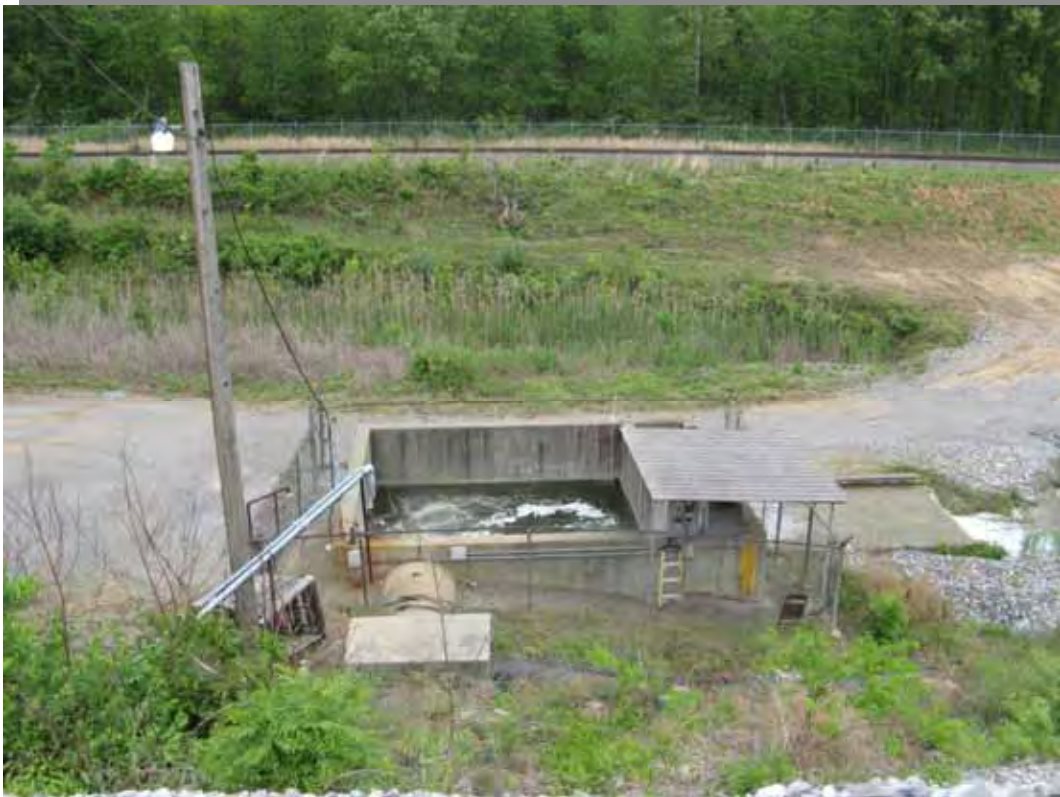
Photo 9 – pH balance outlet structure. Note HDPE pipe running parallel to toe (Southern Pond discharge) joining with concrete pipe (Northern Pond discharge) outside of structure.

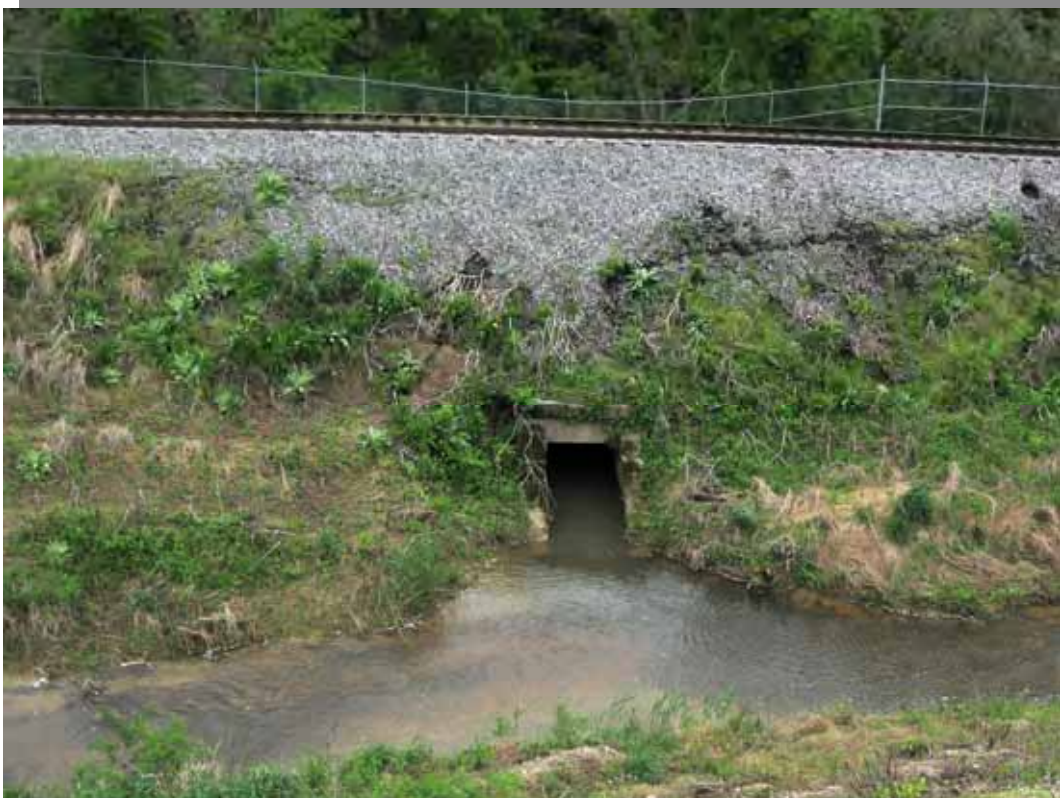
- In addition to the Ash Pond effluent, discharge from a drainage area east of the EEI railroad siding enters the outlet drainage channel (Photo 10).
- The inboard slope was also constructed at a slope of 1.5H:1V, originally with a riprap layer to protect the embankment against erosion. The riprap is now generally buried below bottom ash that has been dredged

Photo 10 – Runoff from drainage area east of Ash Pond merging with Pond effluent..

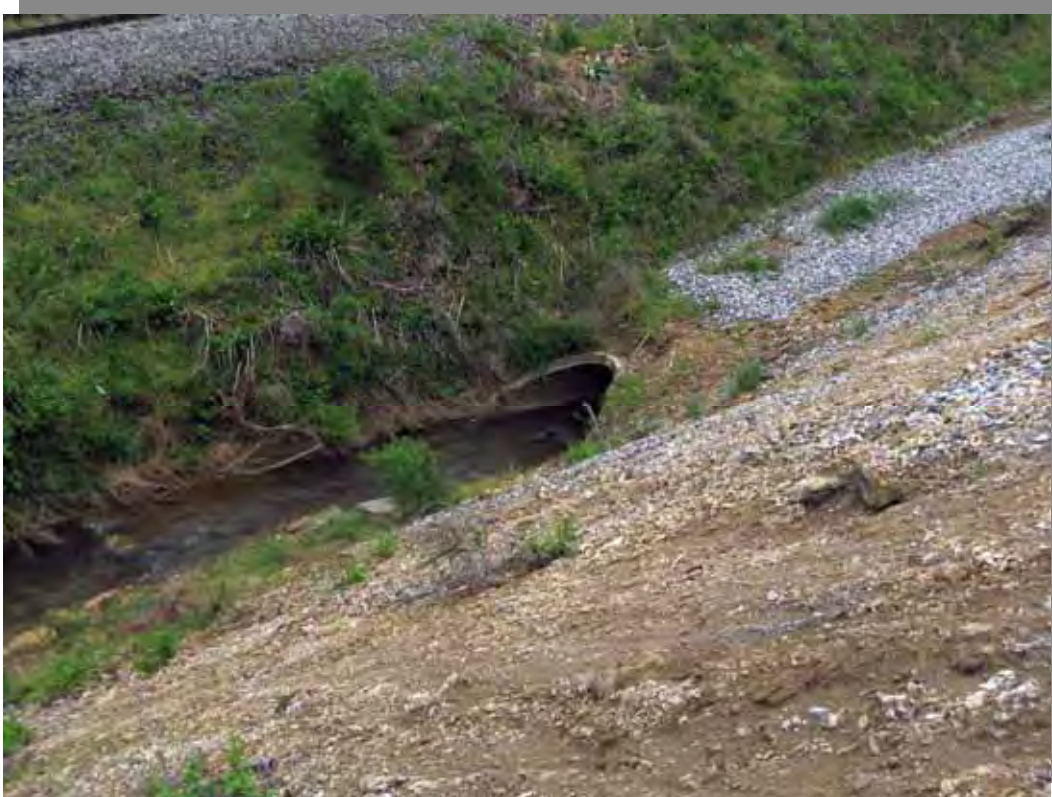
Photo 11 – Ash Pond outlet channel transitioning from open channel to underground culvert.

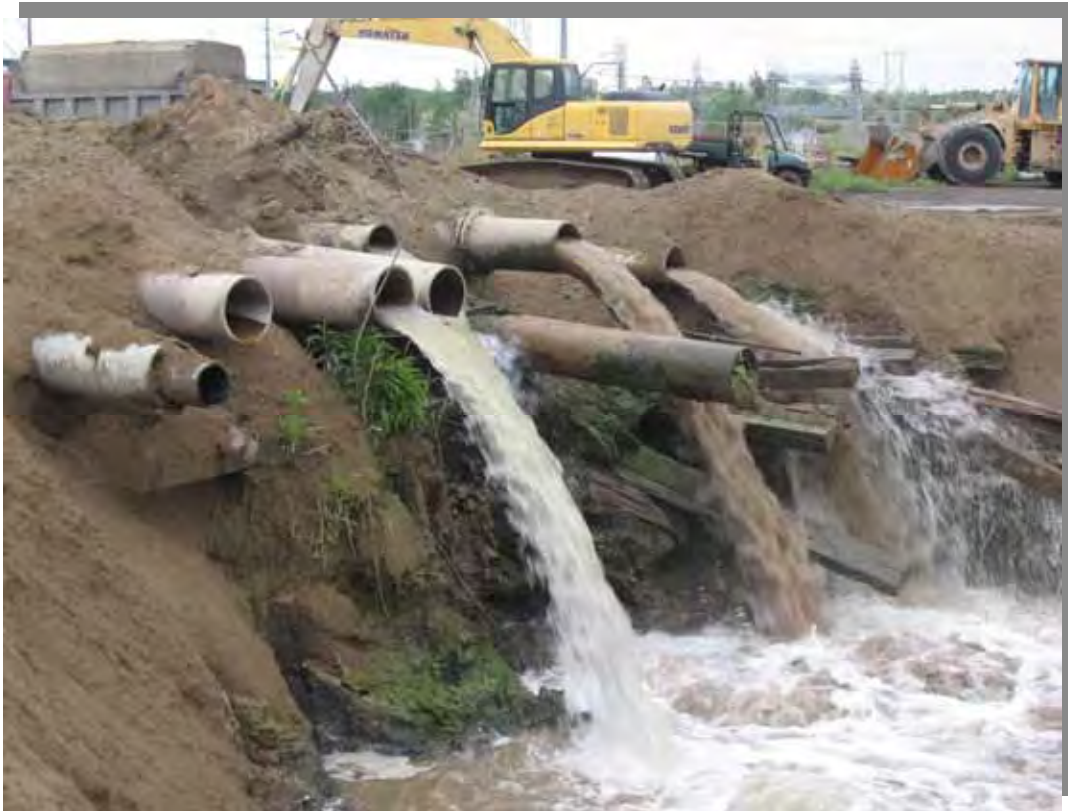
- Sluiced CCW by-product discharge enters the pond in the southwestern corner (Photo 13) and flows along the southern embankment in a channel dredged into dried CCW (Photo 14). Sluice water exits the pond through a 24-inch steel "T" structure located near the northeast corner of the impoundment (Photos 15 & 16).

Photo 13 – CCW discharge from Joppa Plant into Ash Pond at southwestern corner of Southern Pond..

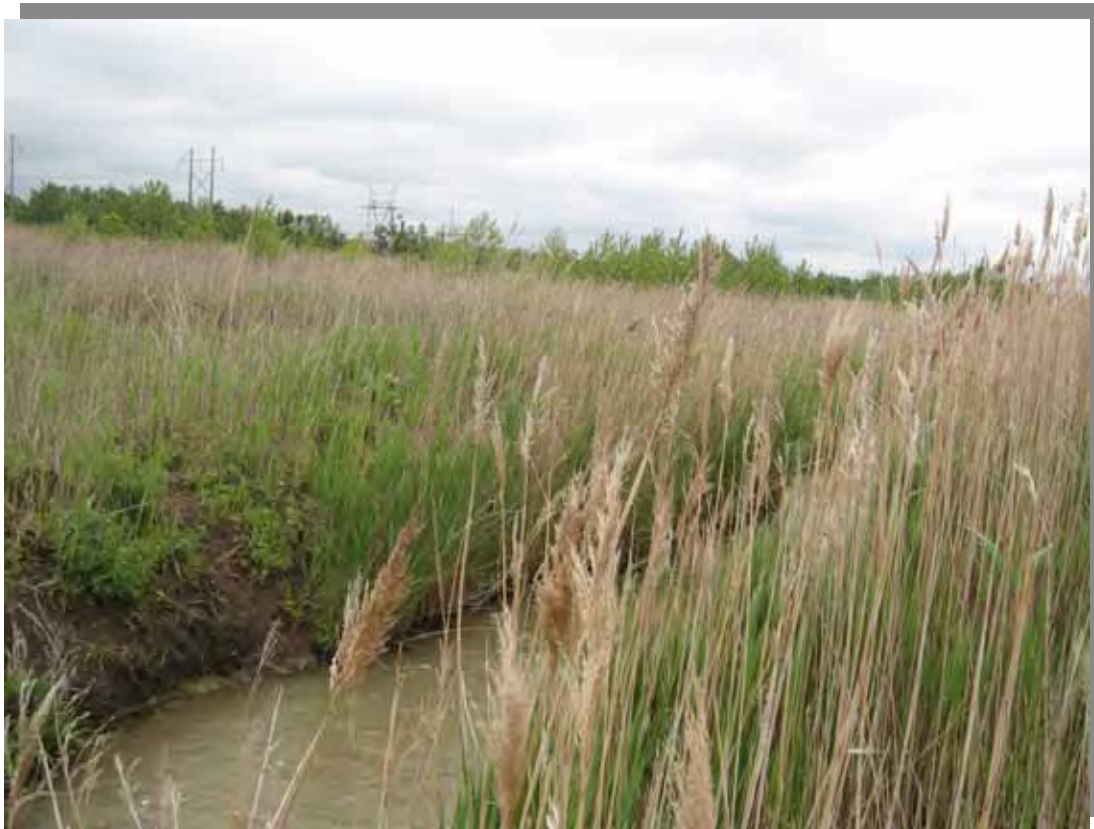
Photo 14 – Channel dredged into CCW that conveys inflow from pipes to eastern side of Southern Pond.

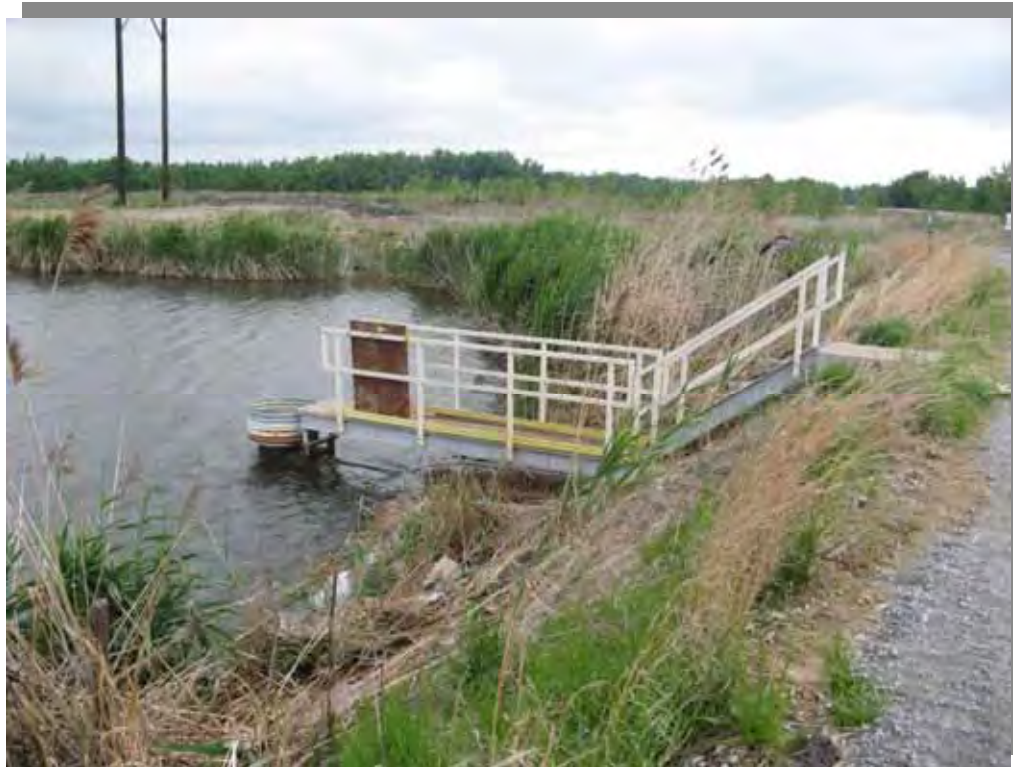
Photo 15 – Southern Pond primary outlet structure.

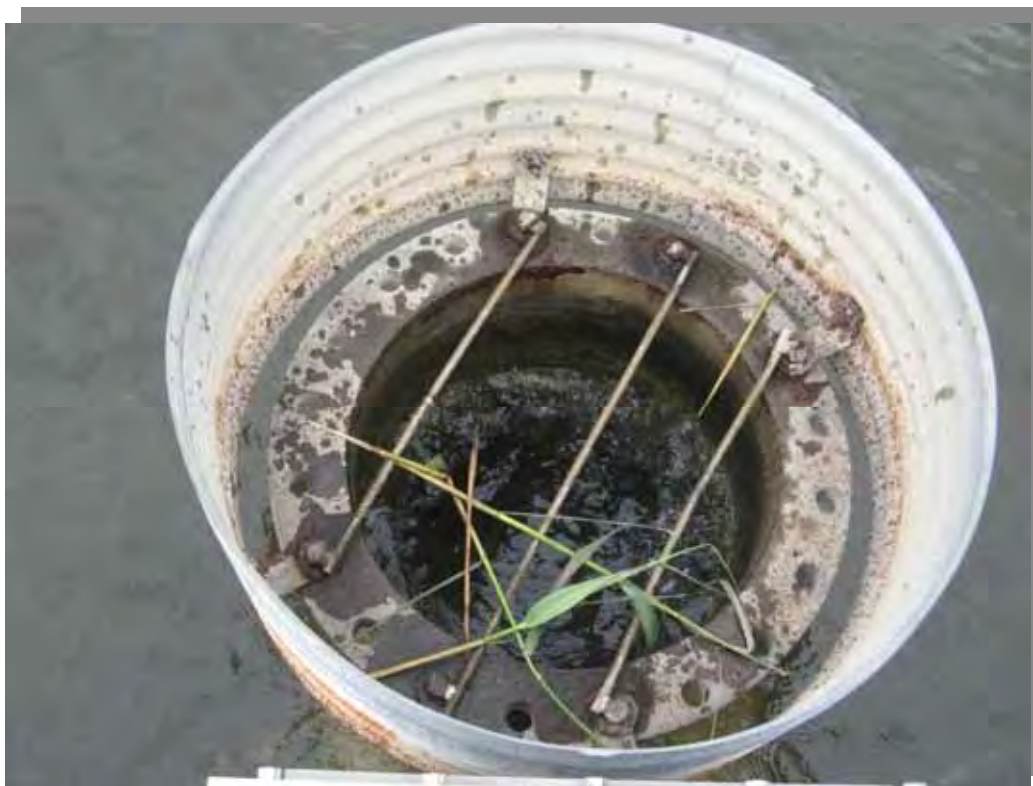
Photo 16 – Interior of Southern Pond primary outlet structure.

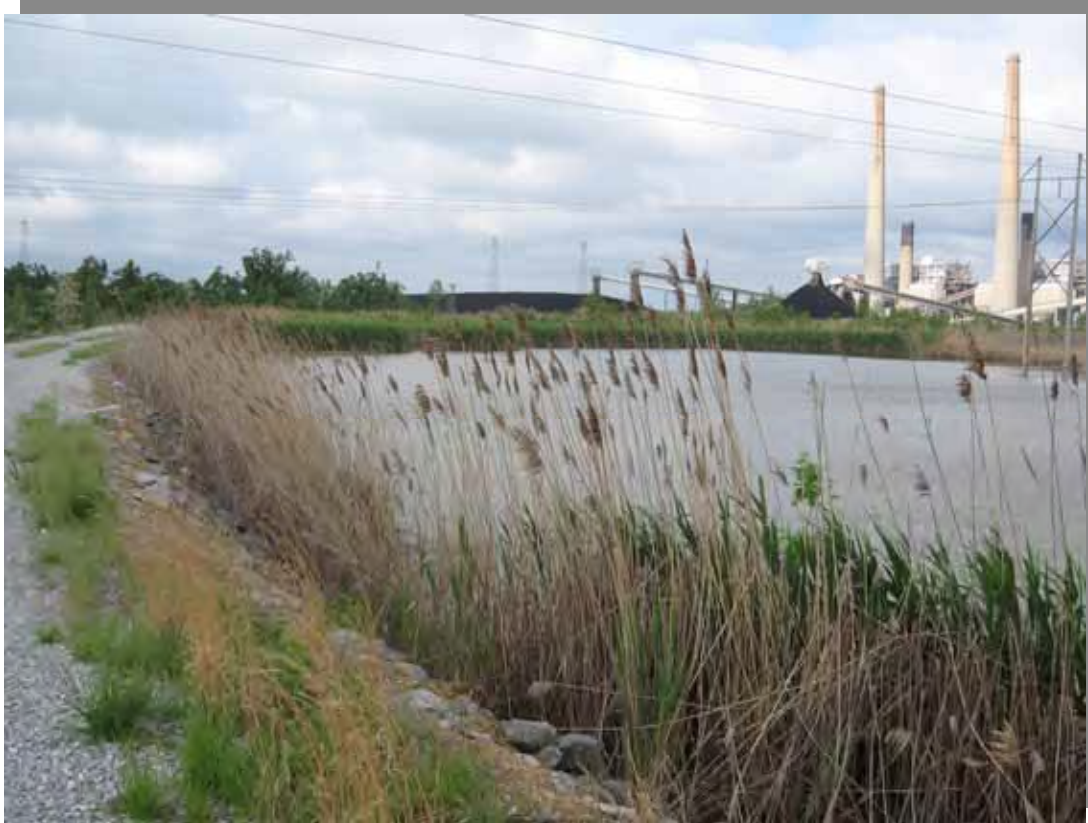
- CCW has accumulated above the normal pool level over an estimated 50 percent of the pond area. Water in the pond is isolated to primarily the eastern half of the pond (Figures 2 & 3, Photo 17).

Photo 17 – Interior of Southern Pond, looking south from primary outlet structure.

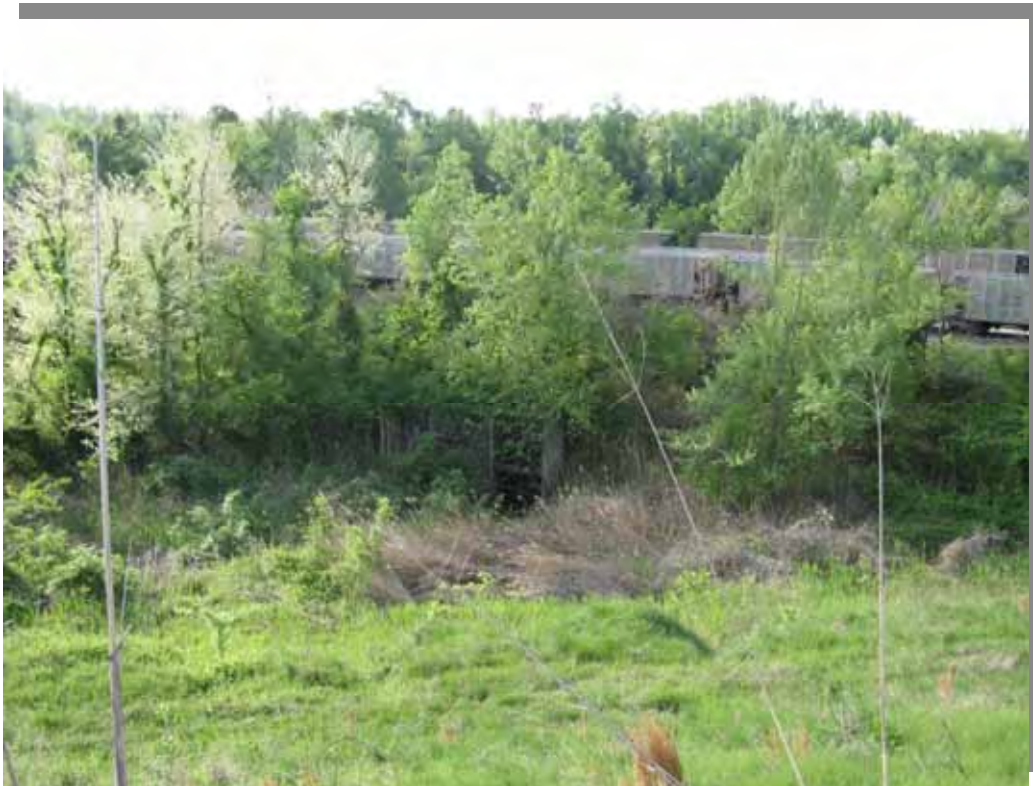
Photo 25 – Ash Pond outlet channel pass-through below EEI railroad siding.
