Coal Combustion Waste Impoundment

Task 3- Dam Assessment Report

John E. Amos Plant (Site 26)

*Fly Ash Dam Complex
American Electric Power
St. Albans, West Virginia*

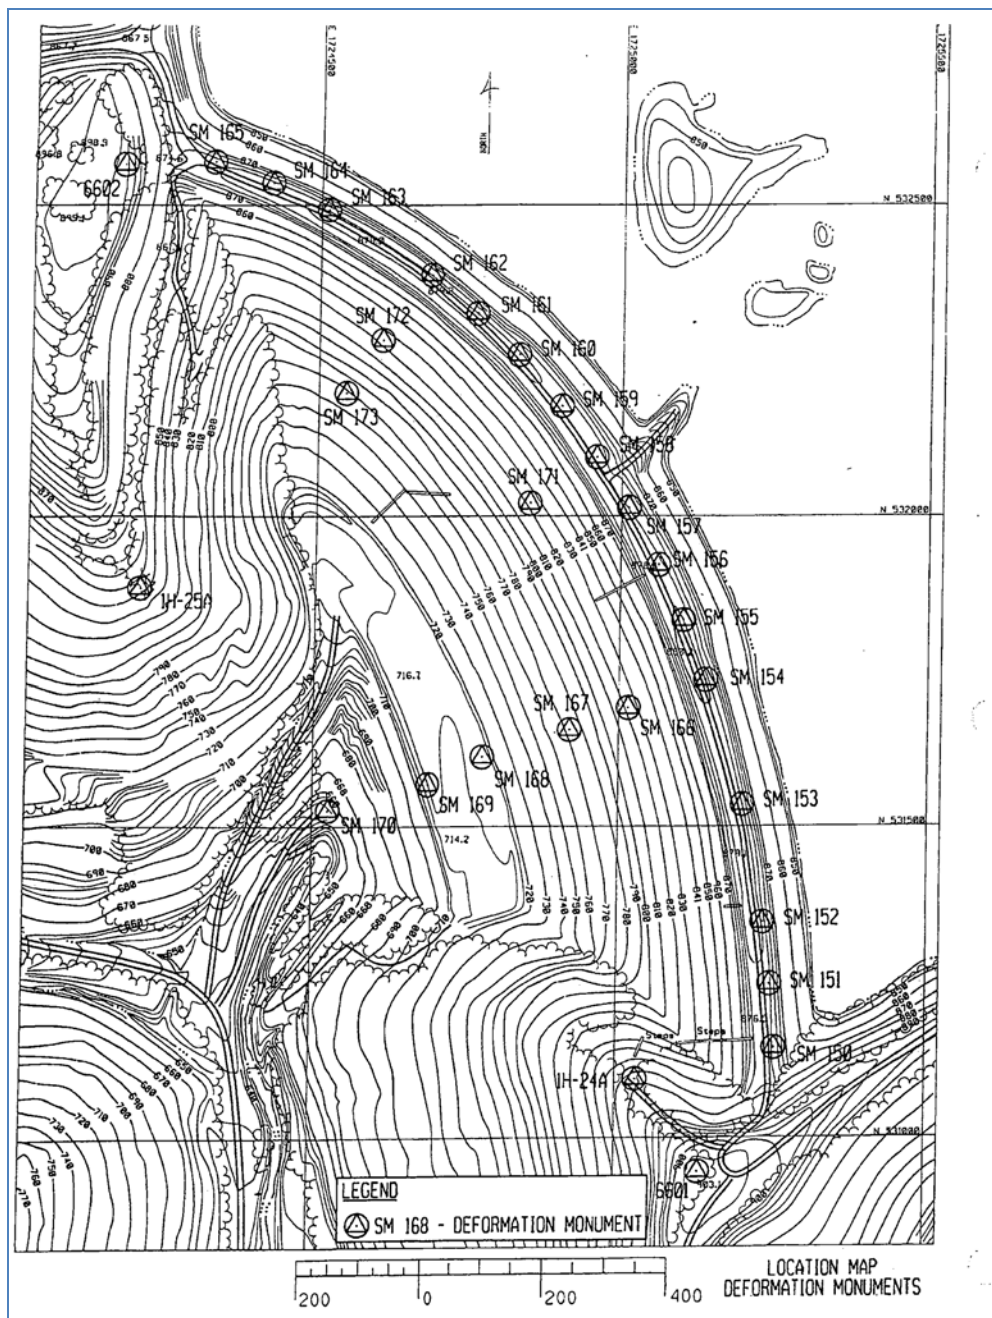
Figure 9.2.1-2. Location Map of Deformation Monuments.

Deformation monitoring data are available for 23 points on the dam: 15 points along the crest and eight points on the downstream face of the dam. The dam configuration and location of monitoring points are shown on Figure 9.2.1-1.

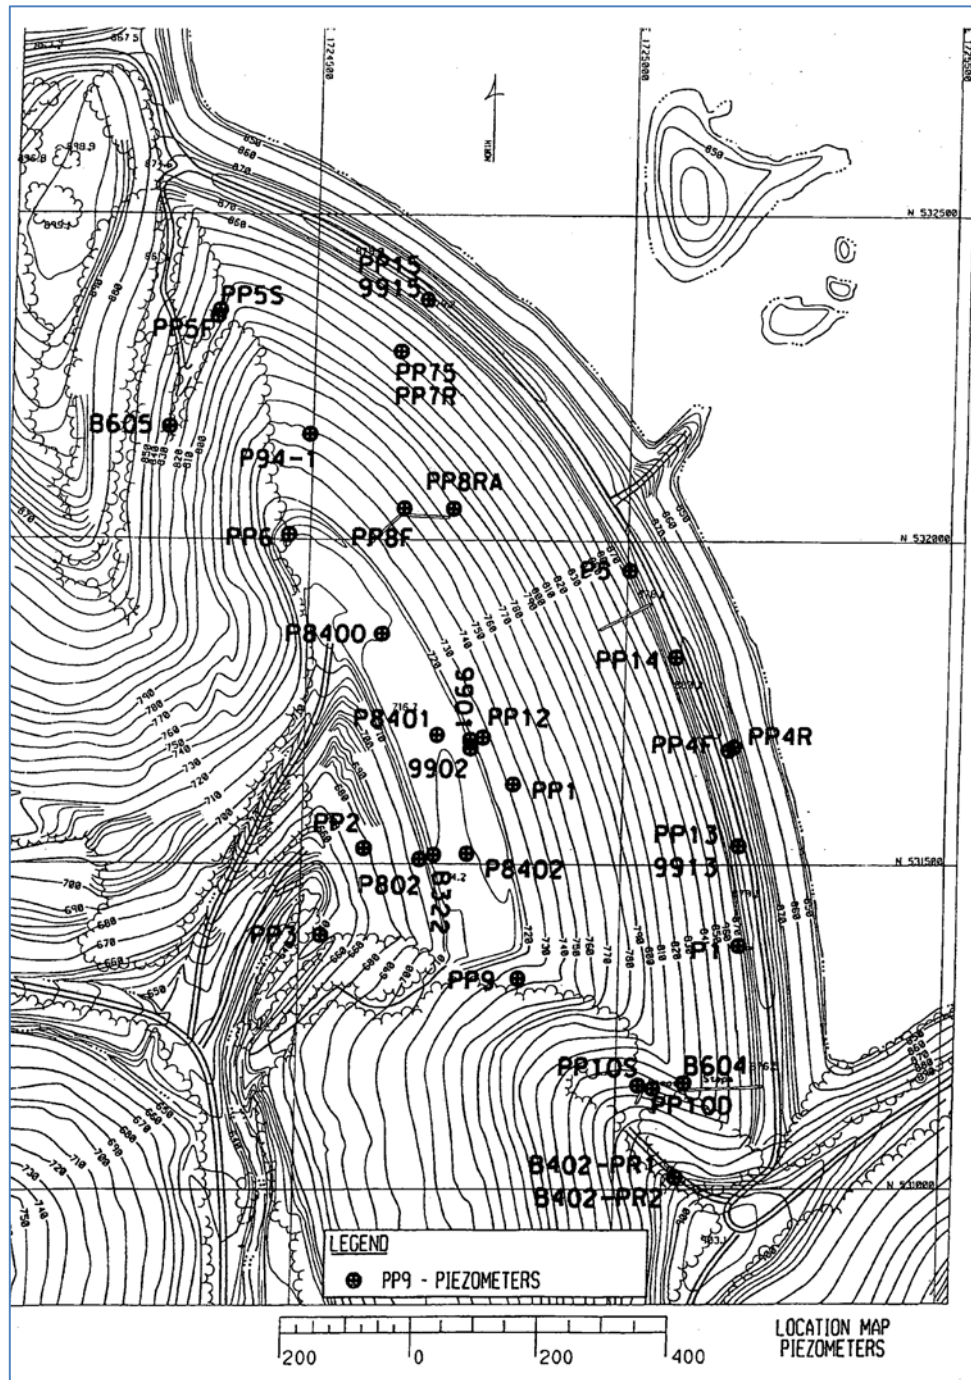
Figure 9.2.1-3. Location Map of Piezometers.

Piezometer readings are obtained monthly for eleven piezometers and quarterly for the remaining 26 by John Amos personnel using a battery powered Sinco water level indicator. Figure 9.2.1-3 is the location map of the piezometers.
