Assessment of Dam Safety Coal Combustion Surface Impoundments (Task 3) Final Report

American Electric Power
Cardinal Power Plant
Brilliant, Ohio

December 9, 2009

CHA Project No. 20085.1080.1510

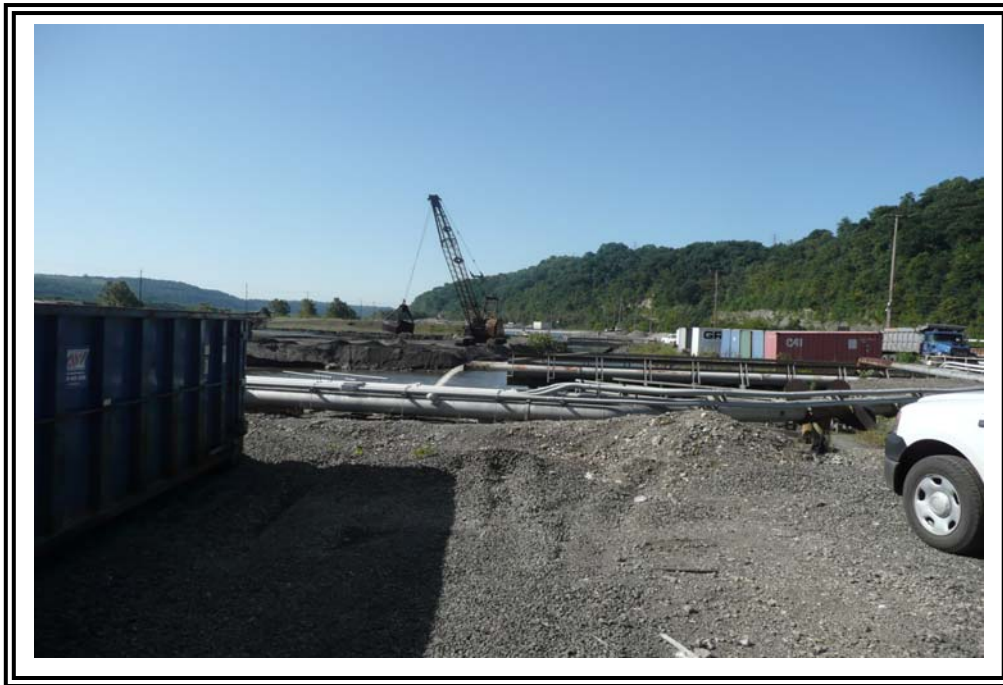
1

North rim of bottom ash pond at ash lines looking south. Note crane on ash delta platform.

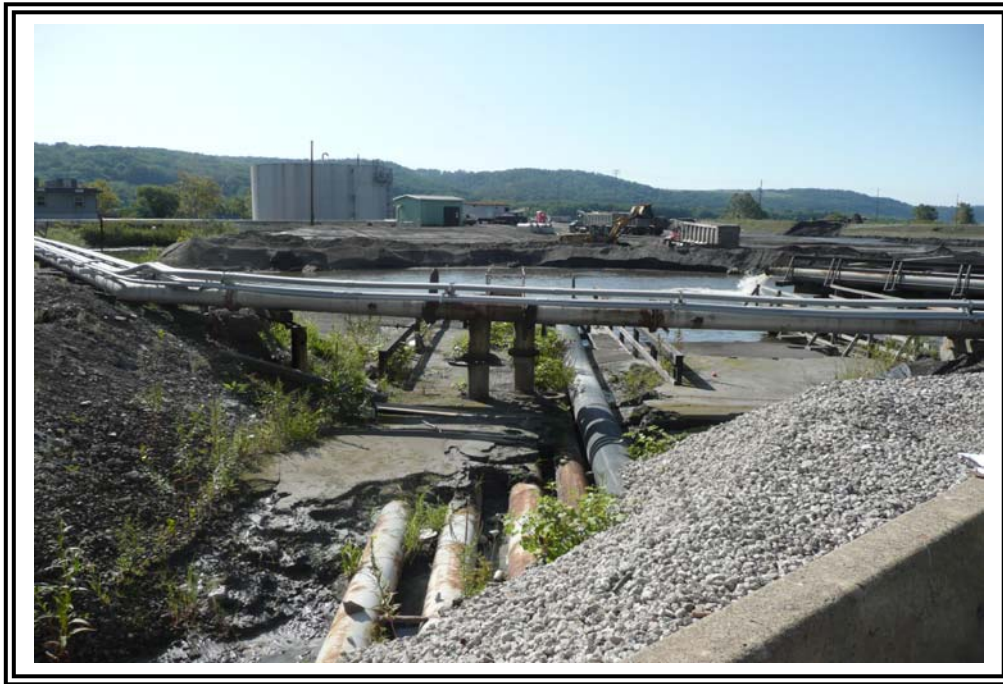
2

View of ash delta working platform from north dike. Note dredge spoil dike in background.

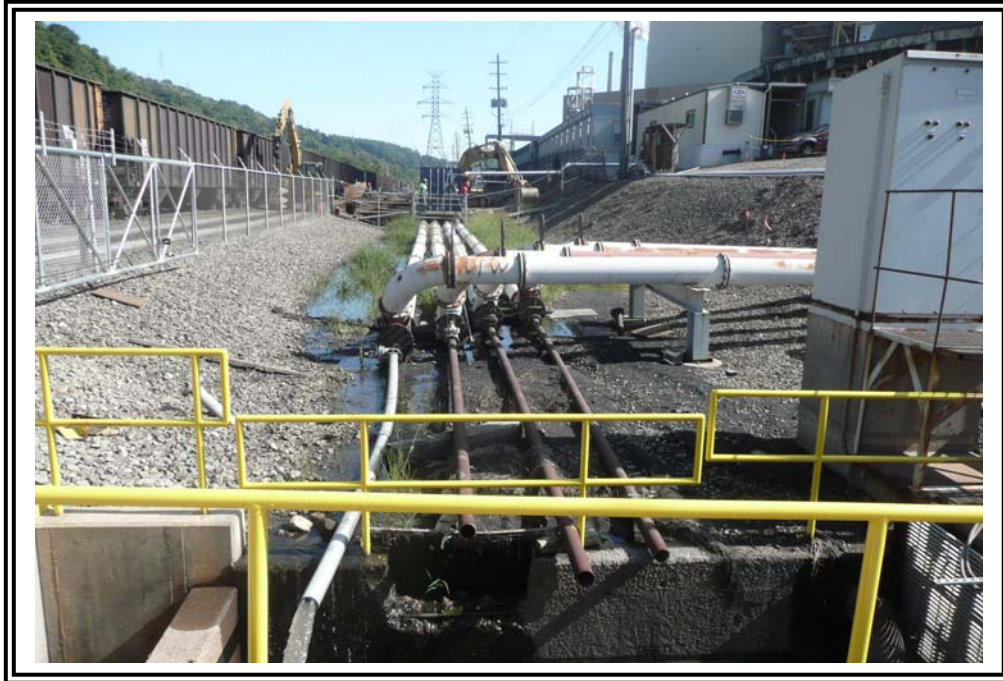
5

Looking north from the yard sump at the drainage swale along the downstream toe of the west dike.

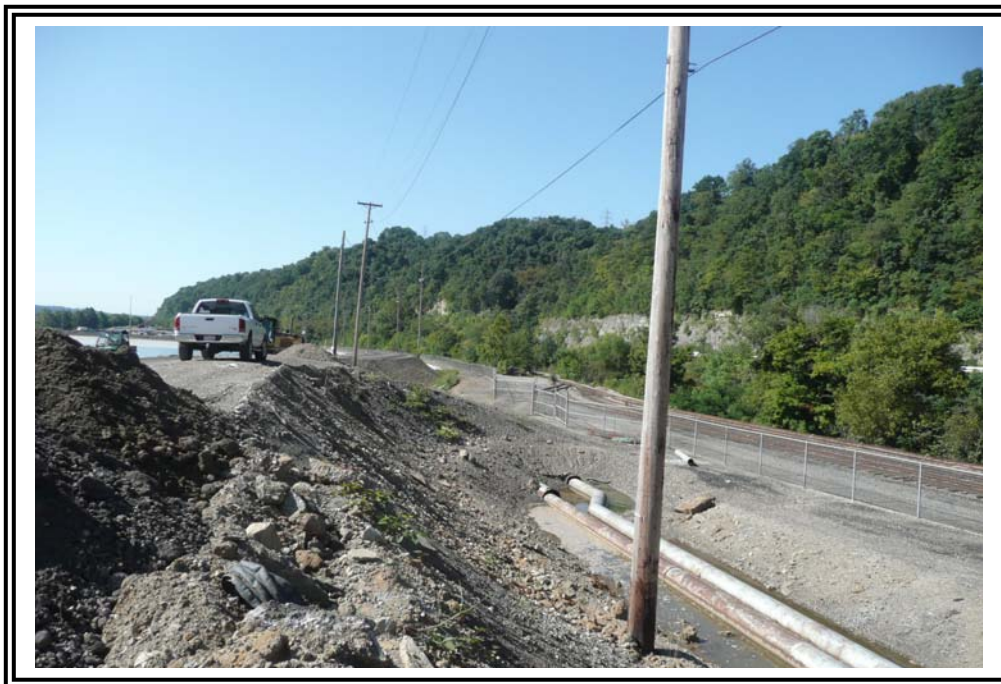
Photos 9 through 12 show the granular surface and erosion rills at the crest-slope interface and slope surface.

Downstream slope of the west dike looking south. Note water collecting around pipes in swale at slope toe which drains to the stormwater/wastewater and drainage sump in Photo # 9.

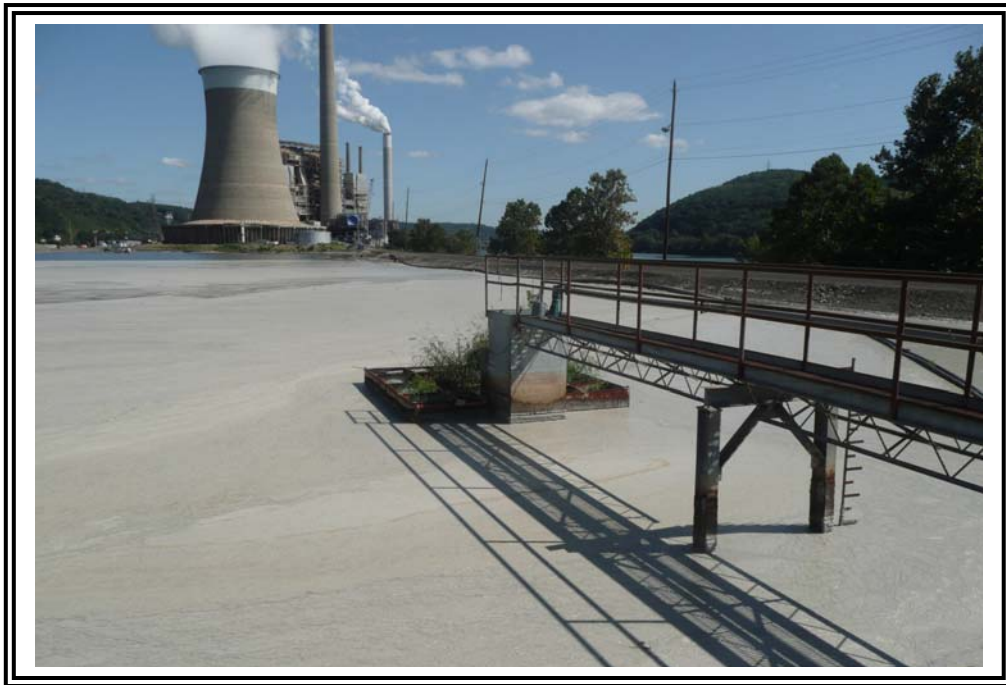
17

Pond spillway tower looking north.

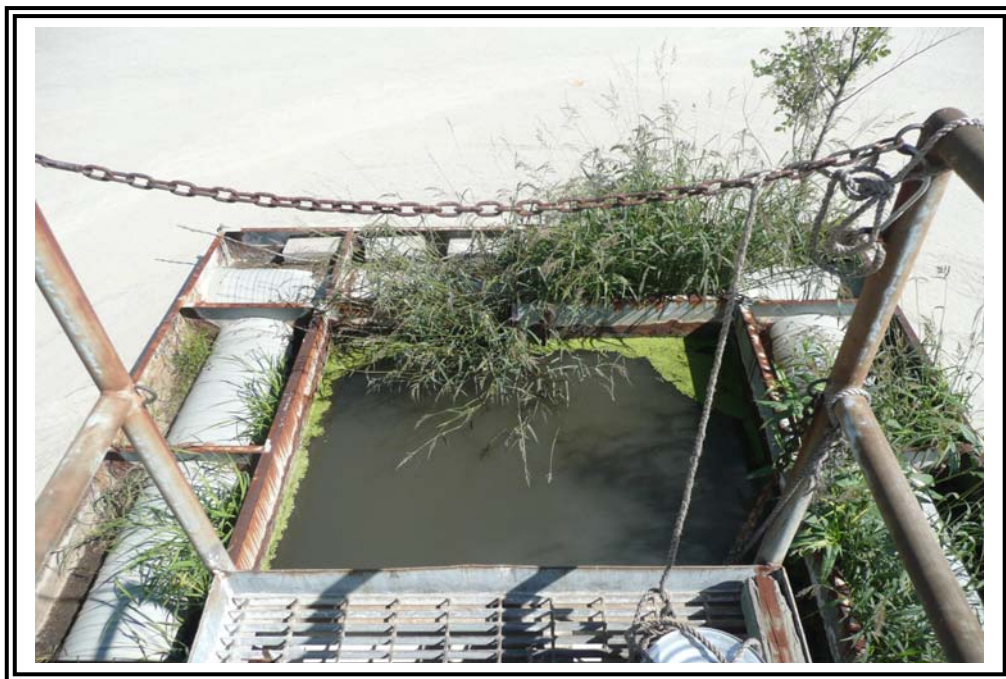
18

Closer view of skimmer at spillway tower and vegetation beginning to establish itself.

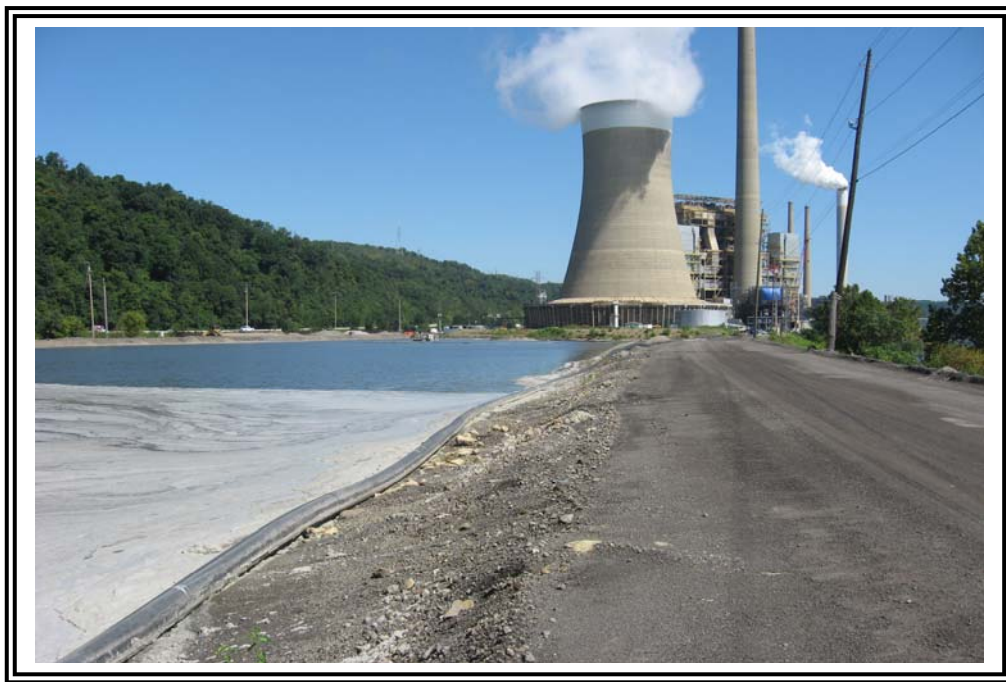
20

Upstream slope and crest alignment of east dike, looking north.

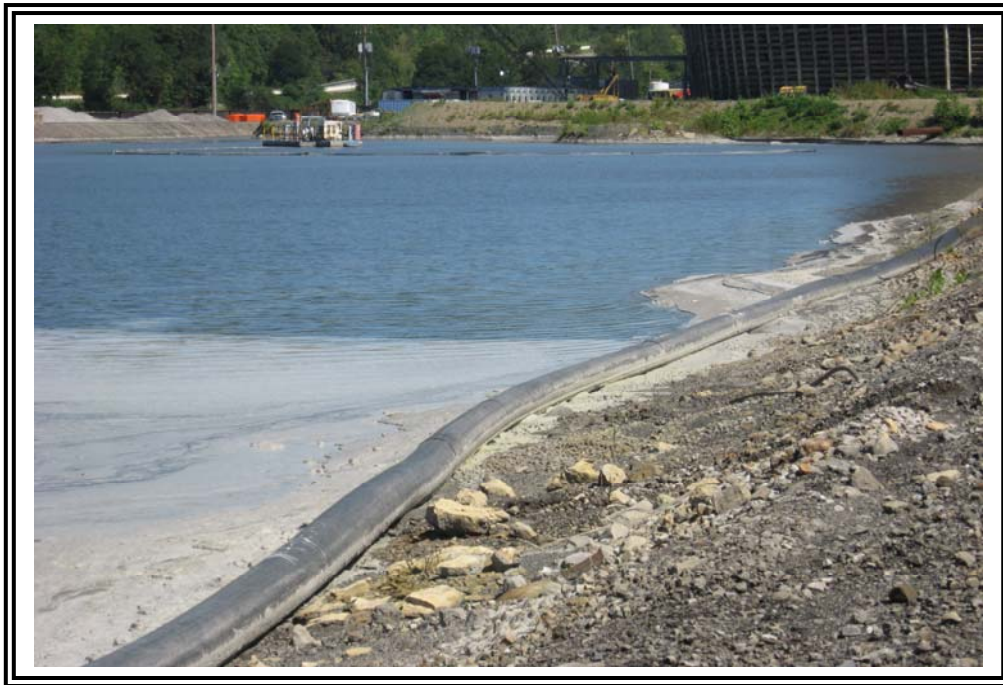
21

The upstream face of east dike is essentially non-vegetated with a fairly coarse granular surface. Erosion from crest runoff has exposed fairly large sized rock fragments in the slope as shown in Photo 21. Beyond the intermittent erosion rills, cracking, slumping, or slough was observed in the upstream face.

Closer view of upstream slope of east dike, looking north.

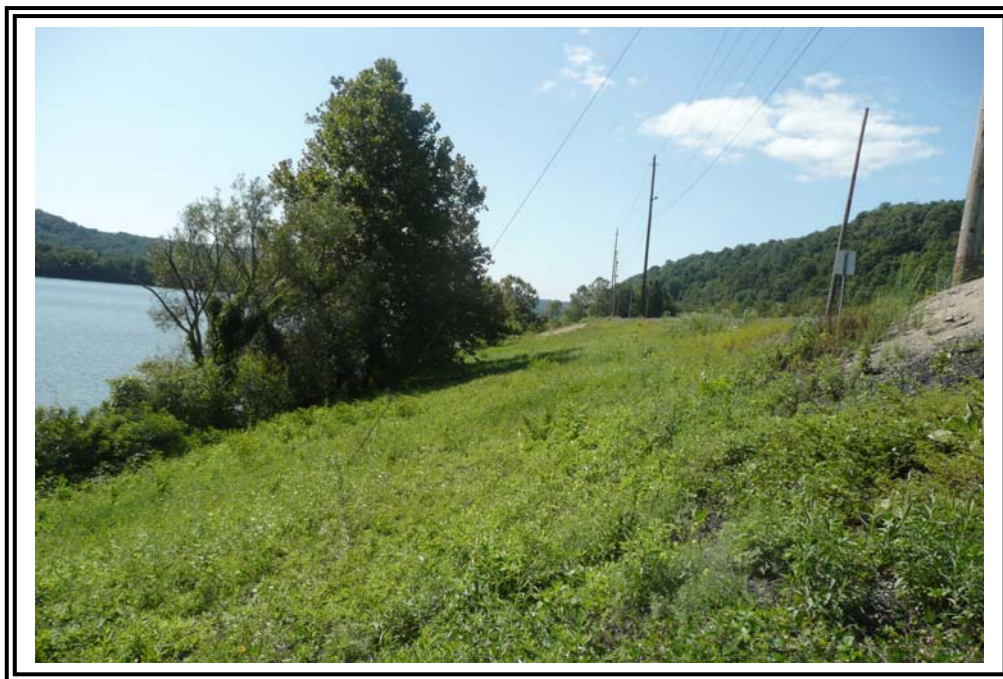
22

Downstream slope on east dike, looking south showing typical moderate, weedy vegetation cover on the slope face and larger brush with isolated trees at river bank.

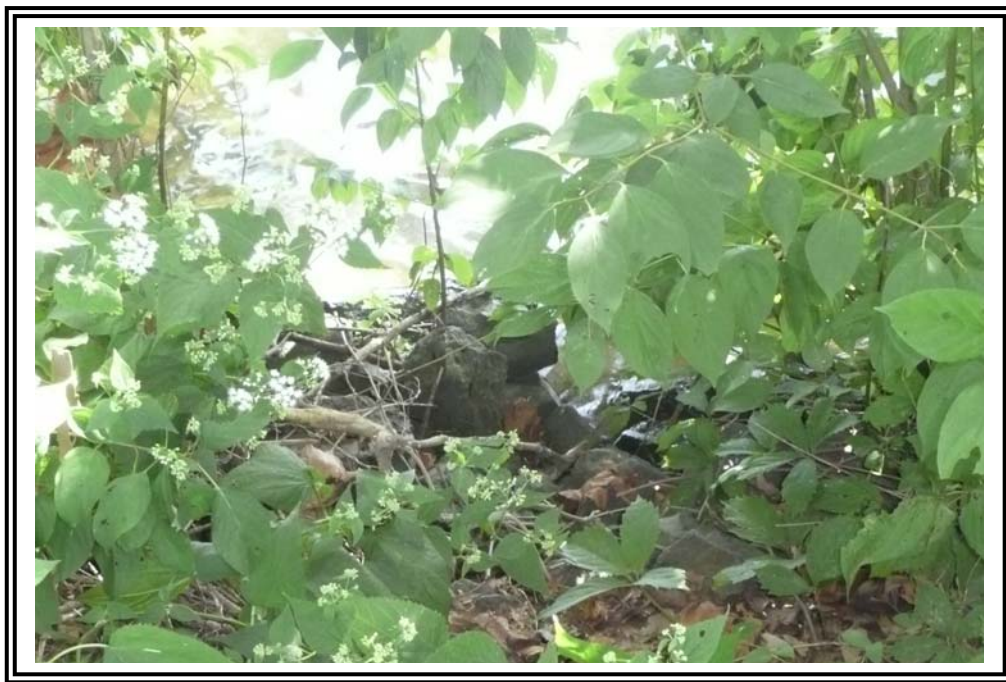
26

Close-up of stone at river bank adjacent to tree in Photo #23.

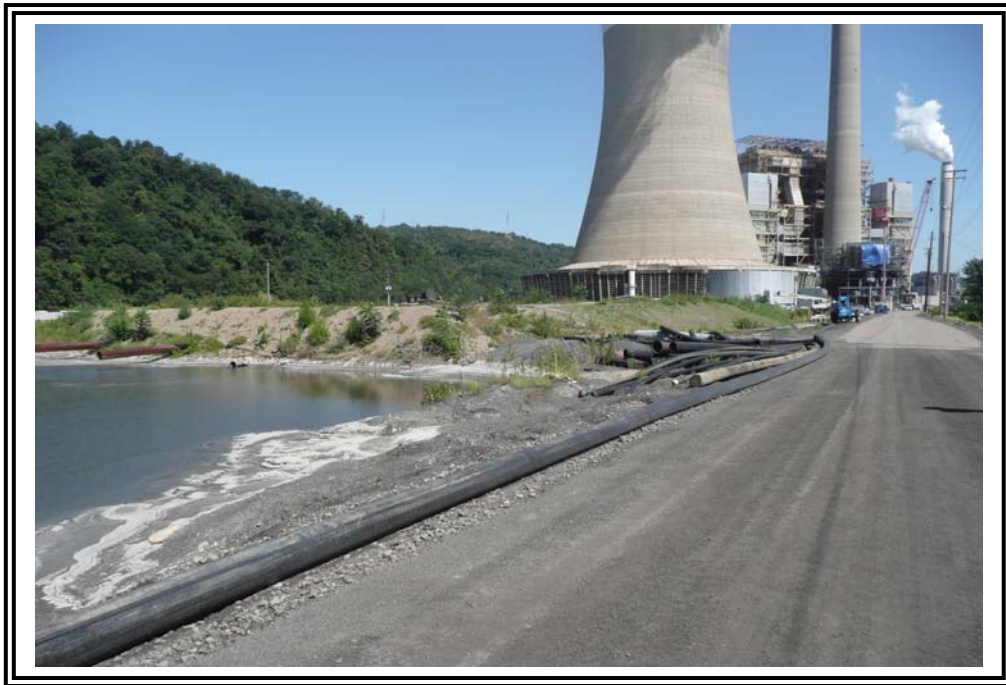
29

East dike crest alignment, pond surface, interior dike, chemical tank (in background) looking north.

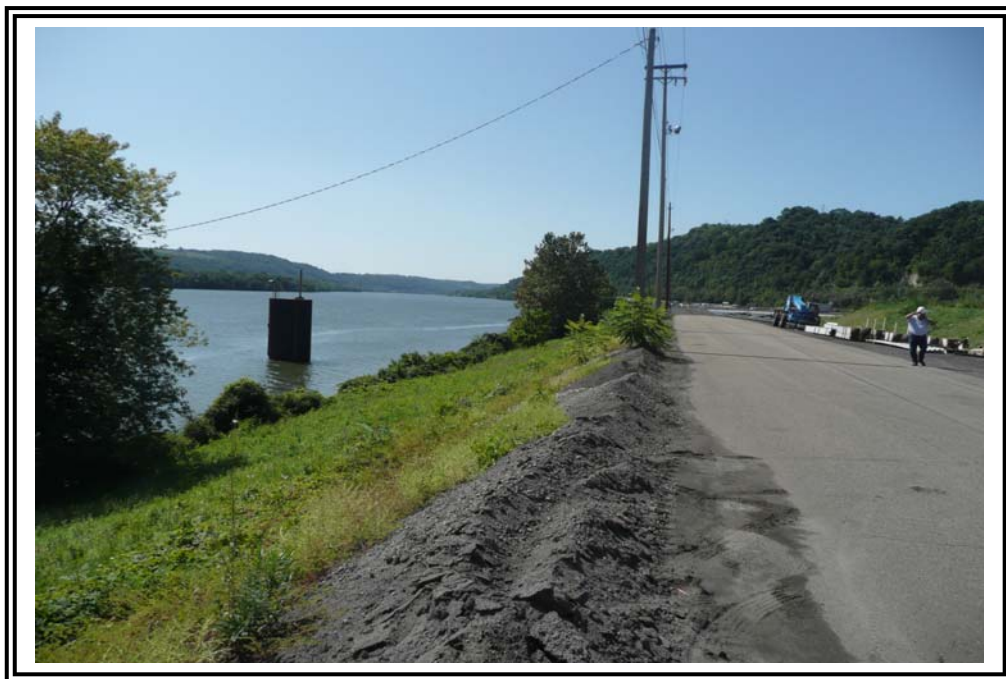
30

East dike crest alignment, looking south, showing ash build up at road edge due to grading activities.

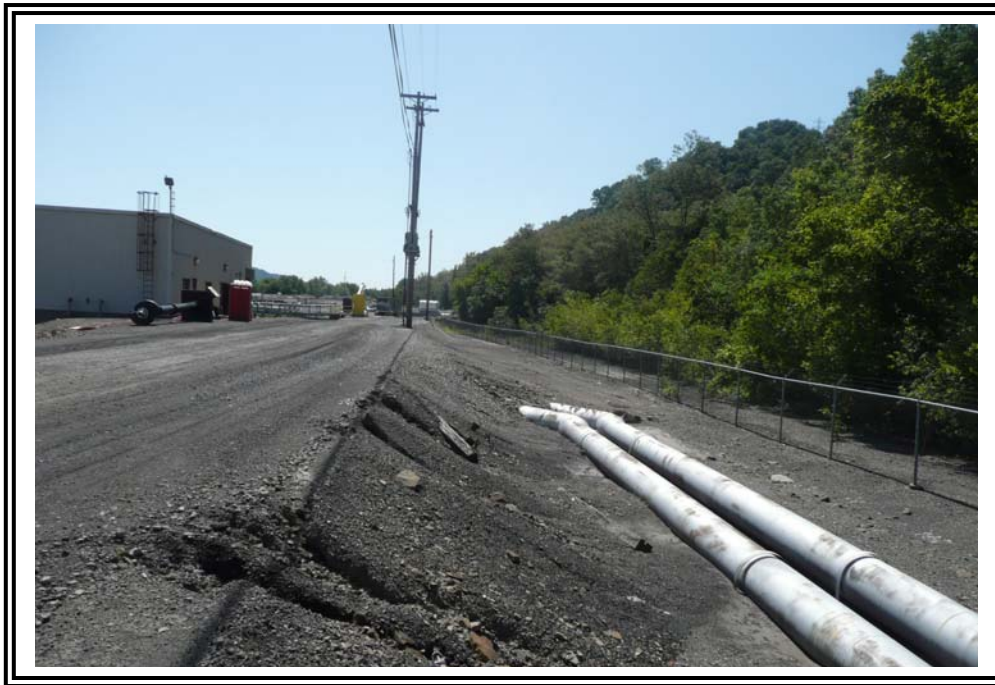
35

Crest and downstream slope at west dike, looking south where recirculation pipes exit slope.
Typical erosion features evident at crest.

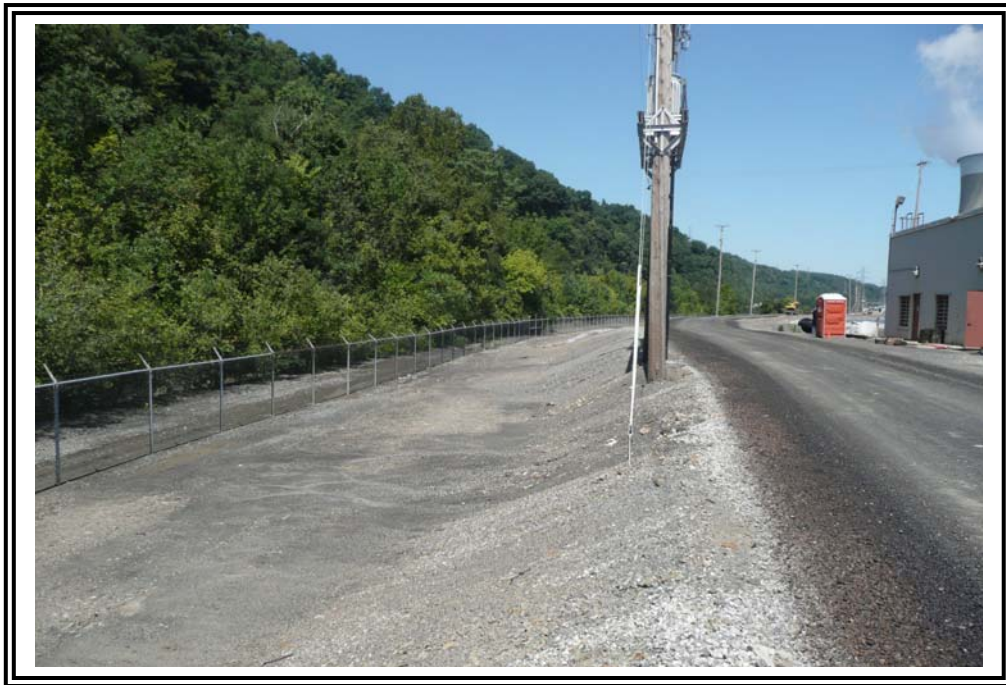
39

Downstream slope of west dike, looking north. Note fairly low height (about 5 feet tall) at this point.

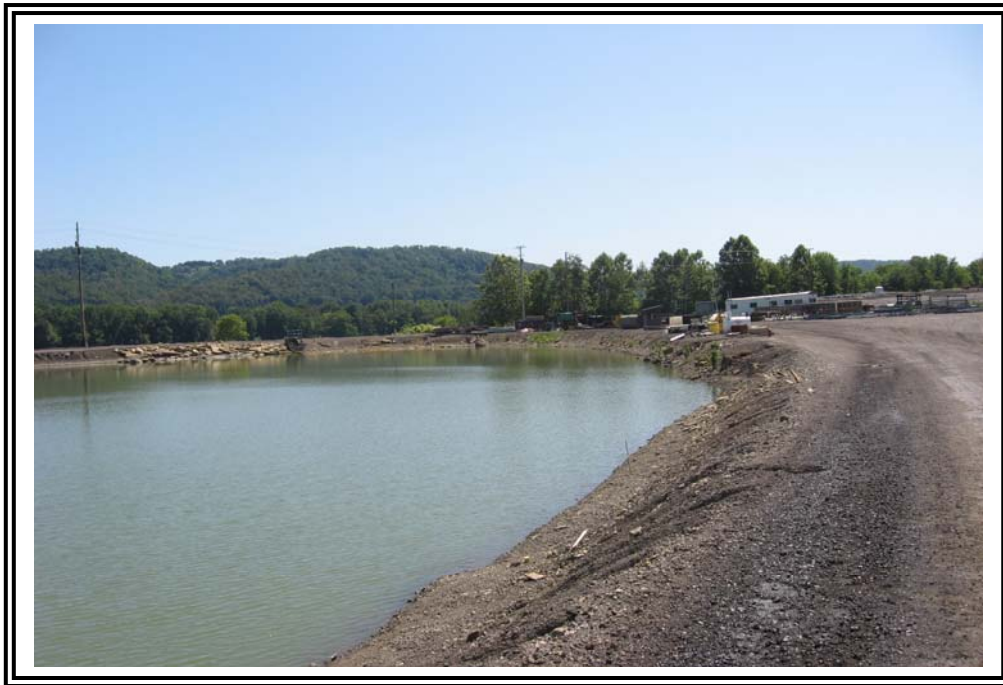
41

Inboard face at south wall, looking east. Pond is essentially incised in this location.

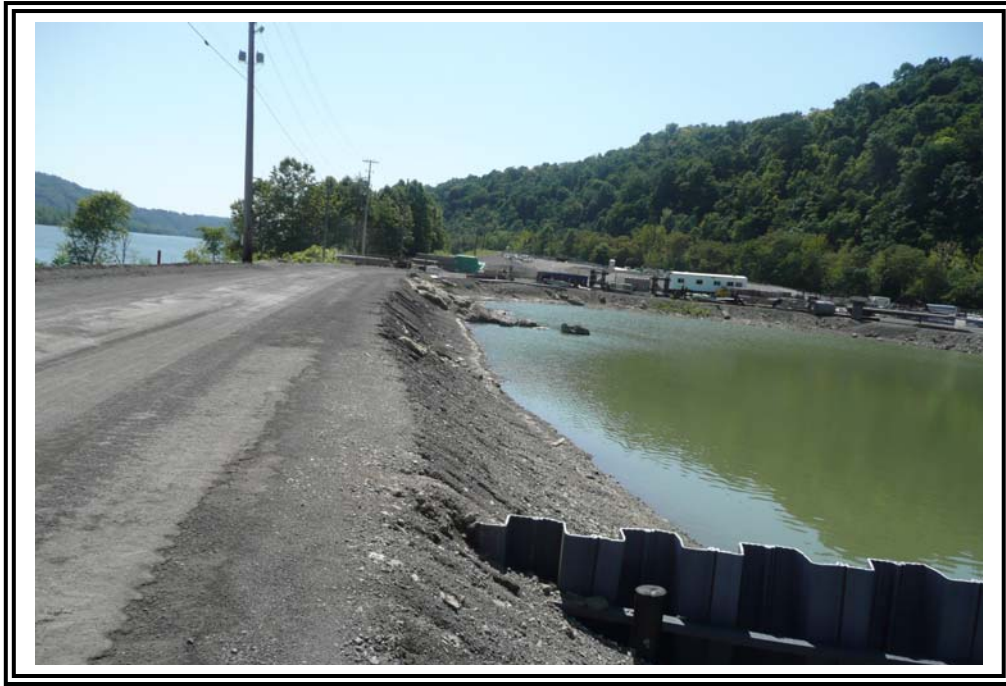
47

The crest area of the east dike does not show indications of abrupt changes in horizontal alignment and the slope areas show no obvious signs of slope instability such as scarps or sloughs. Little to no vegetation cover was observed on the upstream face and large slope protection stone has been placed on the slope face in areas adjacent to the outfall. Minor erosion features as a result of concentrated water flow could be observed on the upstream face on most of the dike. Photos 47, 48, and 42 show the typical conditions of the crest and upstream slope.

Crest and upstream slope of east dike at vinyl wall, looking south.

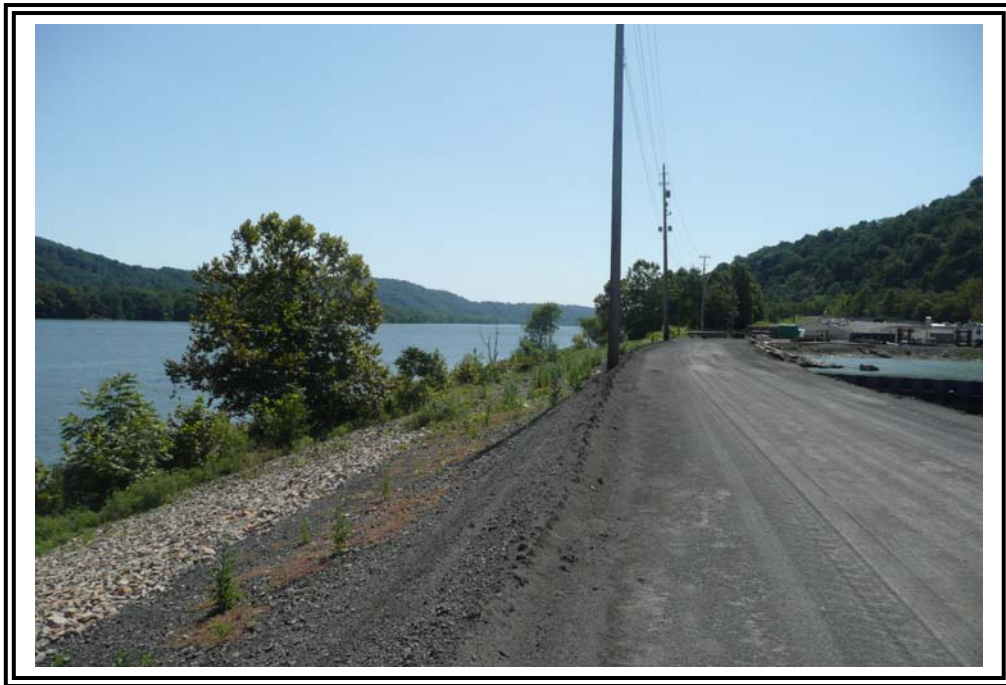
The downstream face has had a stone slope repair apparently as a result of seepage (Photo 46). This area covers roughly half of the Recirculation Pond dike length and appeared dry during the site visit with no outward signs of seepage. Beyond the slope protection area, the downstream slope is vegetated with the exception of the top few feet at the crest where sight grading activities have affected the vegetation growth (Photos 49 and 50).

Crest and downstream slope of east dike, looking south. Note vertical limit of stone facing.

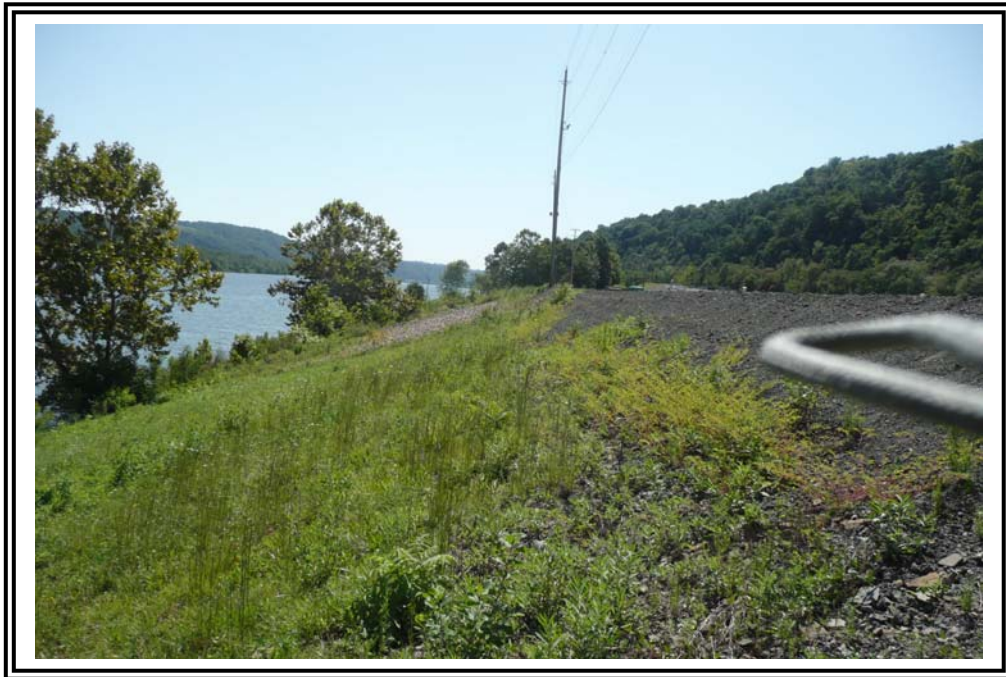
50

Downstream slope of east dike, looking south showing typical vegetation cover.

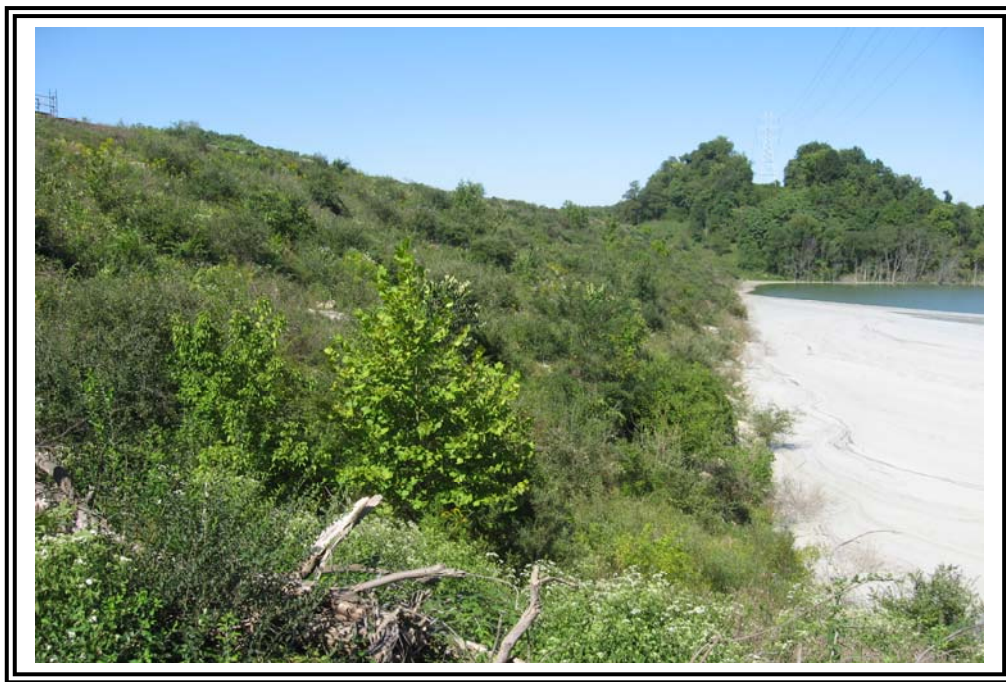
52

The downstream slope is heavily vegetated and armored with large rip rap (Photos 51 and 52). This rip rap has deteriorated over time and the heavy vegetation obscured much of it, giving it the appearance of having been randomly placed (Photos 59 and 60). Heavy vegetation was also observed in the north (left) abutment groin (Photos 57 and 58).

Downstream slope from right (south) abutment, closer to Fly Ash Reservoir No. 2 water surface.

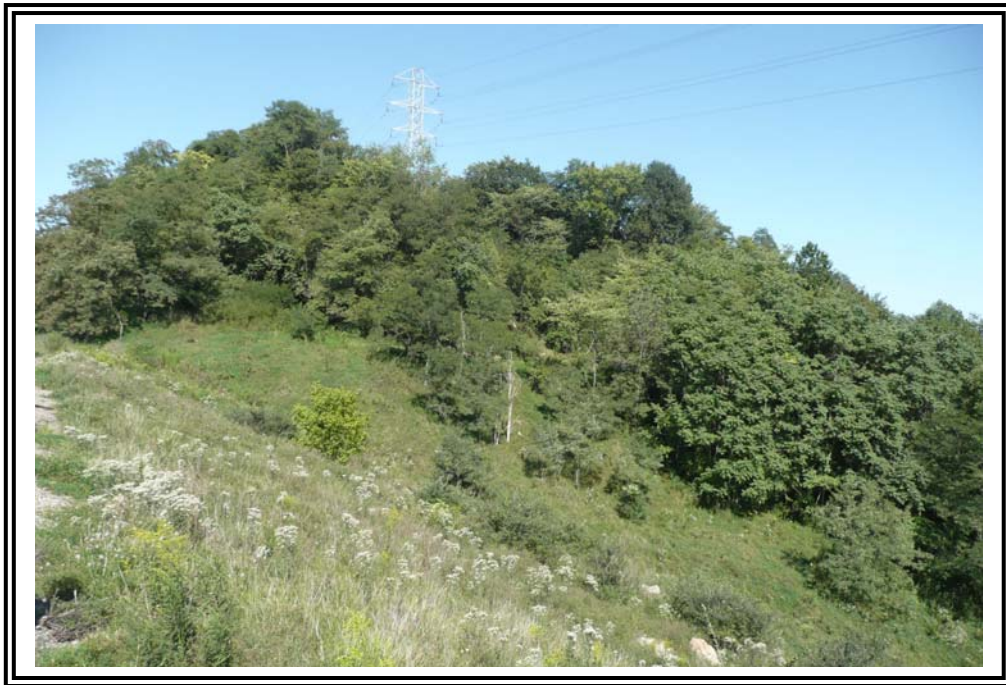
57

Looking north at downstream slope and left (north) abutment contact.

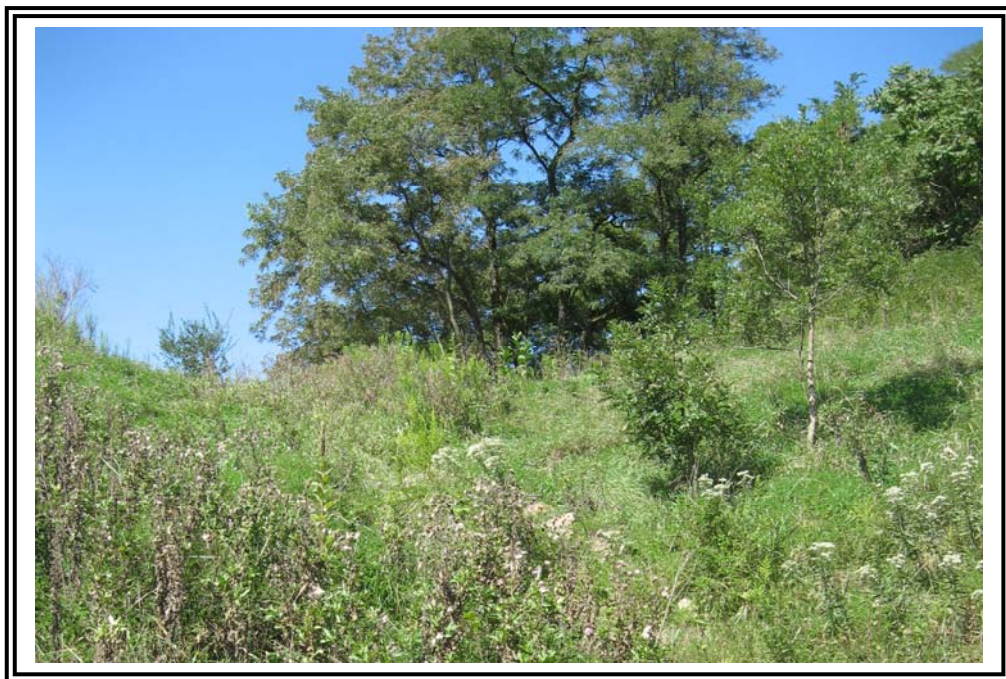
58

Left (north) abutment rock groin; heavily vegetated.

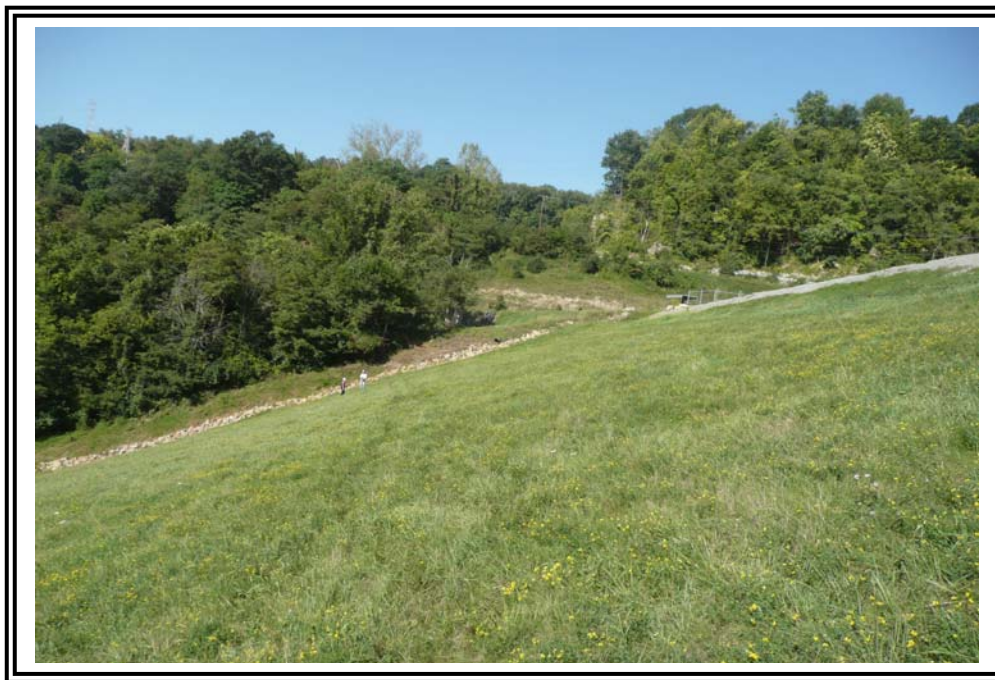
64

The downstream slope areas generally appeared to be well maintained and vegetated with an adequate grass cover as noted in Photos 64, 99, 101, and 105. Much of this cover has grown on the portion of the dam above elevation 925 which is the RCC portion. Isolated grass cover losses were observed in some areas, such as the ones on the upper bench shown in Photos 102 and 103, but these were considered minor. The erosion observed between the upper bench and the west groin is more prominent however, as shown in Photo 100.

Downstream slope below crest, looking west towards right abutment. Note rock groin at abutment contact.

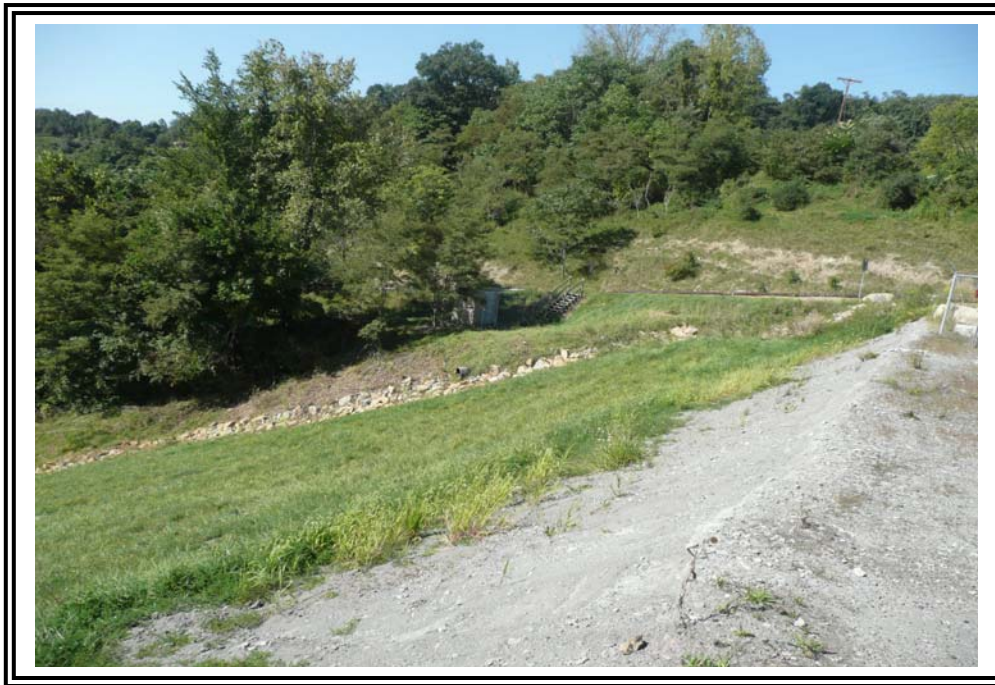
65

Rock lined groins and drainage ditches along the abutment contacts and on the slope face were varied in their conditions. The upper rock groin along the west (right) embankment was generally dry and fairly clear of vegetation (Photo 65). Fairly low vegetation was also evident in the east groin near the toe drain area (Photo 91). This is in contrast to the rock groin in the upper elevation of the east (left) abutment and the downstream slope (Photos 85, 86, and 104). At lower elevations, the abutment groins began to intercept and convey seepage toward the toe drain area (Photos 89, 90, and 106). One of the more prominent seeps on the right abutment is actually drainage from a trench drain in the natural hillside (Photo 88). Another active drain was observed at the east abutment contact. This drain appeared to be conveying flow from the embankment rather than the hillside (Photo 87). Seepage in these areas was clear.

Closer view of rock groin at right (west) abutment hillside contact from crest.

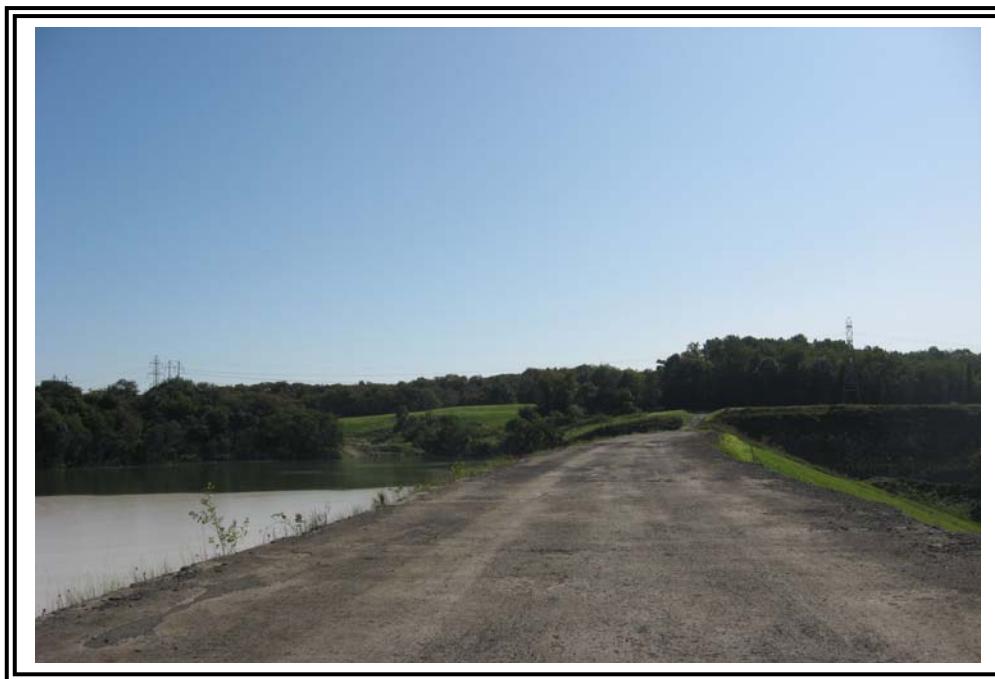
68

In general, the alignment of the crest of Fly Ash Dam No. 2 does not show signs of change in horizontal alignment, which arches slightly in the upstream direction (Photos 63, 68, and 84). Bedrock exposures can be observed on the east abutment at the emergency spillway (Photo 81).

On crest looking east toward left abutment and emergency spillway.

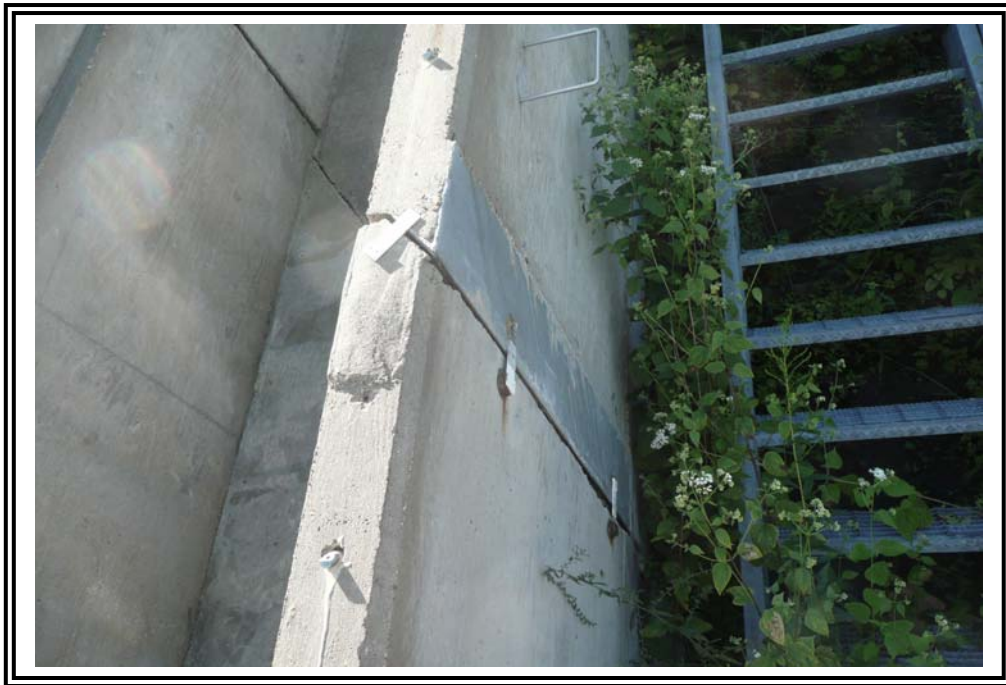
75

Fly Ash Dam No. 2 has an inclined Principal Spillway connected to a 54-inch diameter prestressed concrete cylinder pipe through the RCC embankment which transitions to a 42-inch diameter steel pipe. This steel pipe is exposed along the east abutment and outlets at the base of the slope in a concrete energy dissipater (Photos 99 and 107). The inclined spillway was constructed with a diagonal construction joint to allow potential deformation along a crack in the RCC that had formed while the RCC was being placed. Crack deformation gauges have been placed along this joint to track movement (Photo 74 and 75). Shear displacement along this joint was not readily observable.

Close-up of crack gauges on inclined spillway diagonal joint.

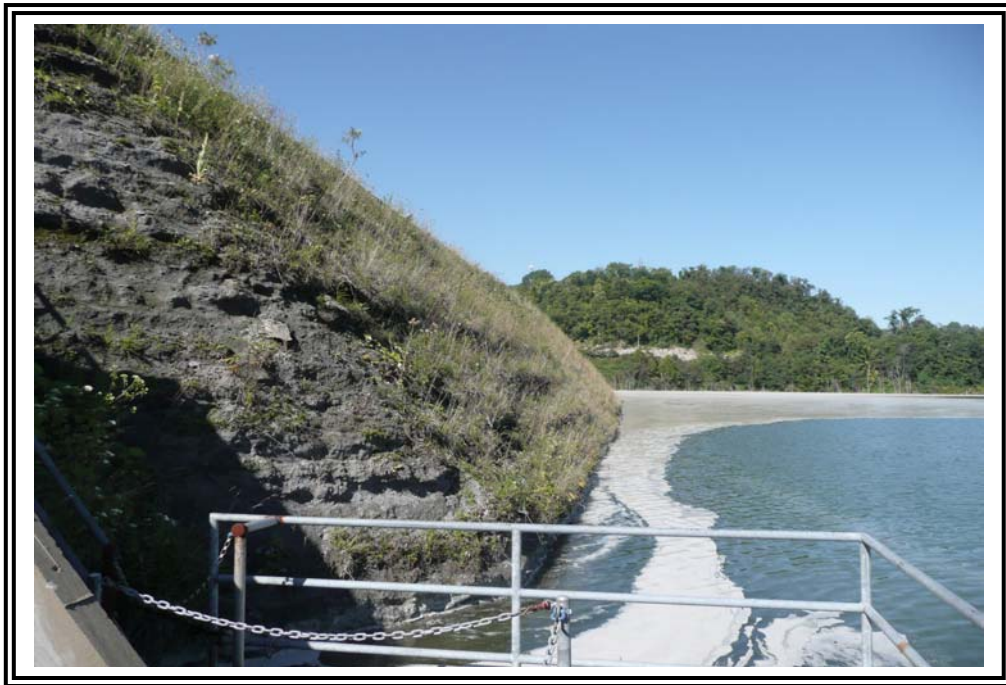
77

Upstream slope looking west from spillway.

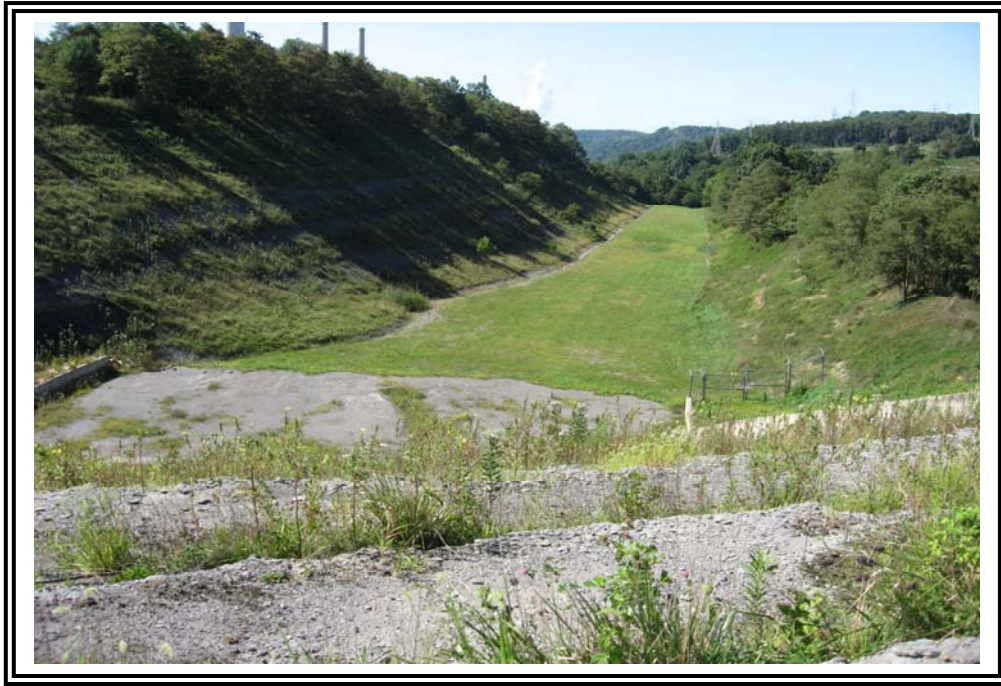
79

Emergency spillway, looking south from crest. Note that this spillway is excavated through hillside.

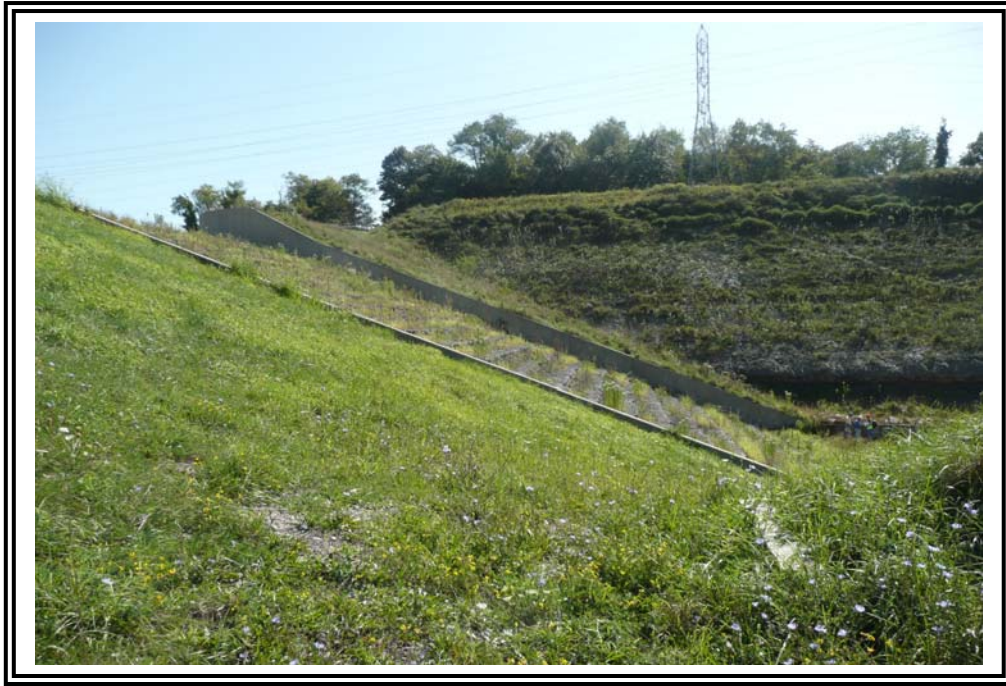
81

Downstream slope on RCC portion looking toward emergency spillway and left (east) abutment. Bedrock is exposed in far slope.

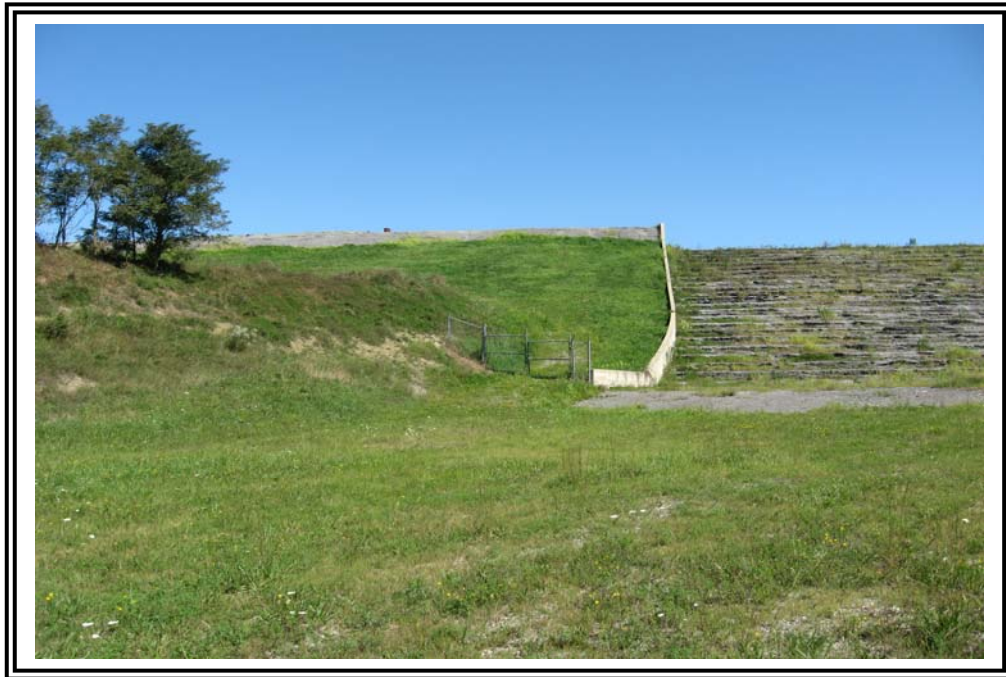
82

Looking north at dam crest and emergency spillway from downstream channel.

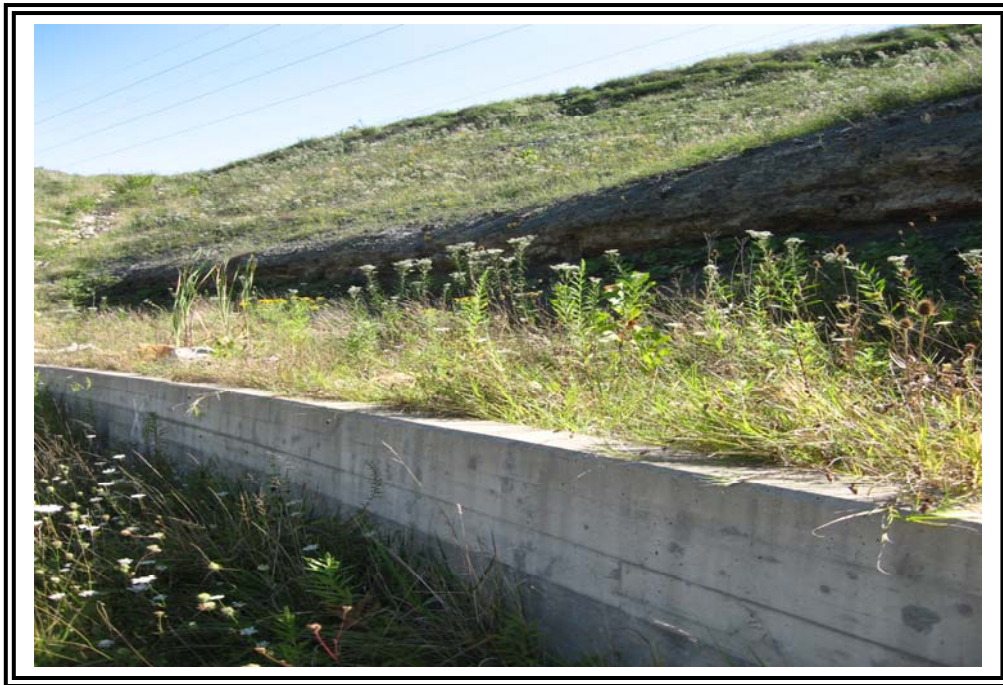
83

Left (east) concrete training wall at emergency spillway outfall channel. Note exposed bedrock.

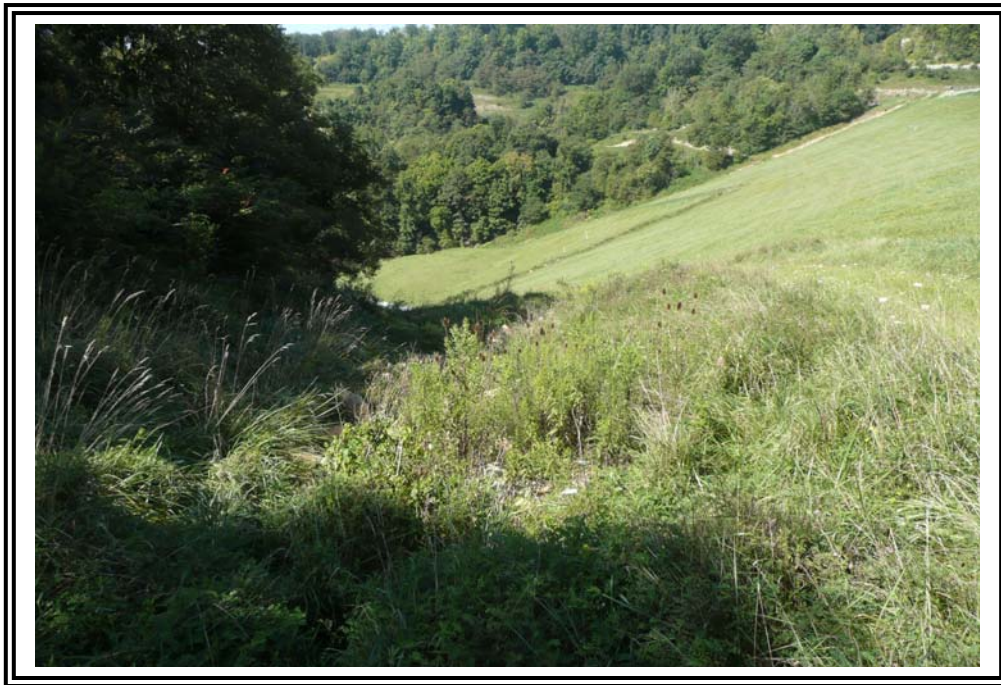
85

Left (east) rock groin at abutment contact. Note moderate to heavy vegetation.
