Assessment of Dam Safety Coal Combustion Surface Impoundments (Task 3) Final Report

American Electric Power
Cardinal Power Plant
Brilliant, Ohio

December 9, 2009

CHA Project No. 20085.1080.1510

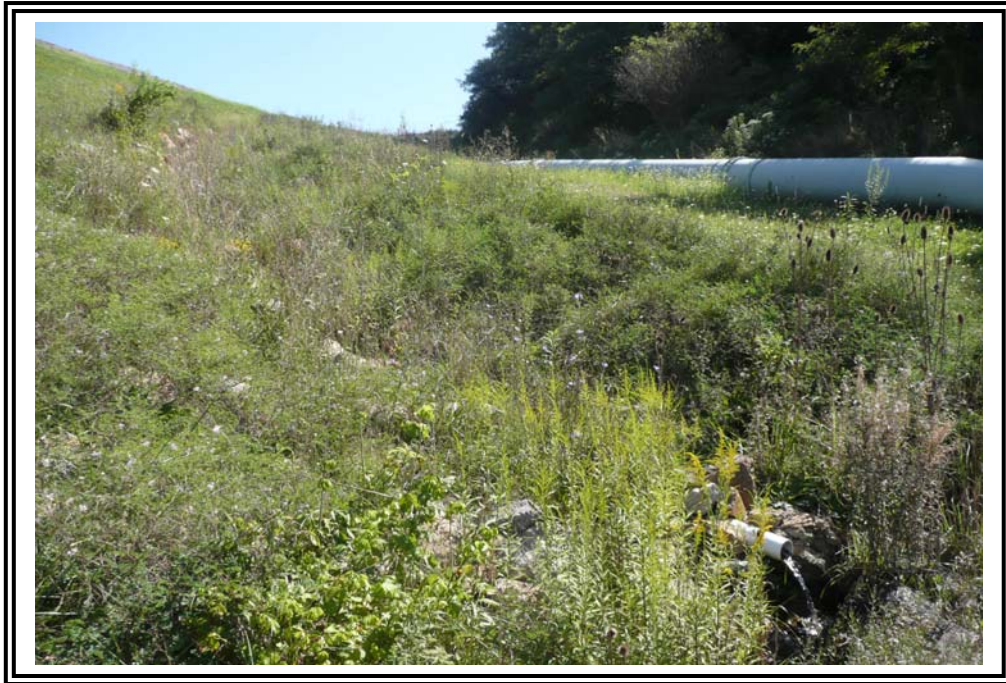
87

Active seepage outlet in left (east) rock groin. Water flowed clear.

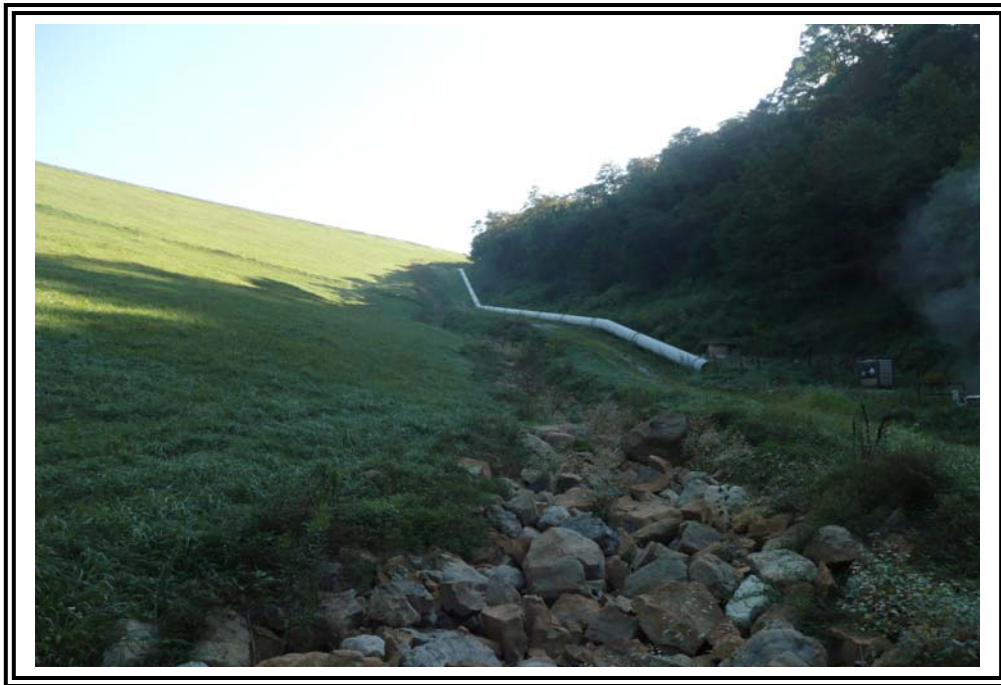
91

Looking upslope at left (east) rock groin and 42" diameter spillway outlet from toe drain.

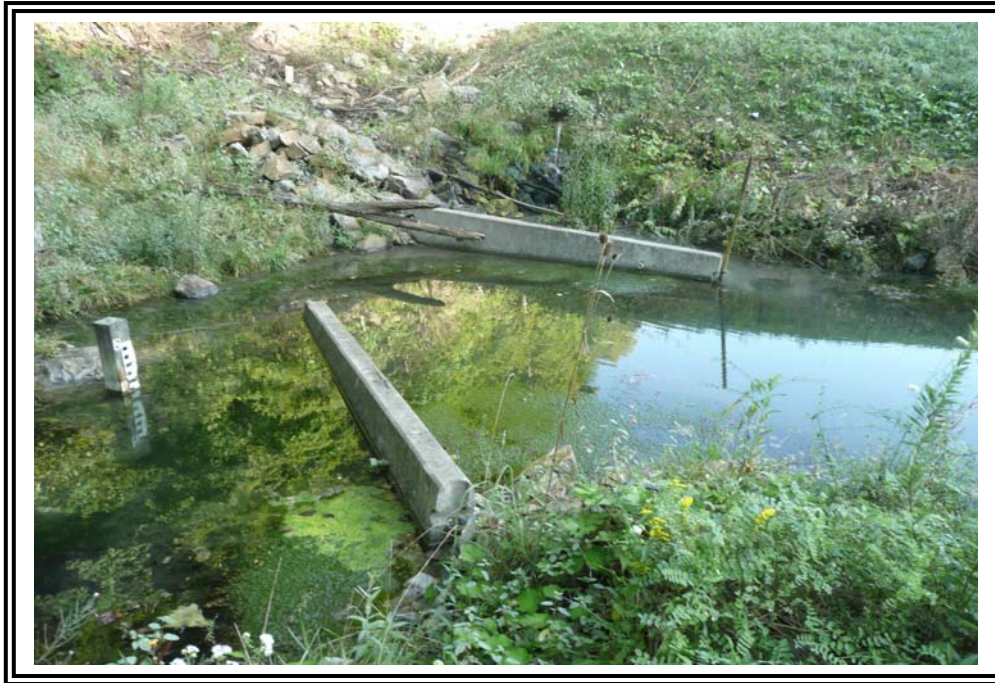
The toe drain is armored with 18-inch diameter rip rap, roughly 5 to 6 vertical feet of which is exposed at the slope toe (Photo 92). This toe terminates in a collection pool where additional drainage pipes actively convey water to the pool (Photos 93 and 94) which in turn empties into a

View of active toe drain discharge, seepage collection pool, and concrete baffles.

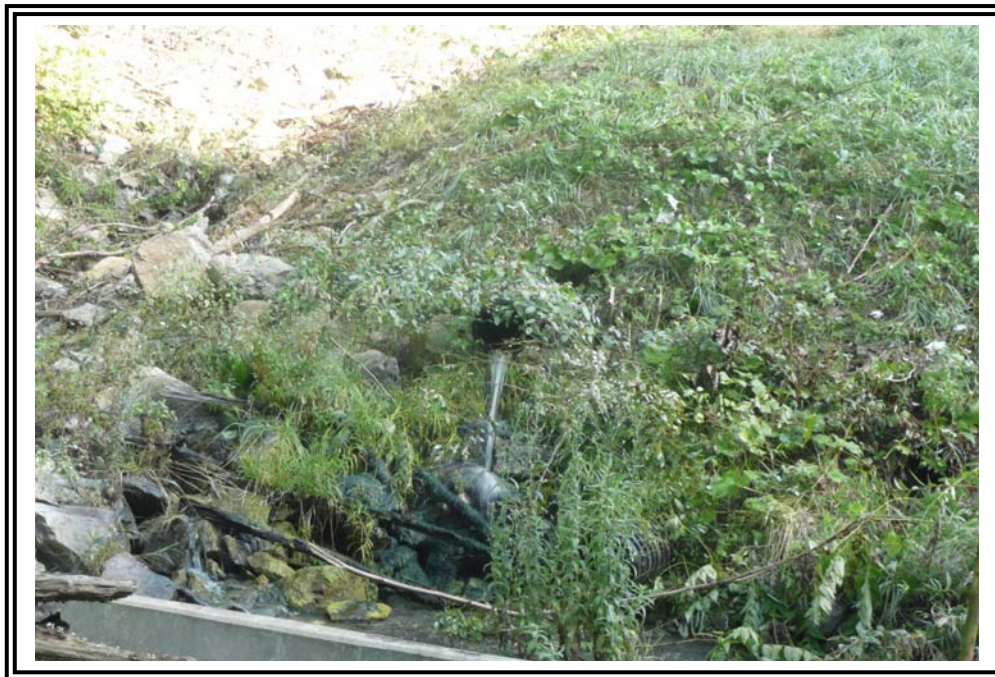
94

Closer view of seepage discharge.

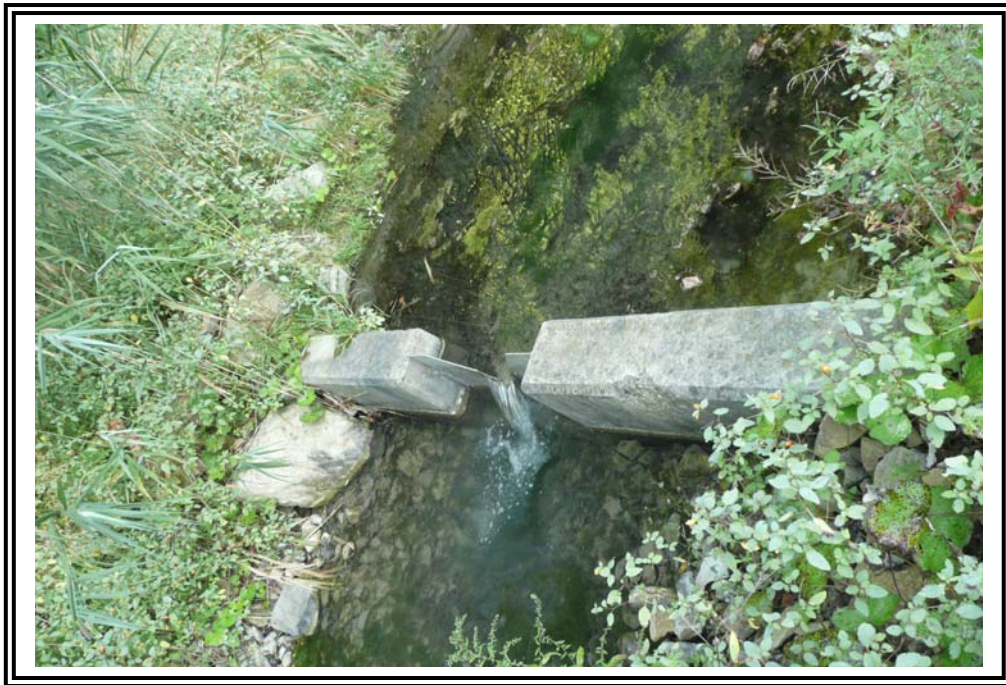
95

Concrete V-notch weir downstream of seepage collection pool.

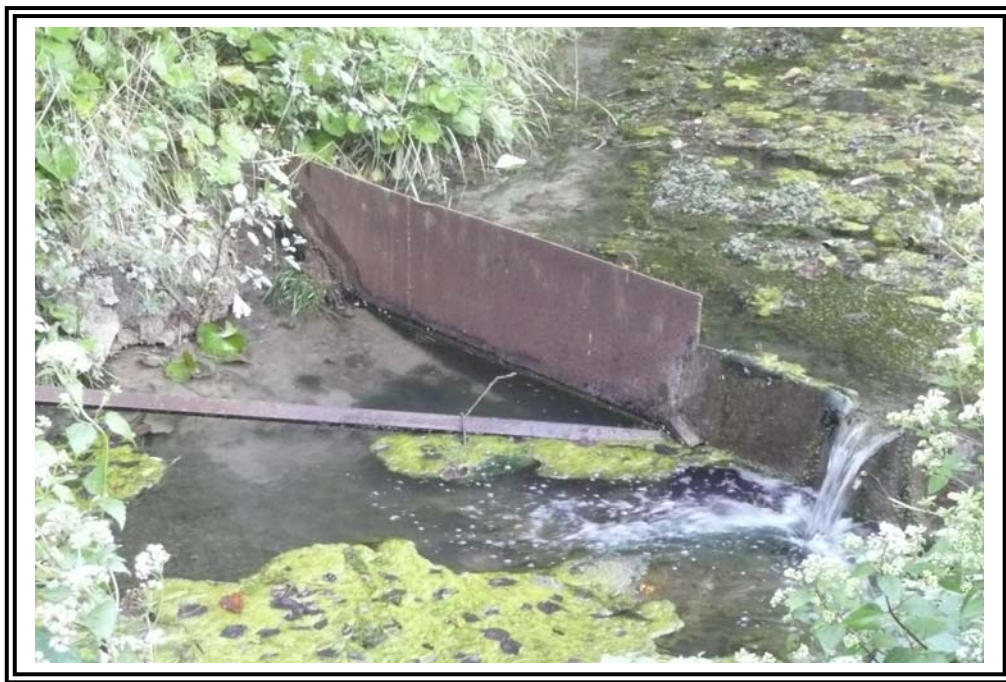
96

Steel V-Notch weir (typical) noted downstream of concrete weir shown in Photo #93.

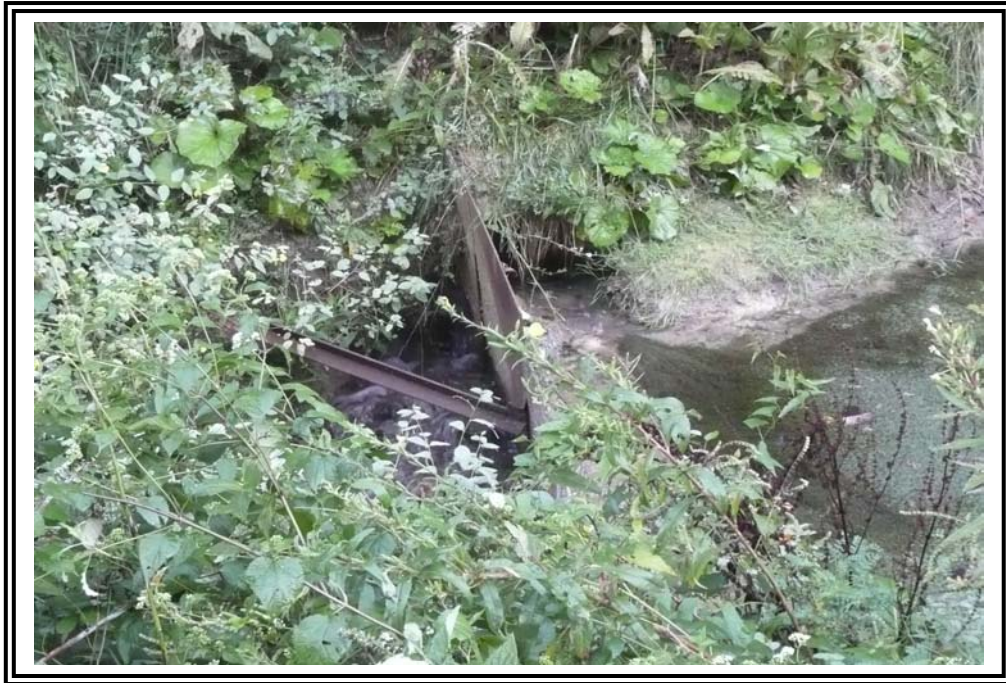
97

Ineffective steel V-notch weir where water flows along seepage path around weir.

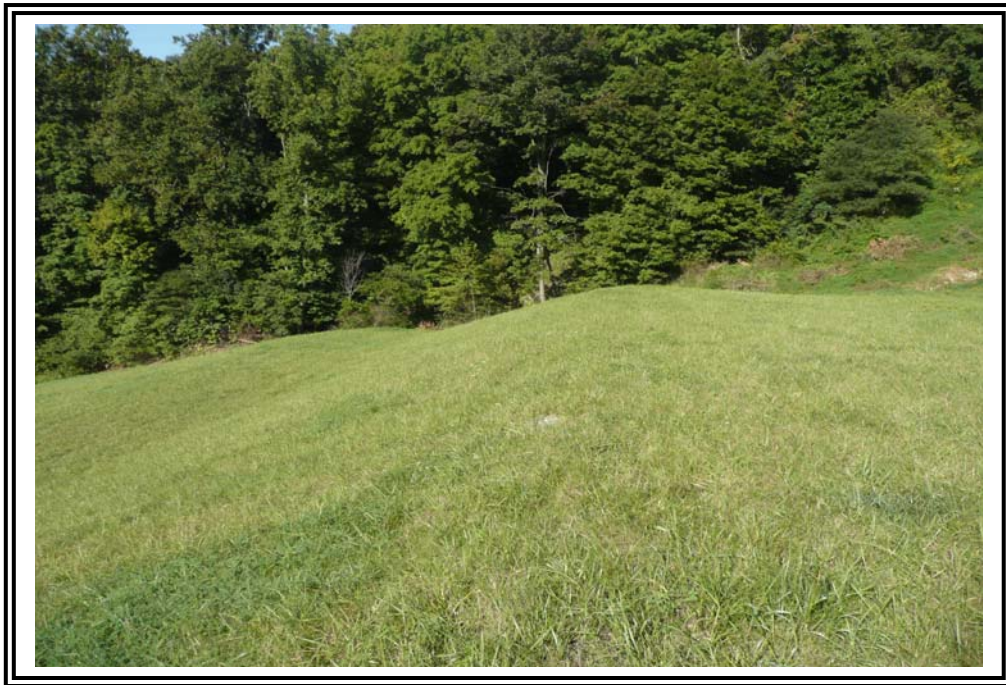
101

Downstream slope looking west at crest of upper bench.

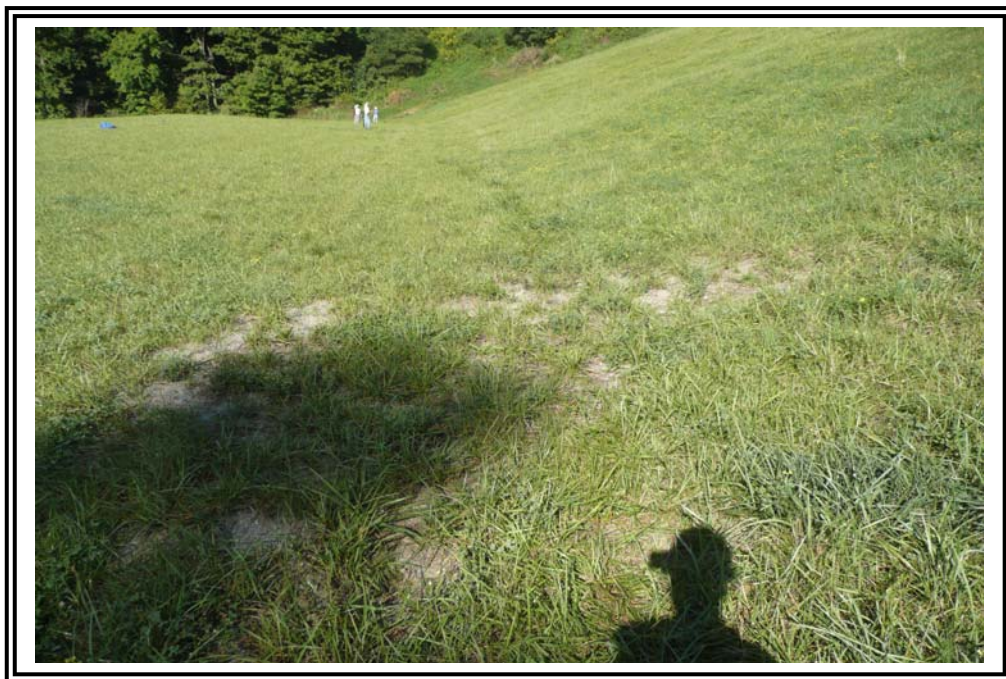
102

Sporadic loss of grass cover on upper bench adjacent to left (east) abutment.

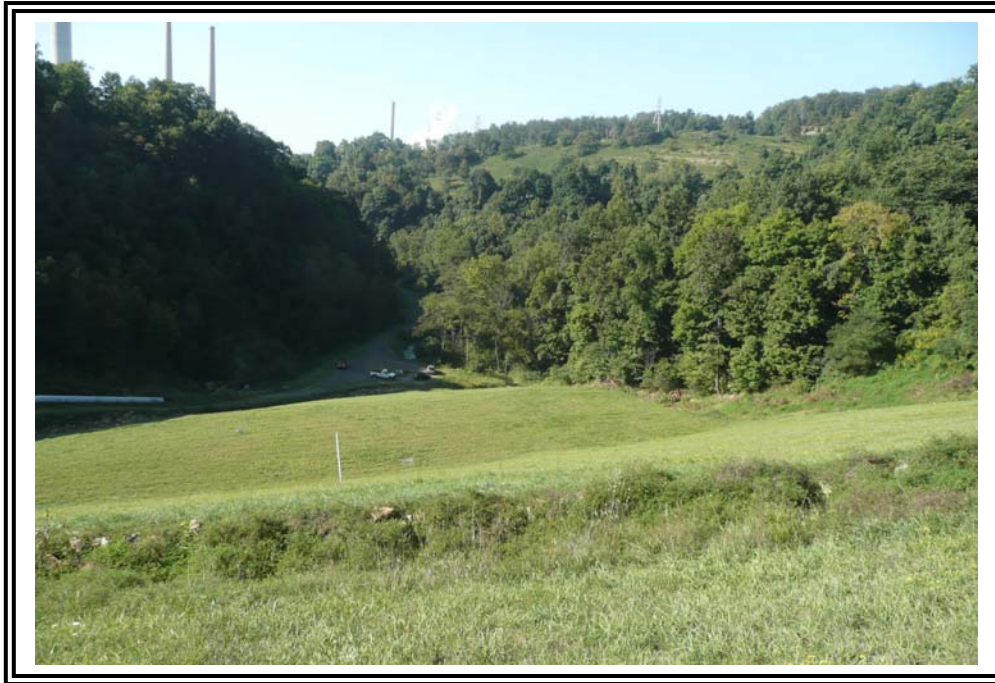
105

Another view of slope groin and general slope grass cover, looking downstream.
