**Coal Combustion Residue Impoundment
Round 9 - Dam Assessment Report**

*Clinch River Power Plant
Ash Pond Management Units
Appalachian Power
d/b/a American Electric Power
Carbo, VA*

Dewberry & Davis, LLC
Fairfax, Virginia

Under Contract Number: EP-09W001727
December 2011

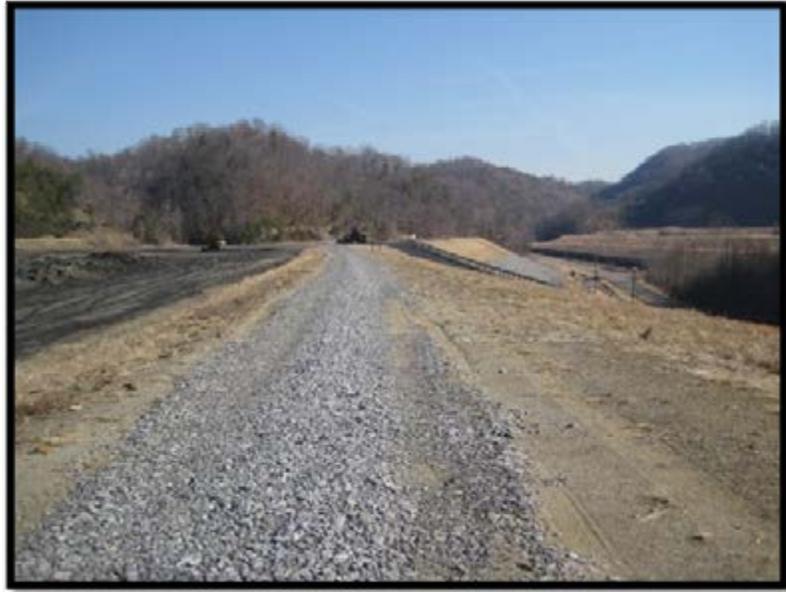
The crest of the perimeter dike had no significant signs of depressions, tension cracks or other indications of settlement or shear failure. Figure 5.2.1-1 and Figure 5.2.1-2 shows the typical crest conditions along the perimeter dike.

Figure 5.2.1-2: Crest, Northeast. Route 616 and railroad to right.

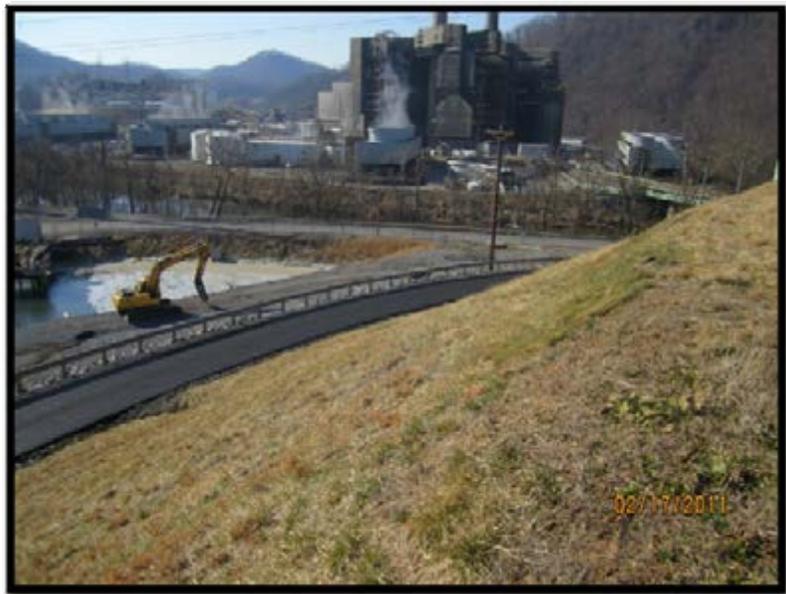
Figure 5.2.3-2: Downstream slope along paved access road, Southwest. Note reclaim beyond the toe of the perimeter dike.

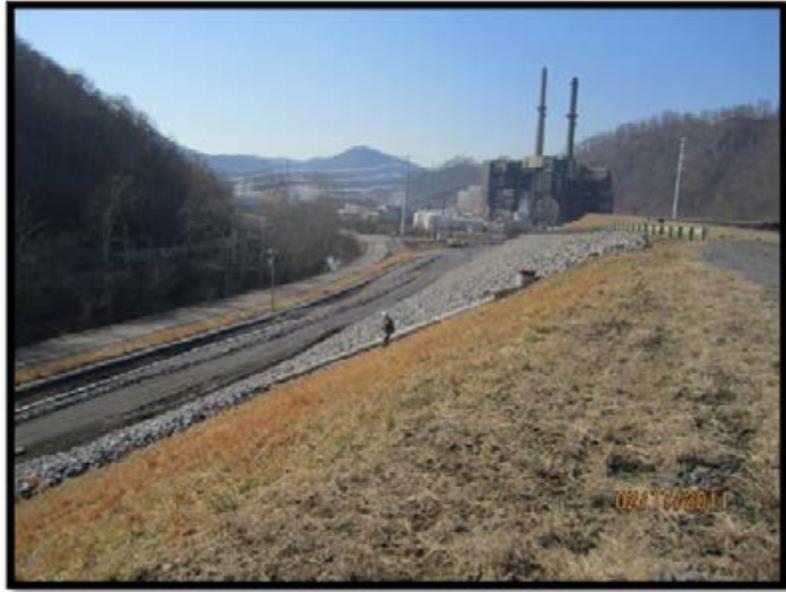
Figure 5.2.3-3: Downstream slope, Southwest. The embankment runs parallel to Route 616. Note transit pipes along edge of riprap. Transit pipes carry offsite runoff through the pond's splitter dike and out to Dumps Creek.

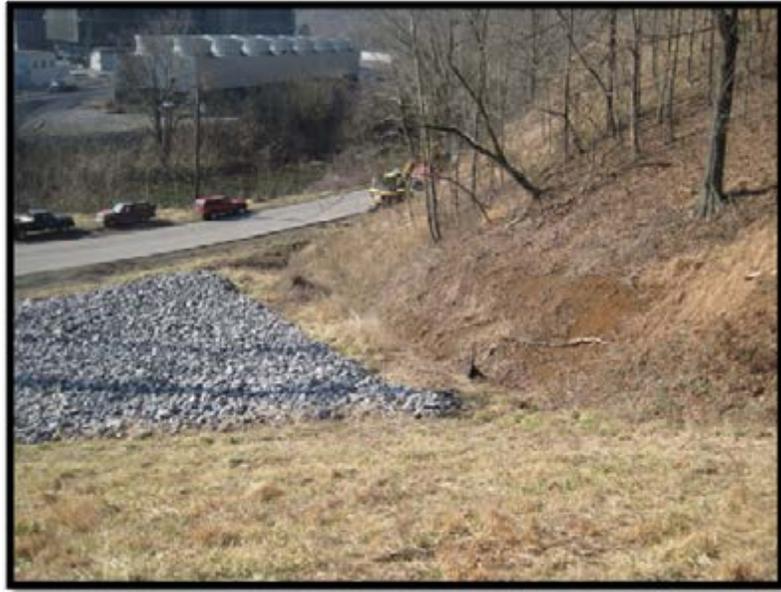
Figure 5.2.4-2: South abutment ditch. Note downstream slope rip-rap used for seepage control and abutment ditch used to convey hillside drainage.

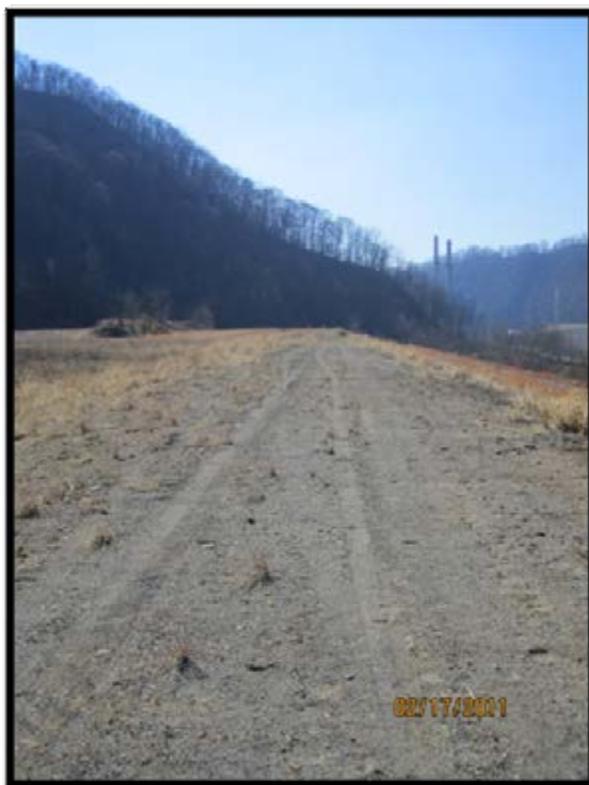
Portions of the upper dike have been removed and some re-grading has been completed near the crest of the middle dike. A small sized animal burrow was observed along the crest of the middle dike. No depressions, tension cracks or other indications of settlement or shear failure were observed on the crest of the middle or lower dike. Figure 5.3.1-1 and Figure 5.3.1-2 show typical crest conditions along the dike.

Figure 5.3.1-2: Middle dike crest, South.
Note removed portions of upper dike and re-grading near crest of the middle dike.

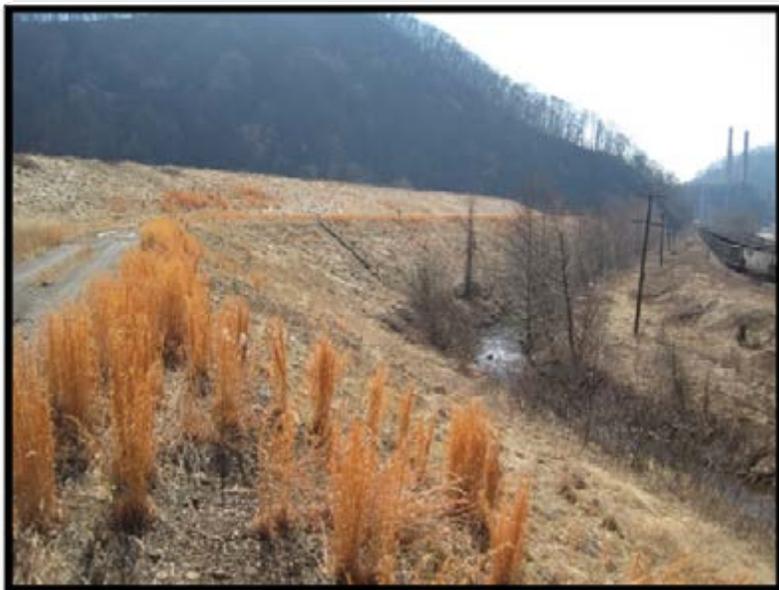
The downstream slopes of the dikes are covered in high grass/weeds. The upper dike had some areas of tree growth. Significant tree growth between the toe of the lower dike and Dumps Creek made visual observations difficult. Based on what could be observed there were no scarps, sloughs, bulging, cracks, depressions or other indications of slope instability along any portion of the dikes. Figures 5.3.3-1 thru 5.3.3-3 show representative sections of the downstream slopes and toe.

Figure 5.3.3-2: Downstream slope of lower dike, Southeast. Note significant tree growth along Dumps Creeks.

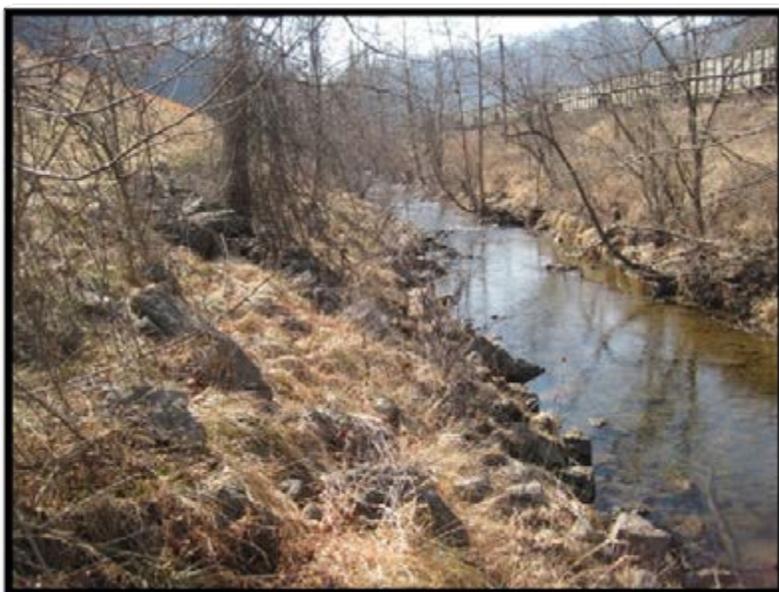
Figure 5.3.3-3: Downstream toe of lower dike. Note significant tree growth and rip-rap adjacent to Dumps Creek.

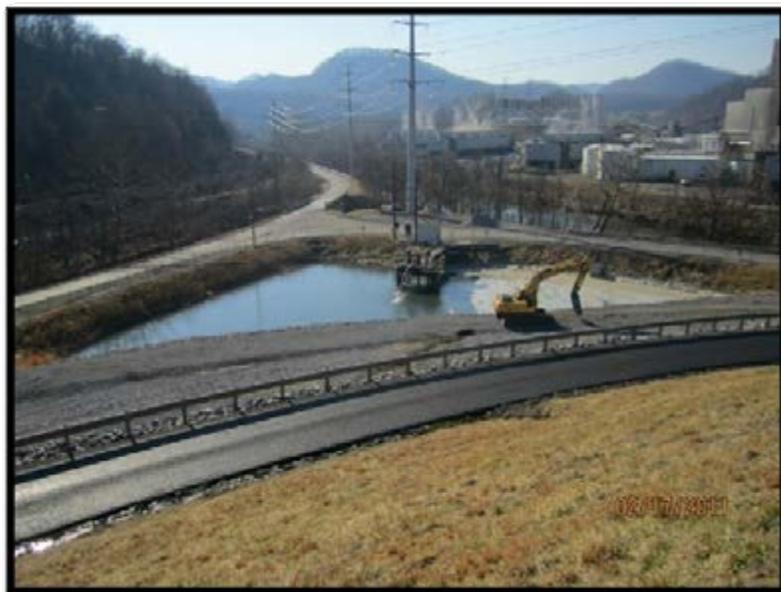
The spillway outlet conduit for Ash Pond 1 consists of a 36-inch reinforced concrete pipe leading to a catch basin that subsequently outfalls to a 30-inch reinforced concrete pipe that drains to the existing reclaim pond. The 30-inch outfall was not visible as it is completely submerged below the permanent pool of the reclaim pond (Figure 5.4.2-1).

Figure 5.4.2-1: Outlet conduit outfall, reclaim pond at intersection of Route 616 and 665.

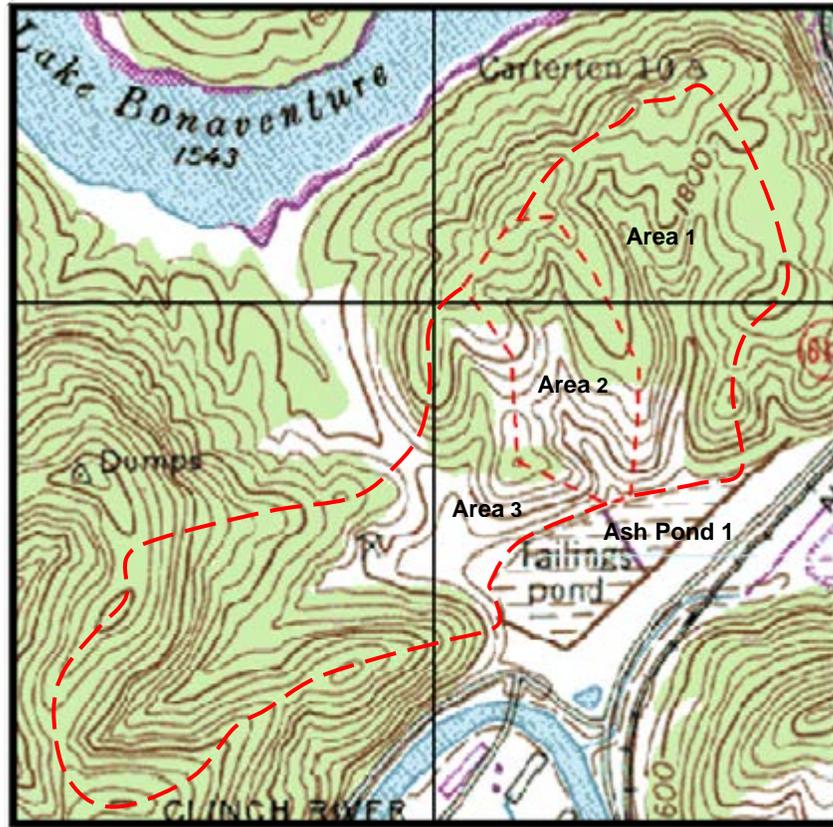
Figure 6.1.2-1: Offsite run-off draining to Ash Pond 1.

Virginia DCR DSFM plans in 2012 to direct the Owner to further investigate runoff control to and from these ash ponds (see Appendix A – Docs 16 and 17).

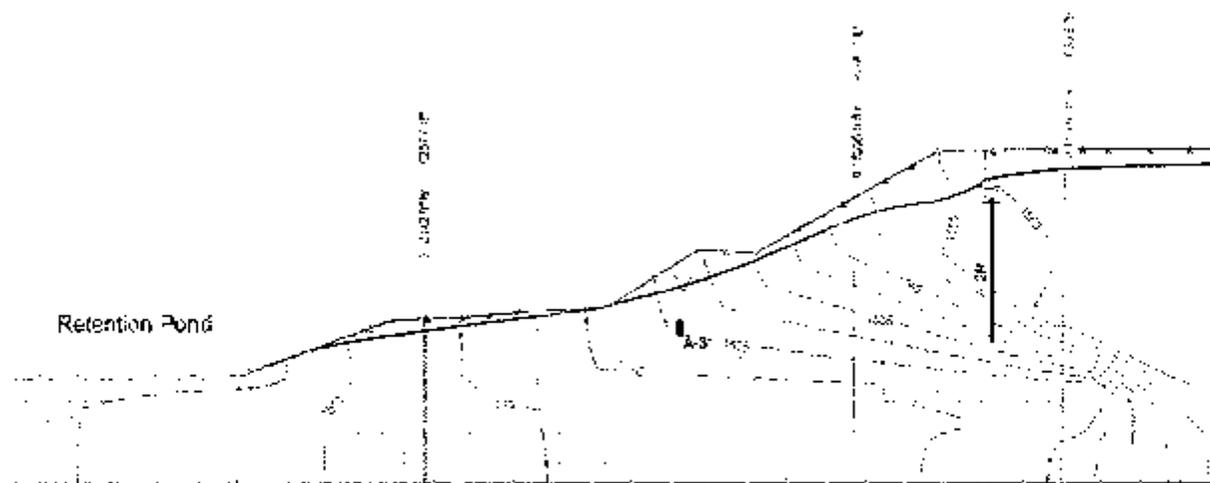
Figure 4. Computed total head distribution in Section A before construction of the cut-off wall.

Each analysis was performed in two stages. In stage one the pool levels were raised from the bottom of each pond to the operational pool levels without the cut-off wall, and in stage 2 the cut-off wall was activated by changing the material type of the elements that defined the wall. Figure 4 presents the computed total head distribution across Section A together with the seepage flow rates per unit length of the dike before the installation of the cut-off wall. The predicted phreatic surface can be seen to be in a reasonable agreement with the historical records of piezometer A-2 and A-3. To achieve such agreement the hydraulic conductivity of the outer shell was adjusted to 0.05 ft/hr. Depicted in Figure 5 are plots of historical readings of all the piezometers that are at or near Section A, including the piezometers installed in 2009. More information on the locations and screening depths of the piezometers has been included Appendix 3. The model predicts seepage at the toe that is confirmed by history of seepage and boils at this area of the dike. In general the model predictions are in reasonable agreement with the field observations and piezometric readings, indicating that the values of hydraulic conductivities and the boundary conditions used in the analysis were well selected.

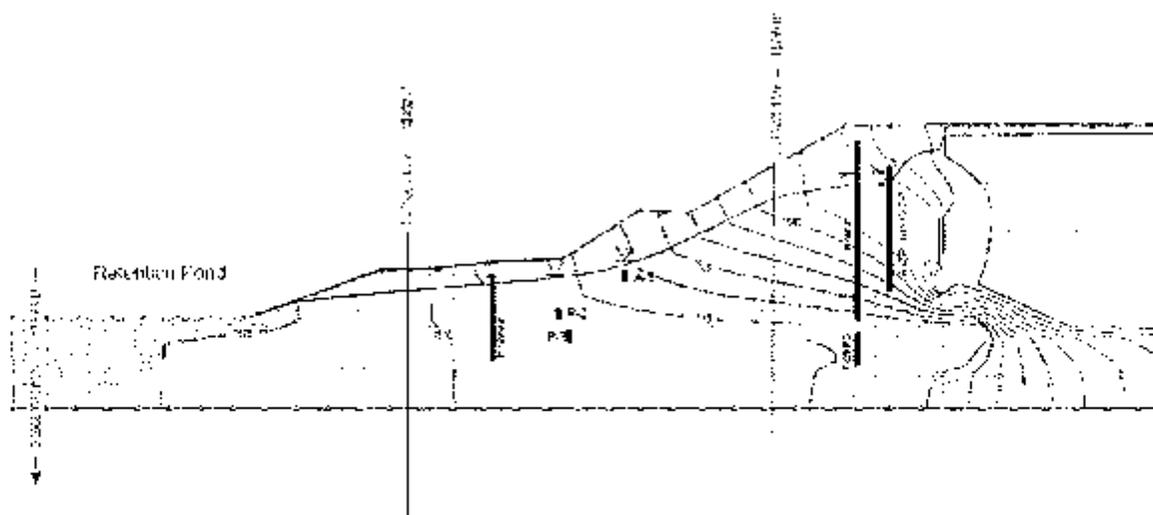
Figure 6. Computed total head distribution in Section A after construction of the cut-off wall.

Figure 6 shows similar results for the second stage of the analysis after the cut-off wall was activated. It can be seen that the computed phreatic surface is in reasonable agreement with the recorded piezometric water levels in piezometers P-0908S, P-0908D, and A-2R. Figure 7 shows the predicted hydraulic gradients (xy-gradient) at the toe and the retention pond. The maximum predicted gradient on the ground surface is about 0.3 that is within the acceptable range for this type of structure. The analysis showed that installation of the cut-off wall can lower the phreatic water levels and significantly decrease seepage flow rates through the embankment. These outcomes were expected and are consistent with field observations and monitoring data. The seepage analysis did not conclude any adverse condition that could be considered as a potential hazard to the safety and stability of the structure. The seepage areas that exist on the toe of the structure are, thereby, believed to be through permeable layers of the foundation soil, a normal phenomenon that occurs in majority of earthen structures and does not pose a threat on the stability. It has to be emphasized that this analysis is not a substitute for the regular inspections and monitoring program that is performed by the plant on quarterly basis. The inspection and monitoring program has to be continued and any unusual condition should be immediately reported to AEP Geotechnical Engineering.

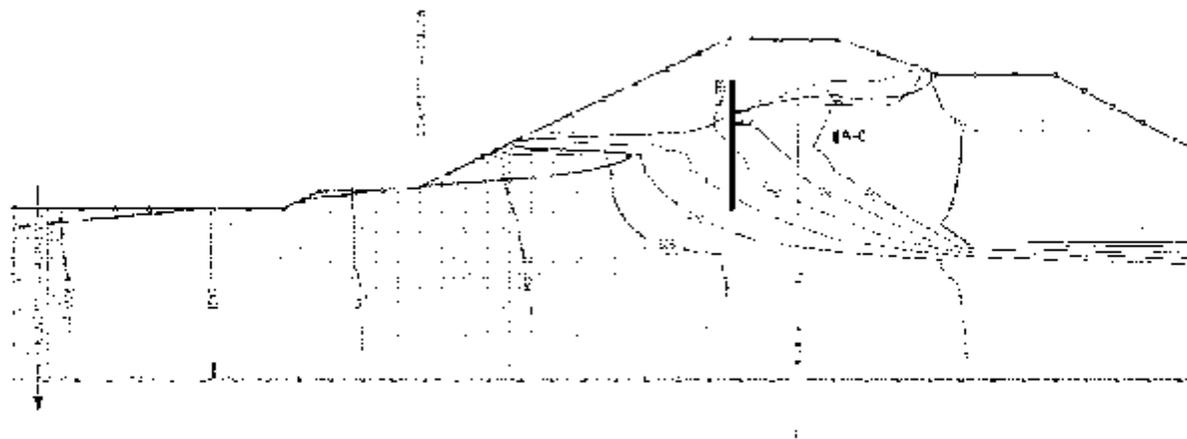
Figure 8. Computed total head distribution in Section B before installation of the cut-off wall.

For the portion of the dike that is represented by Section B, the reported seepage at elevation 1533 ft continued even after construction of the cut-off wall. Furthermore, the observed piezometric level on the downstream side of the wall from piezometer A-7R has been at about the same elevation (1533 ft) since the construction of the wall. Water elevations in the piezometer B-4R and P-0904 have been at (approximately) elevation 1542 ft and 1546 ft, respectively. These observations suggest that a relatively permeable horizontal layer exists at about elevation 1533 ft, which acts as a conduit to transfer water to the slope face. Such a structure could have been formed by segregation of fine and coarse portions of the shale rockfill during placement. A high permeable layer over a low permeable layer within the outer shell is incorporated into the analytical model of Section B, as depicted in Figure 2. Figure 8 shows the computed total head distribution across the cross-section of the dike along with the seepage flow rates per unit length of the dike. A saturated hydraulic conductivity of 0.05 ft/hr was used for the outer shell at this section. The computed water levels for piezometers A-6 and A-7R are in agreement with the recorded water levels that are marked on this figure and also presented in Figure 9. The readings from the piezometers varied with the pool level, however, the maximum water levels (Figure 9), most likely corresponding to the maximum experienced pool level, were used to back-calculate the hydraulic conductivity. The computed levels are within few feet of field observations.

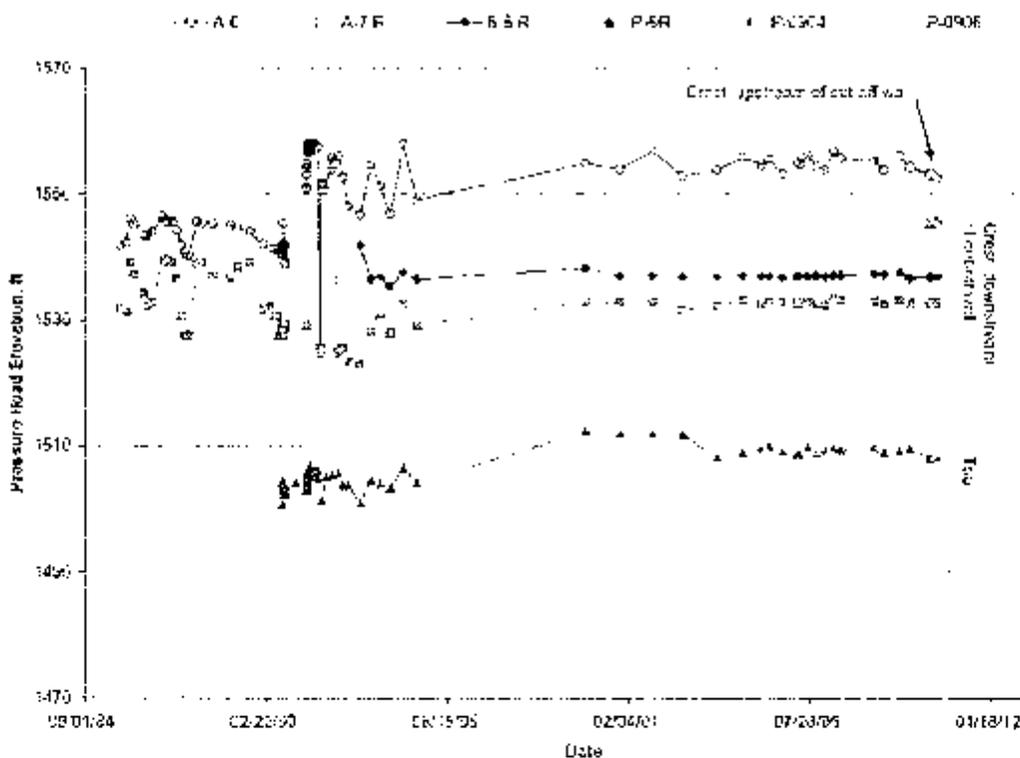
Figure 9. Historical piezometer records near Section B along with the readings from newly installed piezometers P-0904 and P-0905.

Figure 10 illustrates computed total head distribution across the section after construction of the cut-off wall. The model predicted a 5 ft raise in the piezometric levels on the upstream side of the wall and a 5 ft drop on the downstream side, presenting consistency with the readings from piezometers A-6 and A-7R. Furthermore, the computed phreatic water level is in agreement with the readings from piezometers P-0906, P-5 and P-0904. Piezometer B-5R, located in the crest of Pond 1B between Section B and Section C, have a water level of about 1537 ft since 1992 (Figure 9), that is within the predicted levels on the downstream side of the cut-off wall.

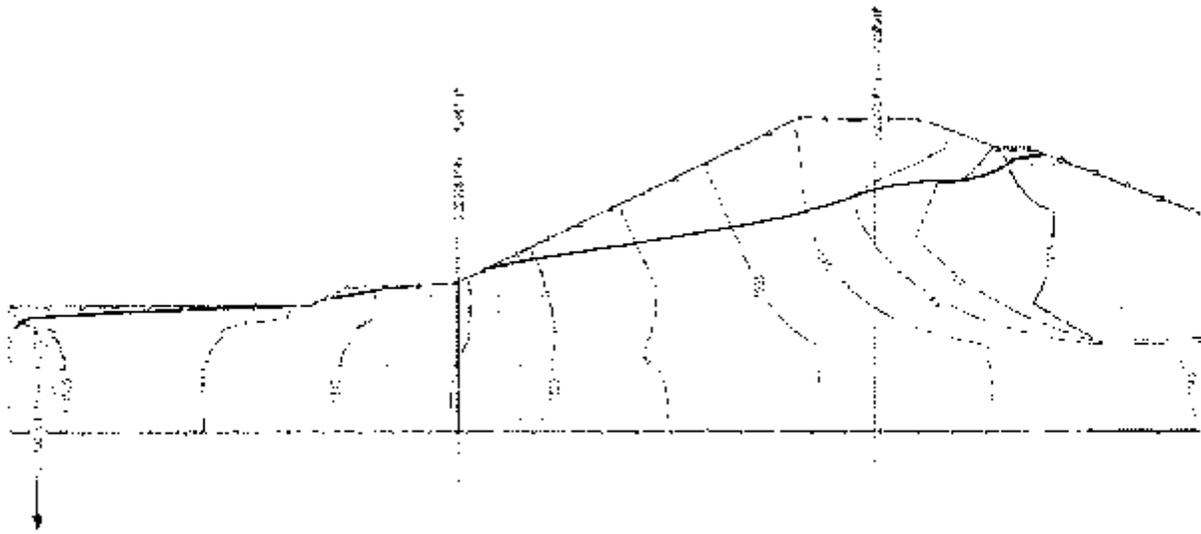
Figure 12. Computed total head distribution in Section C before installation of the cut-off wall.

A thin layer of ash on the slope of the original dike was not included in the seepage model for Section C, as analysis of Section A and B suggested a hydraulic conductivity of 0.05 ft/day for the outer shell that is very close to that of the compacted ash layer (0.08 ft/hr). Figure 12 shows the computed total head distribution across Section C before the construction of the cut-off wall. All the existing piezometers near this section were installed after the construction of the cut-off wall, thus no piezometric data are available to confirm the predicted phreatic surface. A hydraulic conductivity of 0.05 ft/hr back-calculated from analysis of Sections A and B was used for this section. The analysis predicts some seepage at the toe of the embankment before the construction of the cut-off wall, in agreement with the field observations made before 1991.

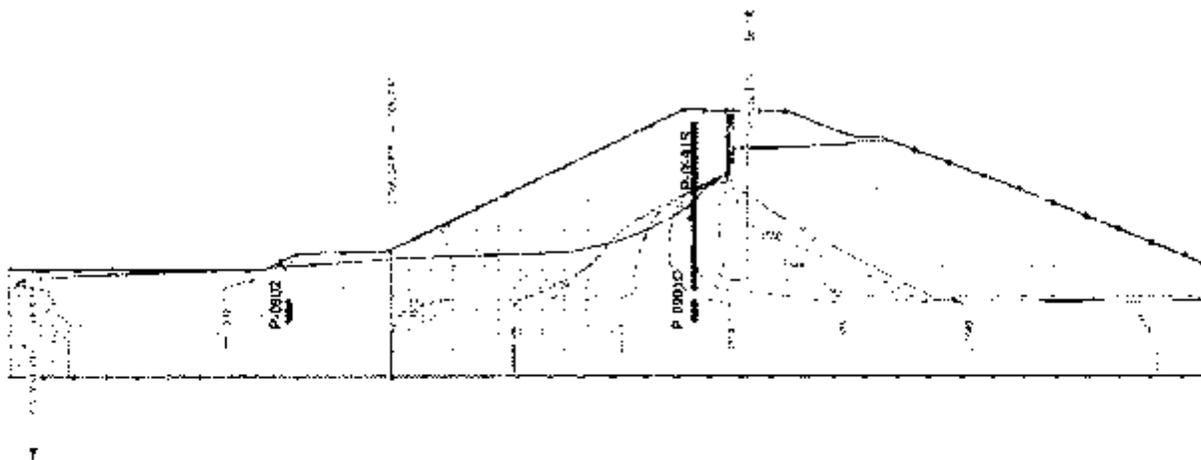
Figure 13. computed total head distribution in Section C after installation of the cut-off wall.

Figure 13 shows similar results for Section C after the construction of the cut-off wall. The predicted phreatic water levels are in agreement with the data from piezometers P-0901 and P-0902. Water level in Piezometer B-6 has not been shown on this figure because the screening depth of this piezometer is unknown. Figure 14 presents plots of recorded piezometric water levels for B-6, P-0901S, P-0901D, and P-0902. Figure 15 presents predicted hydraulic gradients at the toe of the section after construction of the cut-off wall. The maximum predicted gradient at the ground surface is about 0.2. No potential for piping failure due to internal erosion is believed to exist.

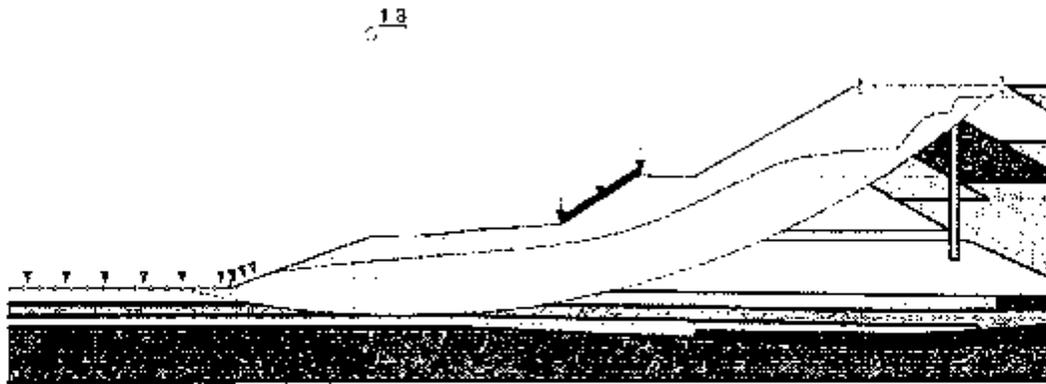
Figure 5.1. Stability of Section A under steady-state condition with a deep failure surface.

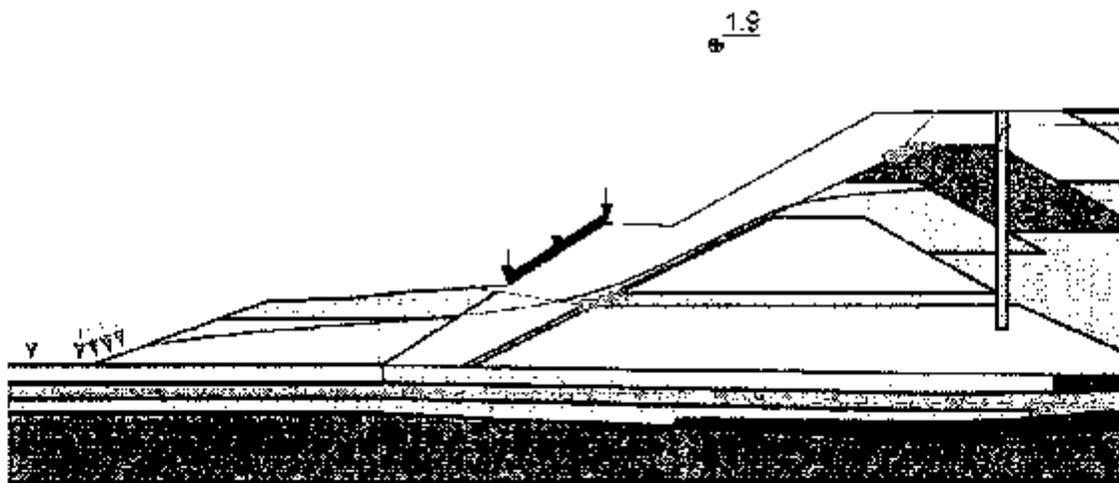
Figure 5.2. Stability of Section A under steady state seepage condition using block failure mode.

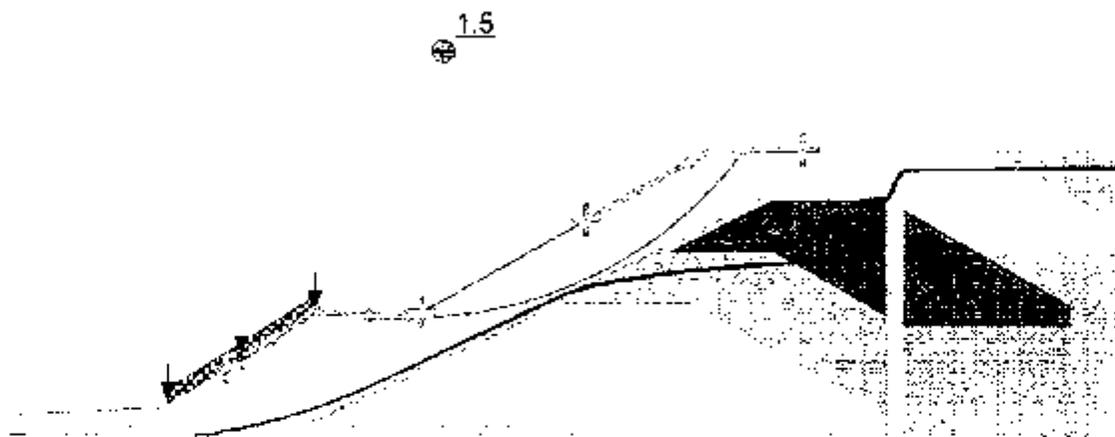
Figure 5.3. Stability of the outer shell of Section A under steady state seepage.

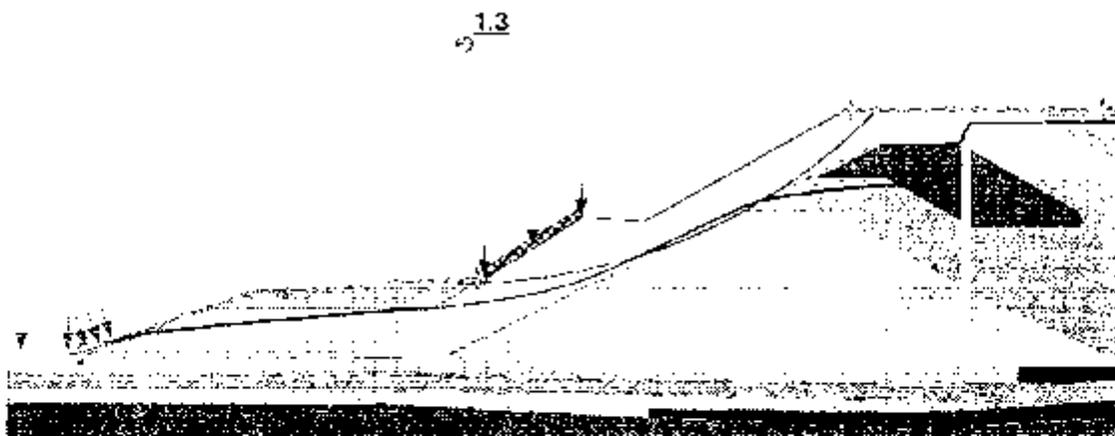
Figure 5.4. Critical failure surface and the corresponding factor of safety under seismic loading condition for Section A using drained material properties.

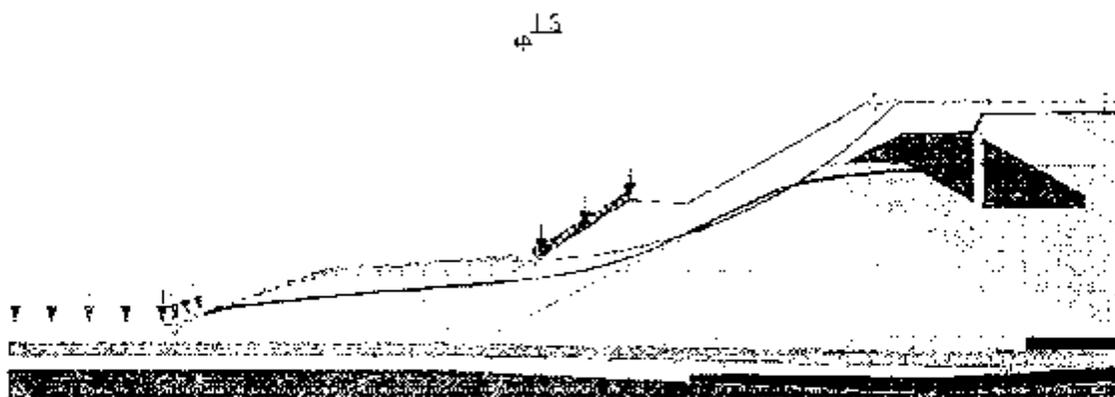
Figure 5.5. Critical failure surface and the corresponding factor of safety under seismic loading condition for Section A using consolidated undrained material properties.

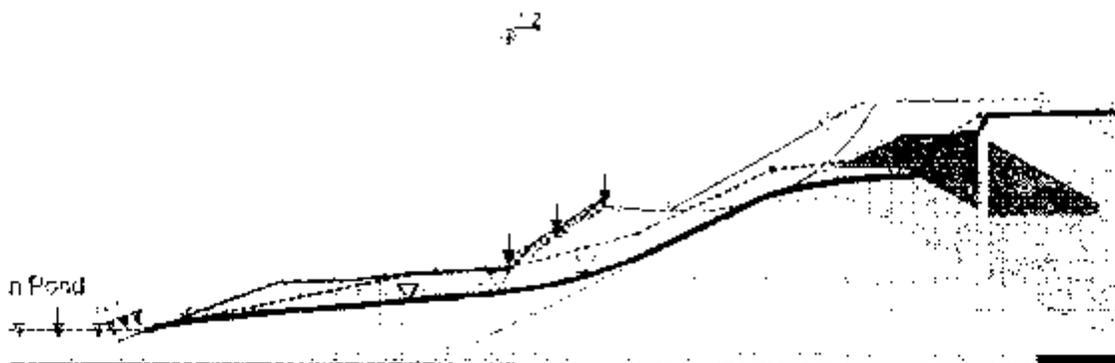
Figure 5.6. Stability of Section A after 7 ft raise in the piezometric water levels.

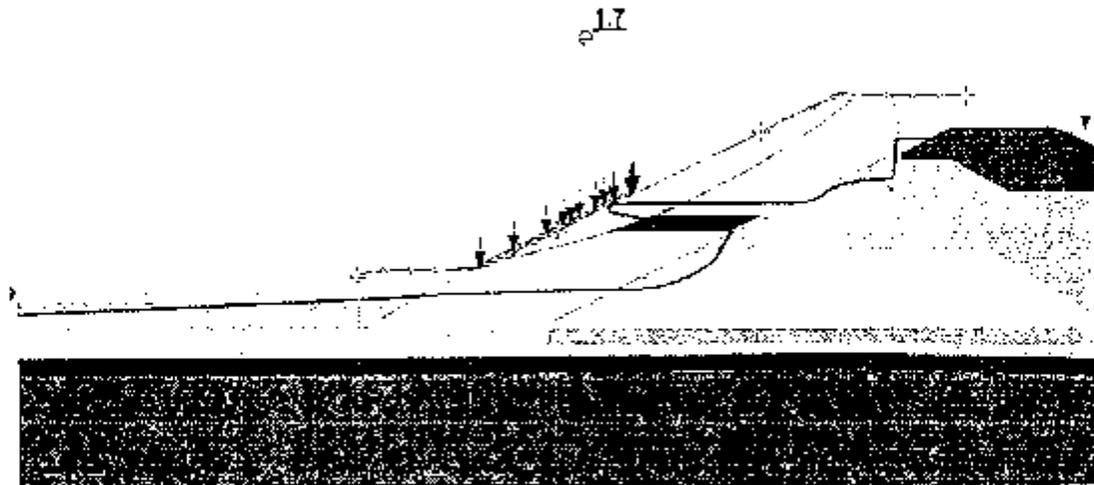
Figure 5.9. Stability of the outer shell of Section B under steady state seepage.

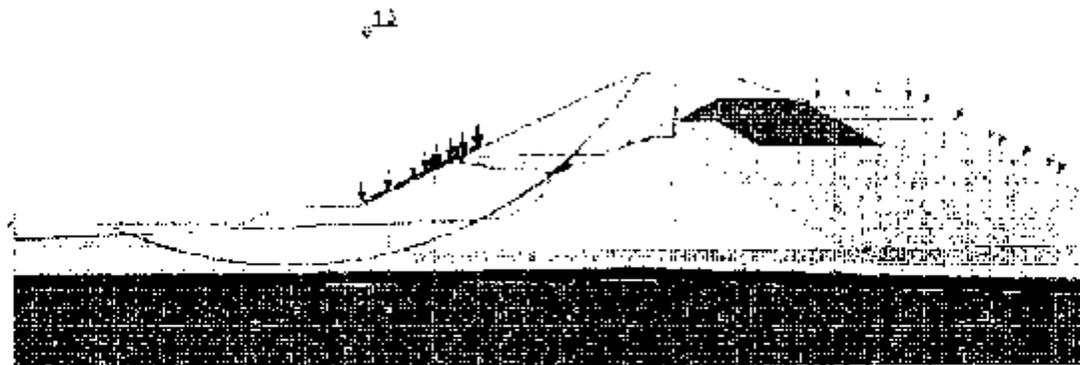
Figure 5.10. Stability analysis results of Section B under seismic loading using drained material properties.

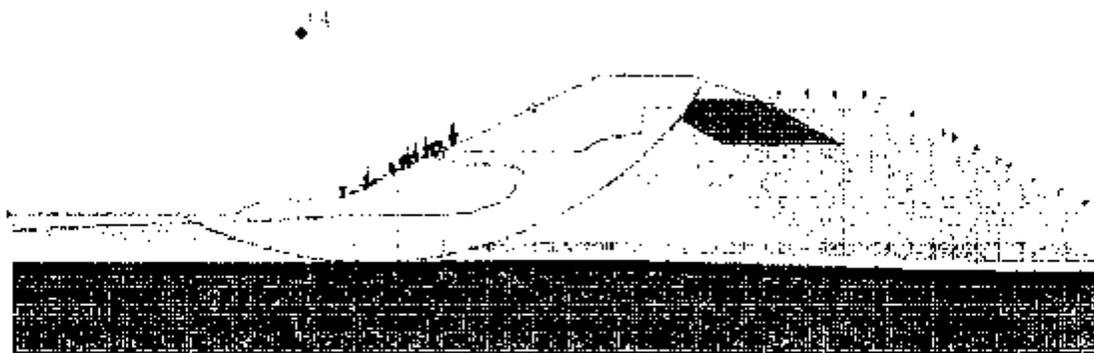
Figure 5.11. Stability analysis results of Section B under seismic loading using consolidated undrained material properties.

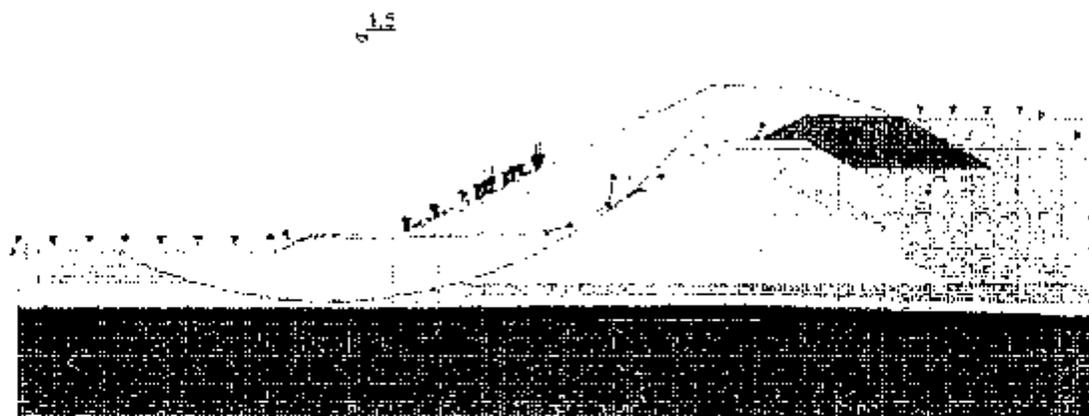
Figure 5.12. The warning water level for Section B was determined to be approximately 7 ft raise in the current piezometric levels.

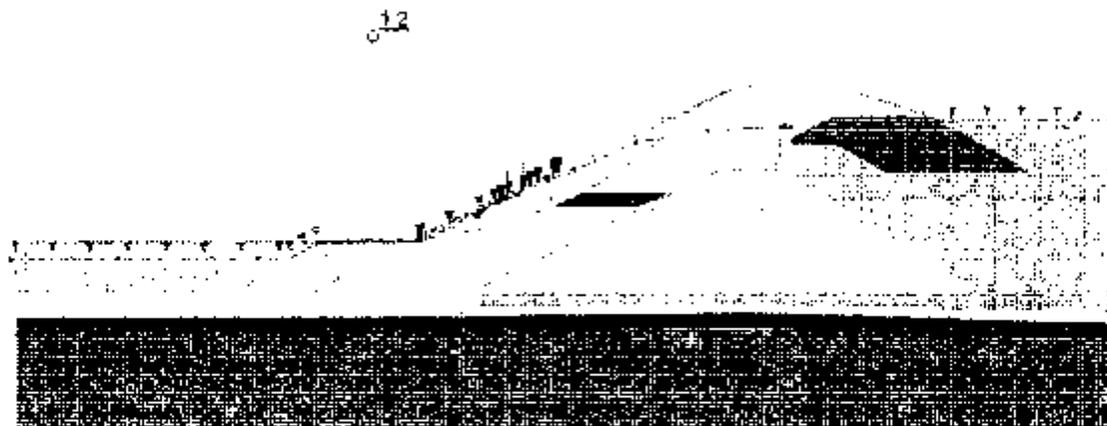
Figure 5.13. The critical water level for Section B is indicated by about 12 ft raise in the piezometric water levels at the crest or about 10 ft raise in the piezometric water levels at the toe.

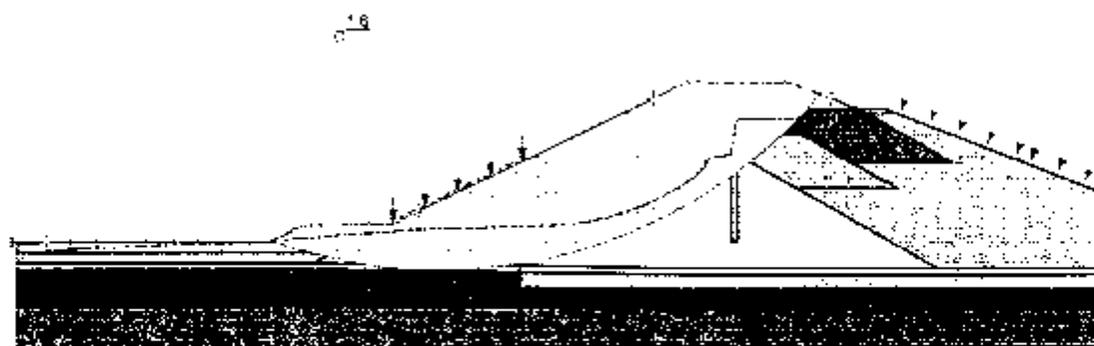
Figure 5.14. Stability of Section C under steady-state seepage condition with a deep failure surface.

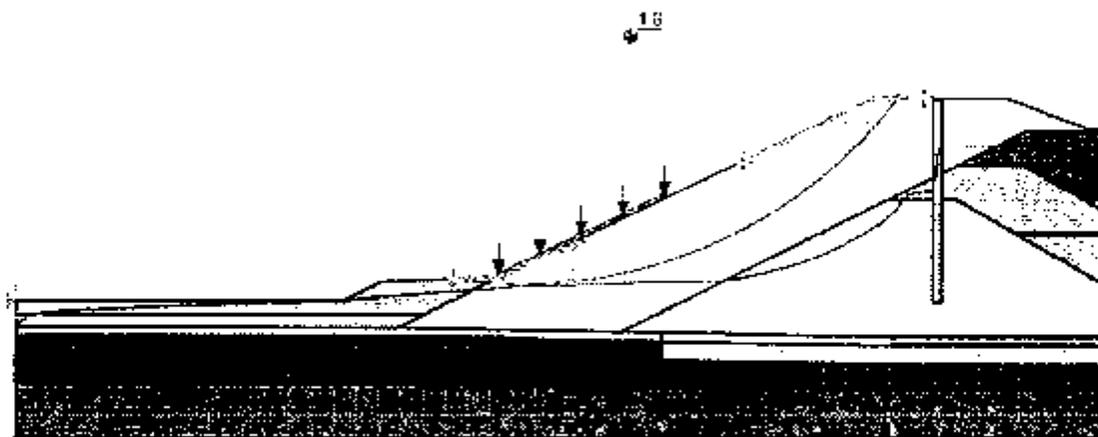
Figure 5.15. Stability of the outer shell of Section C under steady-state seepage condition.

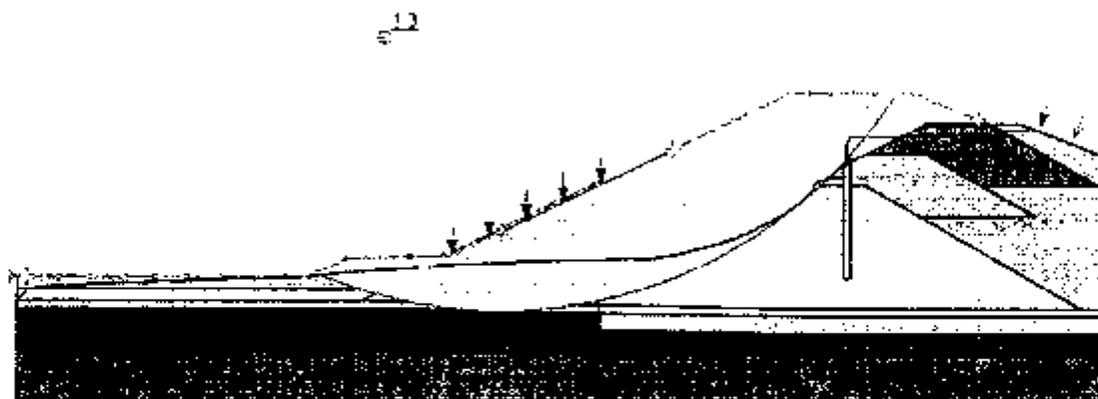
Figure 5.16. Stability of Section C under seismic loading condition using drained material shear strength.

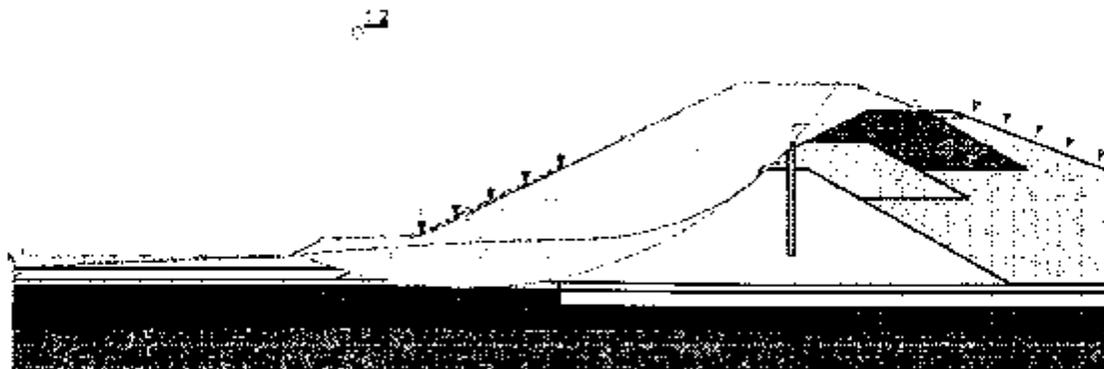
Figure 5.17. Stability of Section C under seismic loading condition using consolidated undrained shear strengths.

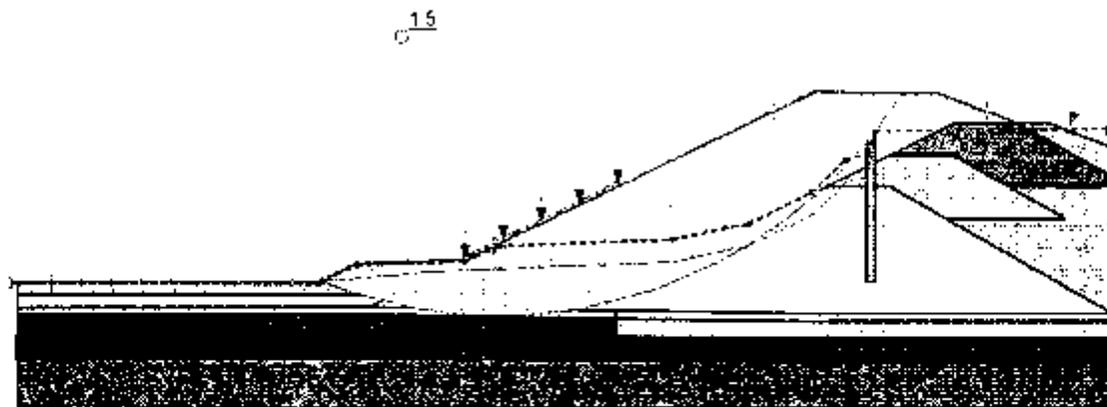
Figure 5.18. Stability analysis results for Section C after 7 ft increase of the phreatic water levels.

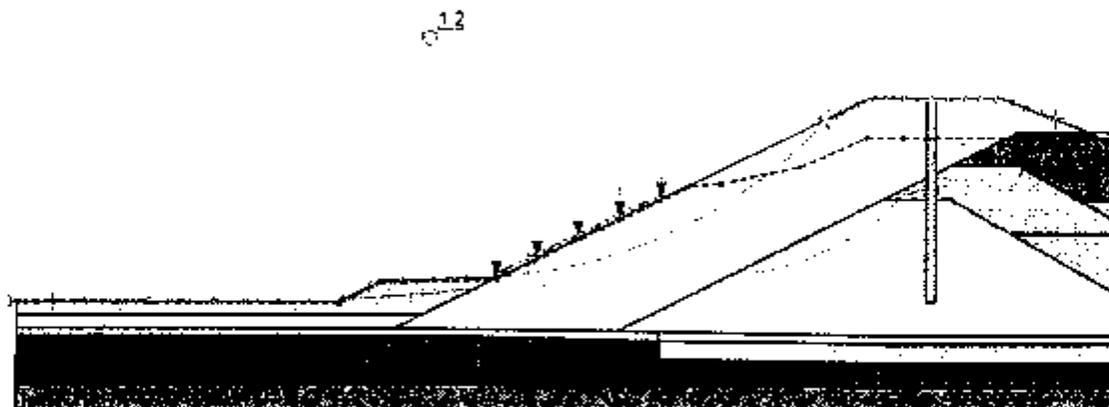
Figure 5.19. Stability analysis for Section C after 28 ft increase in the piezometric levels.

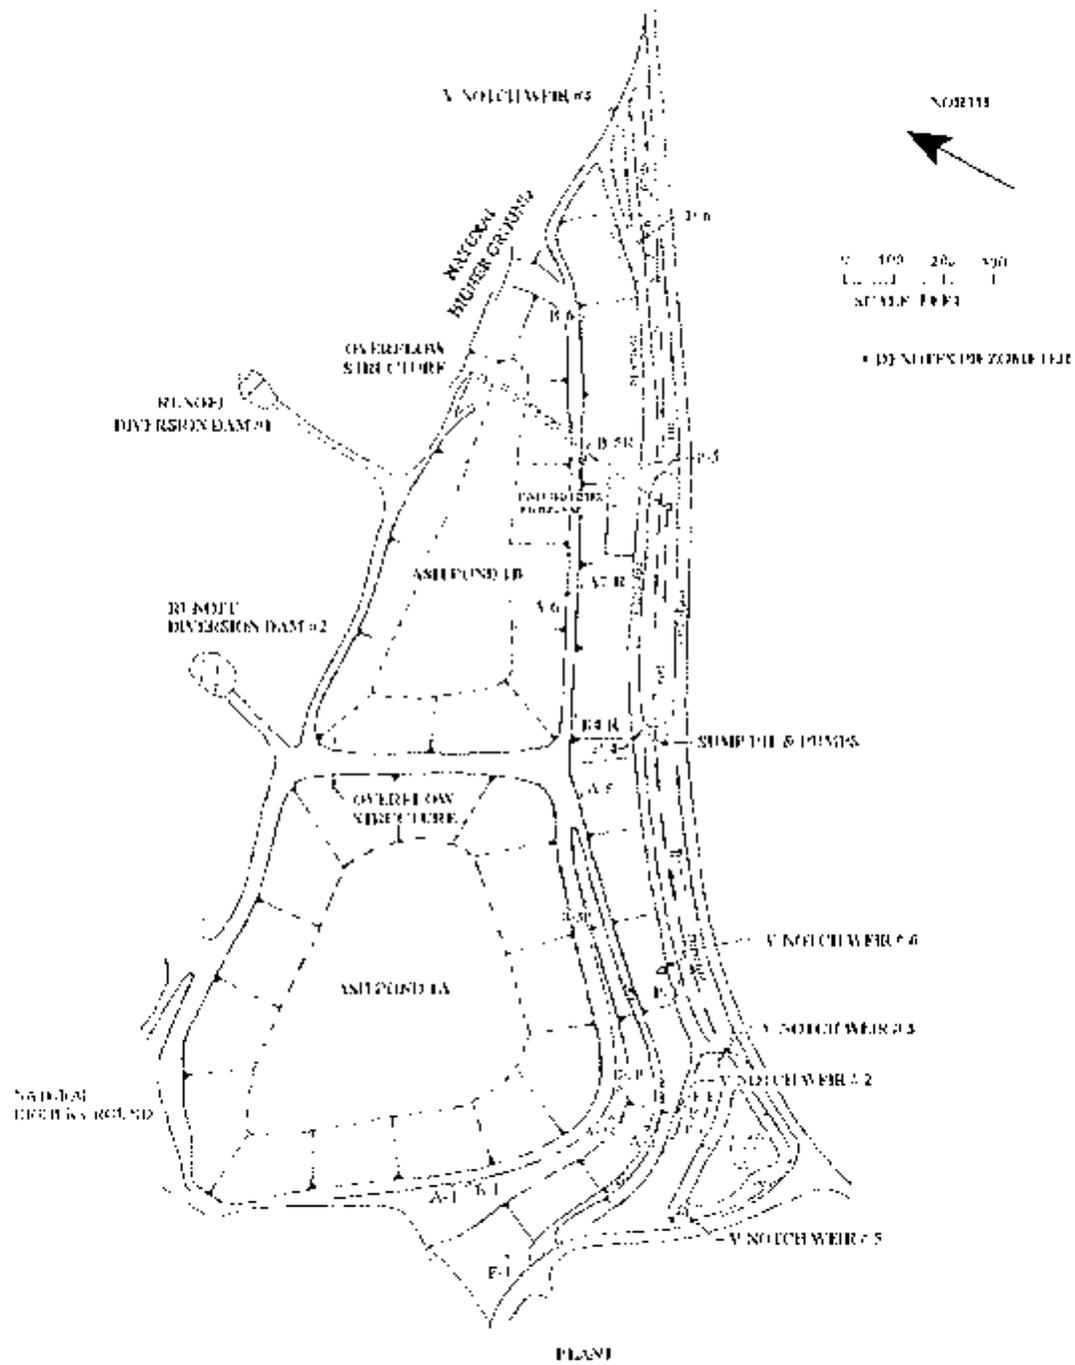
Figure 6. Piezometer location map

Twenty (20) piezometers located on or near the Ash Complex are being monitored by AEP. Locations of the piezometers are shown on figure 6. Figure 7 presents the measurements recorded by the plant since 1985. Measurements recorded by the Plant since 2005 appear similar and within their normal historic range. Piezometers at the dewatered Ash Pond 2 are not included in the current AEP monitoring program. Several new piezometers have been installed on or near the dikes of IA and IB ponds. Plant personnel should monitor these wells along with the other instrumentations.

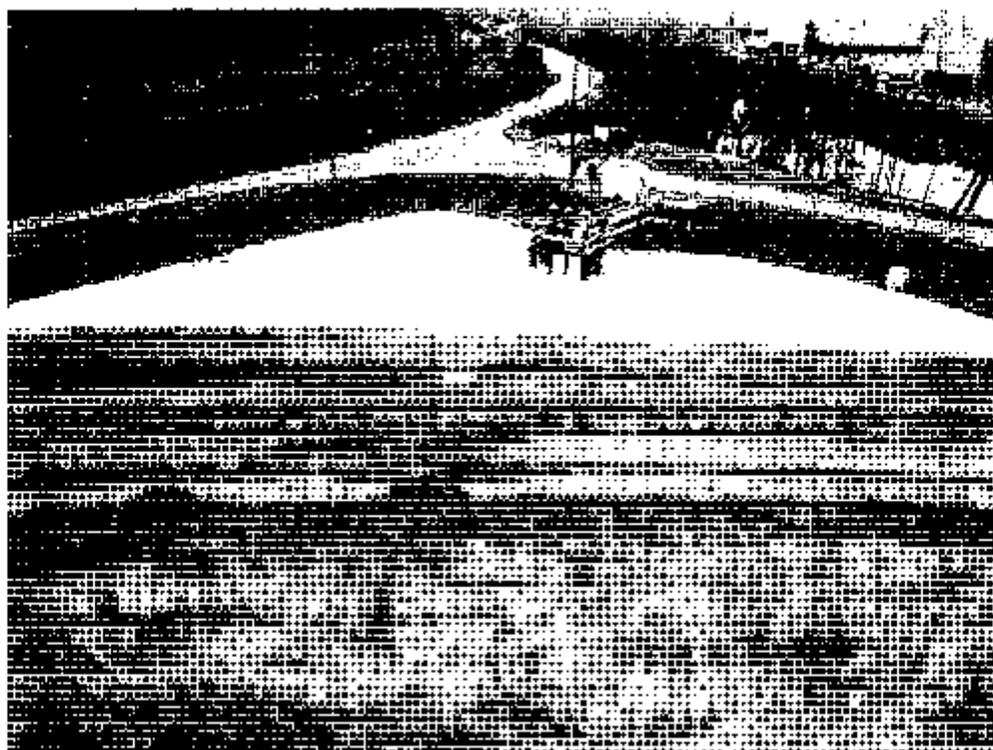
2. The V notch weir boxes referenced as Nos. 2, 3, and 5 were in fair condition. Clear water flow was discharging from all the weirs. Gray precipitate was observed on the downstream of weir box No. 3 (Photo 2), and at the bottom of all the weir boxes.
3. The surface of the Reclaim Pond was entirely covered with ctenospheres (Photo 3).

Photo 3. Reclaim Pond viewed from the crest of West LA dike

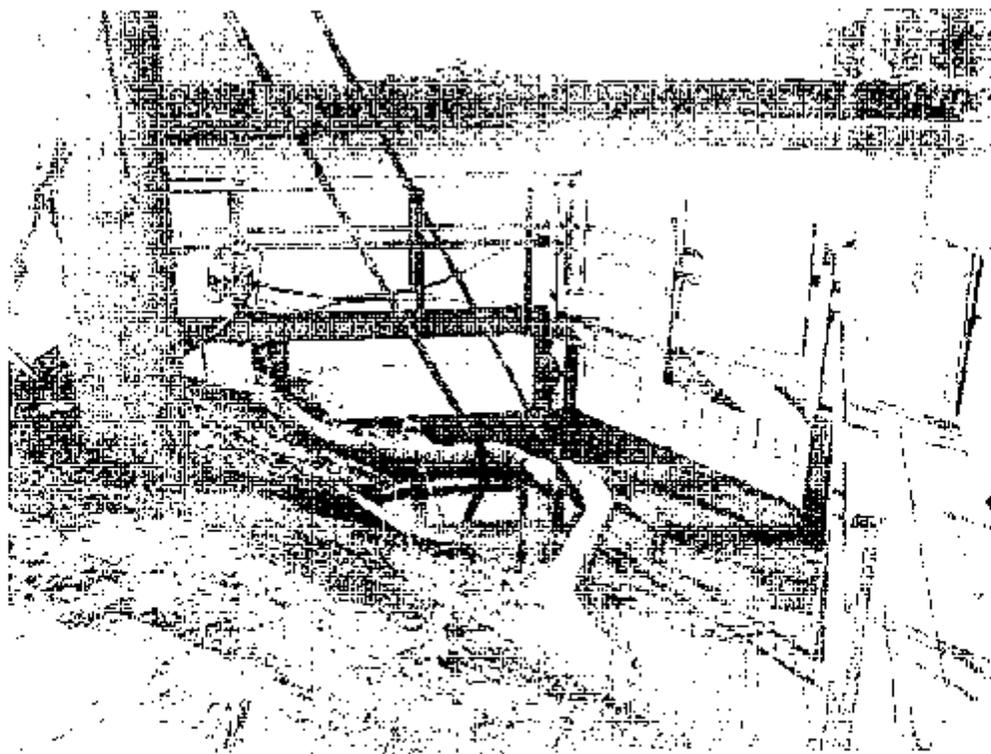
Photo 9. The overflow structure that discharges from IA to IB Ponds
