**Coal Combustion Residue Impoundment
Round 9 - Dam Assessment Report**

*Clinch River Power Plant
Ash Pond Management Units
Appalachian Power
d/b/a American Electric Power
Carbo, VA*

Dewberry & Davis, LLC
Fairfax, Virginia

Under Contract Number: EP-09W001727
December 2011

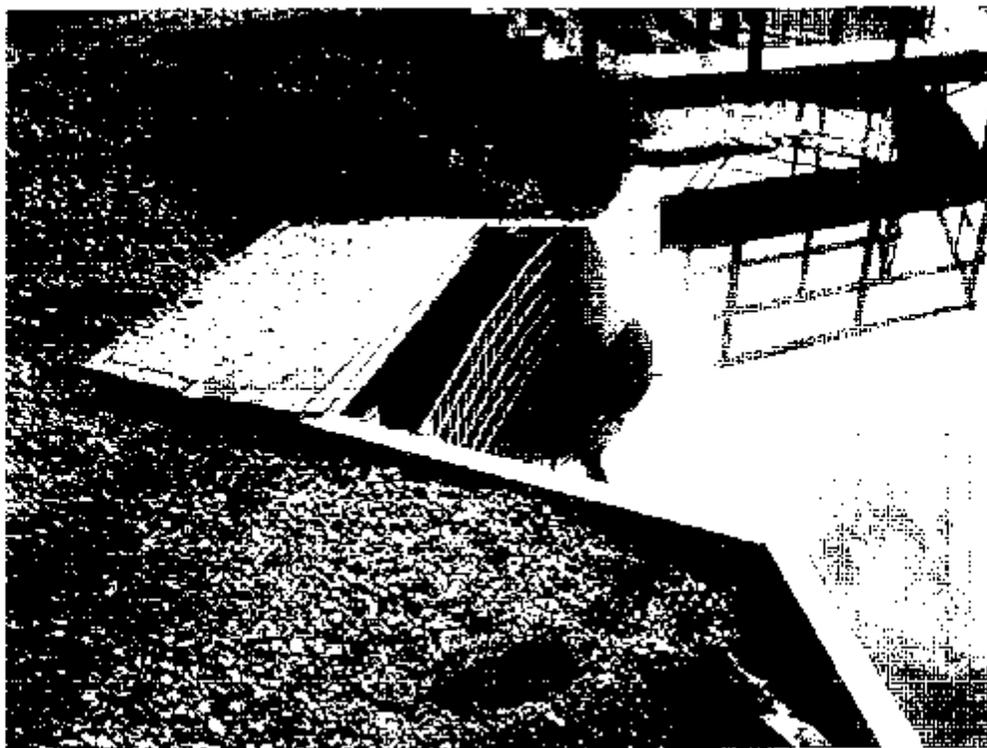
11. Two temporary spillway shafts have been installed to discharge the flow from 1A to 1B ponds to facilitate maintenance of the main spillway shaft. Photo 10 shows one of the new spillway shafts to the north of the overflow tower. The second shaft, located to the south of the overflow tower, has a higher invert elevation to pass discharge water from 1A to 1B ponds if the pool level increases to higher than normal levels during a storm event.

Photo 10. Inlet of the new spillway shaft from 1A to 1B ponds

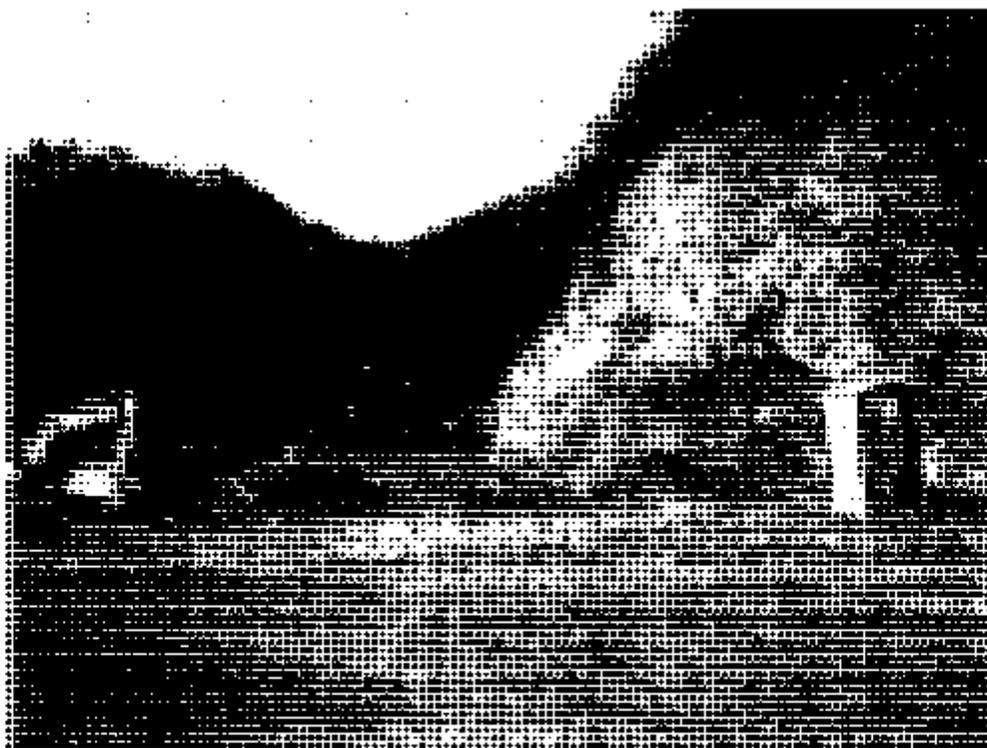
13. The rock slope on the northwest side of 1A pond appeared to be in stable condition. There was no visual indication of major cracks, rock deterioration, displacement, or instable rock blocks (Photo 11).

Photo 11. Rock slope on the northeast of 1A pond
