**Coal Combustion Residue Impoundment  
Round 9 - Dam Assessment Report**

*Northeastern 3 & 4 Station*

*Bottom Ash Basin*

*AEP Public Service Company of Oklahoma  
Oologah, Oklahoma*

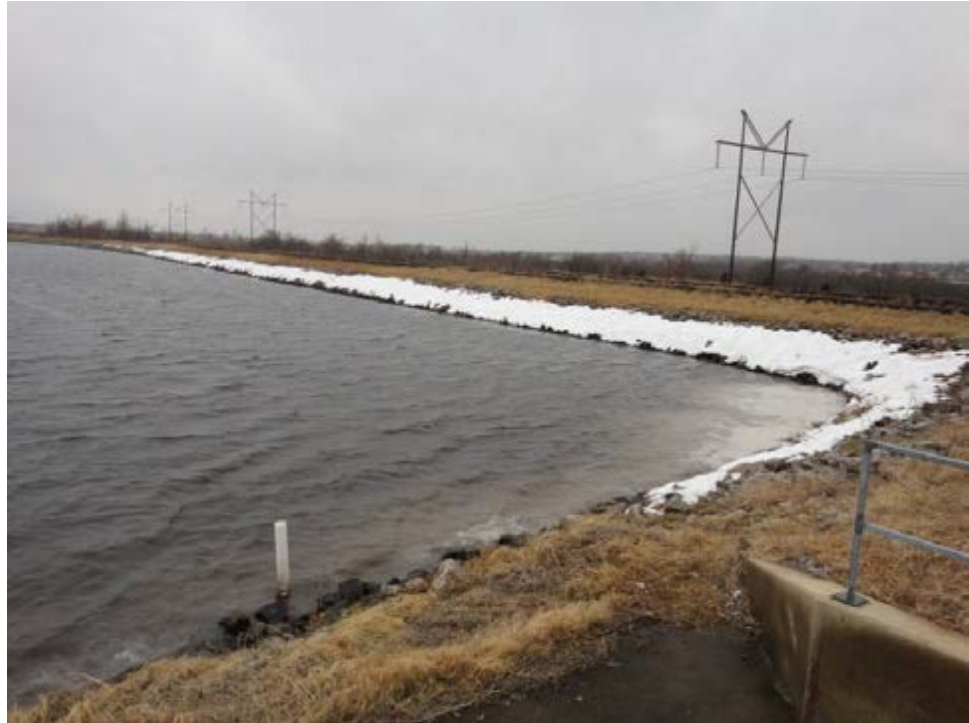
The impoundment's inside slope is generally grass covered, with the exception of the railroad track ballast and embankment slope riprap. Figures 5.2.1-1 and 5.2.2-1 shows these areas.

Figure 5.2.2-1. Inside slope grass and riprap

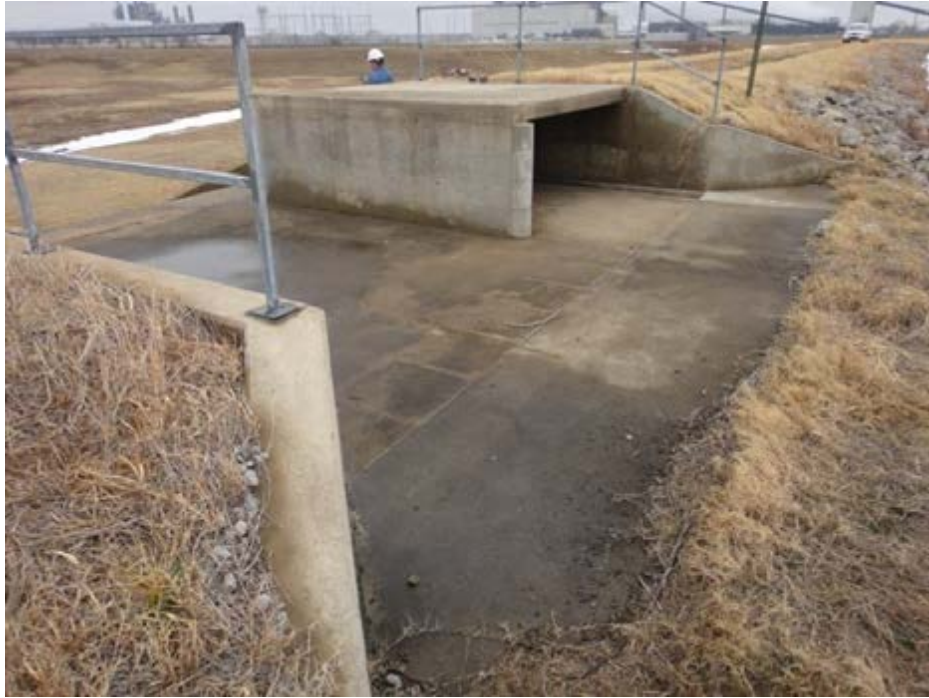
The Overflow Structure is detailed in the original design drawings (See Appendix A – Doc 9). The structure has a 24-foot wide opening. The crest elevation is 625.00. The downstream end of the structure has a rock riprap area 10 feet long by 35 feet wide. There was no sign of debris on /in the structure and it is anticipated that the structure will operate as designed when/if the need arises. Doc. 9 and 10 in Appendix A shows the Overflow Structure.

Figure 5.5.1-1. Inlet end of the Overflow Structure.

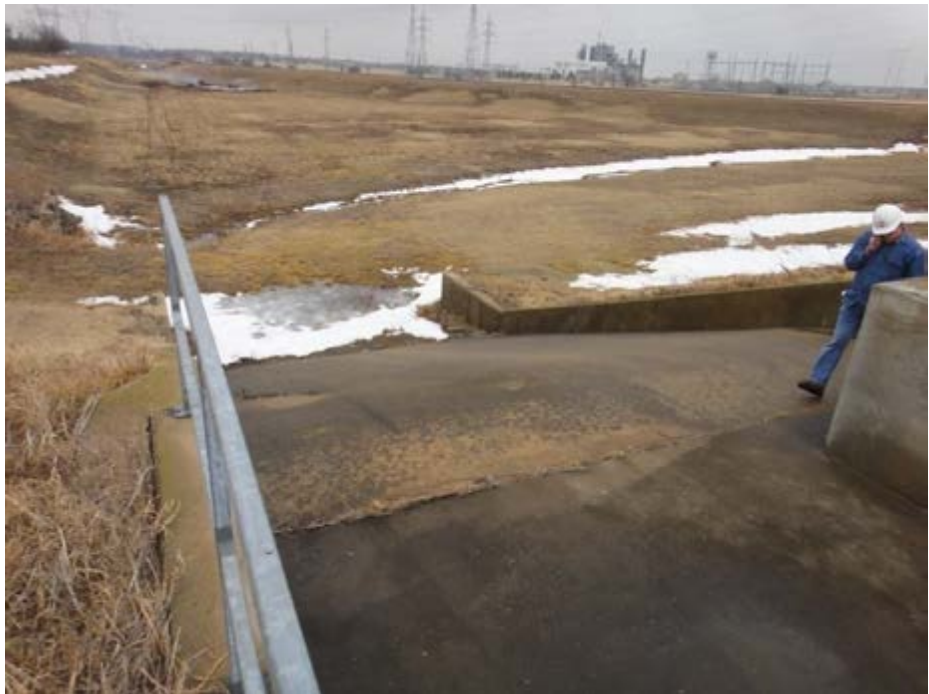
Figure 5.5.1-2. Downstream view of Overflow Structure.

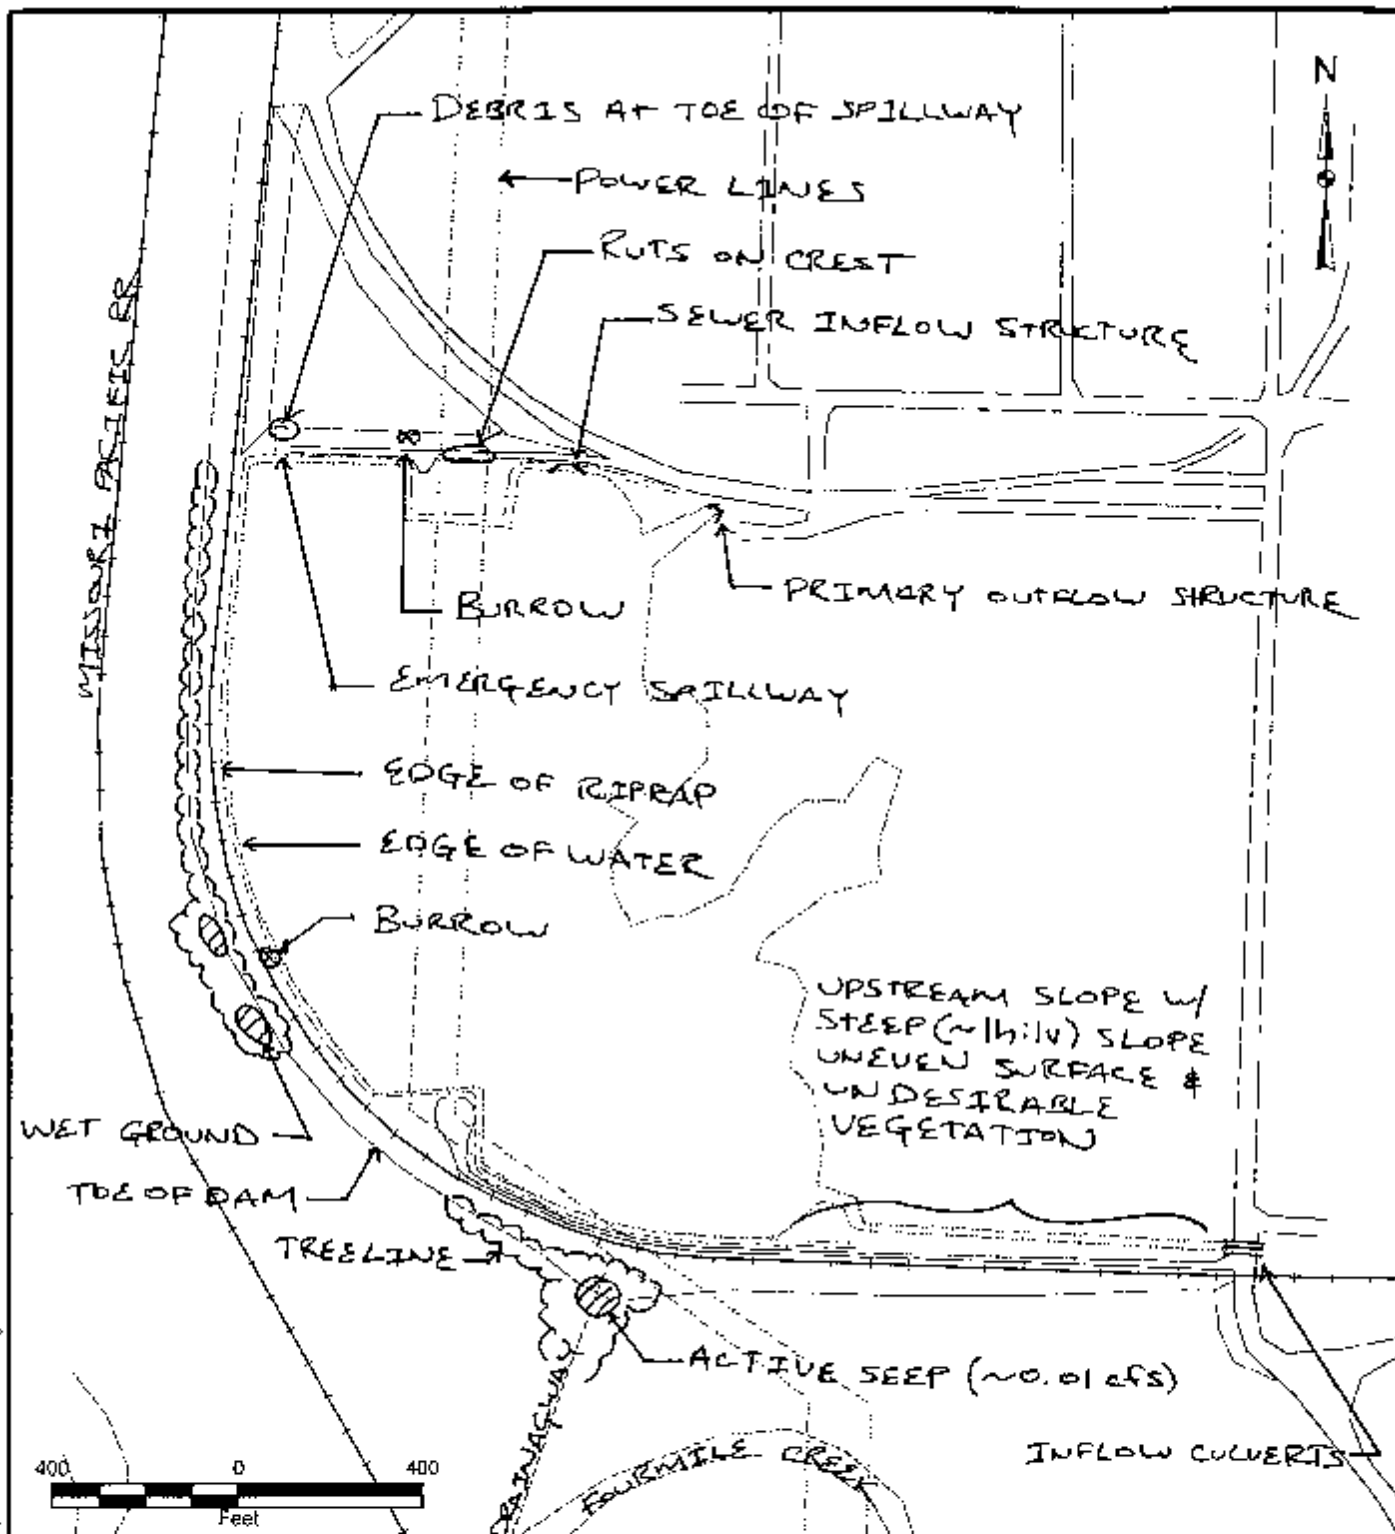
- ⊗ - BURROW > 6"  $\phi$ . MANY SMALLER BURROWS (< 6"  $\phi$ ) ARE SCATTERED THROUGHOUT SITE.

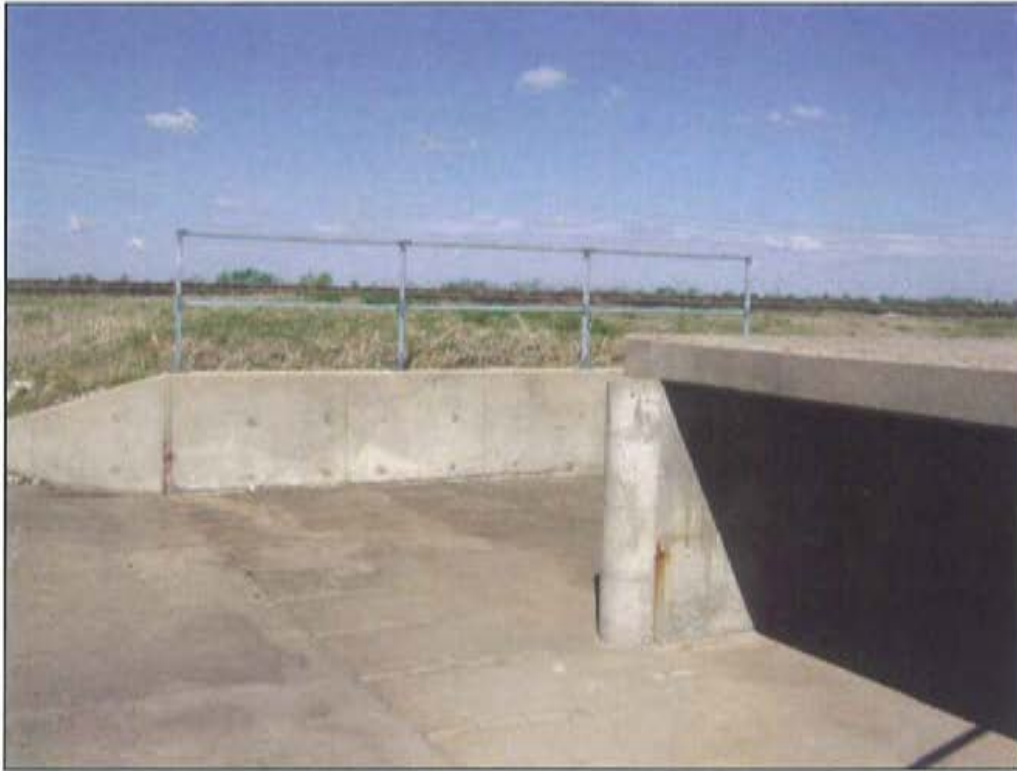
**Figure 5 - Bottom Ash Pond Spillway**

depressed area contained by the railroad embankment. Two 48-inch HDPE culverts run under the railroad embankment. The original culverts were 60-inch corrugated metal pipe (CMP) culverts, but HDPE slip-liners were recently installed. The overall spillway system, including these downstream culverts, was modeled with a steady-state HEC-RAS<sup>5</sup> model. The HEC-RAS model accounts for submergence of the tailwater from the downstream culverts, which will significantly restrict flow through the spillway. The discharge rating curve for the spillway is shown in Table 4. A photograph of the spillway is shown in Figure 5, along with a photograph of the downstream stilling basin and culverts in Figure 6. Detailed calculations for the discharge rating curve are included in Appendix B.
