**Coal Combustion Residue Impoundment  
Round 9 - Dam Assessment Report**

***Oklahoma Power Station***

***Wastewater Evaporation Pond 6 – WMU 001***  
***American Electric Power***  
**Vernon, Texas**

**April 2011**

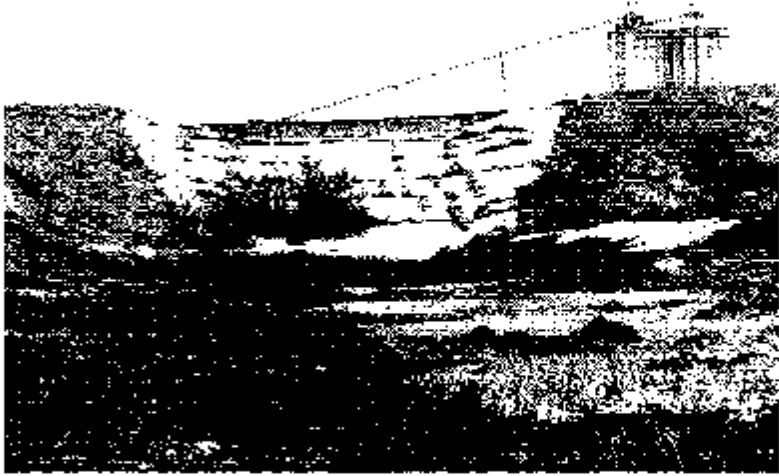
<p>Photo # 1</p>

<p>Spillway on downstream side of Wastewater Evaporation Pond #7.</p>	
<p>Photo # 2</p>

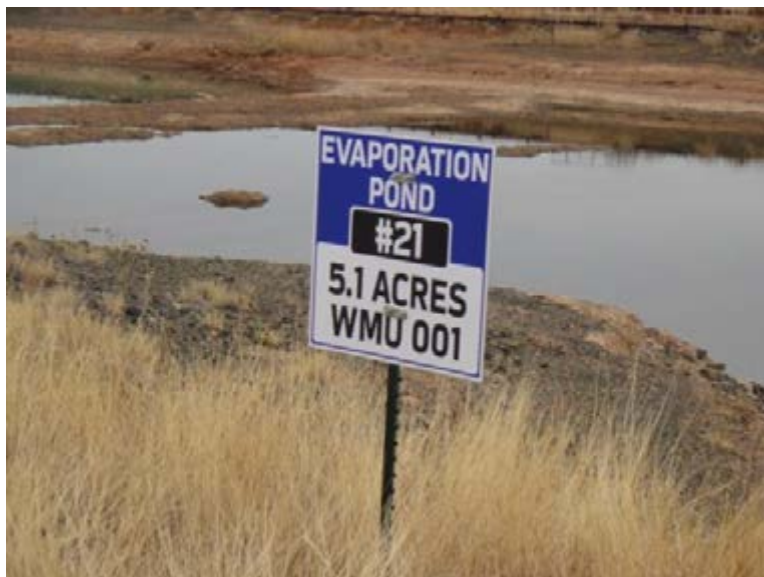
Figure C-1. Additional incised CCR pond #21

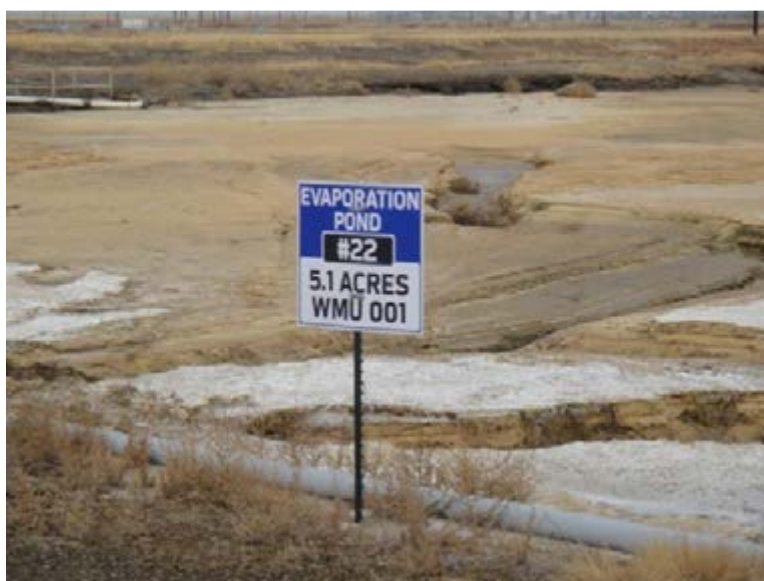
Figure C-2. Additional incised CCR pond #22

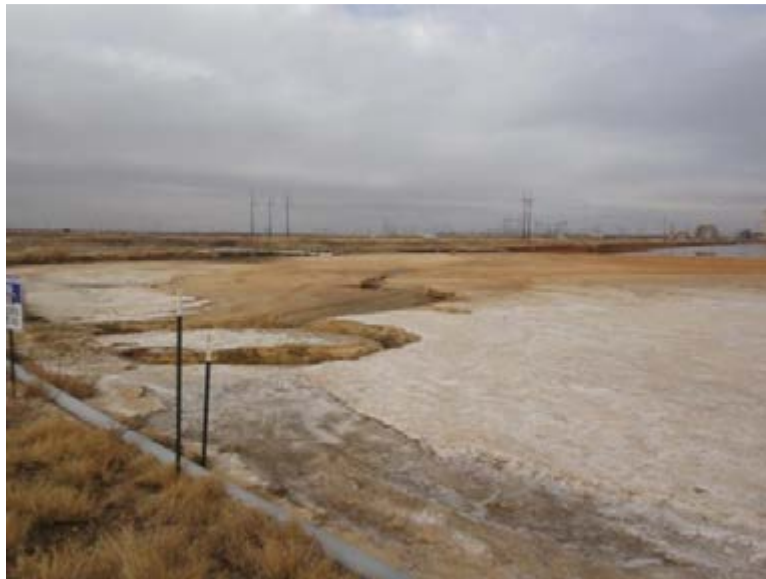
Figure C-3. Additional incised CCR pond #23

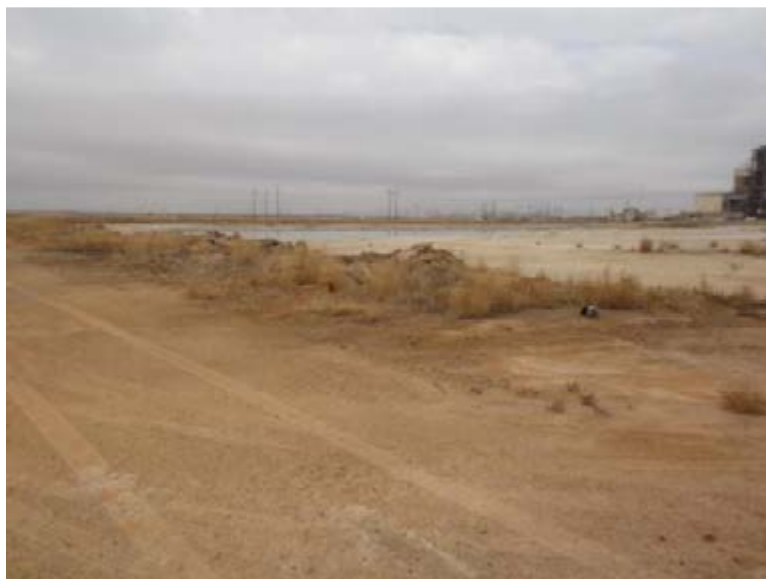
Figure C-4. Additional incised CCR pond #7
