Report of Dam Safety Assessment of Coal  
Combustion Surface Impoundments  
American Electric Power (AEP) and Southwest  
Electric Power Company (SWEPCO)  
H.W. Pirkey Power Plant, Hallsville, TX

AMEC Project No. 3-2106-0183.0003

November 2010

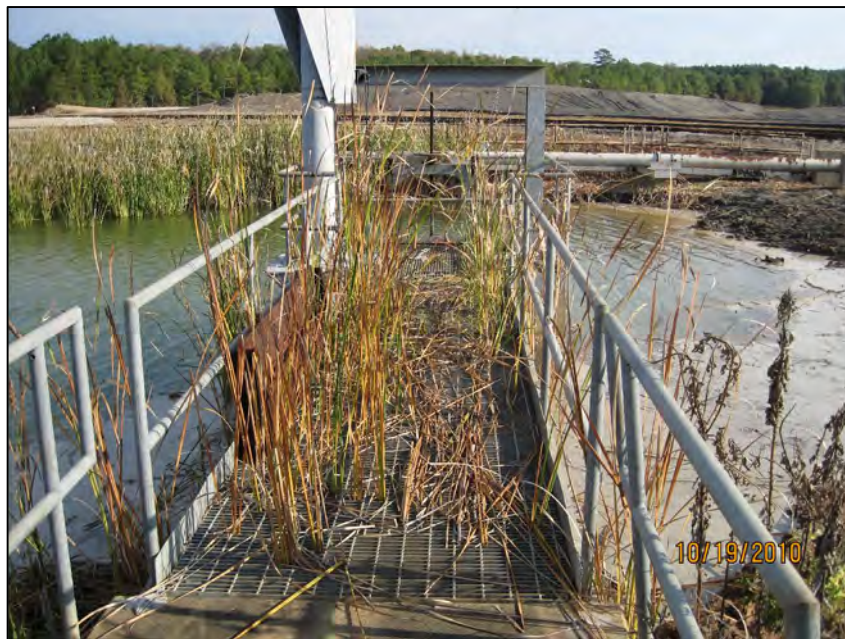
**WAP-2**  
**TOP OF DISCHARGE STRUCTURE**

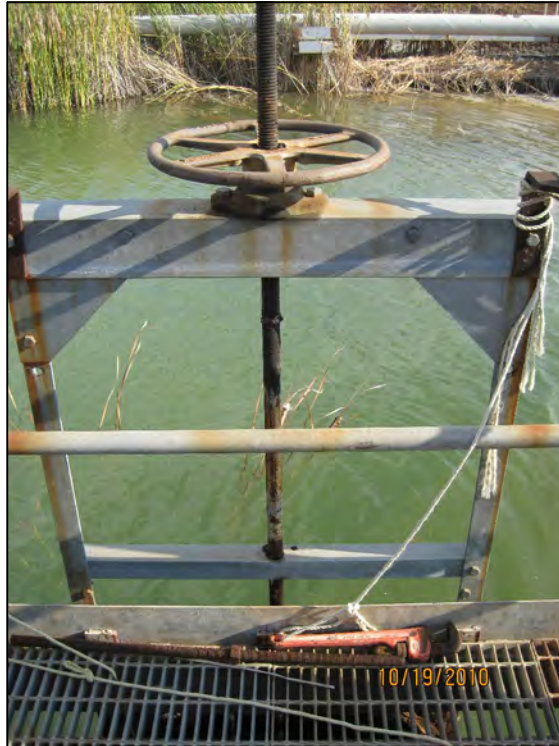
**WAP-3  
DISCHARGE PIPE VALVE OPERATOR**

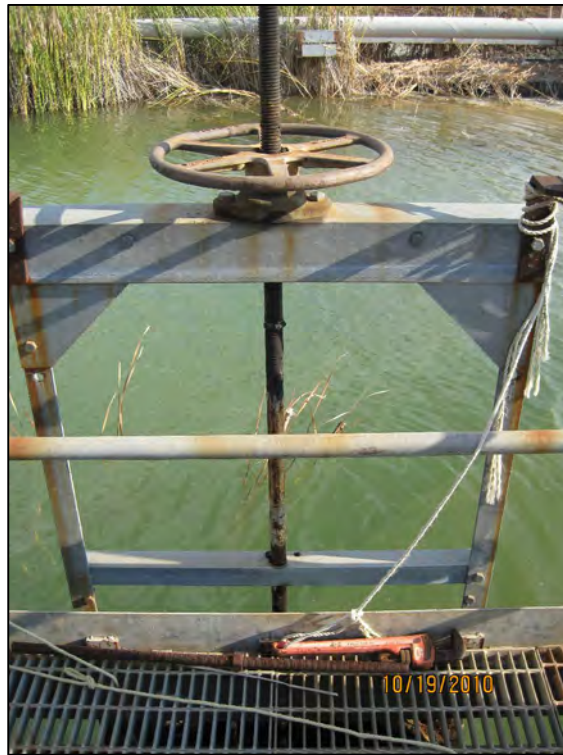
**WAP-3  
DISCHARGE PIPE VALVE OPERATOR**

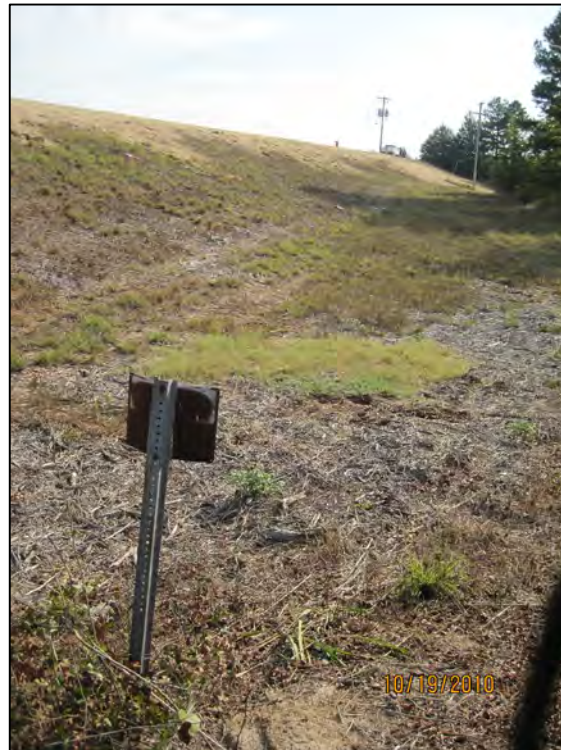
**WAP-6**  
**LOOKING EAST ON SOUTH DOWNSTREAM EMBANKMENT**

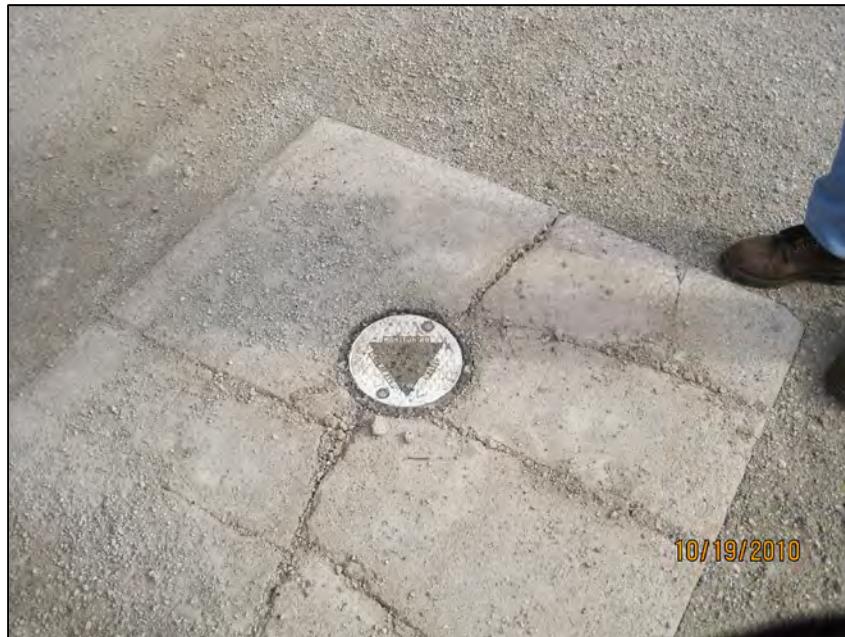
**EAP-3**  
**PIEZOMETER ON CREST OF NORTHERN EMBANKMENT**

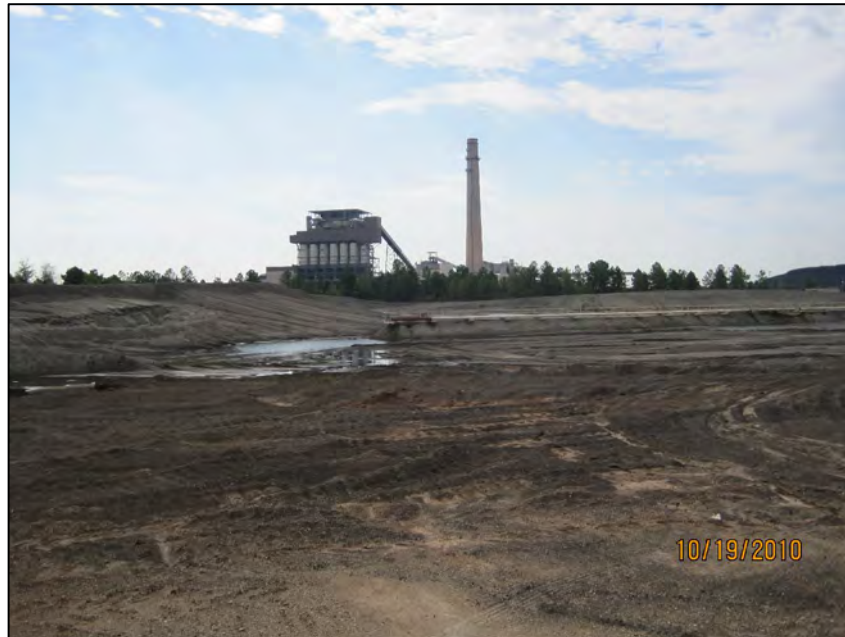
**EAP-5**  
**LOOKING SOUTH FROM NORTHERN EMBANKMENT**

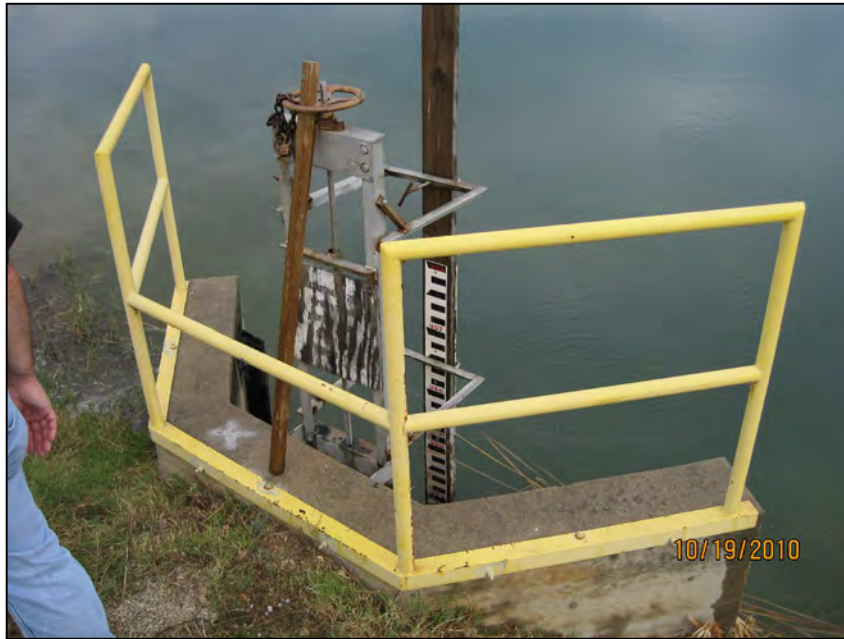
**SAP-3**  
**NPDES DISCHARGE OUTFALL 006 AT SOUTHWEST CORNER**

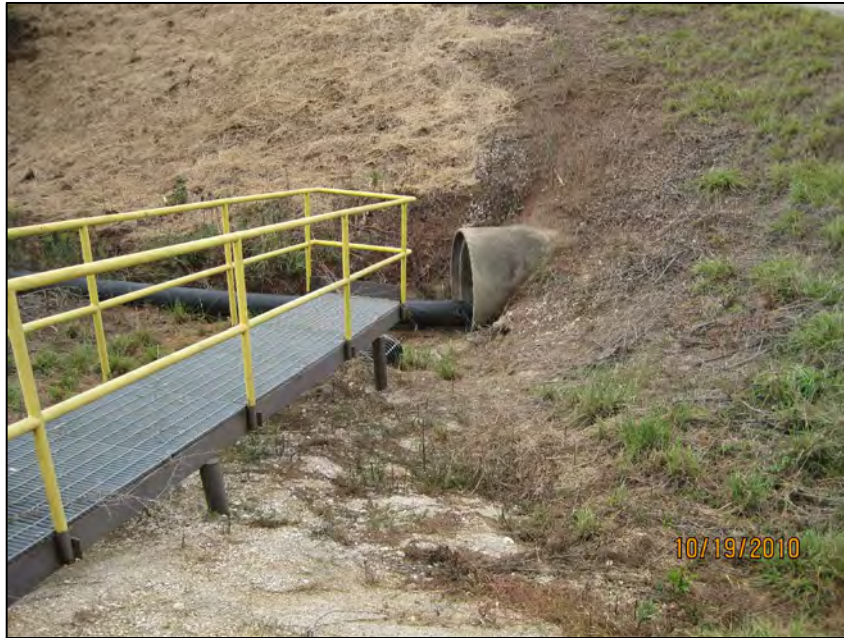
**SAP-4**  
**TRANSFER PIPE CARRYING REUSE**  
**FLOW TO ADJADENT LIGNITE MINE**

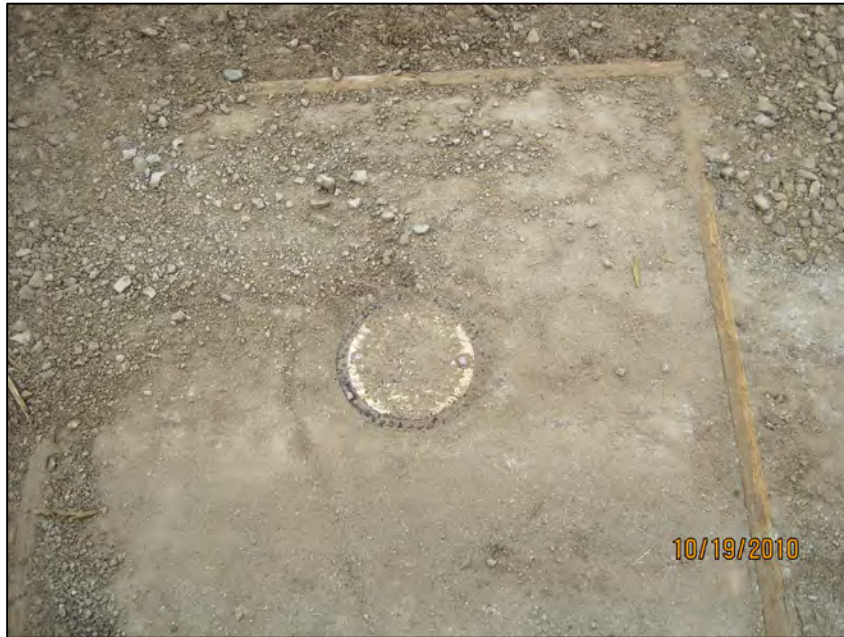
**SAP-5  
PIEZOMETER AT SOUTHWEST CORNER**

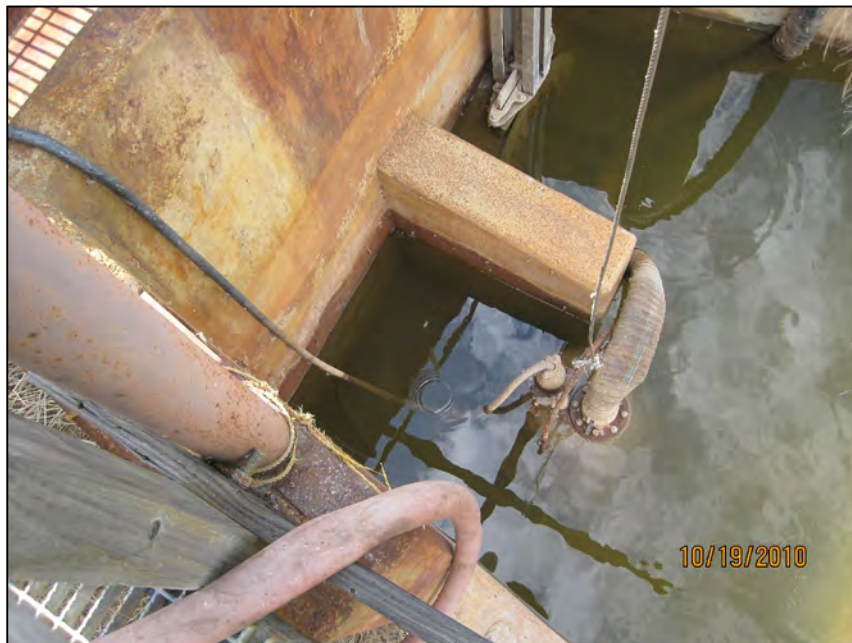
**LRP-2**  
**POND DISCHARGE STRUCTURE-NPDES OUTFALL 004**

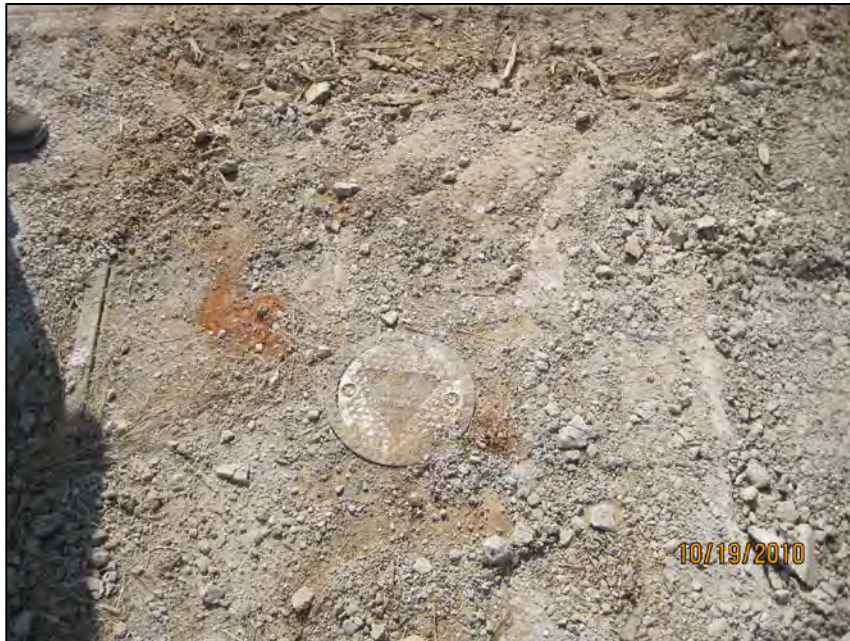
**LRP-5**  
**PIEZOMETER ON EMBANKMENT CREST**
