Report of Dam Safety Assessment of Coal  
Combustion Surface Impoundments  
American Electric Power (AEP) and Southwest  
Electric Power Company (SWEPCO)  
H.W. Pirkey Power Plant, Hallsville, TX

AMEC Project No. 3-2106-0183.0003

June 2011

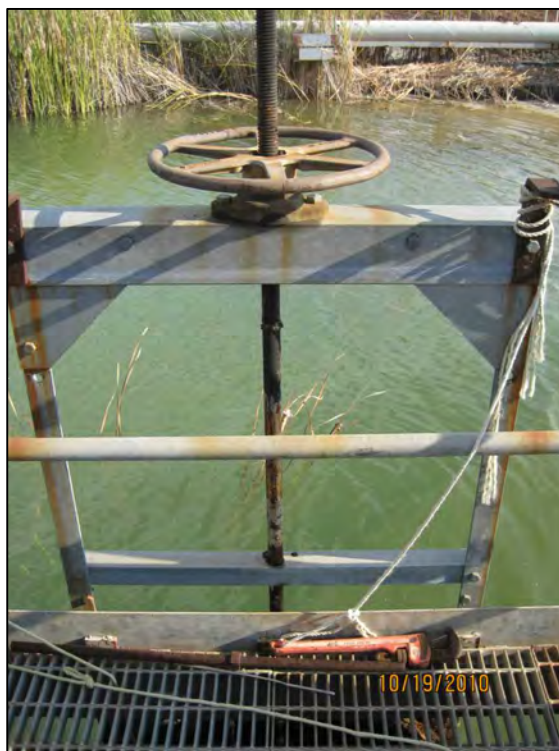
WAP-3  
DISCHARGE PIPE VALVE OPERATOR

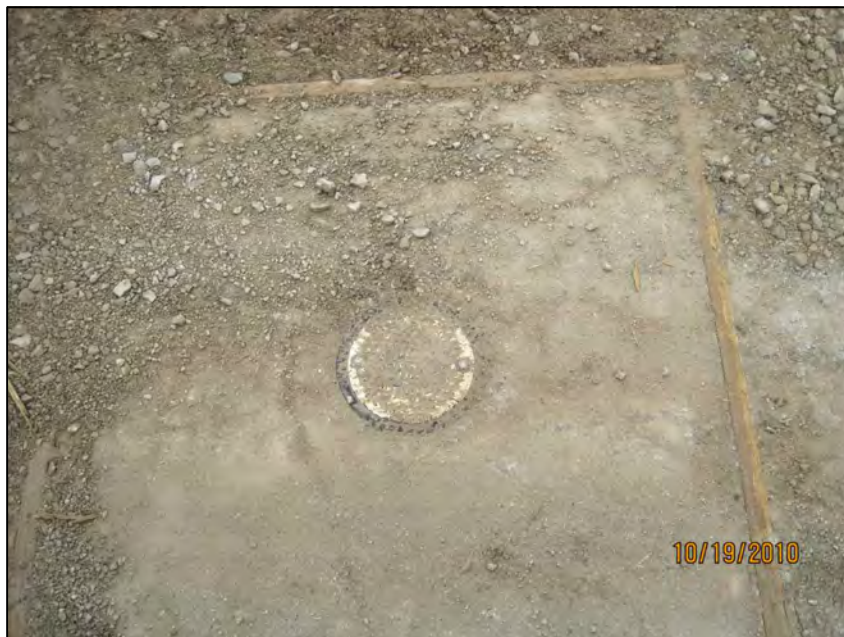
SAP-5  
PIEZOMETER AT SOUTHWEST CORNER

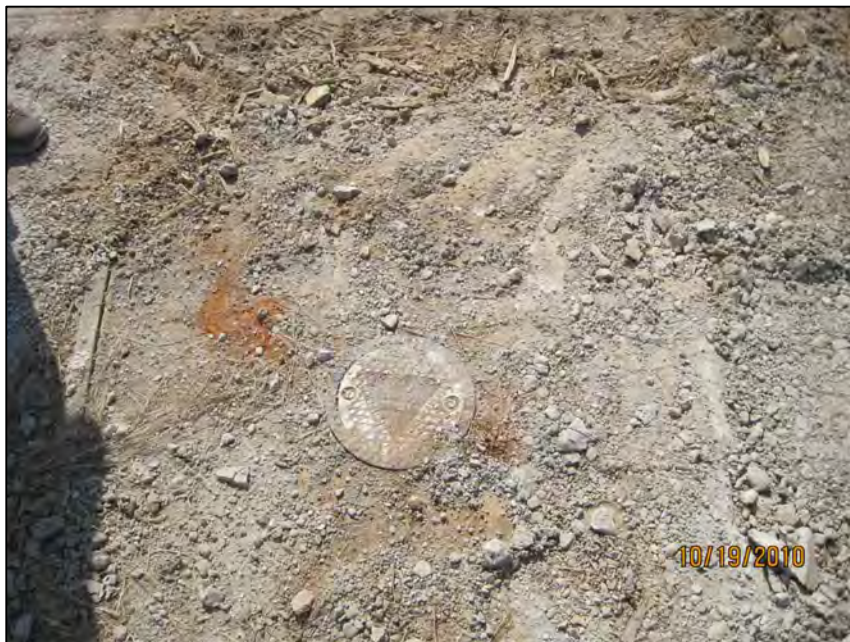
LRP-5  
PIEZOMETER ON EMBANKMENT CREST
