Assessment of Dam Safety Coal Combustion Surface Impoundments (Task 3) Final Report

American Electric Power
Big Sandy
Generating Station
Louisa, Kentucky

February 17, 2010

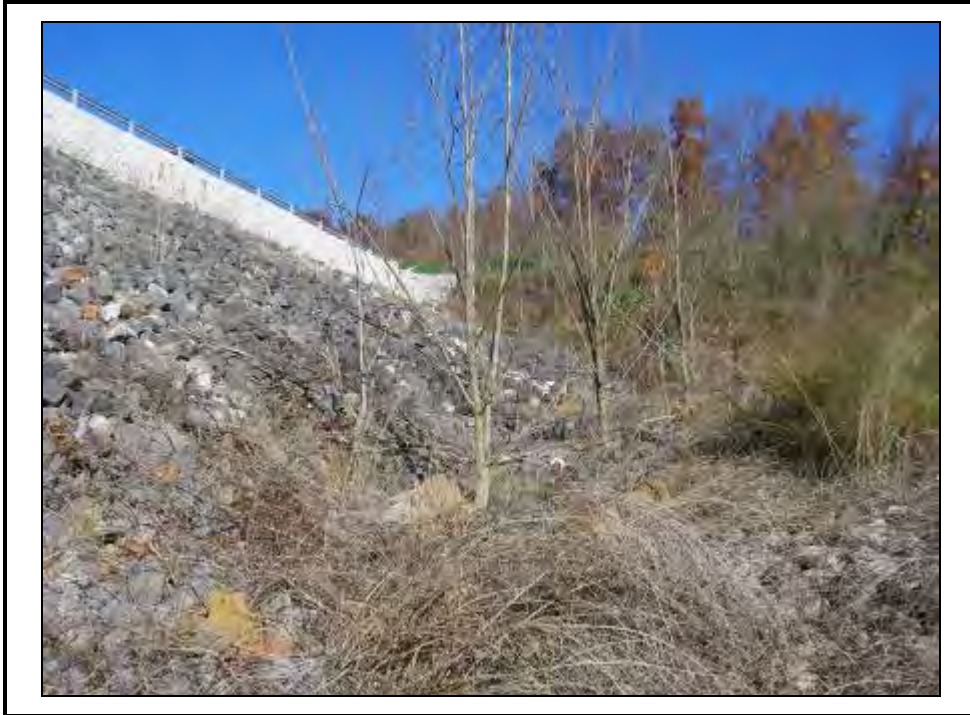
5

Close-up of trees in north downstream groin.

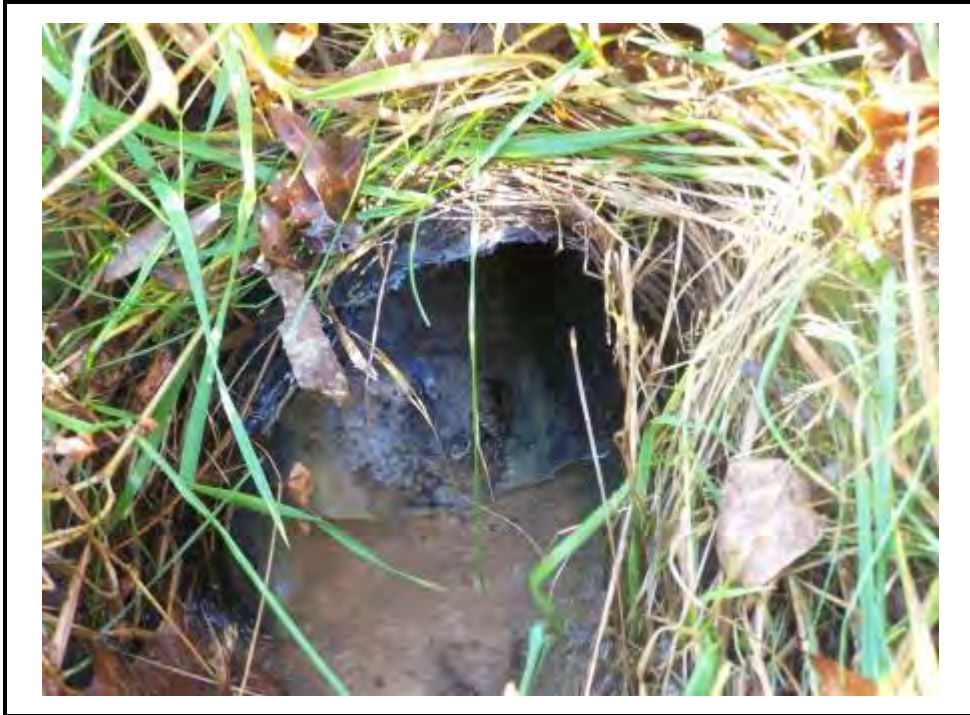
11

Toe drain outlet after clearing vegetation.

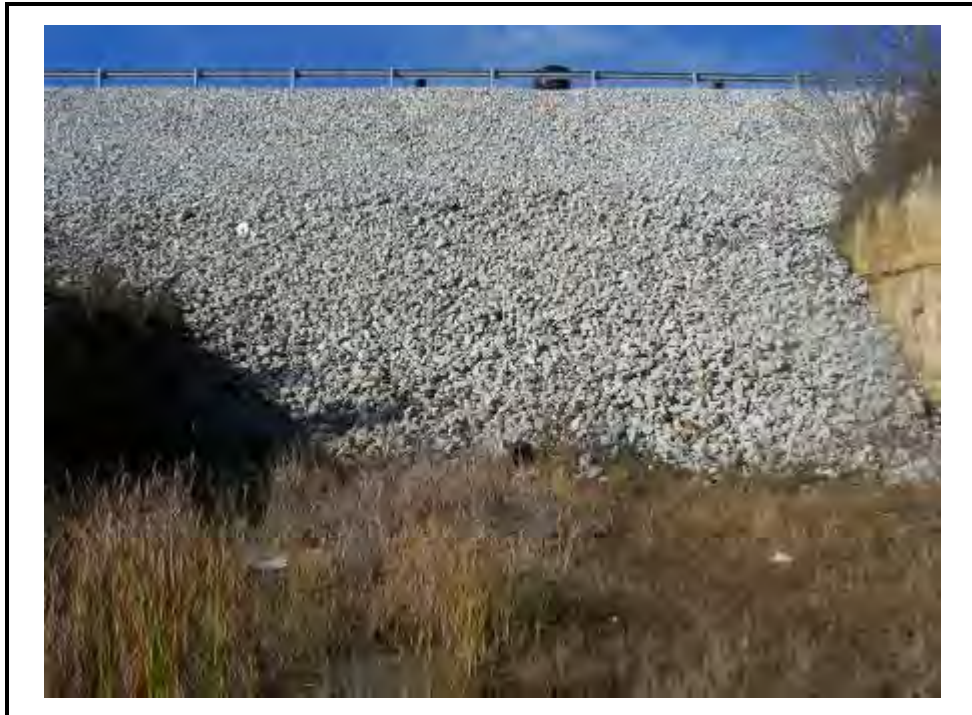
13

Downstream slope of Saddle Dam filling original emergency spillway.

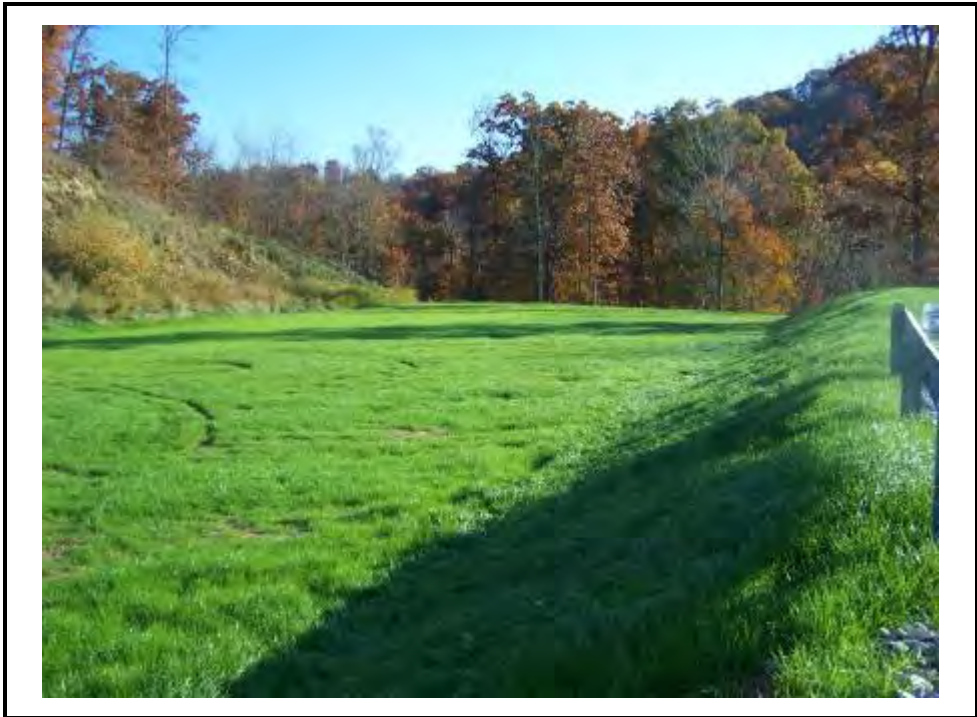
15

“New” emergency spillway at north abutment of Saddle Dam.

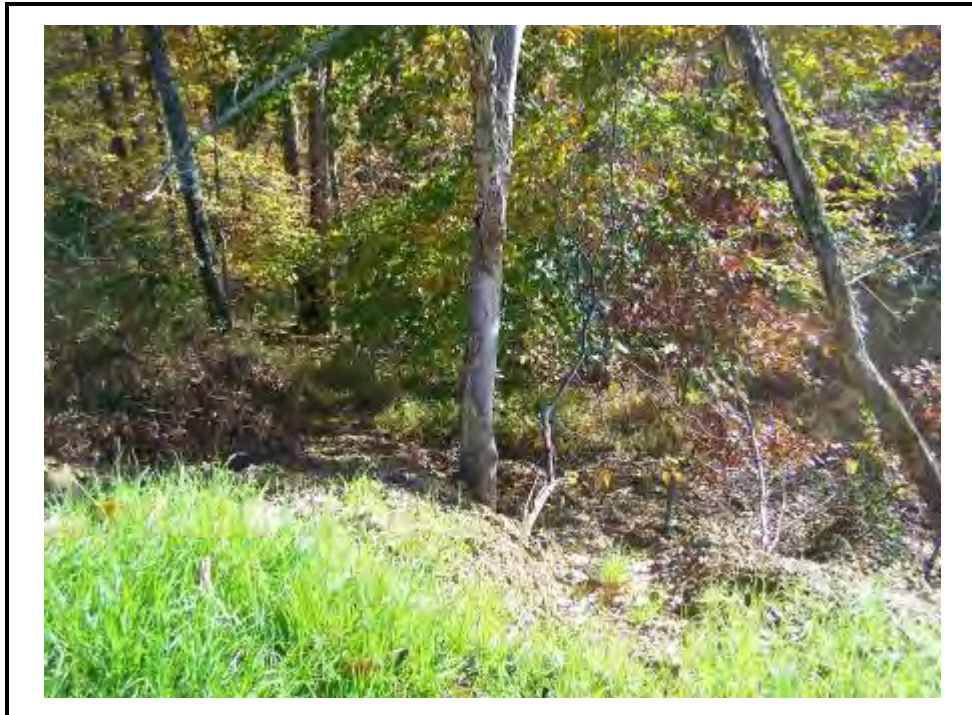
17

Downstream condition of "new" emergency spillway.

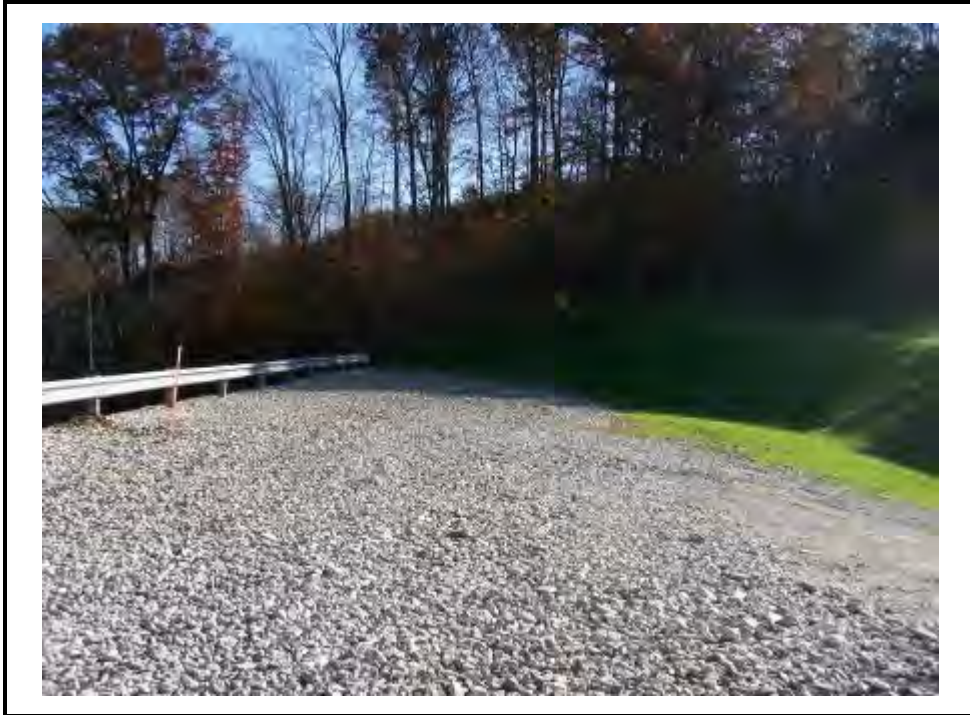
19

East abutment and crest of Horseford Creek Dam, looking east.

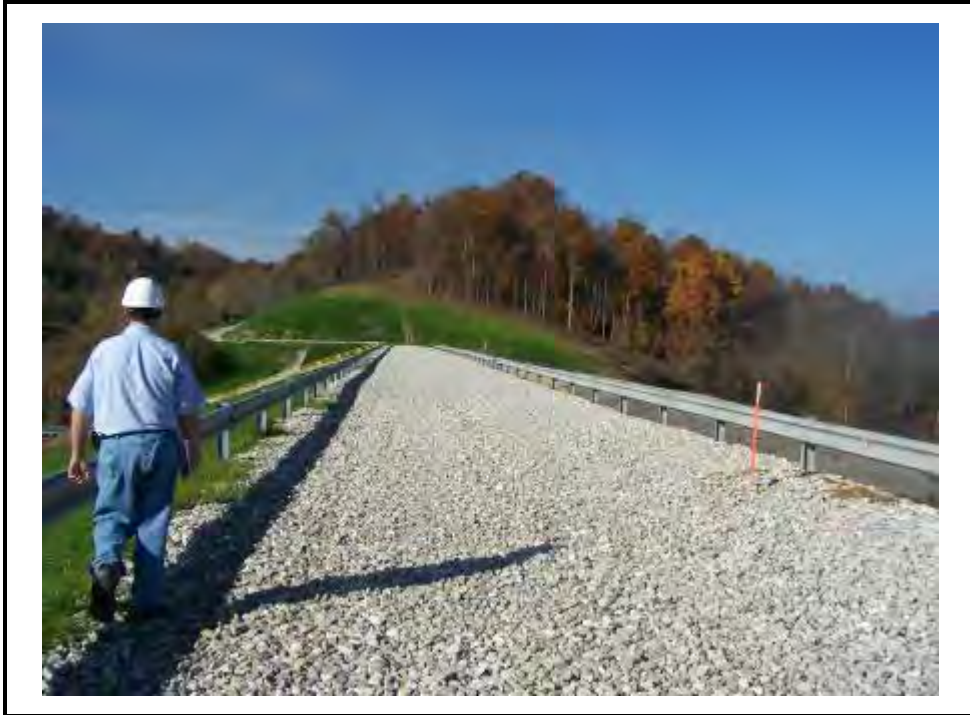
21

Crest of Horseford Creek Dam, looking east.

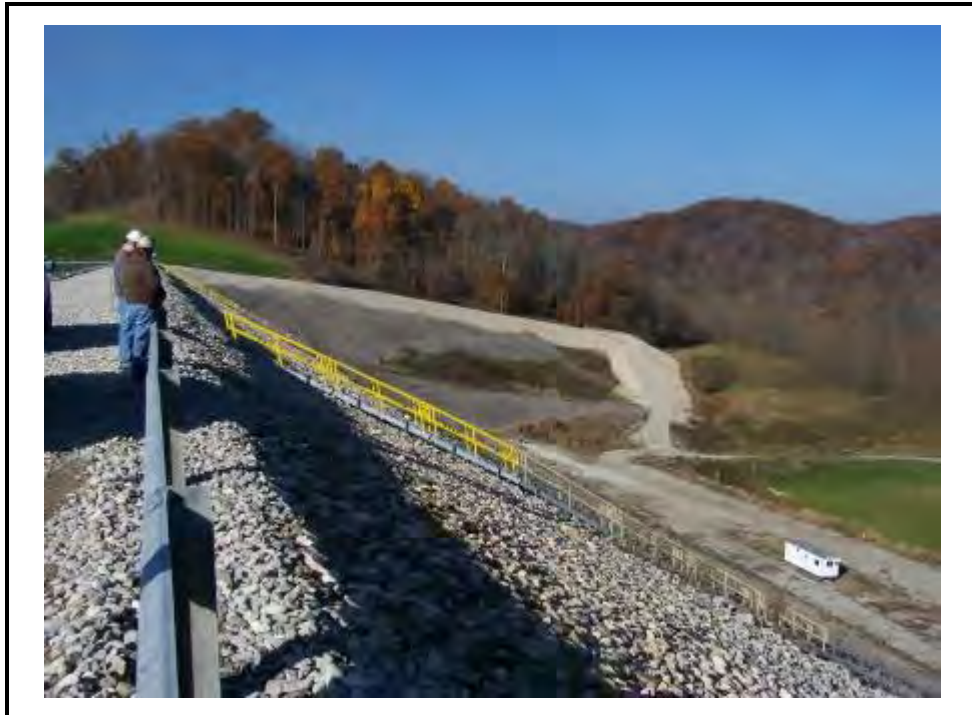
23

Downstream slope Horseford Creek Dam, looking west.

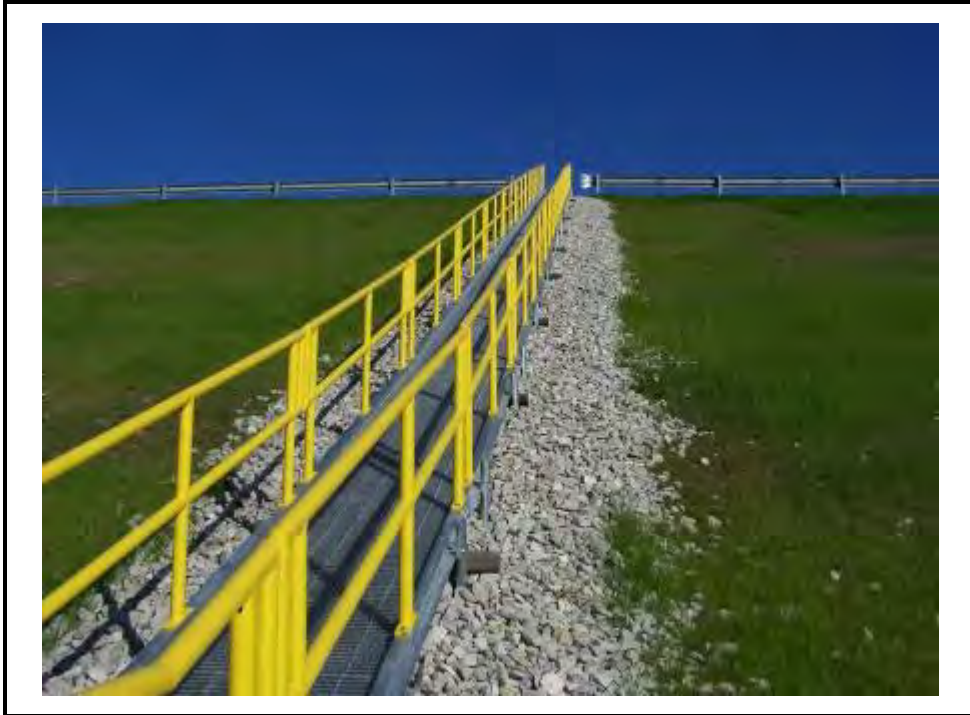
Access ramp to Horseford Creek Dam outlet structure.

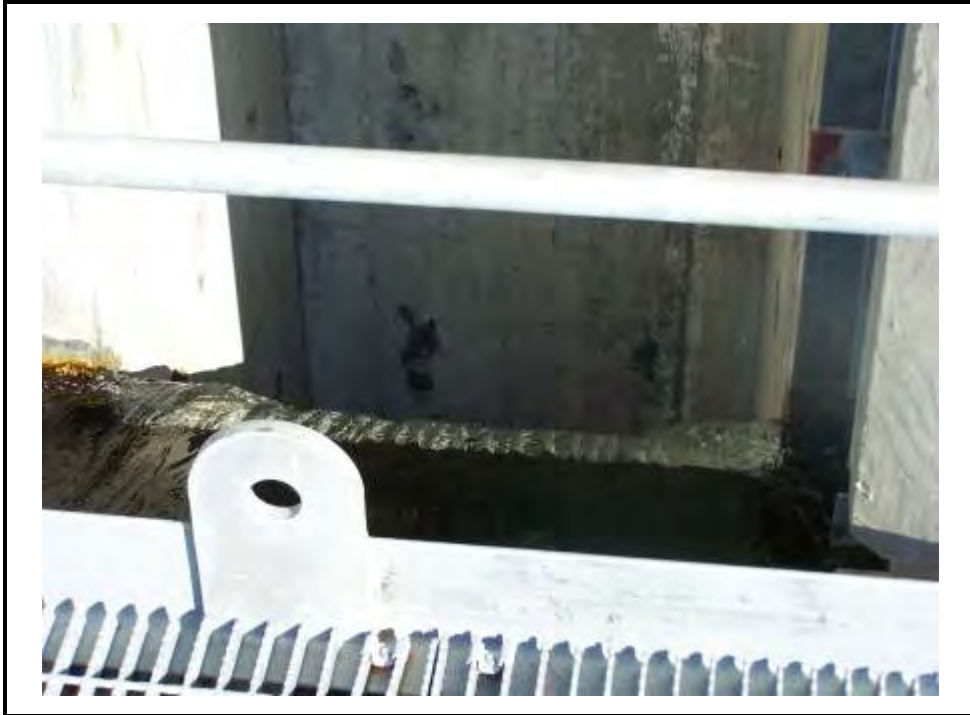
Close-up on one stop log opening at Horseford Creek Dam outlet structure.

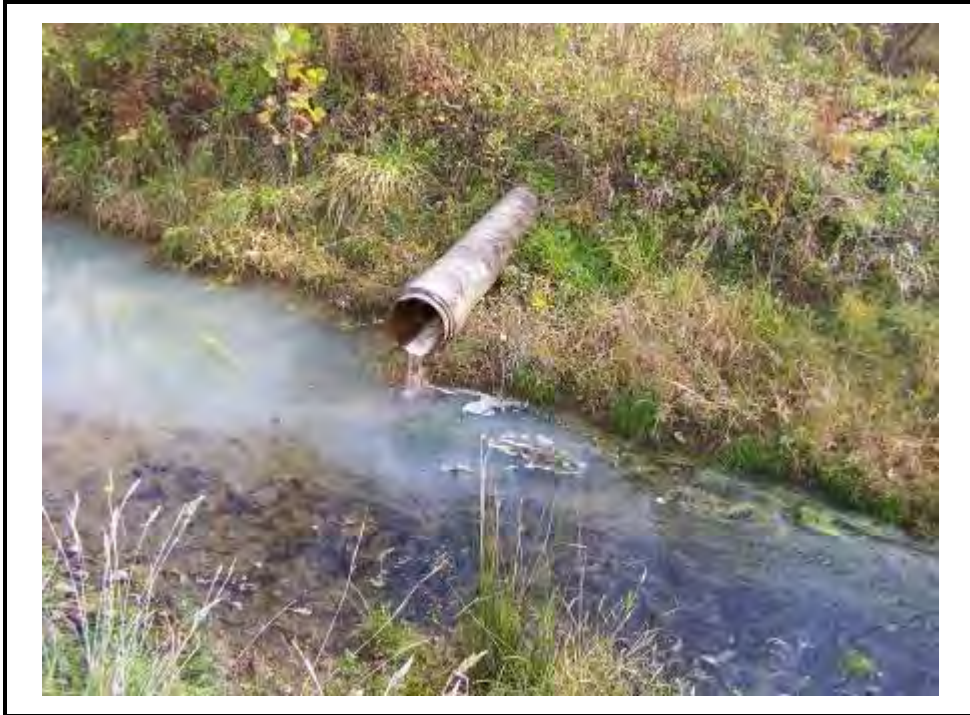
Drain pipe from east abutment area of Horseford Creek Dam.
Note calcium deposits in water from limestone formations.

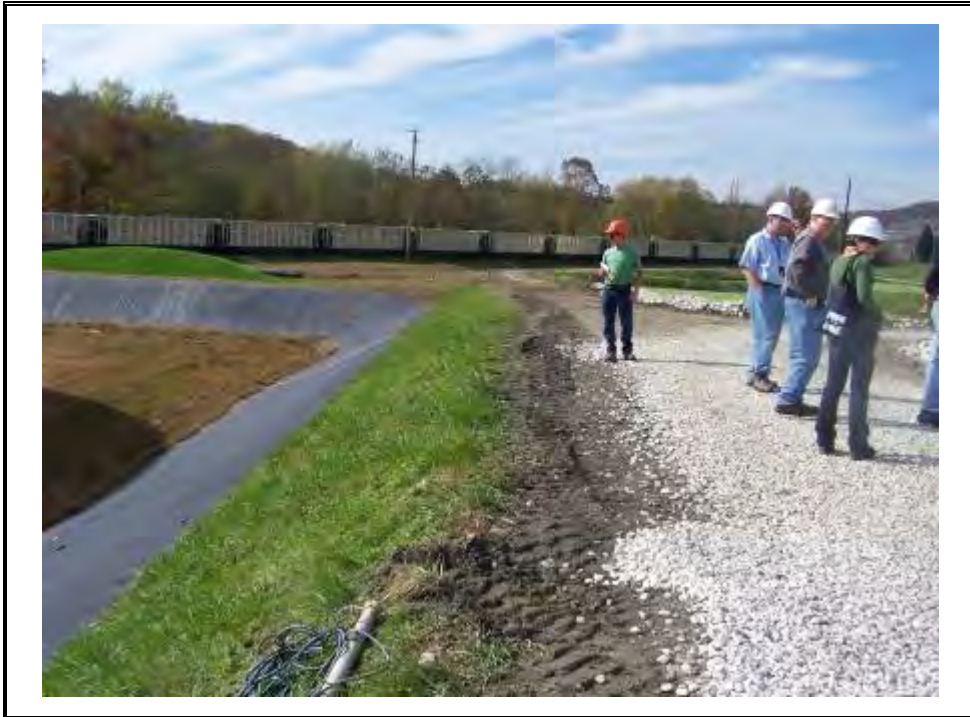
Crest of the South Dike at the Bottom Ash Complex looking west. Note dike crest slopes to about original grade adjacent to the south clear water pond. Liner on downstream slope is part of chemical spill containment berms.

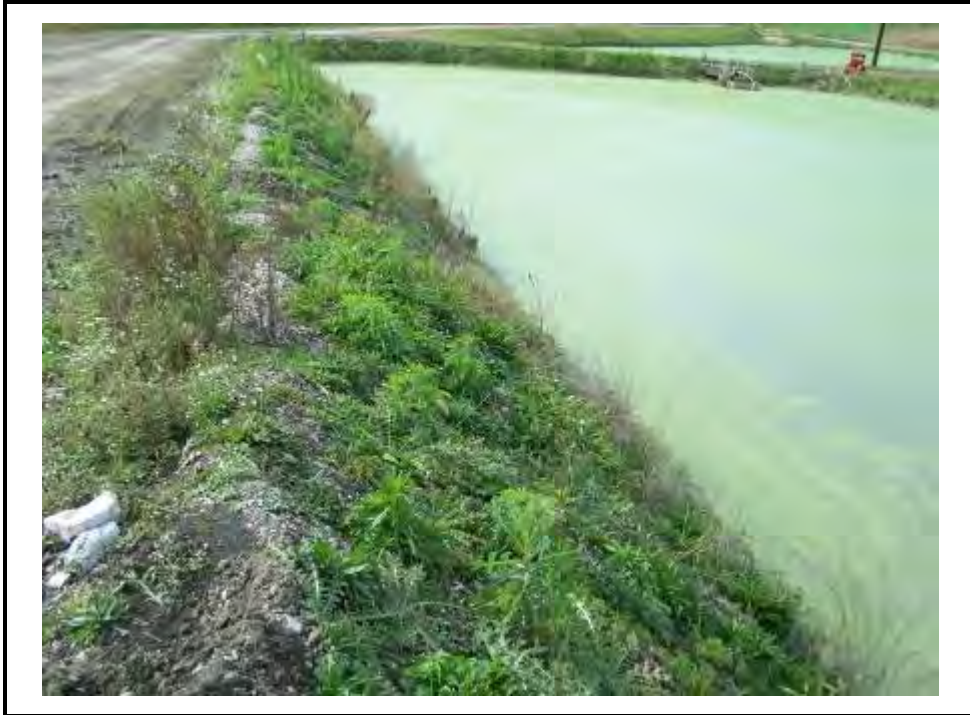
Upstream slope of South Dike of Bottom Ash Complex at south Clearwater Pond, looking west.

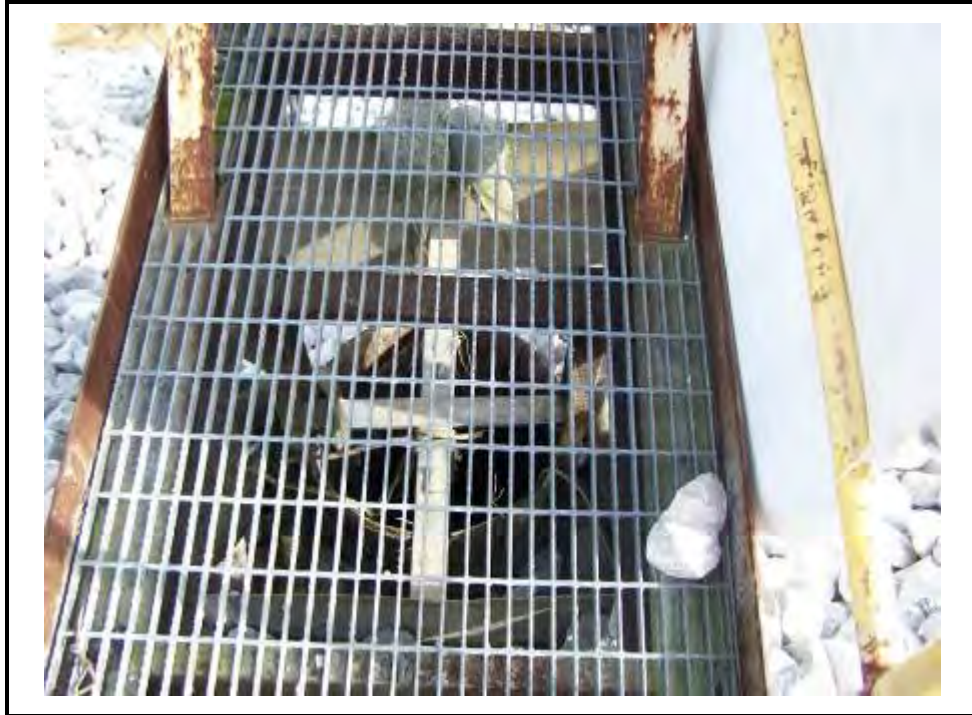
Close-up of south Bottom Ash Pond decant structure.

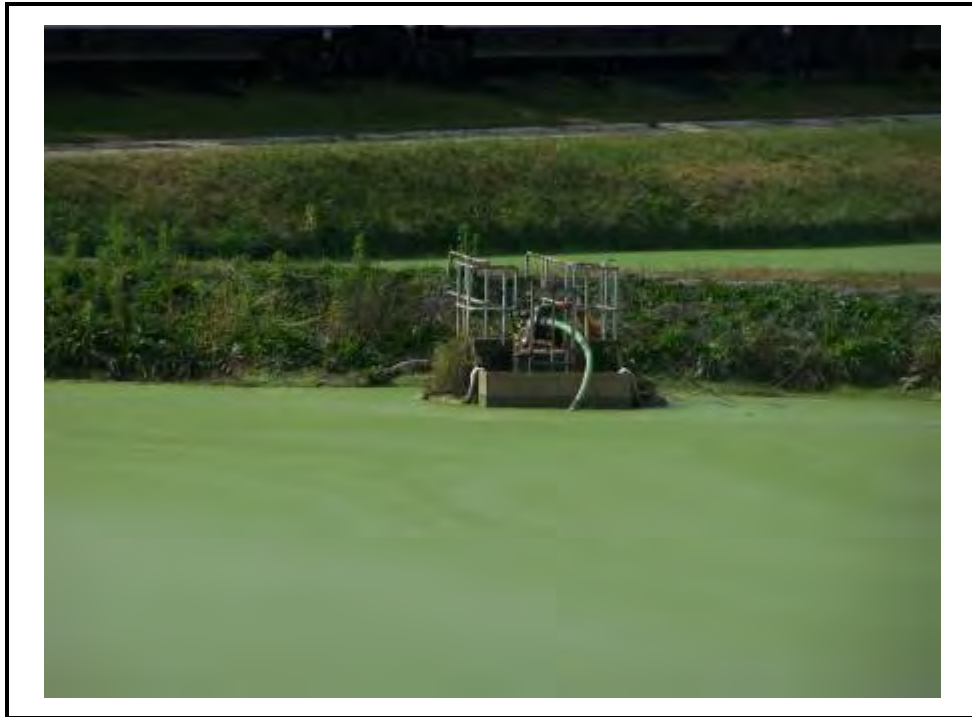
Decant structure from south Clearwater Pond to the Reclaim Pond.

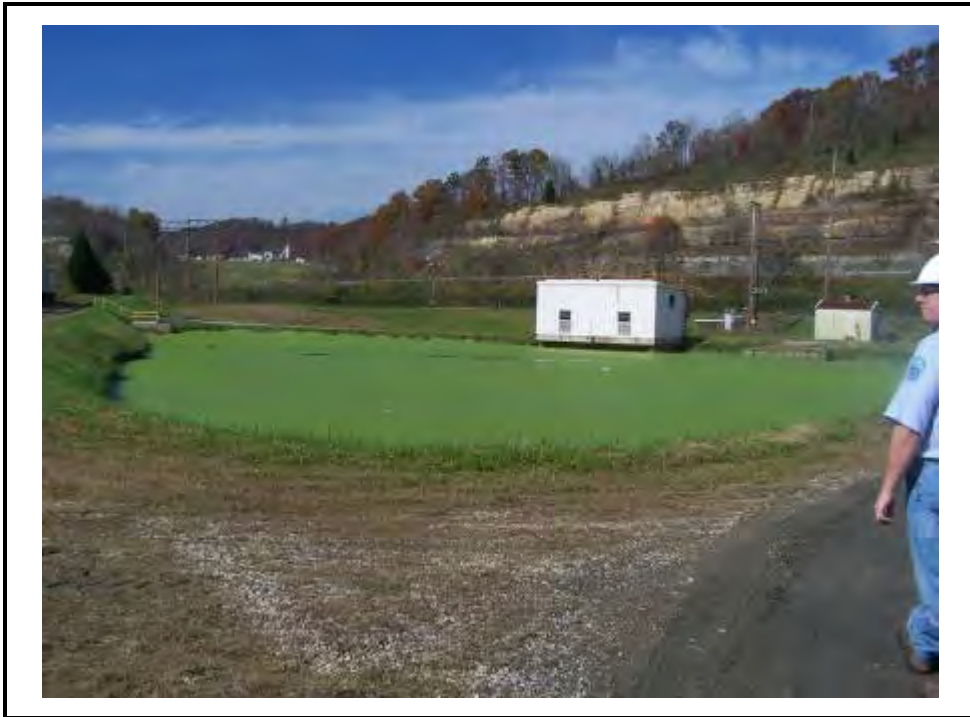
Reclaim Pond (incised) looking west. Building is the pump station which diverts flows back to the plant or to Horseford Reservoir. At west end of pond is a non-permitted overflow to the Big Sandy River.
