**Coal Combustion Waste Impoundment
Dam Assessment Report**

Site 25

***Fly Ash Pond & Bottom Ash Pond
American Electric Power
Philip Sporn Generating Plant
New Haven, West Virginia***

**Assessment of Dam Safety
Coal Combustion Surface Impoundments
For the REAC Program**

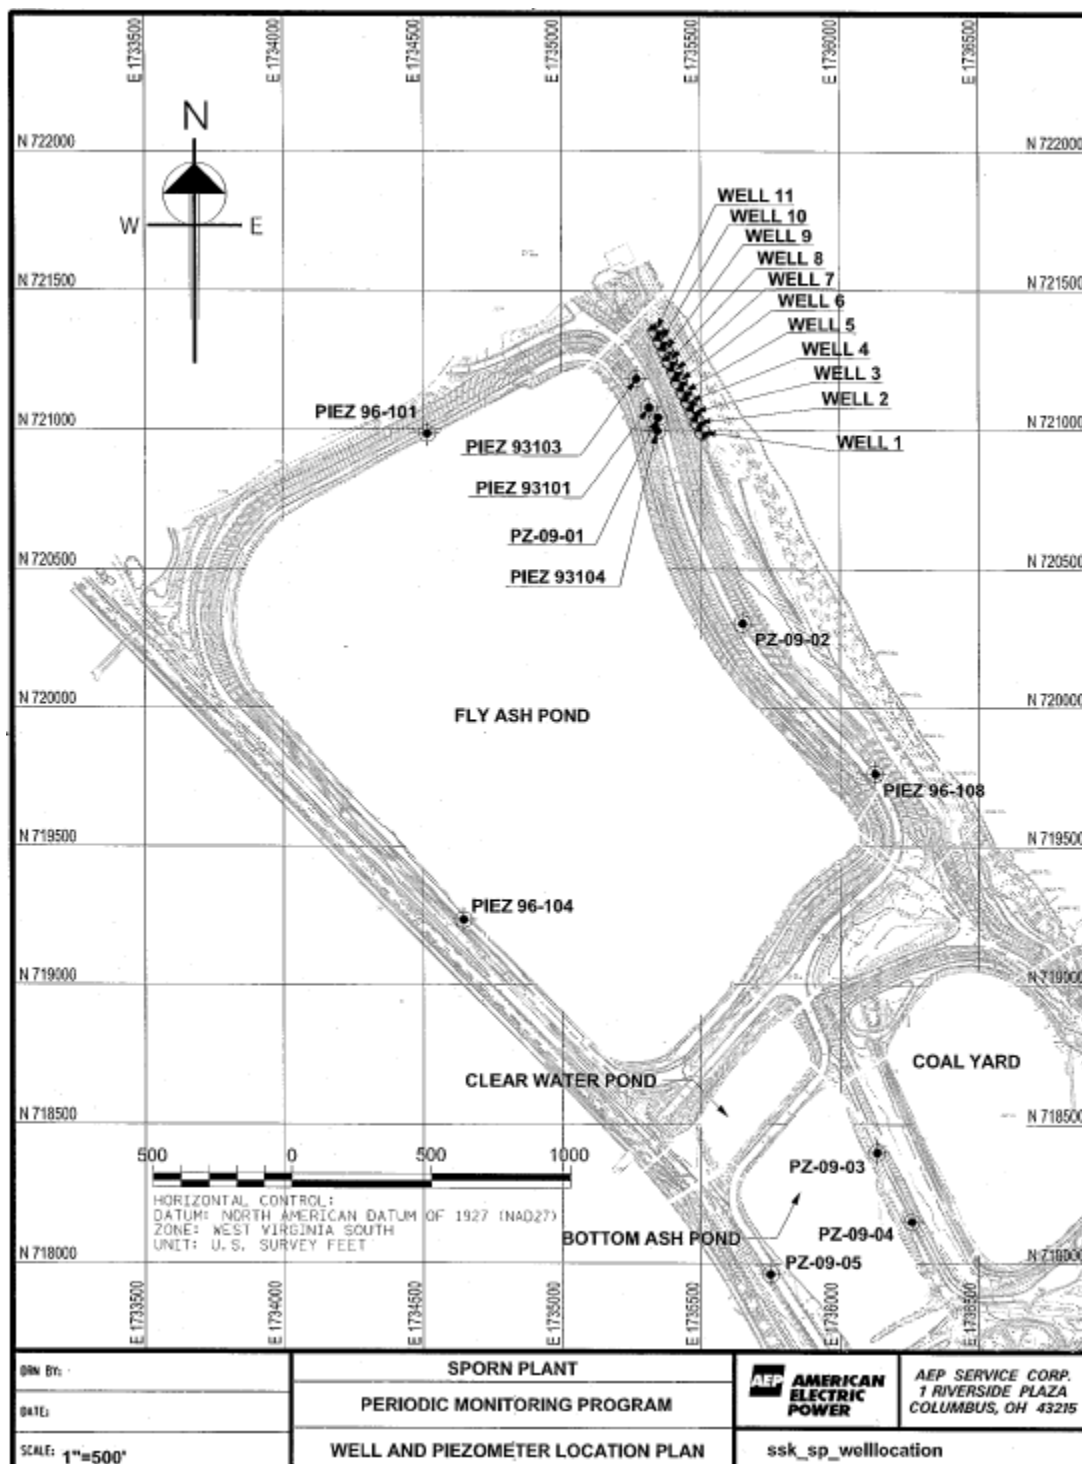
Figure 9.2.1: Fly Ash and Bottom Ash Ponds Well and Piezometer Location Map

Bottom Ash Pond – Monitoring instrumentation (piezometers) are in place at this facility, per Figure 9.2.1.

Bottom Ash Pond – The surveillance and monitoring programs should include additional monitoring of the downstream toe of embankments for seepage.
