# Assessment of Dam Safety Coal Combustion Surface Impoundments Draft Report

American Electric Power  
General James Gavin  
Power Plant  
Cheshire, Ohio

July 2, 2009

CHA Project No. 20085.4000.1510

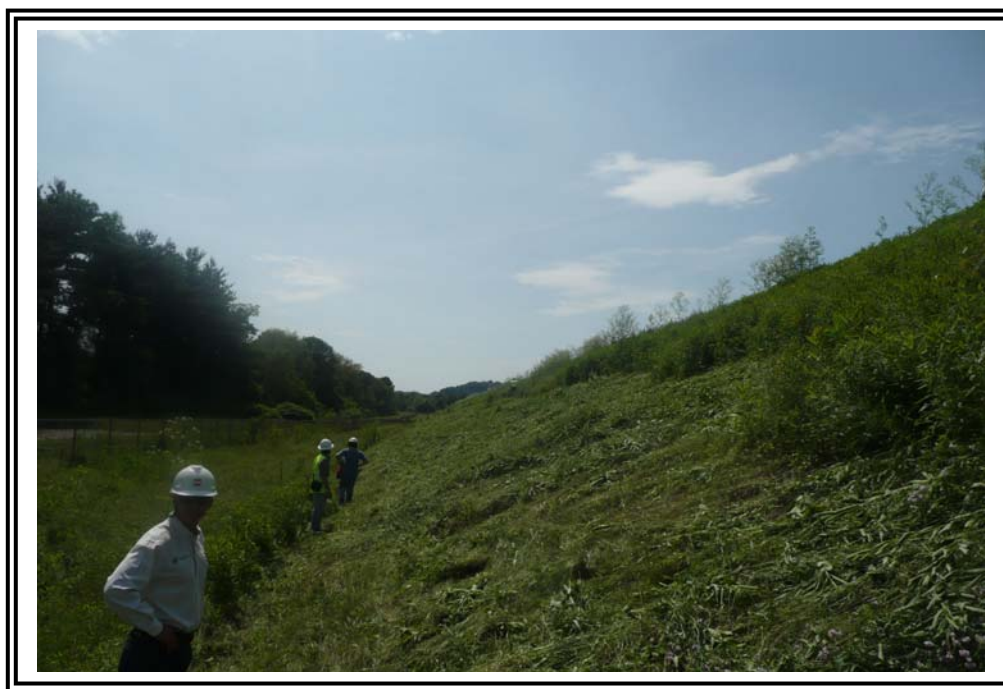
29

Downstream slope of south dike, looking west.

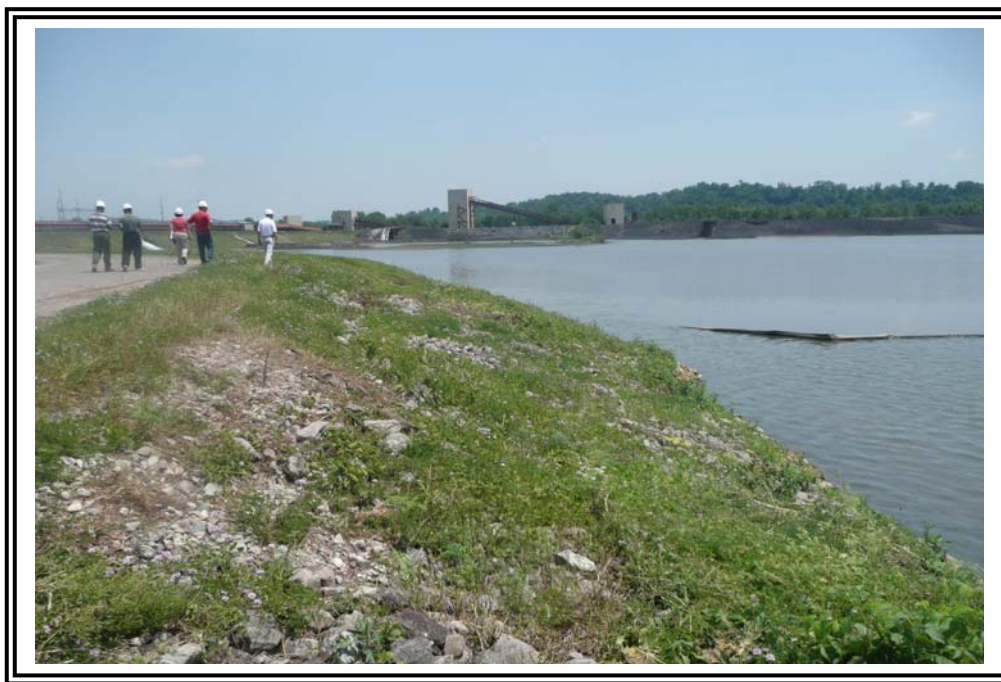
38

Intermediate dike, looking east.

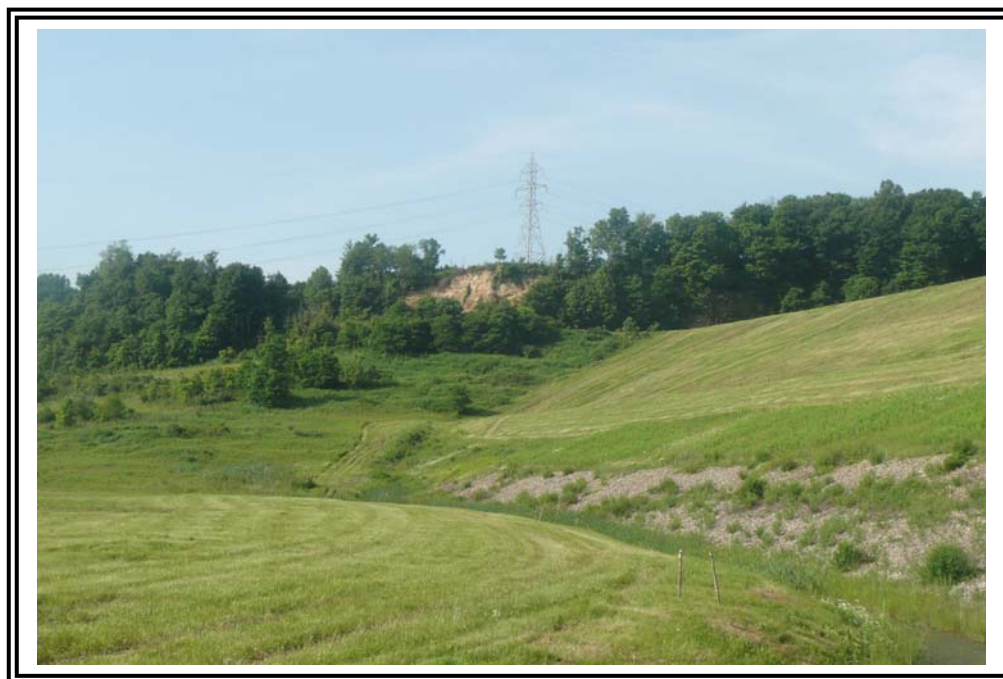
50

Right (south) downstream abutment contact.

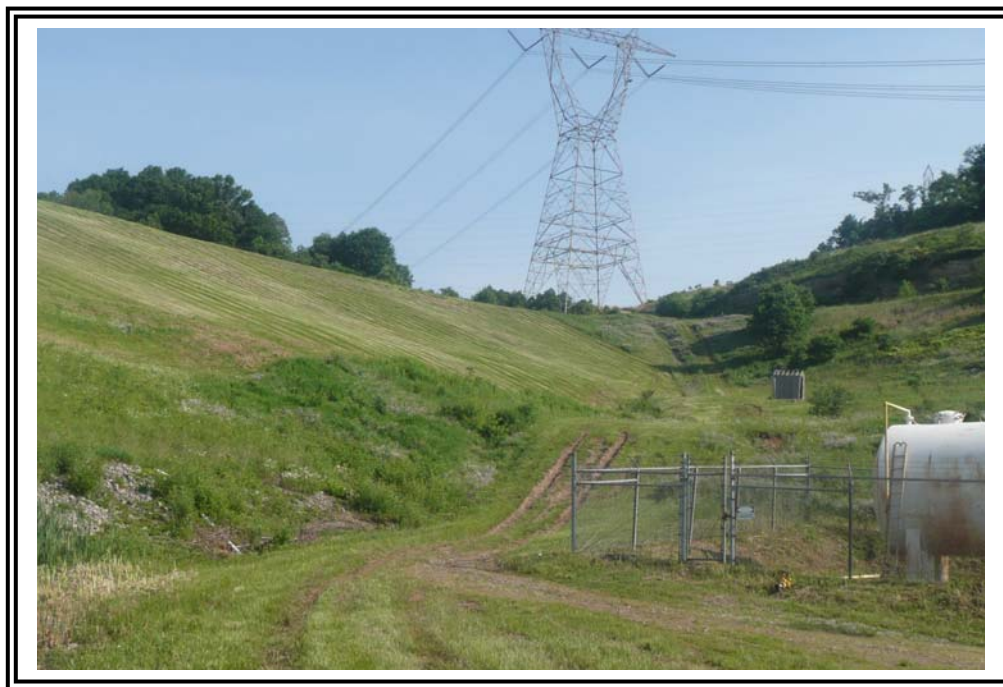
51

Left (north) downstream abutment contact.

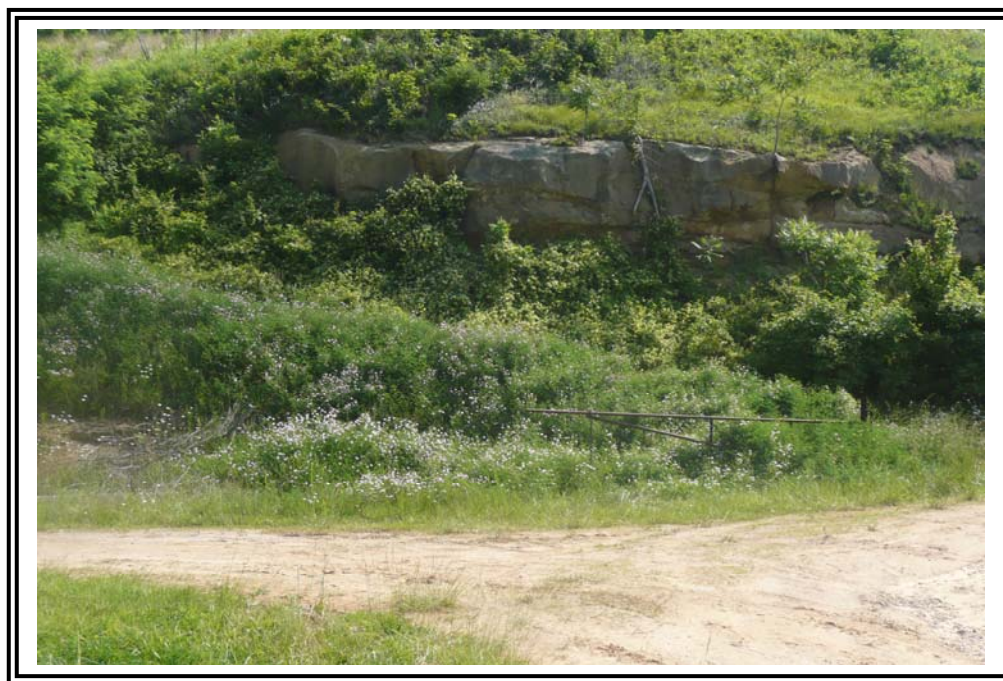
62

Left (north) abutment.

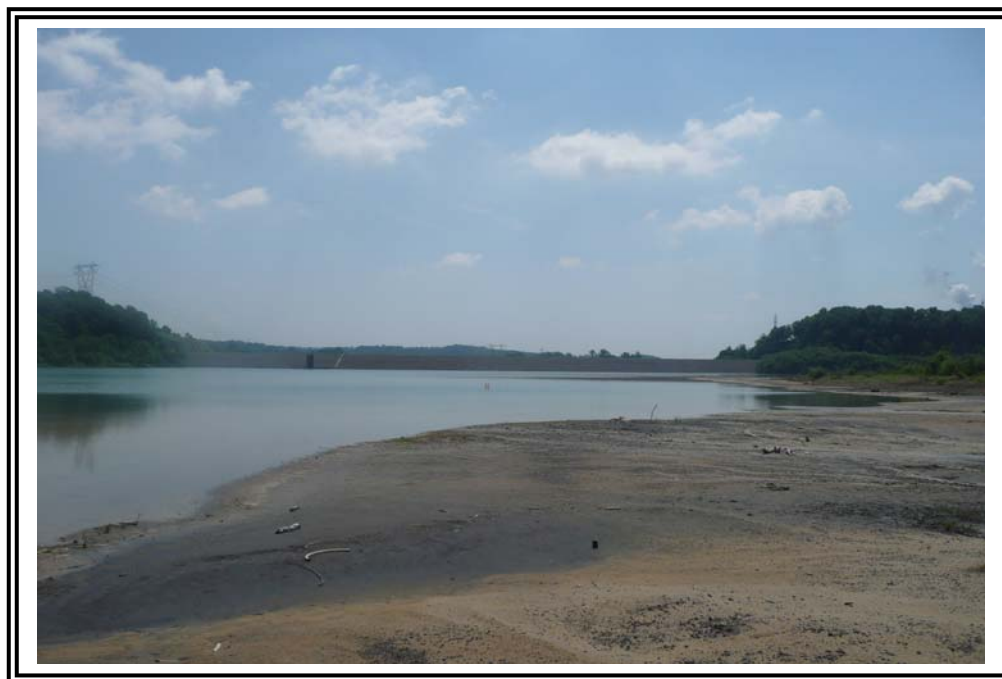
64

Upstream slope of the dam.

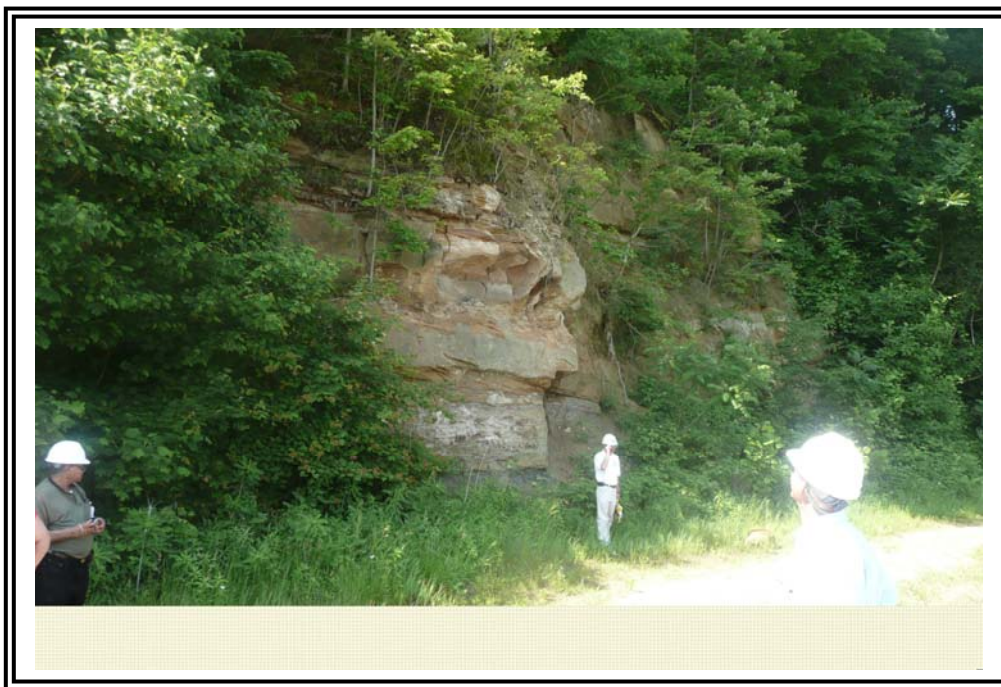
69

Right (south) abutment.

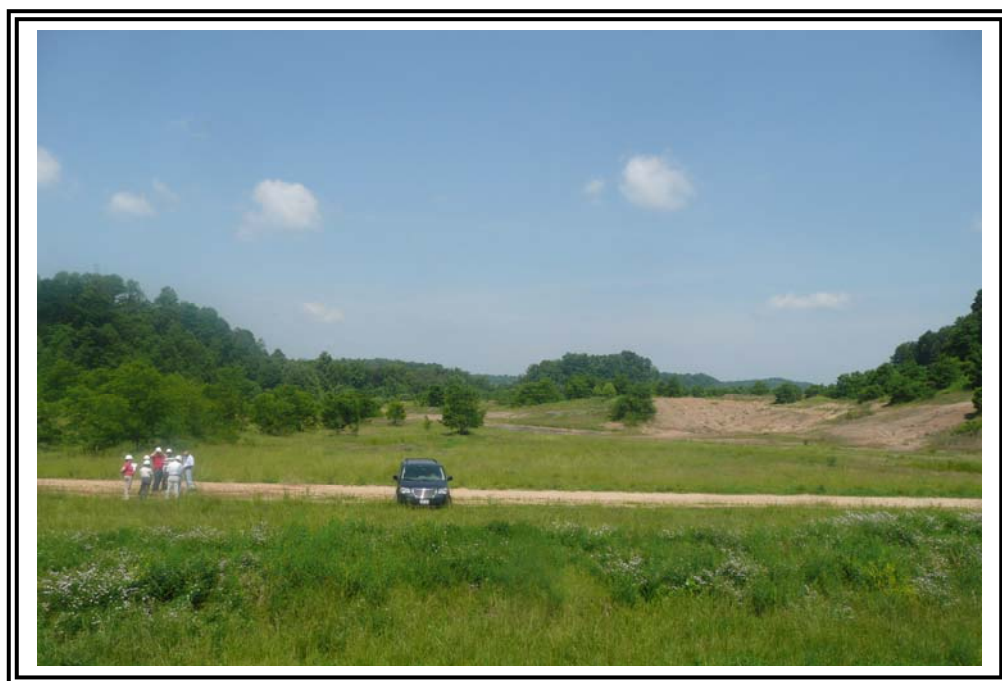
72

Abandoned emergency spillway looking toward reservoir.
