# Assessment of Dam Safety

## Coal Combustion Surface Impoundments (Task 3)

### Final Report

American Electric Power  
General James Gavin  
Power Plant  
Cheshire, Ohio

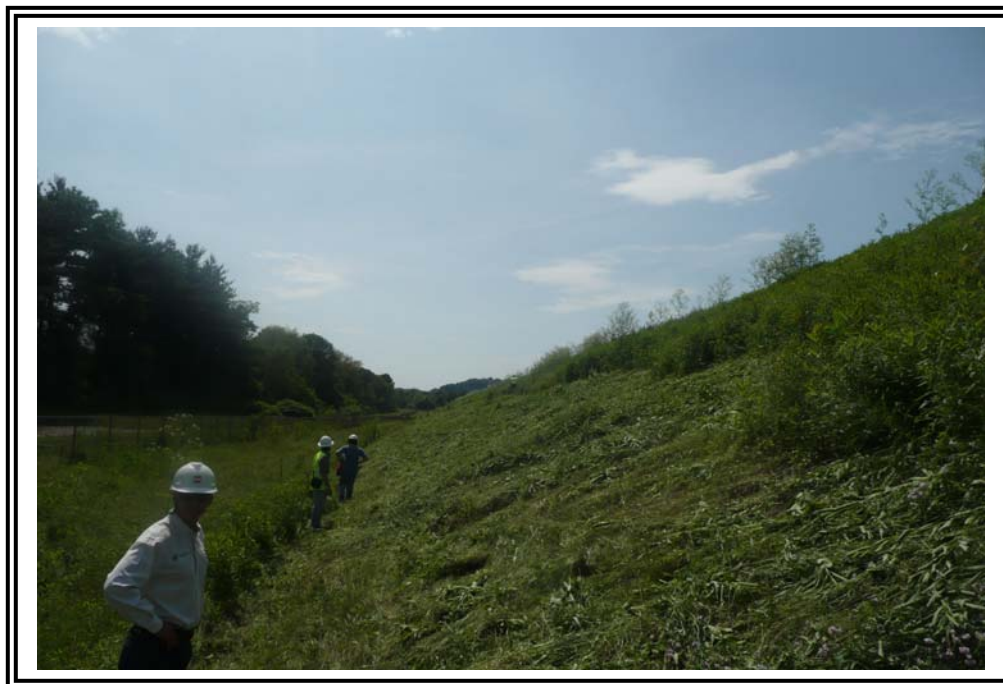
29

Downstream slope of south dike, looking west.

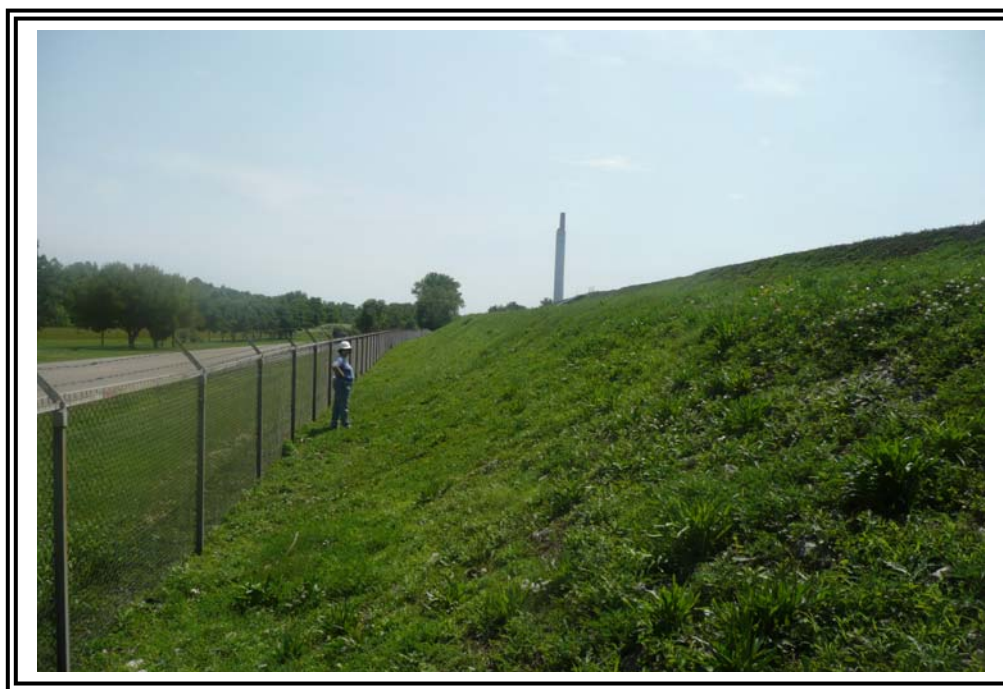
31

Downstream slope of east dike, looking south.

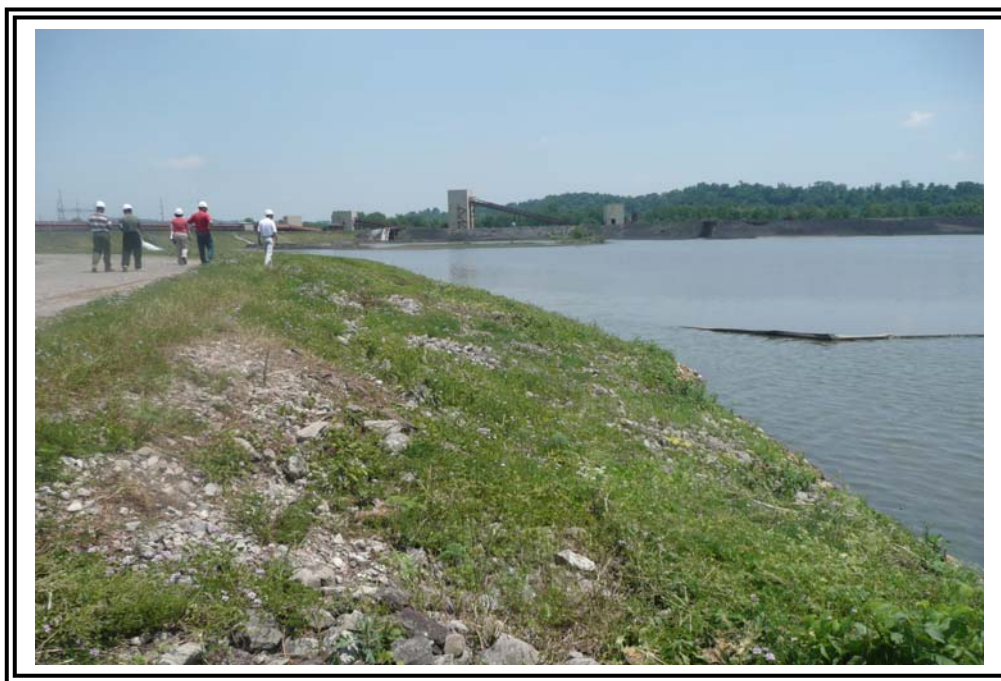
38

Intermediate dike, looking east.

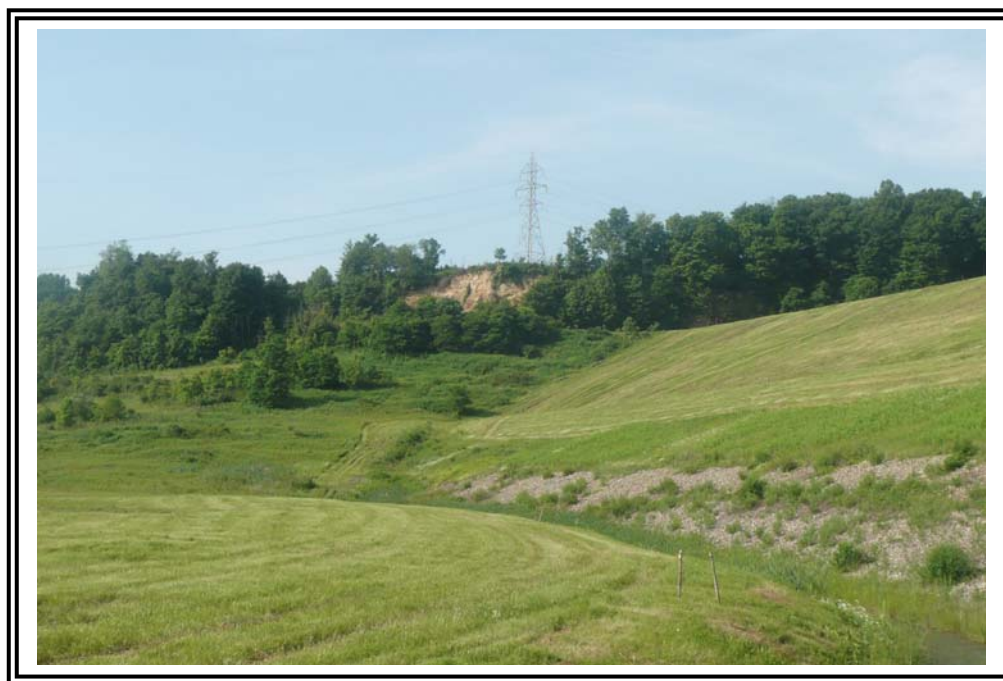
50

Right (south) downstream abutment contact.

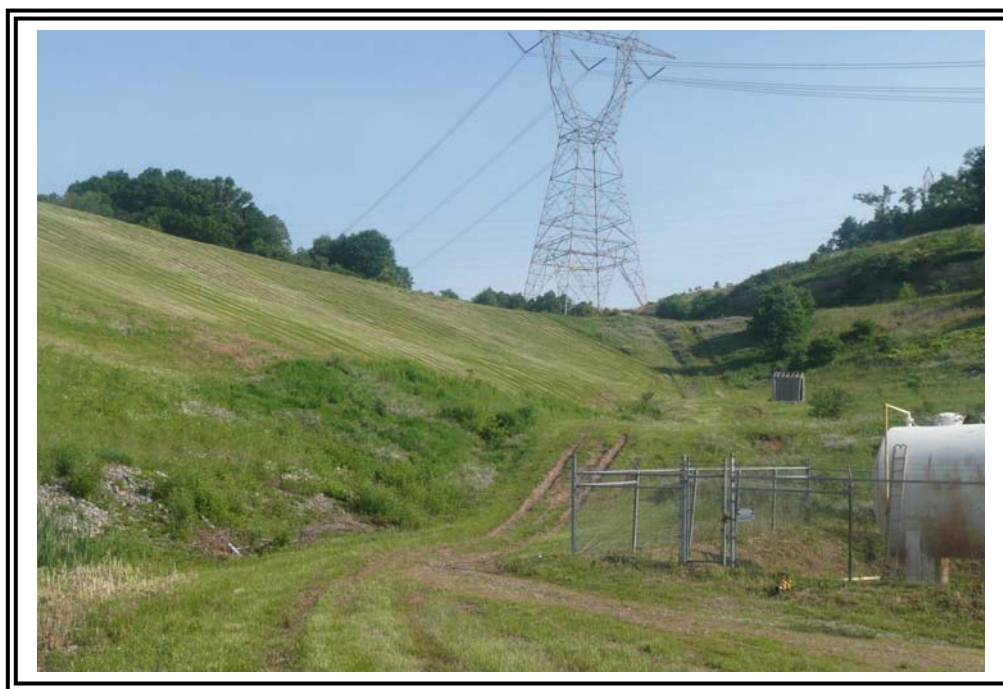
51

Left (north) downstream abutment contact.

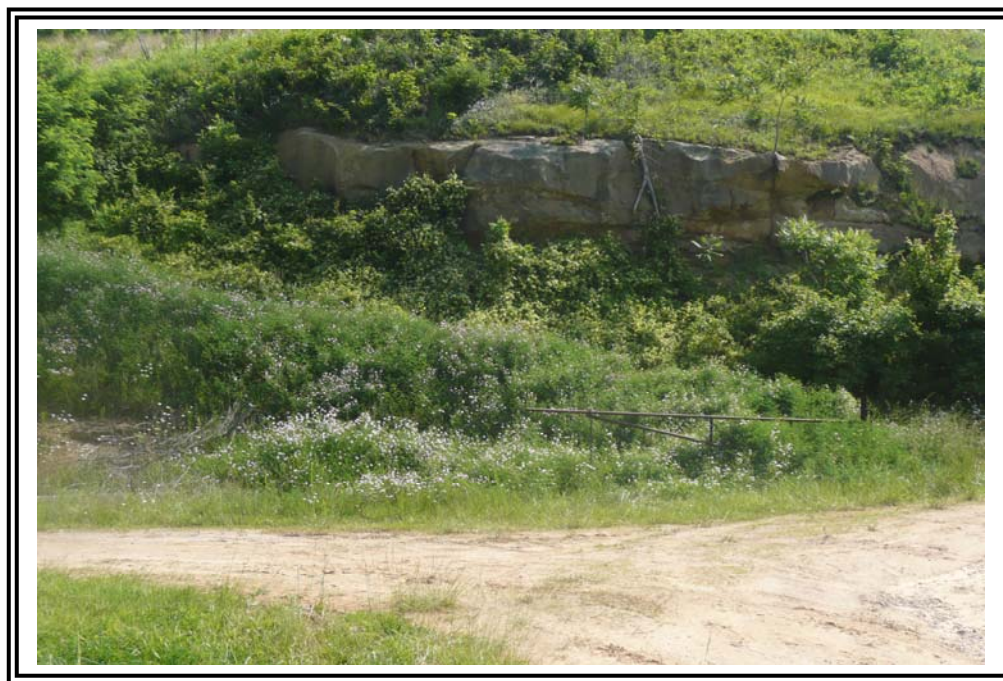
62

Left (north) abutment.

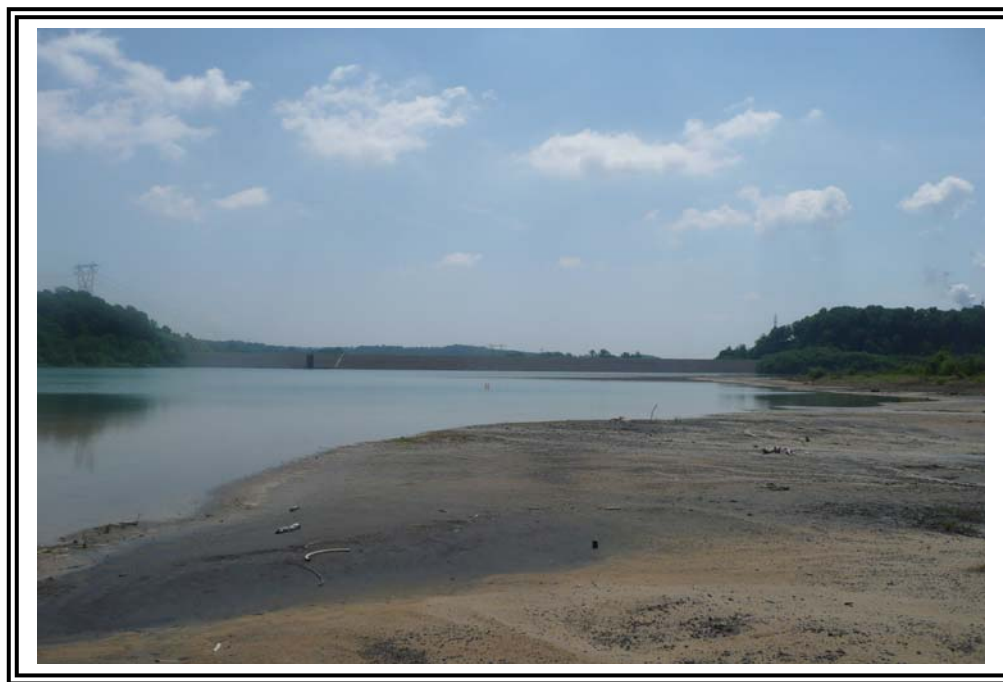
64

Upstream slope of the dam.
