**FINAL REPORT  
ROUND 10 DAM ASSESSMENT  
AMERICAN ELECTRIC POWER  
PICWAY GENERATING STATION  
ASH POND**

**August 17, 2012**

Re: Round 10 Dam Assessment - Final Report  
EPA Contract No. EP10W001313  
American Electric Power – Picway Generating Station  
Ash Pond  
Lockbourne, Ohio

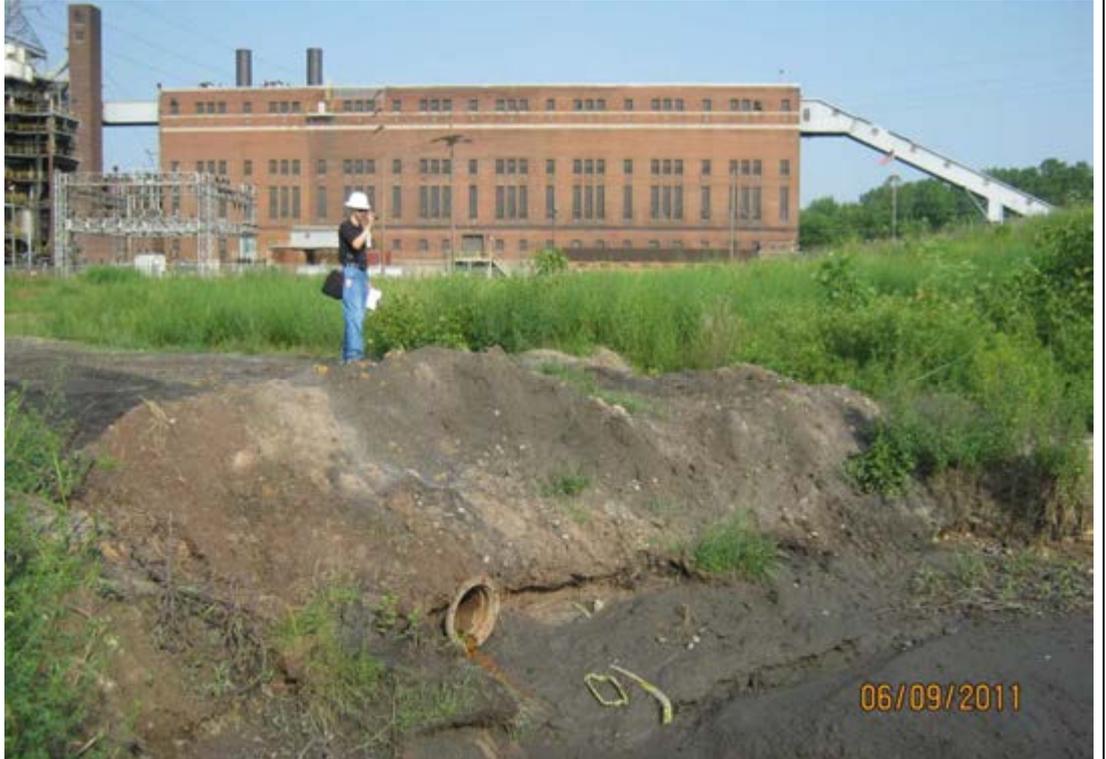
Photo No. 2

Description: Outlet structure located in Cell S3 of south pond.

6. Maintain interior slopes of at least 2H:1V during ash excavation as recommended by BBC&M;
7. Install a staff gauge on or near the outlet structure in Cell S3 and on or near the concrete discharge structure in the clearwater pond in order to take periodic measurements of the Ash Pond water surface elevation;

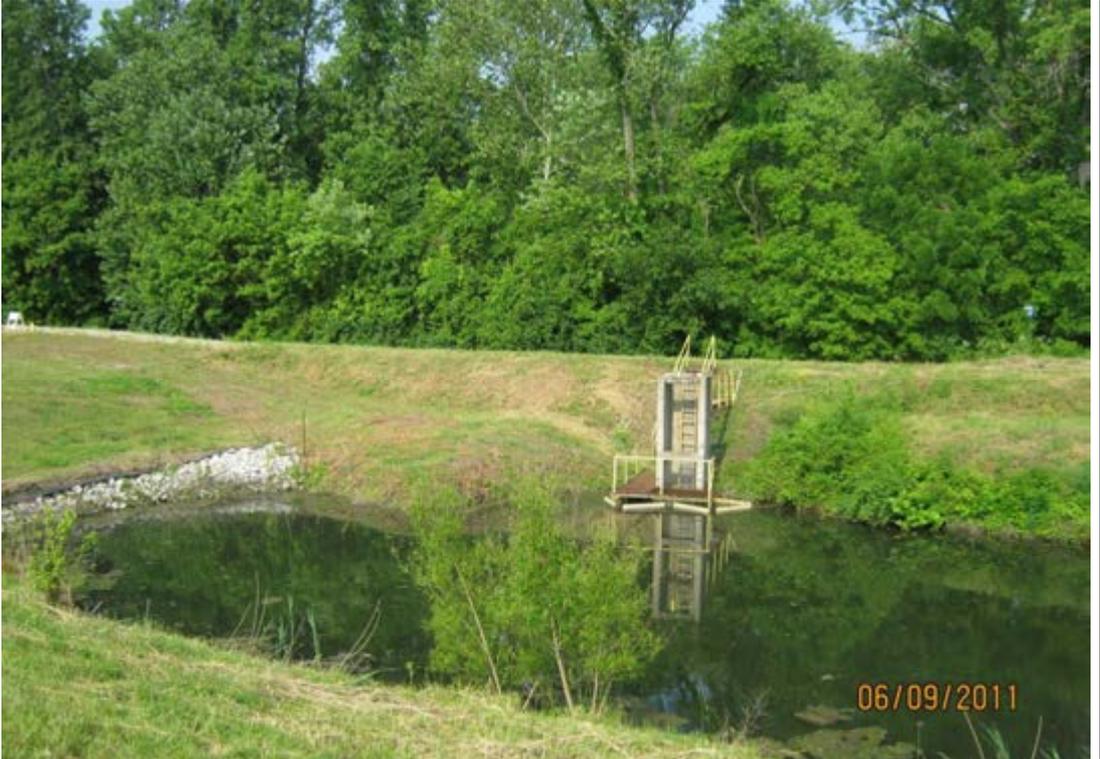
<b>Client Name:</b> U.S. Environmental Protection Agency		<b>Site Location:</b> American Electric Power (AEP) Picway Generating Station Lockbourne, Ohio	<b>Project No.</b> 01.0170142.30
<b>Photo No.</b> 9	<b>Date:</b> 06/09/11

10. Minor ruts on crest from vehicle traffic;
11. Minor surficial pitting or flaking/cracking on the concrete discharge structure;

<b>Direction Photo Taken:</b> Southwest			
<b>Description:</b> View of concrete discharge structure in clearwater pond.

1. Minor concrete repair work on the concrete discharge structure in the clearwater pond;
2. Re-seed and/or over seed bare areas of the embankments and crest to establish healthy grass cover;
3. Clear the area of established vegetation near the lower portion and toe of the outer embankment slopes near the outfall structure; and,
4. Regrade areas near the toe of exterior slopes to facilitate proper drainage away from the embankments.

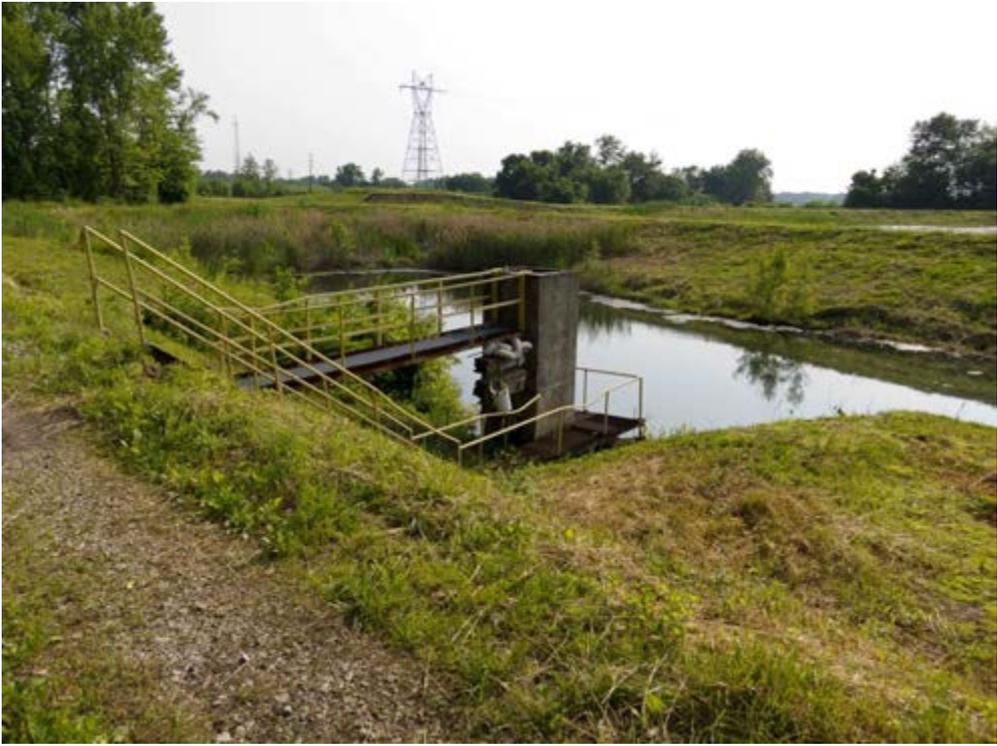
<b>Photo No.</b> 10	<b>Date:</b> 06/09/11

<b>Direction Photo Taken:</b> Northeast		
<b>Description:</b> View of concrete discharge structure in clearwater pond.

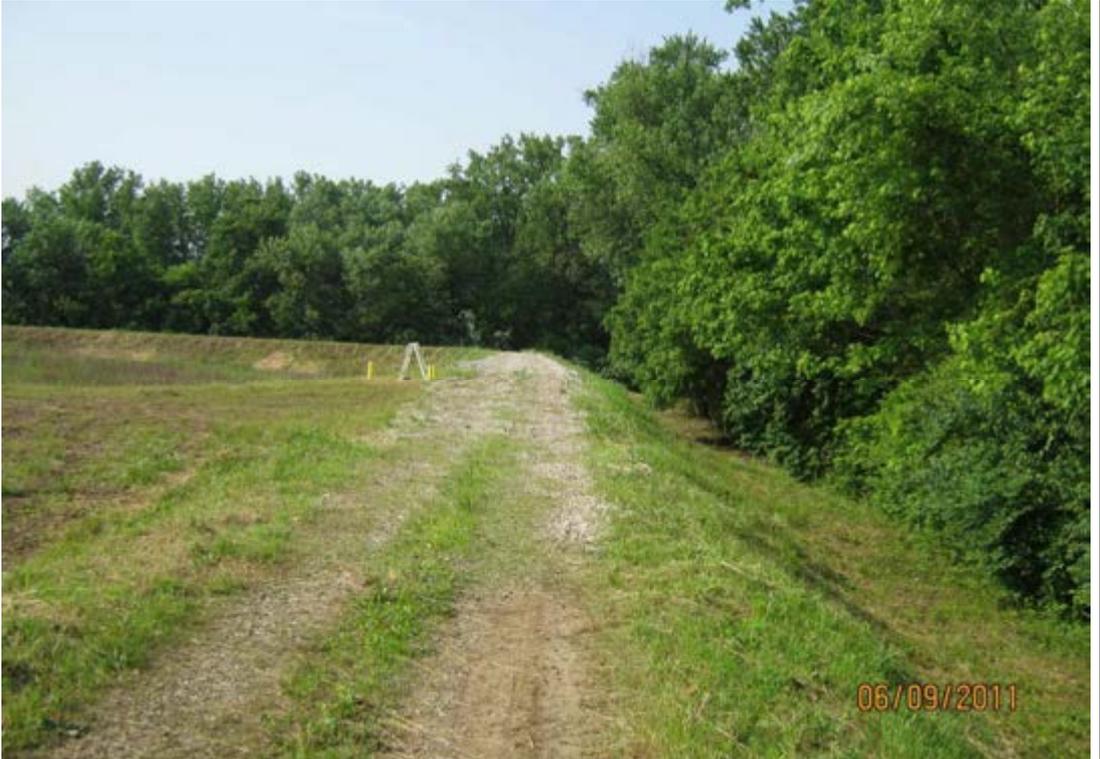
<b>Client Name:</b> U.S. Environmental Protection Agency		<b>Site Location:</b> American Electric Power (AEP) Picway Generating Station Lockbourne, Ohio	<b>Project No.</b> 01.0170142.30
<b>Photo No.</b> 15	<b>Date:</b> 06/09/11

<b>Direction Photo Taken:</b> South			
<b>Description:</b> View of west embankment of the south pond in vicinity of concrete discharge structure in clearwater pond and vicinity of boring B-0903 performed by BBC&M in August 2009. Note variable elevation of crest

1. Survey of the crest of both ponds by a licensed Professional Surveyor to evaluate the current elevation profile of the crest and confirm that survey monuments are not moving horizontally;
2. Evaluate freeboard conditions based on maximum pool elevation and more recent topographical data; and,
3. Camera survey of the CMP outfall should be performed.

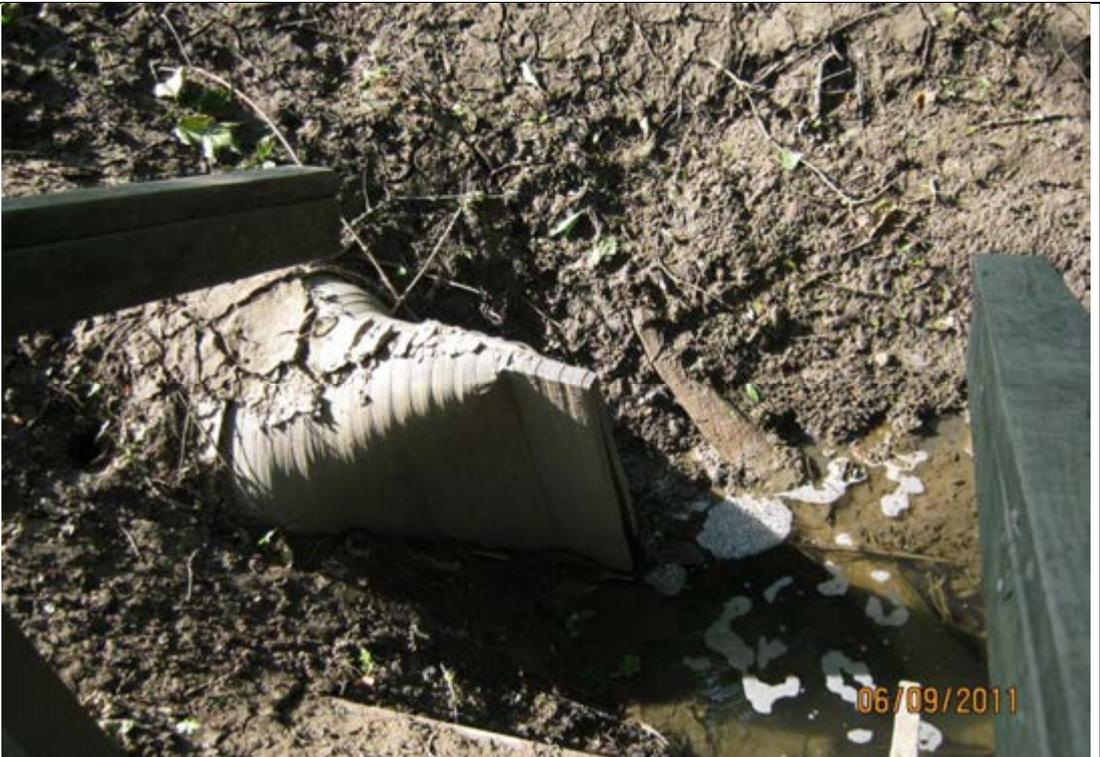
<b>Photo No.</b> 16	<b>Date:</b> 06/09/11

<b>Direction Photo Taken:</b> South			
<b>Description:</b> View of duck-bill flap gate outfall (Outfall 601 in NPDES permit). Water discharges from clearwater pond to a canal that ultimately discharge into the Scioto River.

9. Perform periodic water level measurements in the monitoring wells to evaluate water levels below the crest and at the toe of the embankments; and,
10. If AEP has the opportunity to stop discharging from the clearwater pond for a limited time period, inspect the discharge pipe from the concrete discharge structure to the duck-bill flap gate to verify that the pipe is operating correctly and is in good condition. This may be performed by video photography.

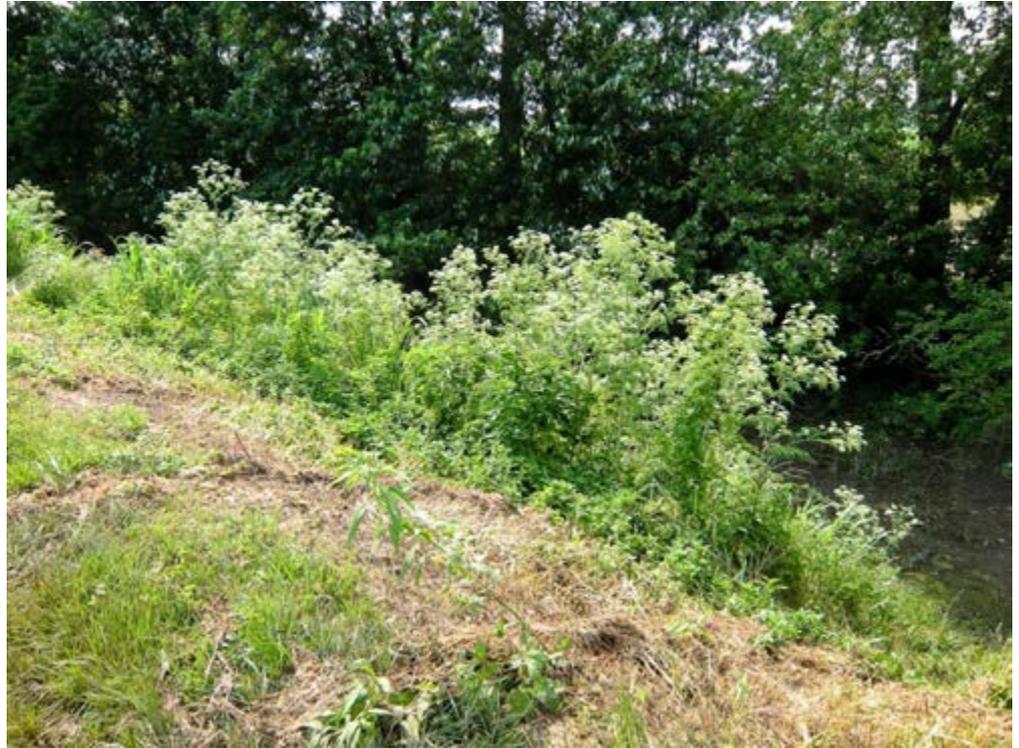
View of crest and outer south embankment of the north pond. Note un-mowed vegetation.

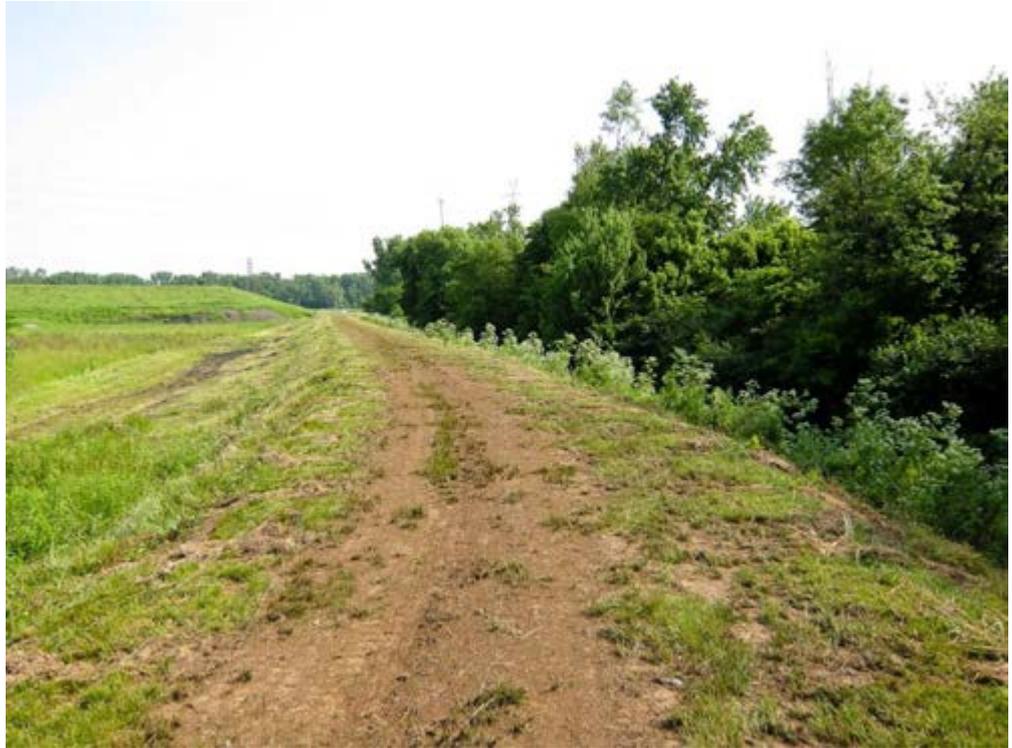
View of crest of east embankment of the north pond. Note un-mowed vegetation on outer embankment and capped portion of north pond in left background.

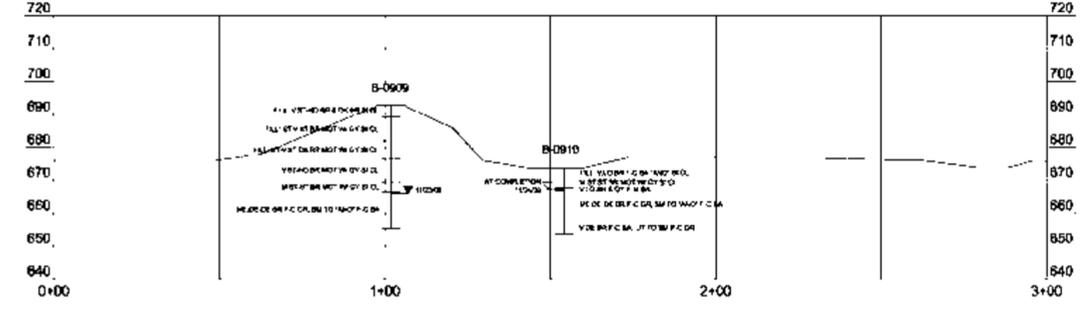
SECTION D  
B-0909 & B-0910

As can be seen in the profile of Section D, the south embankment on the south pond is over-steepened and shallow sloughs have been observed at this location. As was noted by BBCM in the previous condition survey (March 2009), the outboard slope of this embankment should be re-graded. BBCM understands that subsequent to our March 2009 inspection visit, an attempt has been made to regrade the slope back to original design grades with a sidehill fill, however proper benching techniques were not used and the fill material flowed down the slope. To this end, it is important that additional steps be taken to stabilize this area.
