# ASSESSMENT OF DAM SAFETY OF COAL COMBUSTION SURFACE IMPOUNDMENTS

**FirstEnergy Corp  
Albright Power Station  
Albright, West Virginia**

Prepared for  
*U.S. Environmental  
Protection Agency  
Washington, D.C.*

October 2012

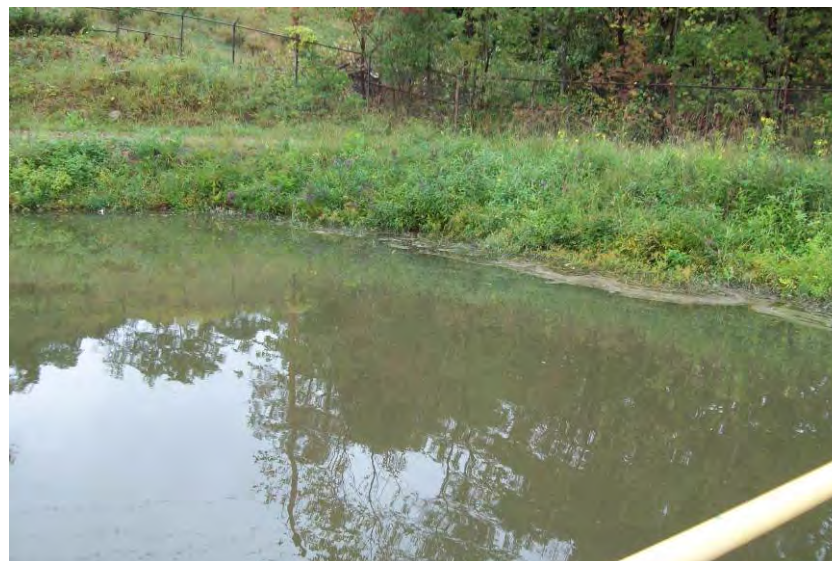
Photo 14: North embankment interior slope, looking west.

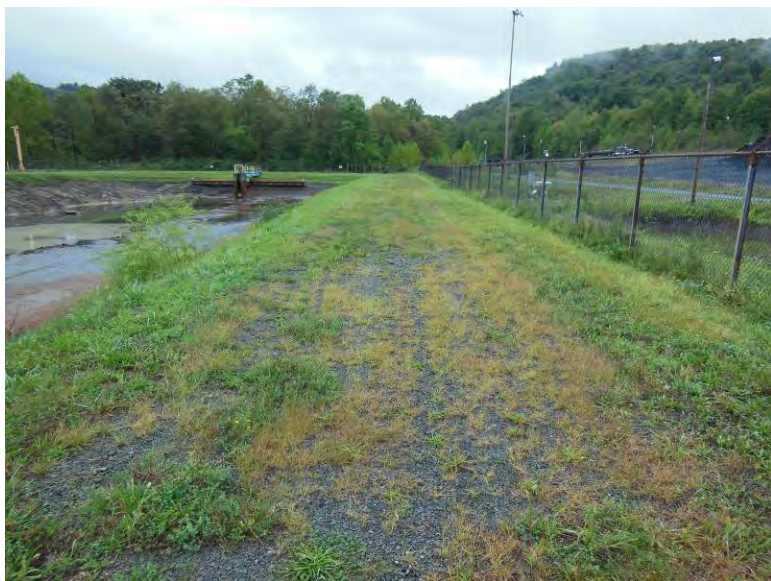
The crest of the South Lagoon appeared to be in satisfactory condition (Photographs 28, 32, 37 and 43). The crest ranged from 20 to 25 feet wide. The crest of the embankment consists of compacted gravel and grass and is exposed to minimal vehicle traffic. No depressions or evidence of settlement were observed on the crest.

Photo 32: West embankment crest, looking south.

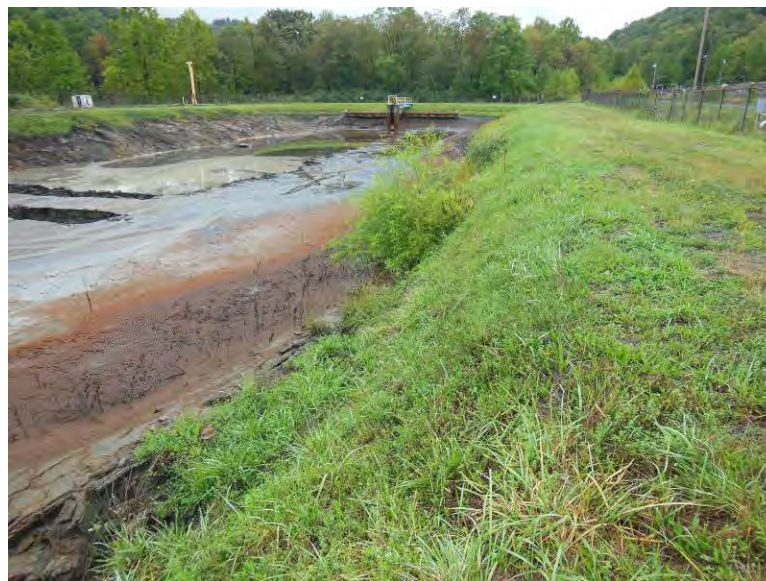
Interior slopes appeared to be in fair condition (Photographs 29, 33, 36, and 45). Areas of erosion were located just downstream at each of the three inlet pipes at the north embankment (Photograph 31) and at the inlet pipe at the west embankment (Photograph 34). Based on construction drawings, the interior slopes are 3H:1V at all embankments. Grassy vegetation covered the upper portion of the interior slopes.

Photo 33: West embankment interior slope, looking south.

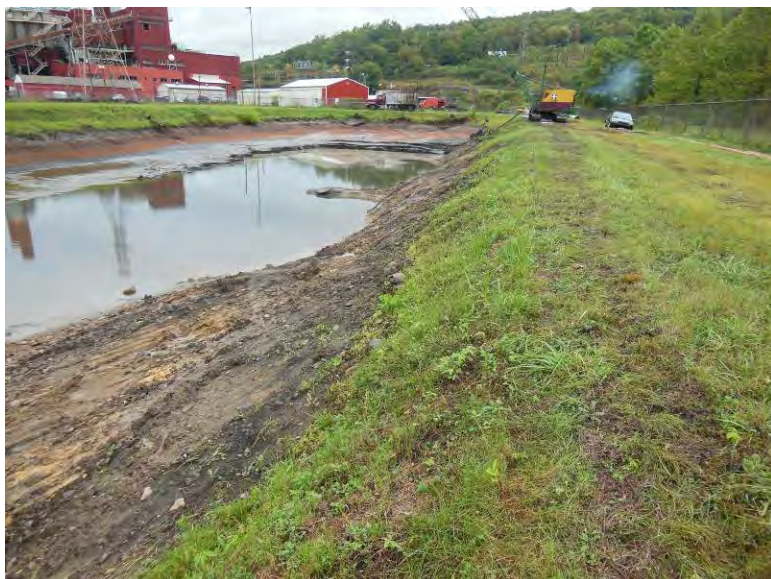
Photo 44: East embankment interior slope, looking north.

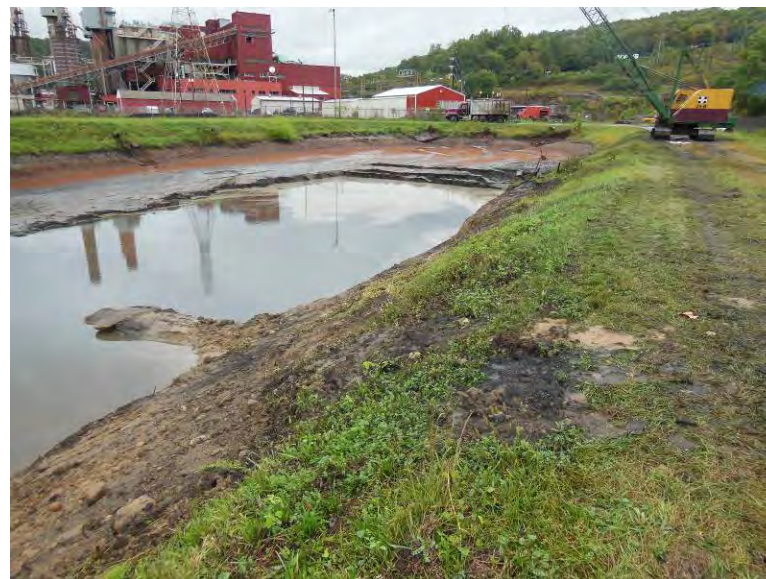
Photo 45: East embankment interior slope, looking north.

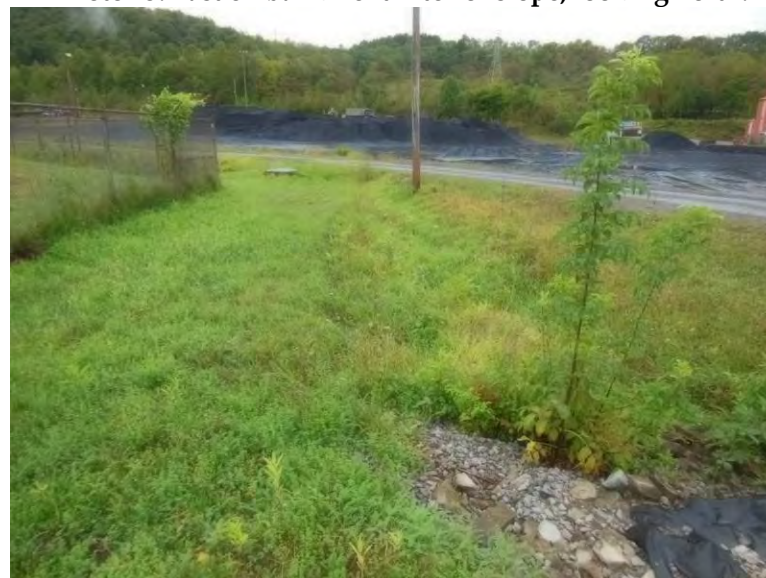
The lagoon includes exterior slopes on the west, east, and south embankments. The north embankment is incised (Photograph 47). Due to the terrain and vegetation on the exterior slopes of the east and south embankments of the South Lagoon, the slopes were only visible from the embankment crests. The west embankment exterior slope is a coal pile runoff drainage and storage ditch which was nearly full during the site assessment (Photographs 49, 51, and 52). Based on observations during the site assessment, the exterior slopes appear to be in satisfactory condition. The exterior slopes of the south and east embankments are between 1H:1V and 3H:1V based on topographic drawings. The exterior slopes of the south and east embankments are generally covered in dense vegetation (Photographs 55, 56, 59, and 62). The Cheat River is at the east embankment's exterior toe (Photographs 56 and 62).

Photo 47: North embankment exterior slope, looking west.

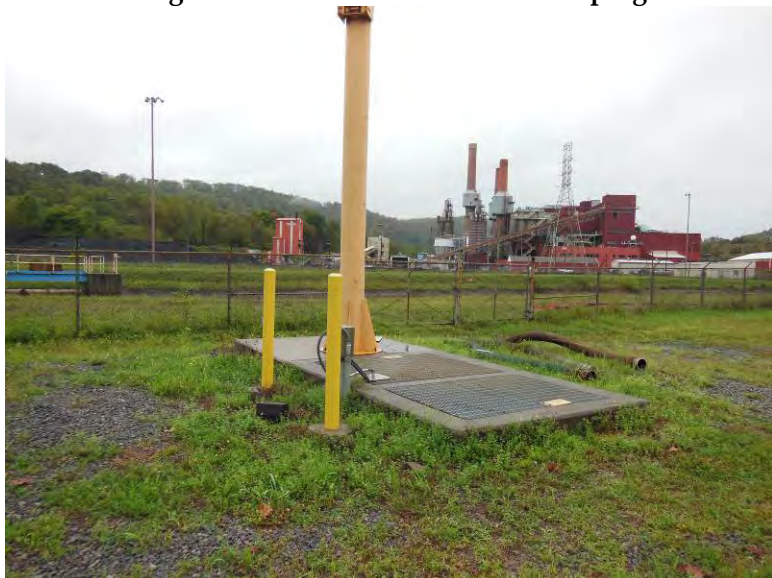
Photo 58: Sump structure near southeast corner, looking northwest.

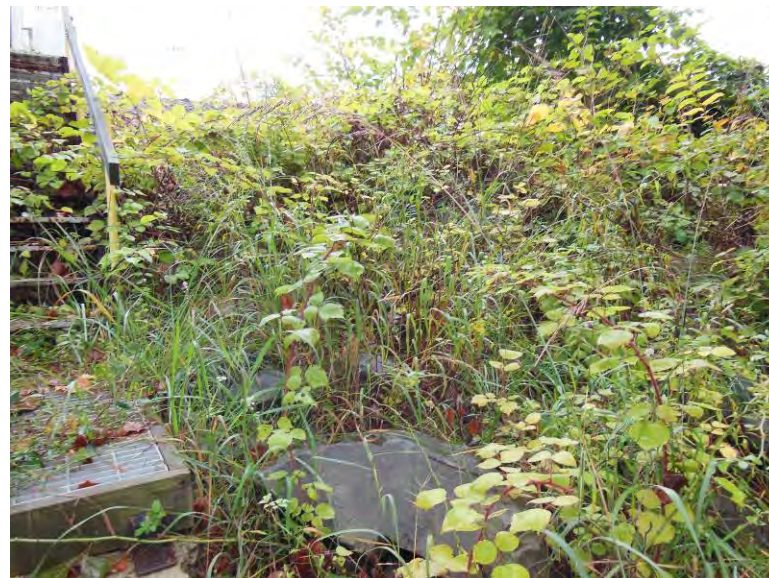
Photo 59: East embankment exterior slope at stairs to outfall, looking northwest. Note typical vegetation.

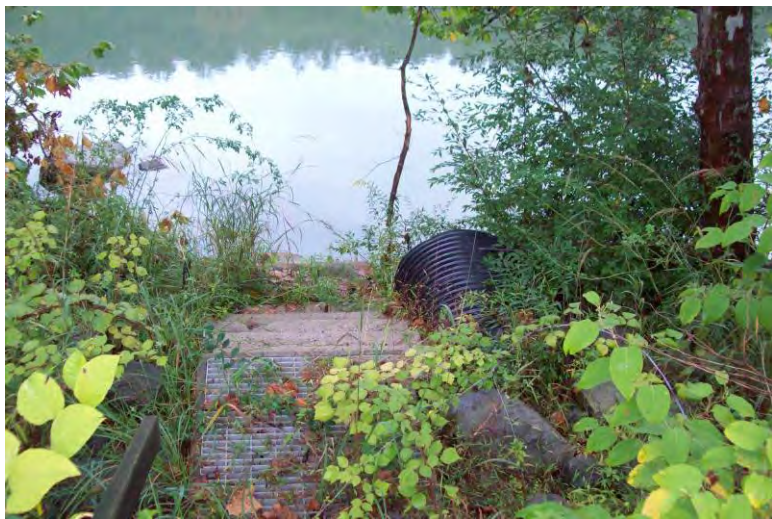
The outlet structure consists of a metal v-notched weir near the north embankment discharging to a 24-inch concrete pipe (Photographs 36, 39, and 42). The outlet structure also includes an opening with stoplogs at the end of a catwalk (Photograph 41) which also discharges to the 36-inch concrete pipe (Photograph 40). The stoplogs were removed during the site assessment. The 36-inch concrete pipe discharges into a sump structure (Photograph 58) that directs liquids to the on-site wastewater treatment plant or discharges to the outfall at the Cheat River (Photograph 60).

Photo 60: 36-in-dia outfall into Cheat River at east embankment exterior slope, looking east.
