Report of Geotechnical  
Assessment of Coal Combustion Surface  
Impoundments  
Minnesota Power  
Boswell Energy Center, Cohasset, MN

AMEC Project No. 3-2106-0174.0300

June 2010

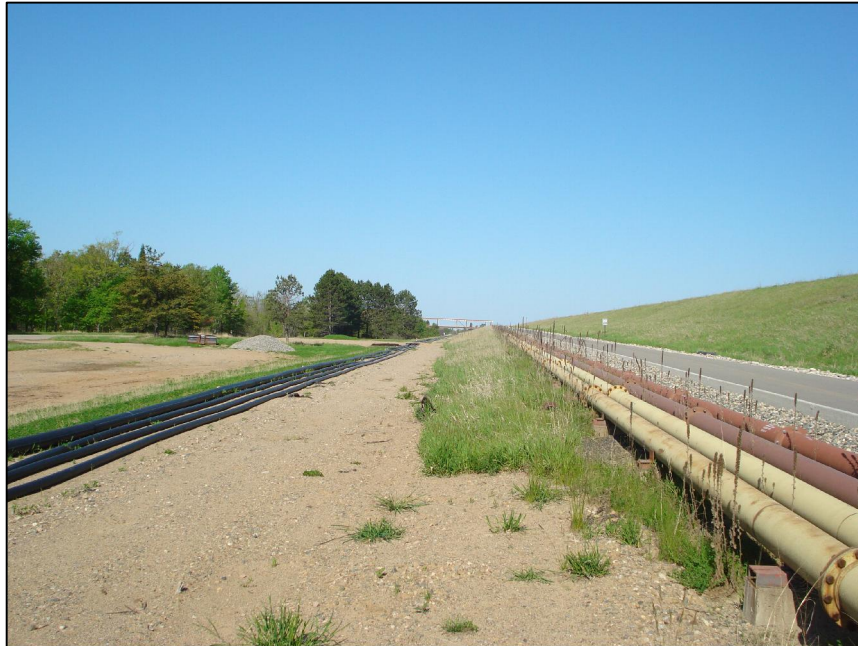
**1-5**  
**FROM TOE OF SOUTHEAST DIKE LOOKING WEST**
