minnesota power / 30 west superior street / duluth, minnesota 55802-2093 / 800-228-4966 / www.mnpower.com

Re. Minnesota Power Laskin Energy Center CCR Site Assessment Follow-Up

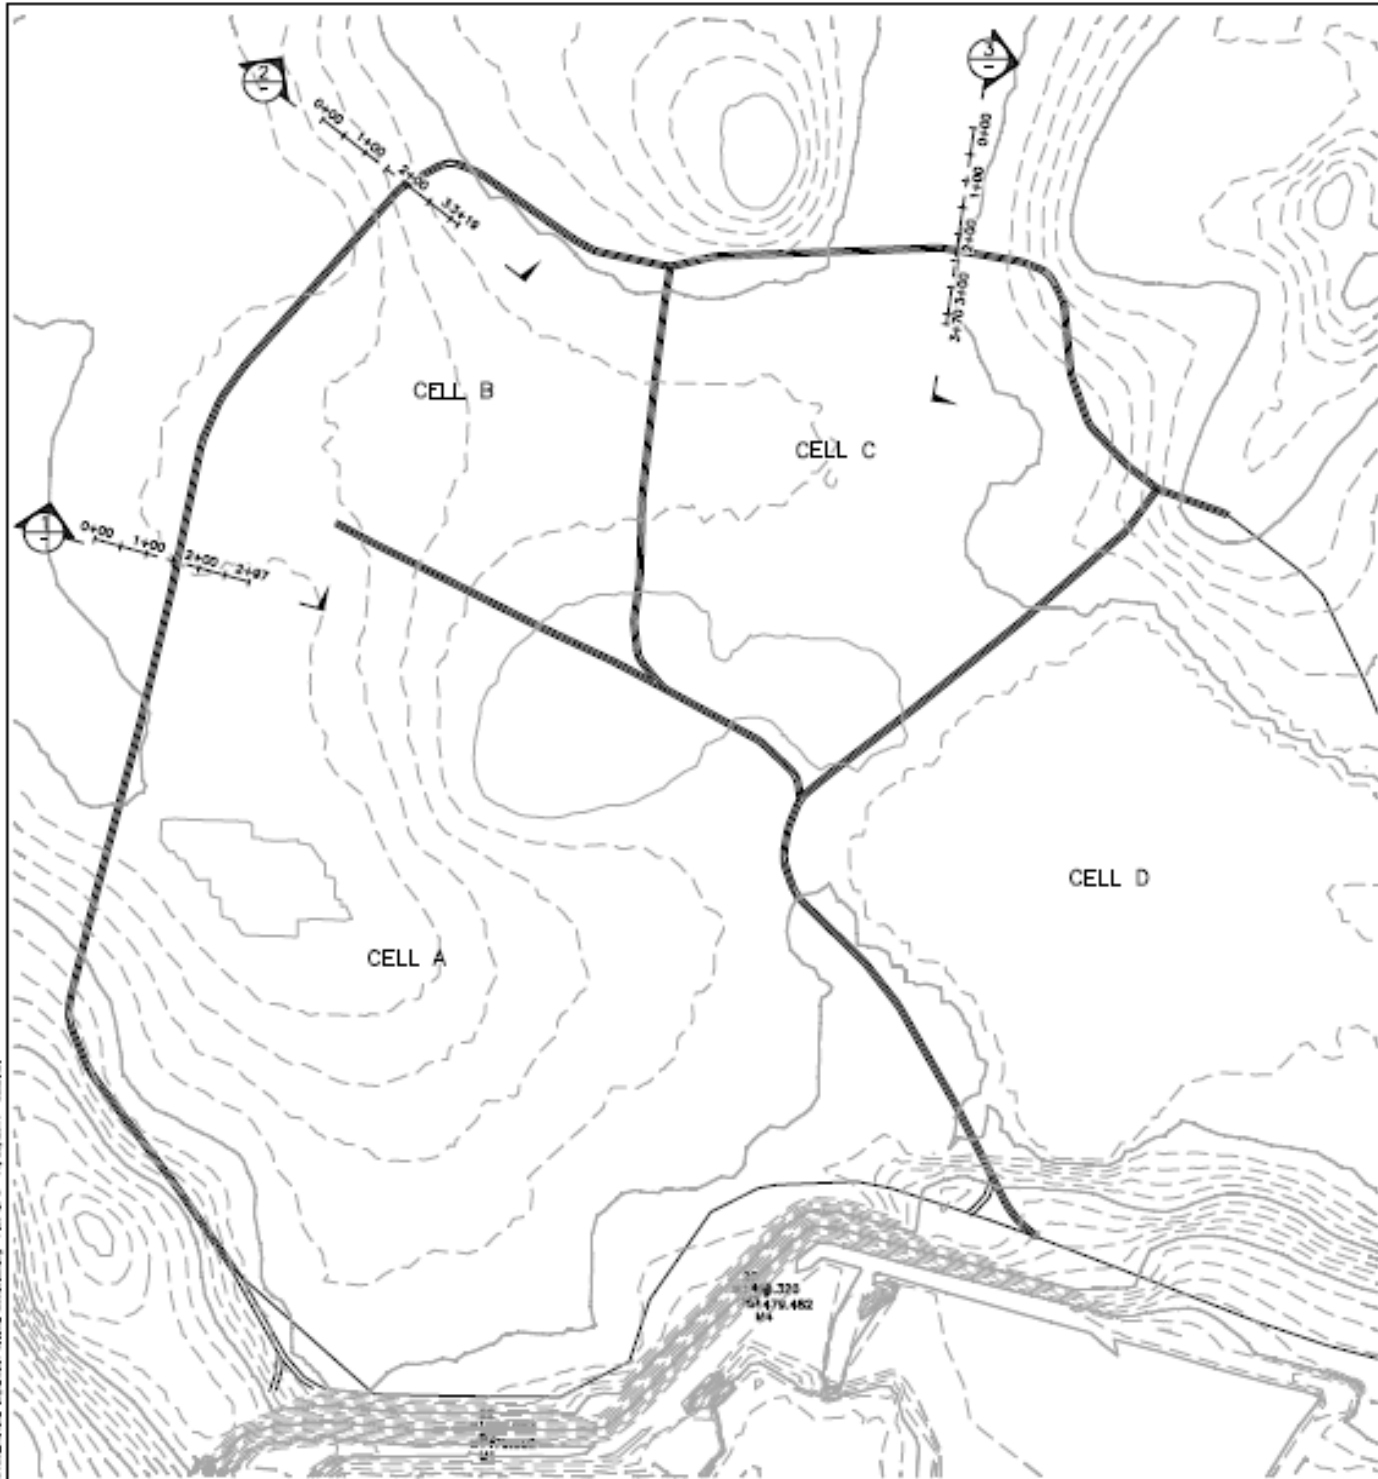
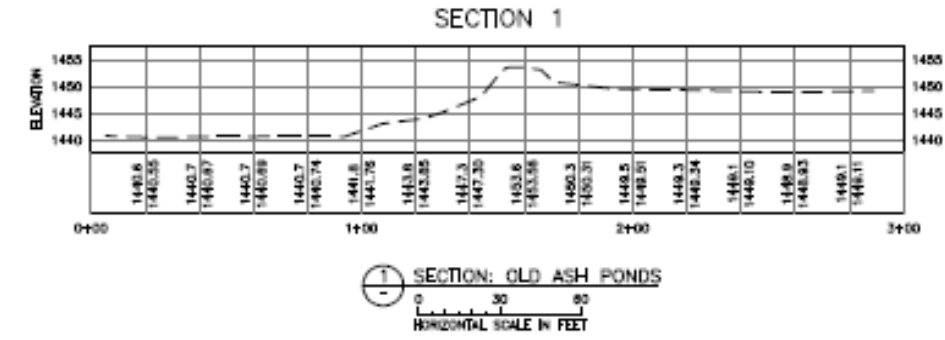
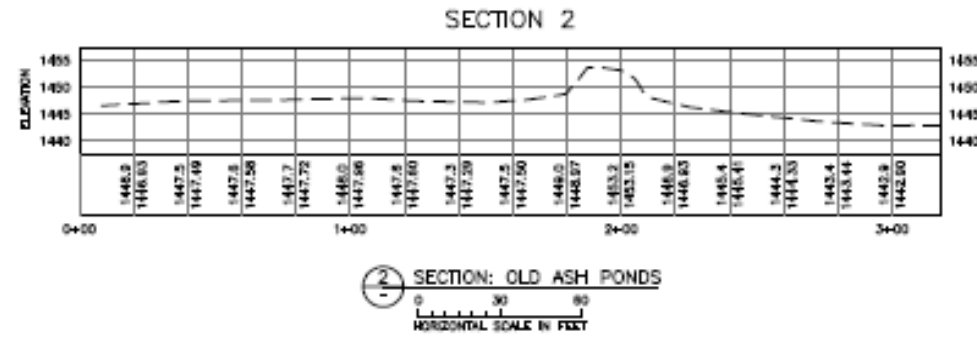
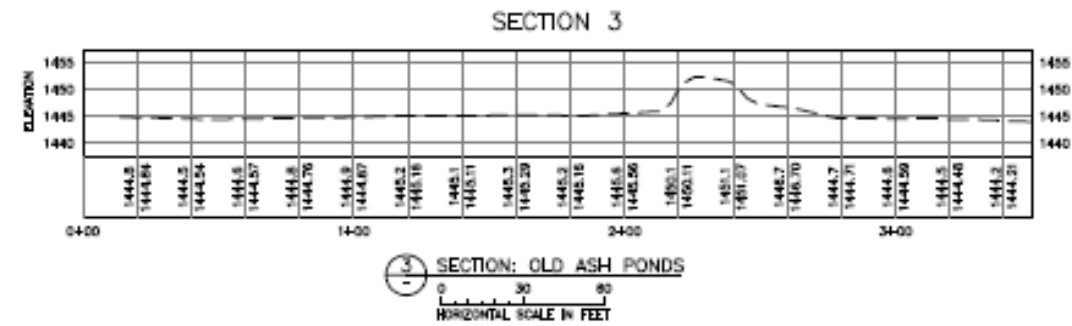
As noted in our August 19, 2011 letter outlining our slope stability analysis plan; the analysis was to be based on assumed material strength parameters. For this analysis we utilized an Effective Stress Stability Analysis (ESSA) on the basis of the embankment having been in place for dozens of years, on the basis of the ash cells having been idle for approximately 12 years, and on the basis of the absence of any ponded water on the interior of the ash cell at the location of Section 1. For the embankment construction materials, which are believed to consist primarily of the on-site glacial till (silty sand and gravel with occasional cobbles and boulders), assumed friction angles were utilized and cohesion was taken as zero. Likewise, for the contained ash and again under the assumption effective stress conditions, assumed friction angles were utilized and cohesion was taken as zero. A sensitivity analysis was performed by varying the embankment material effective stress friction angles within a range of 3 degrees and, although no pond exists in Cell A (the location of Section 1), slope stability analyses were also completed for a hypothetical condition of an elevated pond condition.

Barr Engineering Company recommends that Minnesota Power achieve a long term slope stability safety factor of equal to or greater than 1.5 for long term effective shear stress conditions. This is achieved per the analysis results summarized above. Barr indicates that safety factors as low as 1.3 or lower are acceptable for the hypothetical pond bounce water elevation condition described herein.. This is due to the limited feasibility of such an occurrence. Pond elevations above 1448.5 may have occurred during operations with continuous discharge of ash sluice water into the ponds. However, lacking this discharge, annual precipitation is insufficient to sustain significant ponding in Cell A and even if such a pond bounce were to occur, it would be expected to be short lived.

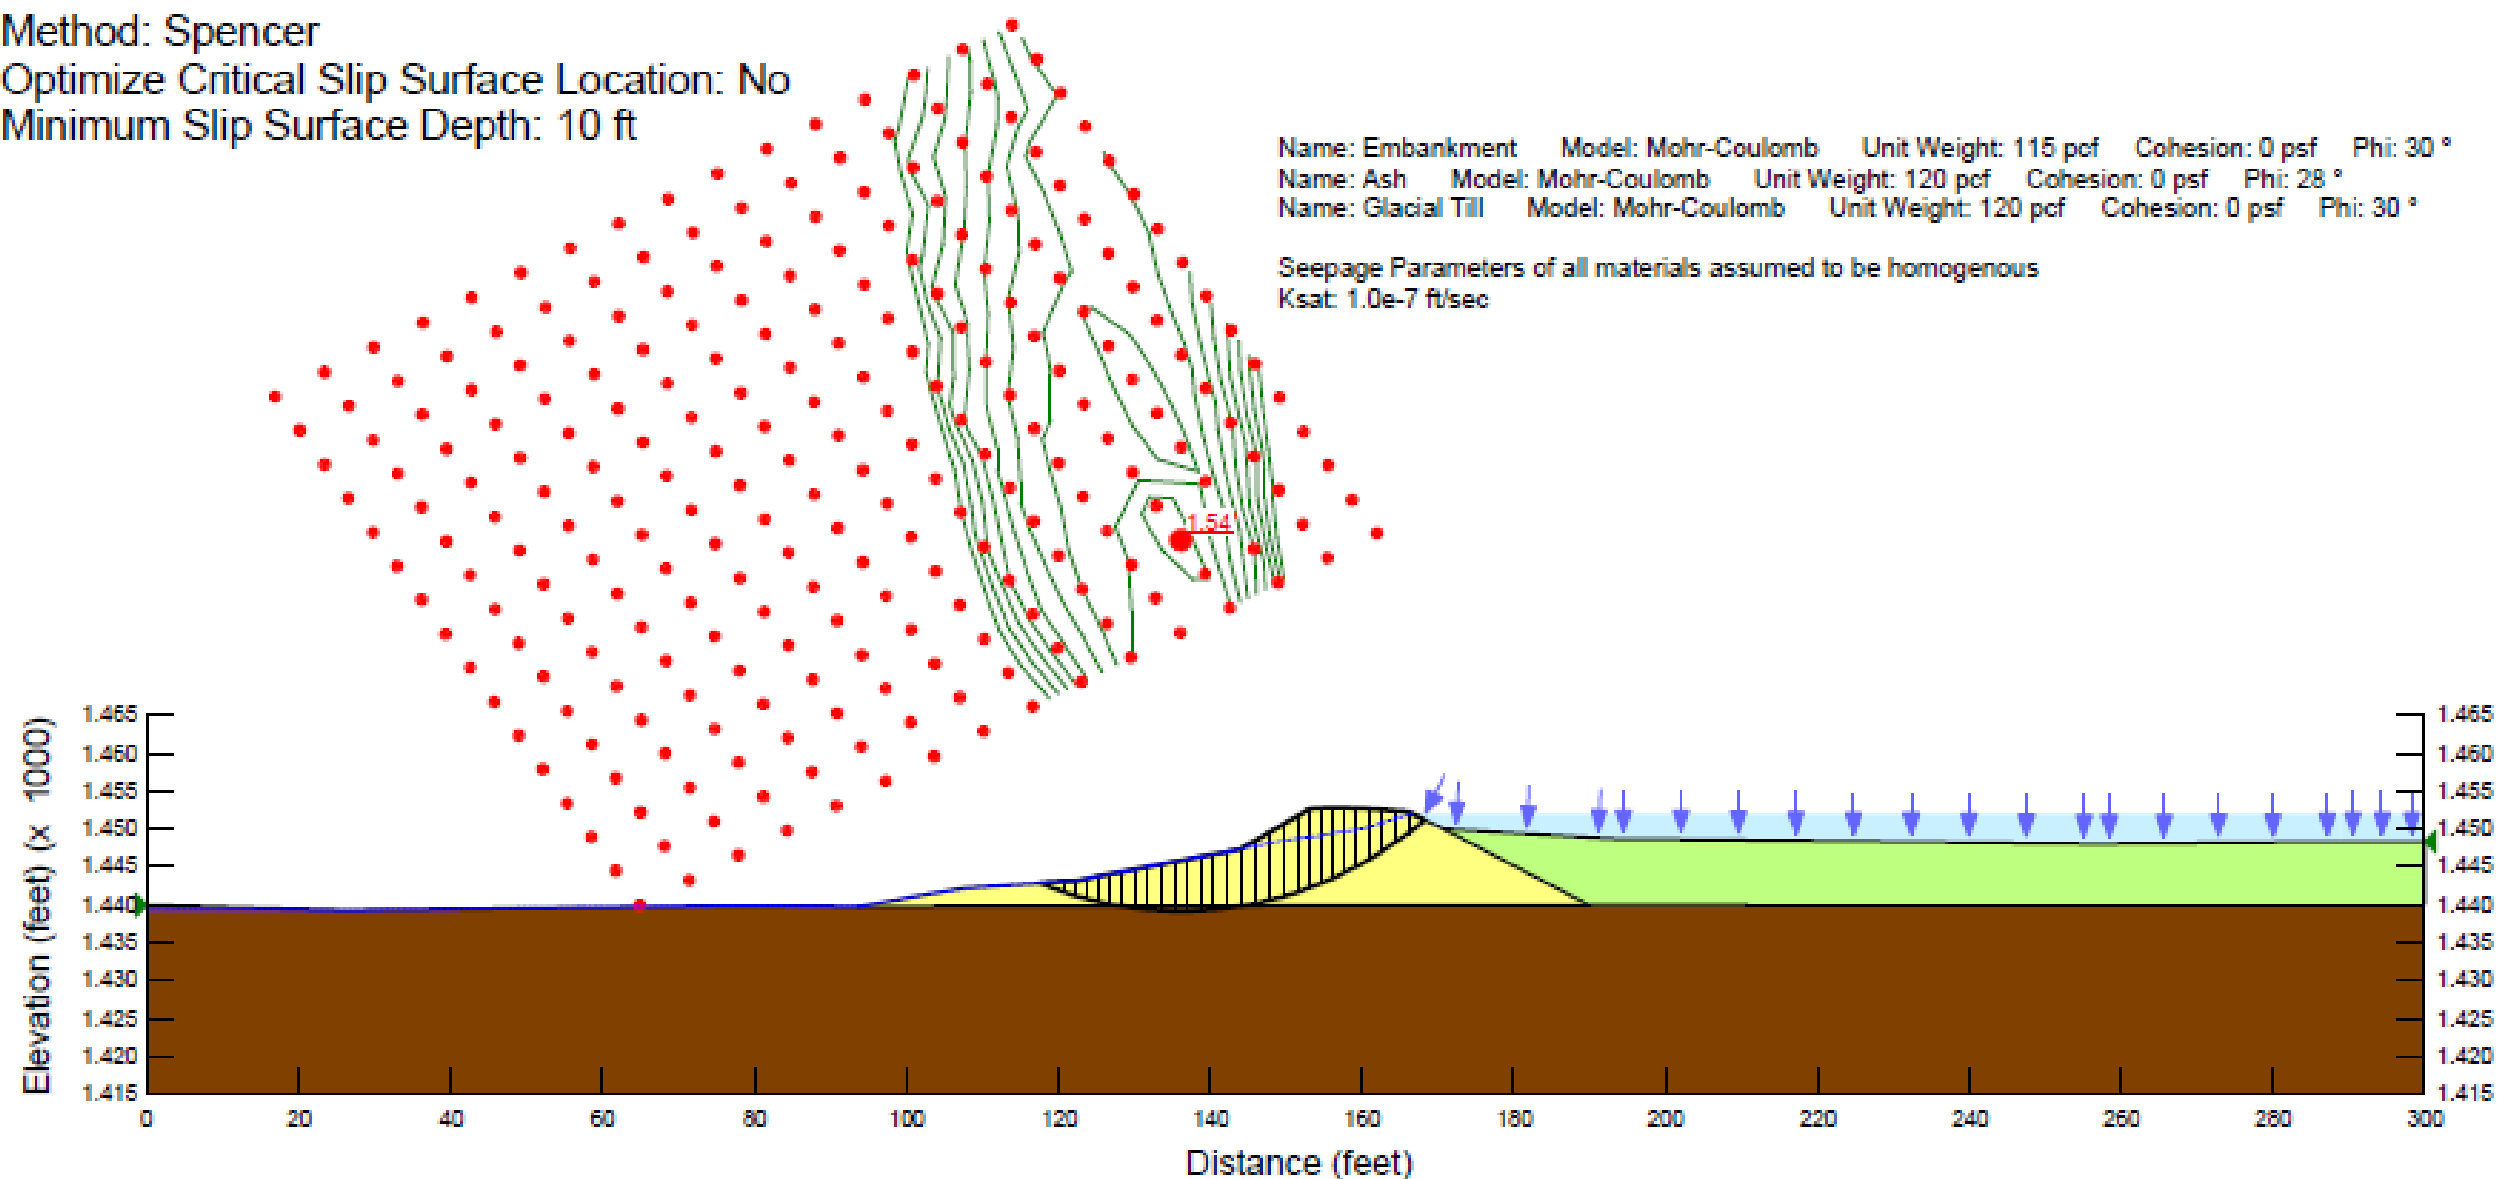
Laskin Energy Center  
Minnesota Power  
EPA Critical Slope Stability Analysis - Section 1  
Steady State Seepage Model - Pond Elev. 1452.0 feet

Critical FOS: 1.54  
Method: Spencer  
Optimize Critical Slip Surface Location: No  
Minimum Slip Surface Depth: 10 ft
