**Coal Combustion Waste Impoundment
Round 7 - Dam Assessment Report**

Burlington Generating Station

*Ash Impoundment Dikes
Interstate Power and Light
Burlington, Iowa*

June 2011

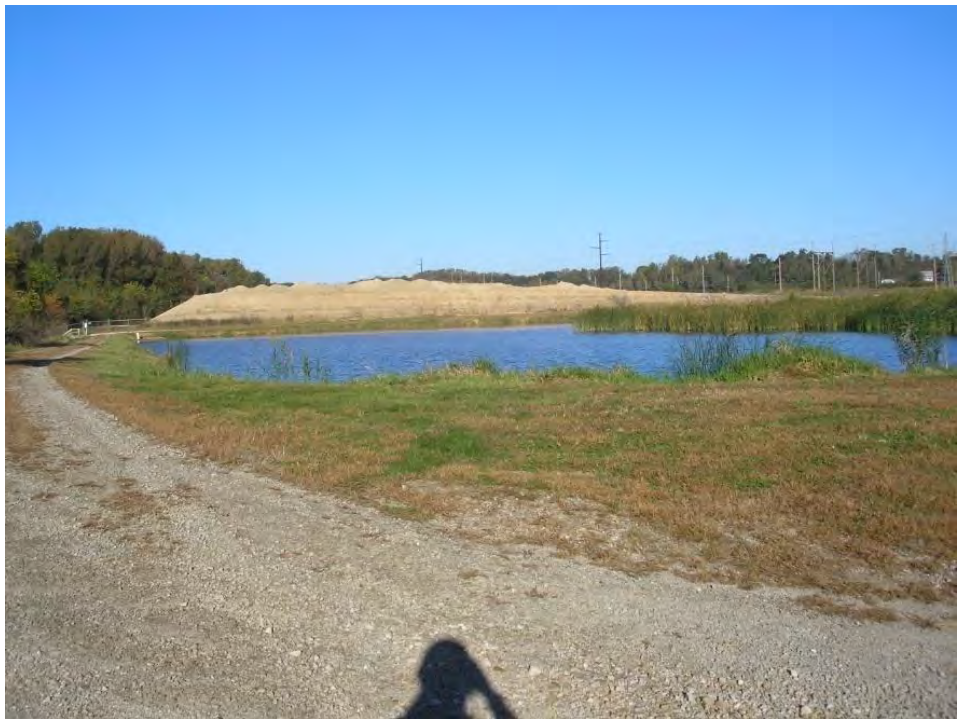
Figure 5.2.1-2: Ash Seal Pond South Dike Crest

The Ash Seal Pond south dike crest is paved with a gravel surface roadway. The crest had no signs of significant depressions, tension cracks or other indications of settlement or shear failure. Photograph 5.2.1-2 shows the Ash Seal Pond south dike crest.

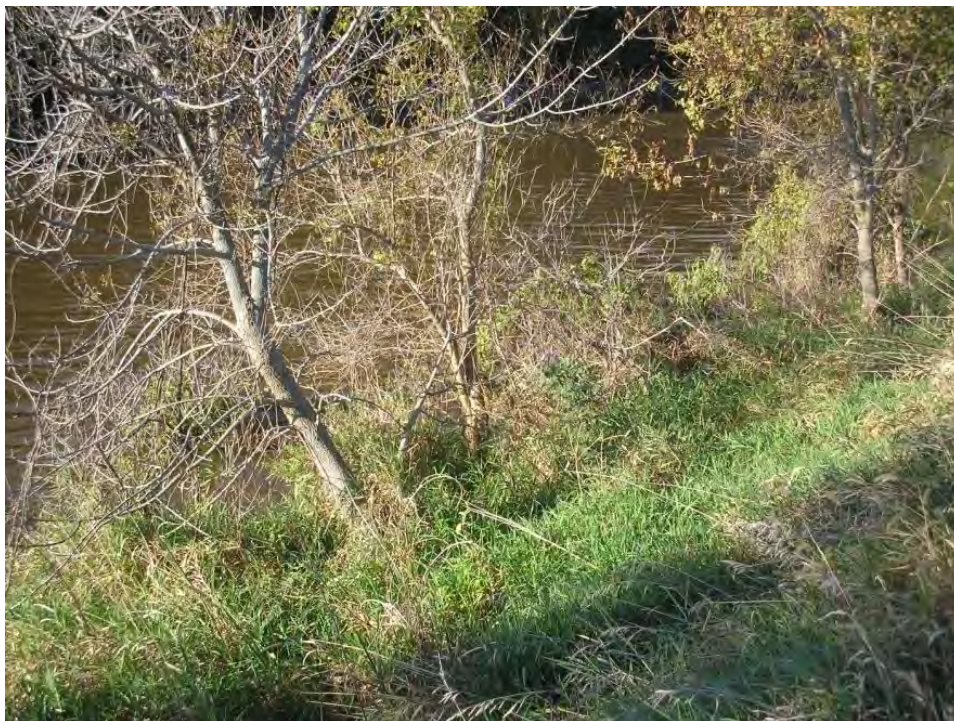
Figure 5.2.3-2: Ash Seal Pond South Dike: Canal High Water against Toe of Outside Slope

The Ash Seal Pond south dike is bordered by the condenser discharge canal that empties directly into the Mississippi River. At the time of Dewberry's site visit flooding of the Mississippi River raised the water level in the canal to reach the toe of the outside slope of the dike. Figure 5.2.3-2 shows the canal against the slope of the embankment.

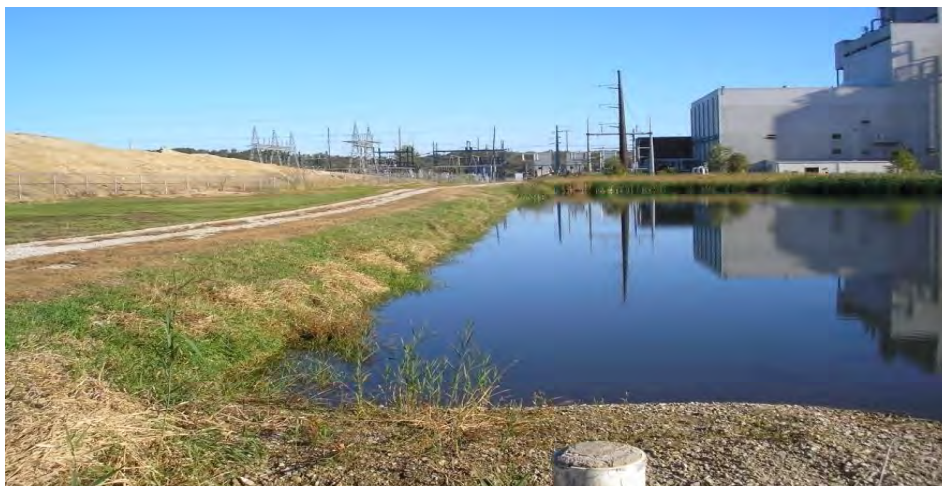
Figure 5.2.3-3: C-Stone Storage Pile over Outside Slope Ash Seal Pond West Dike

The area adjacent to the outside slope of the Ash Seal Pond west dike had been filled to become the C-Stone (local product name for hydrated fly ash) storage. The C-Stone pile at the outside slope of the Ash Seal Pond west dike is shown in Figure 5.2.3-3.

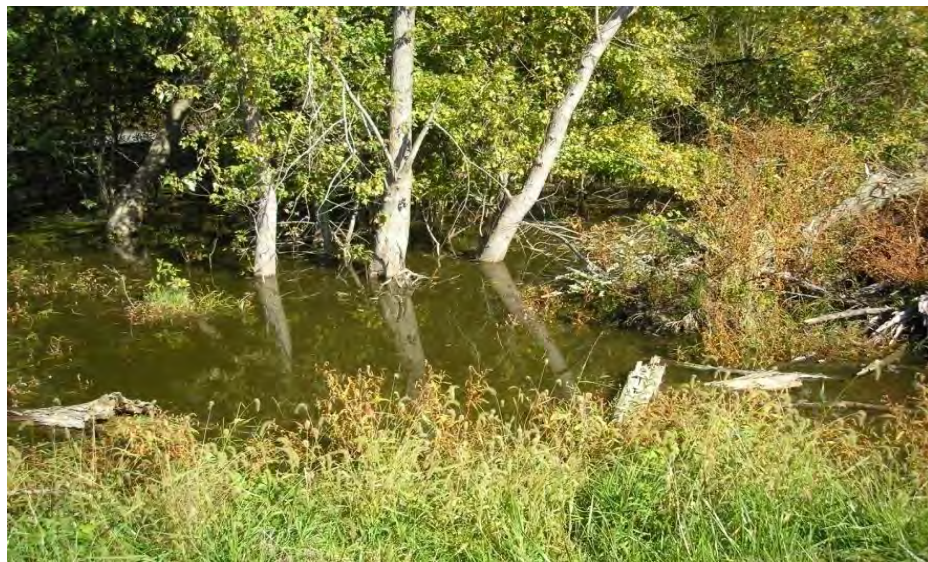
Figure 5.3.3-2: Bottom Ash Pond South Embankment: Discharge Canal Flooding back-up to Downstream Slope Toe

Flooding of the Mississippi River into the condenser discharge canal resulted in high water along the toe of the Bottom Ash Pond south dike downstream slope. Figure 5.3.3-2 shows canal water along the slope toe.

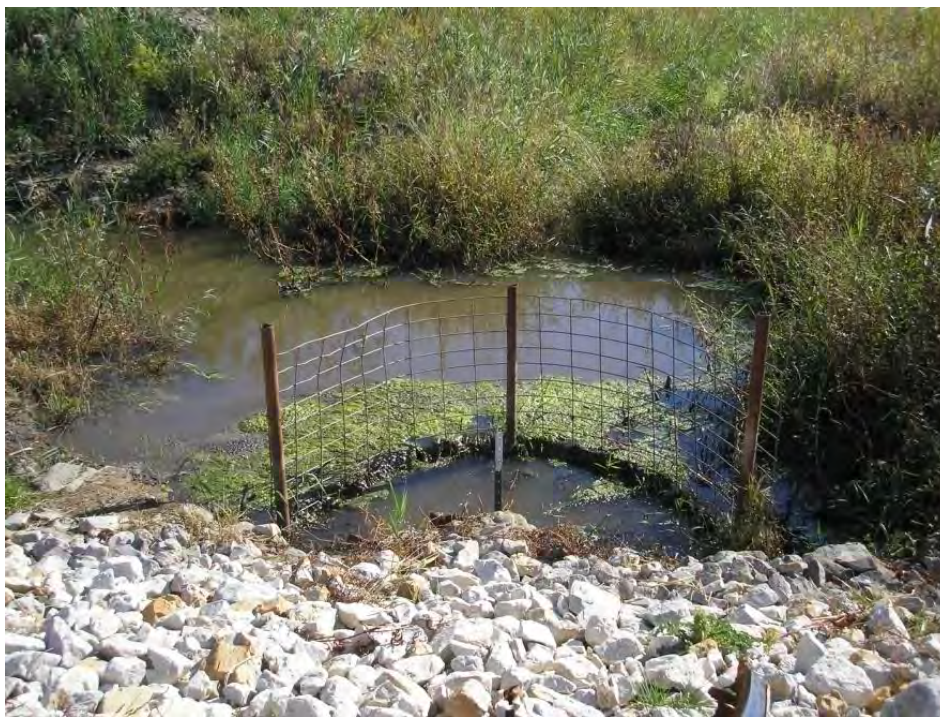
Figure 5.4.4-1: Economizer Ash Pond West Abutment and Pipe Spillway Invert

The Economizer Ash Pond east abutment area was filled with dry fly ash. As the west abutment was the location of the gravity discharge to Ash Pond 1, standing water was present. Figure 5.4.4-1 shows standing water at the western abutment of the Economizer Ash Pond dike.

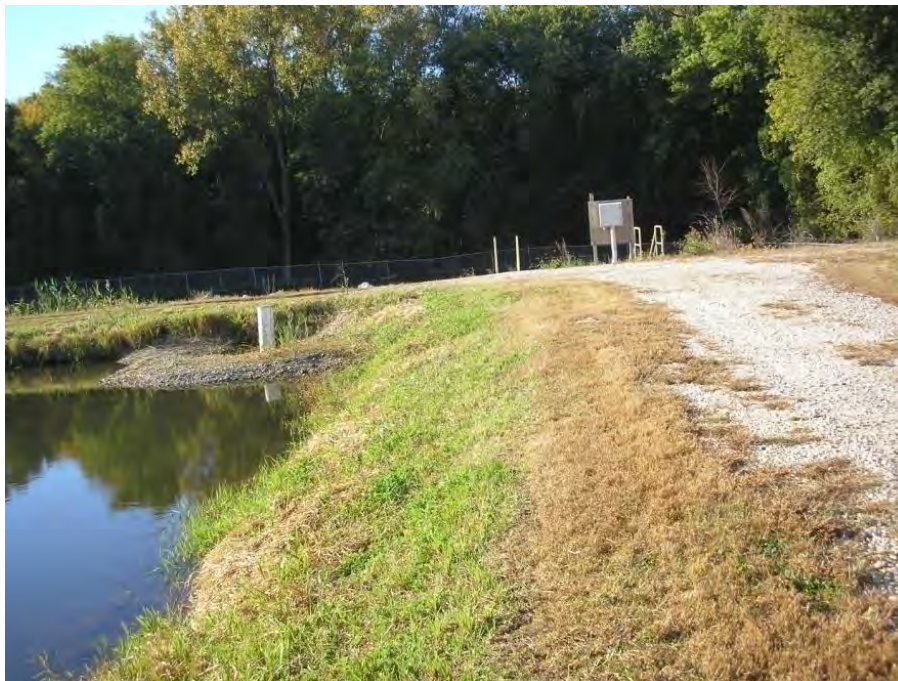
Figure 5.7.1-1: Ash Seal Pond Primary Spillway Structure.

The Ash Seal Pond former overflow structure is located in the southwest corner of the impoundment at the intersection of the south and west dikes. The overflow structure was permanently closed and decommissioned in 2009. The outfall has been removed from the NPDES permit. Figure 5.7.1-1 shows the overflow structure.

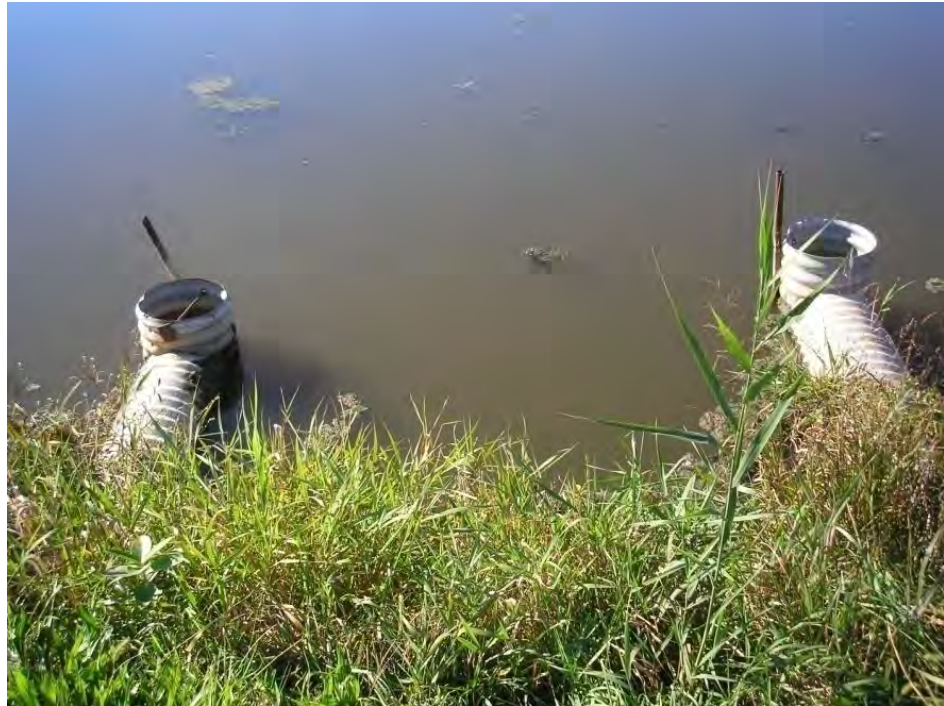
Figure 5.7.1-2: Bottom Ash Pond Primary Spillway Structure

Water in the Bottom Ash Pond is routed by interior ditches to the south and west, then north to the main plant access road embankment, which also serves as the north dike of the Bottom Ash Pond. Water then flows from the Bottom Ash Pond through two 18-inch diameter corrugated metal pipes through the access road embankment. Figure 5.7.1-2 shows the Bottom Ash spillway pipes.

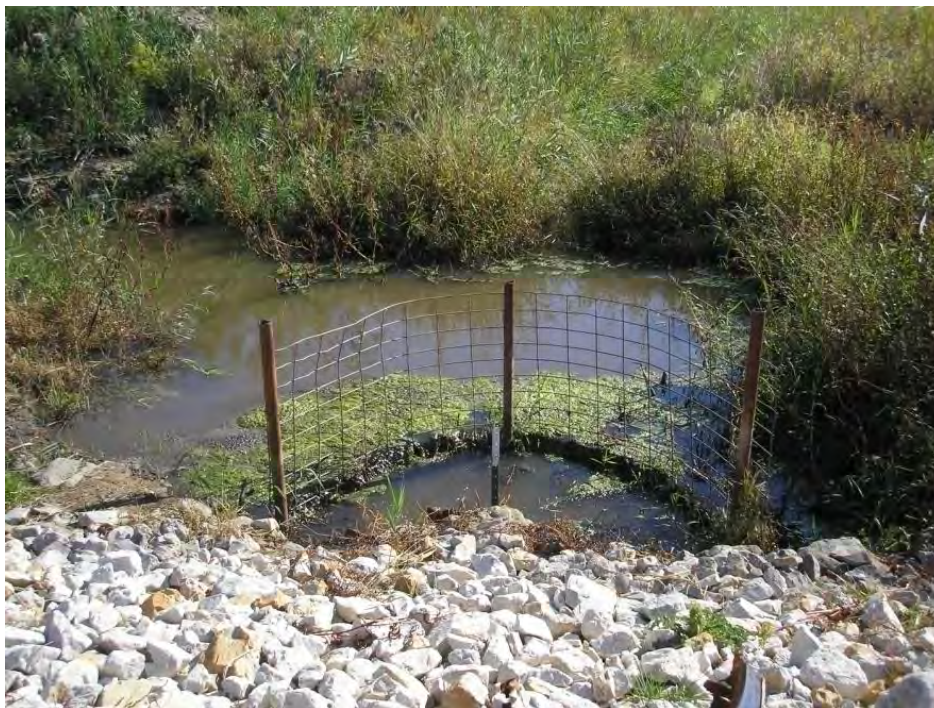
Figure 5.7.1-3: Economizer Ash Pond Spillway Location

Water in the Economizer Ash Pond is routed by interior ditches to the southwest corner of the impoundment. Water flows through an inlet structure to two 18-inch diameter concrete pipes. At the time of Dewberry's site visit the Economizer Ash Pond water level had submerged the spillway inlet. Figure 5.7.1-3 shows the Economizer Ash Pond spillway inlet location.

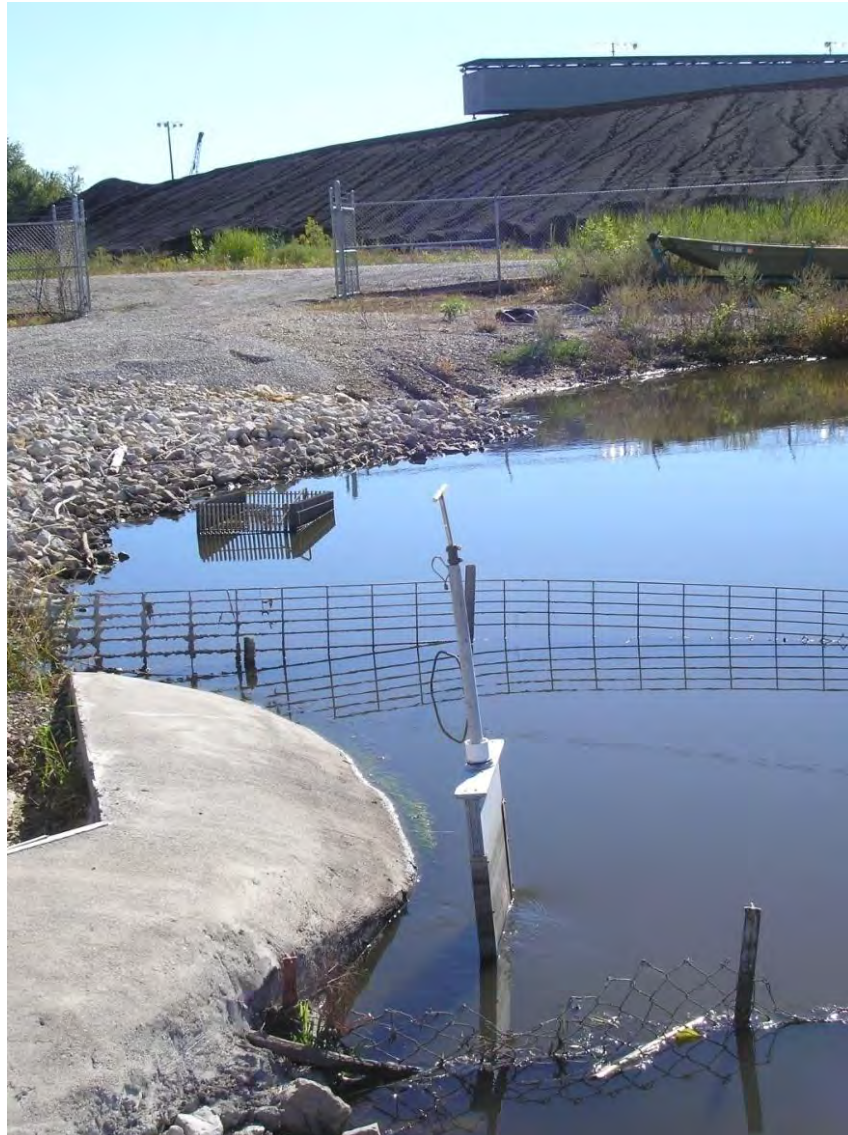
Figure 5.7.1-4: Ash Pond 1 Spillway Location

The Ash Pond 1 primary spillway is located in the northeast corner of the impoundment. The spillway area is bordered by wire fencing serving as a trash rack. A manually operated screw lift stop log is used to control discharge from Ash Pond 1. Figure 5.7.1-4 shows the Ash Pond 1 spillway inlet location.

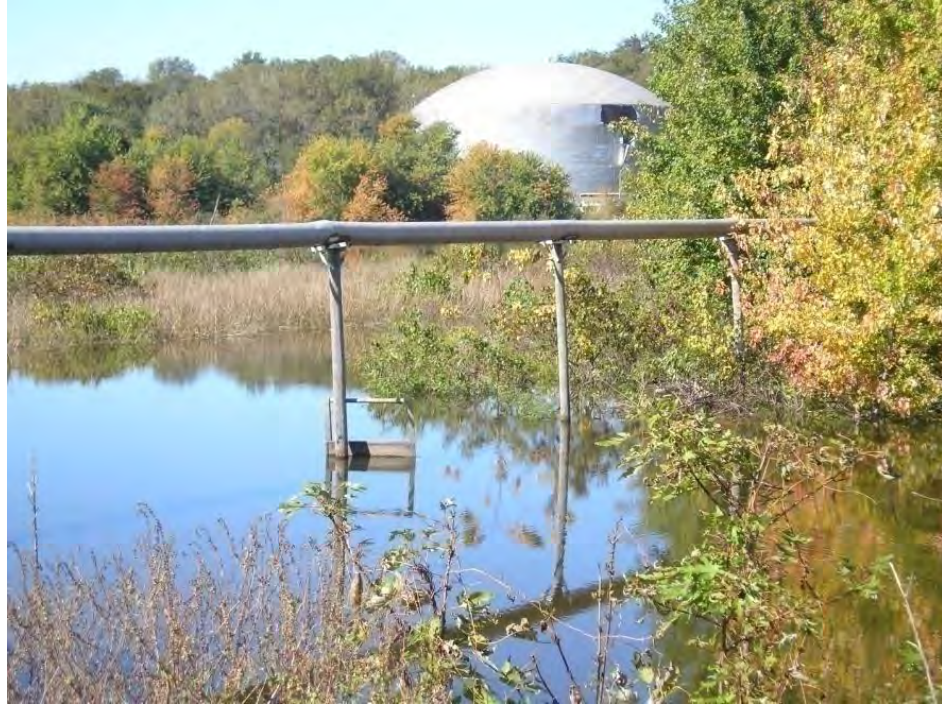
Figure 5.7.1-5: Ash Pond 2 Top of Spillway Stop Log Device

The Ash Pond 2 spillway is located in the northeastern portion of the impoundment. As floodwater from the Mississippi River had overtopped the Ash Pond 2 dike, only the top of the spillway stop log was visible during Dewberry's site inspection. Figure 7.7.1-5 shows the top of the manually operated spillway stop log device.

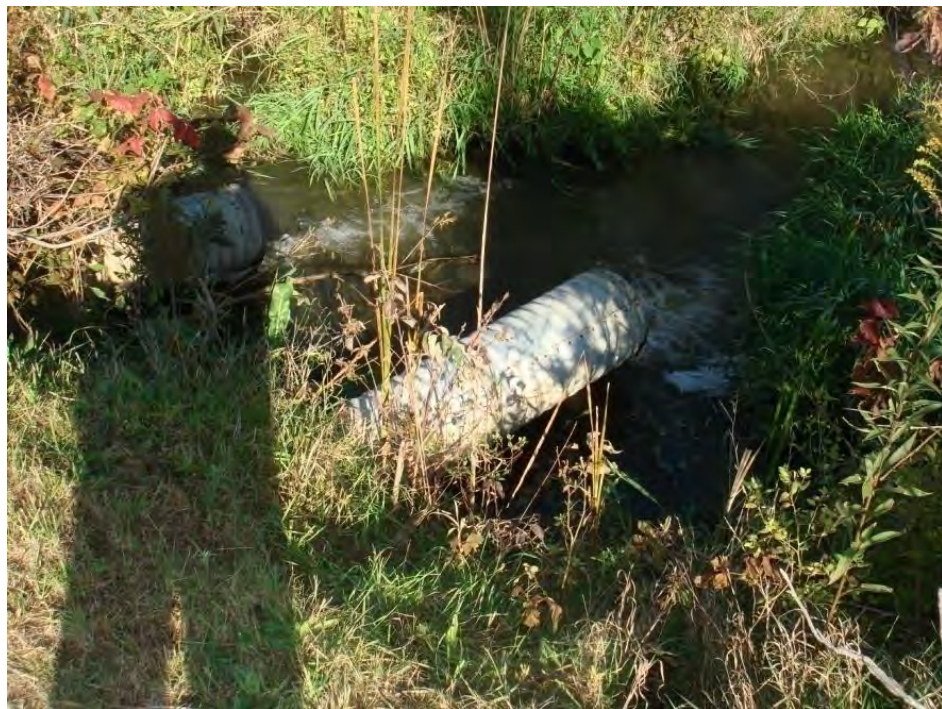
Figure 5.7.2-1: Bottom Ash Pond Spillway Outlet Conduits

The Bottom Ash Pond discharges into an interior drainage ditch at the southwest corner of Ash Pond 1. Figure 5.7.2-1 shows the Bottom Ash Pond spillway outlet discharge.

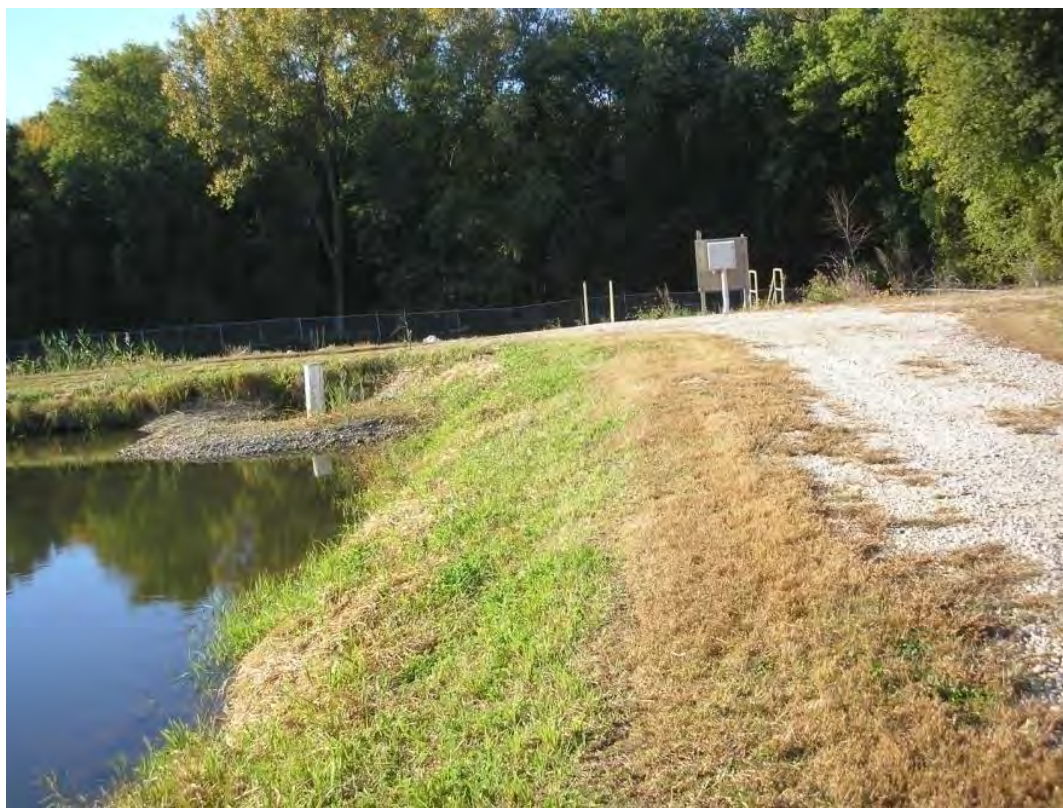
Figure 8.1-1: Ash Seal Pond Interior Low Dike and Spillway Riser

Ash Seal Pond - Materials stored in the Ash Seal Pond may include fly ash, bottom ash, and economizer ash from past sluicing activities. Due to the 2009 re-routing of the ash seal water, the Ash Seal Pond only receives storm water runoff from the plant site and the hydrated fly ash (Product name C-Stone) storage. No new coal combustions wastes are added to the Ash Seal Pond. A low dike around the spillway riser was constructed to prevent water from being discharged through the closed outfall. Figure 8.1-1 shows the interior dike and sealed spillway inlet.

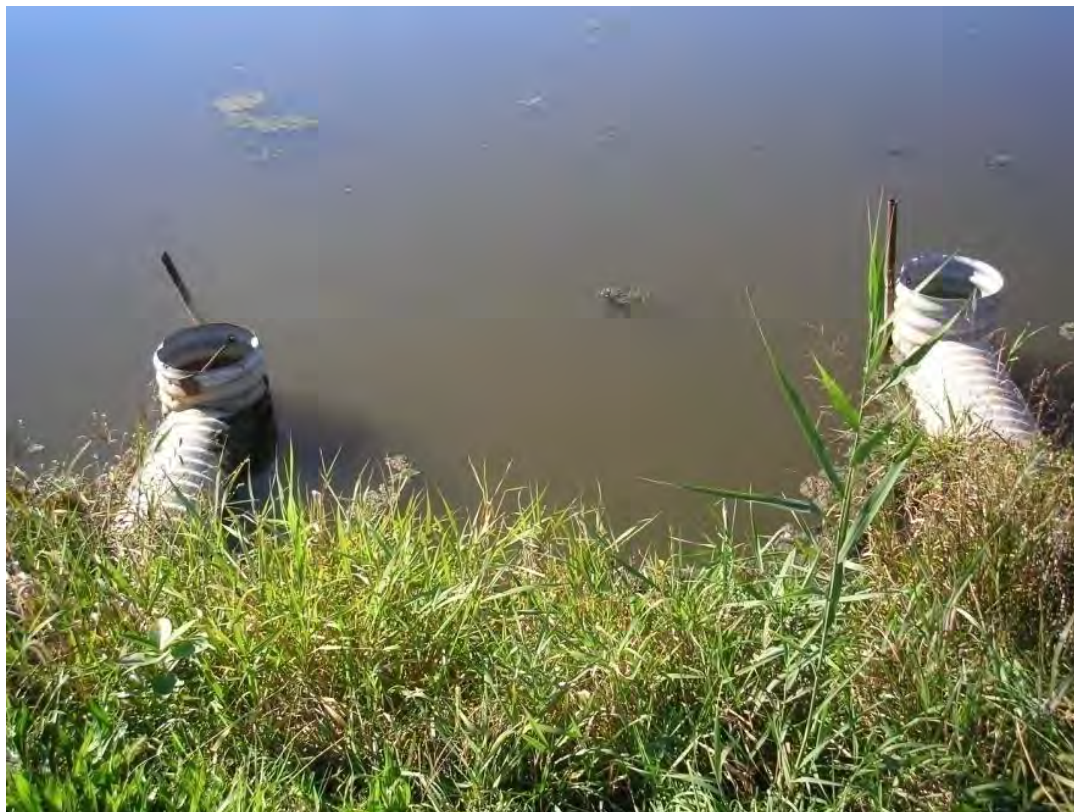
Figure 8.1-2: Bottom Ash Pond Primary Spillway Inlet

impoundment where it flows through a spillway consisting of two 18-inch diameter corrugated metal pipes beneath the plant main access road embankment into Ash Pond 1. Figure 8.1-2 shows the spillway inlet.

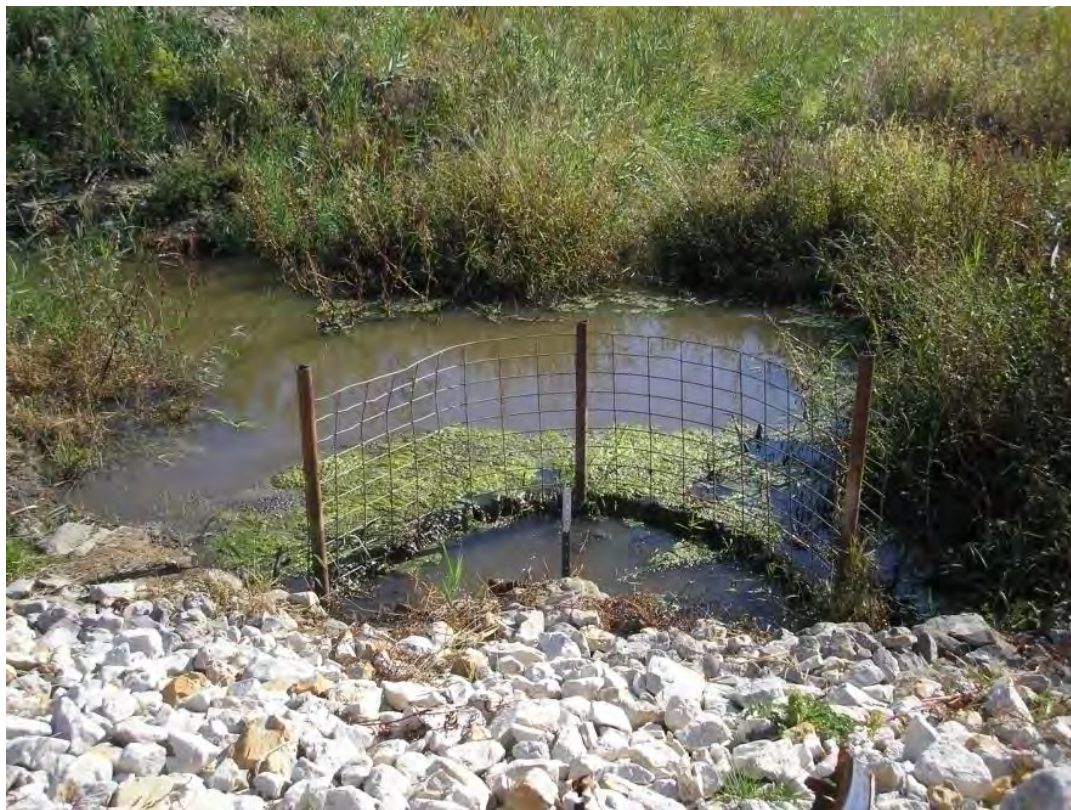
Figure 8-1-3: Economizer Ash Pond Spillway Inlet

Economizer Ash Pond - Materials stored in the Economizer Ash Pond may include fly ash, bottom ash, and economizer ash from previous sluicing activities. Wastewaters sent to the Economizer Ash Pond for further treatment include economizer and sluice waters; boiler blowdown; non-chemical air heater basket wash water; oil water separator discharge resulting in the treatment of plant floor drains; plant storm water runoff; and wastewaters associated with the treatment of Mississippi River water for steam grade water makeup. In addition, the Economizer Ash Pond receives coal pile runoff and Solids Contact Unit sludge created during the first phase of treatment of the Mississippi River water in steam grade water production (see Appendix A – Doc 6). Water collected in the Economizer Ash Pond is routed to the south and west with interior perimeter ditches to the southwest corner of the impoundment. The water flows through two 18-inch diameter concrete pipes beneath the Economizer Ash Pond dike discharging into an Ash Pond 1 interior drainage ditch. Figure 8.1-3 shows the Economizer Ash Pond spillway inlet.

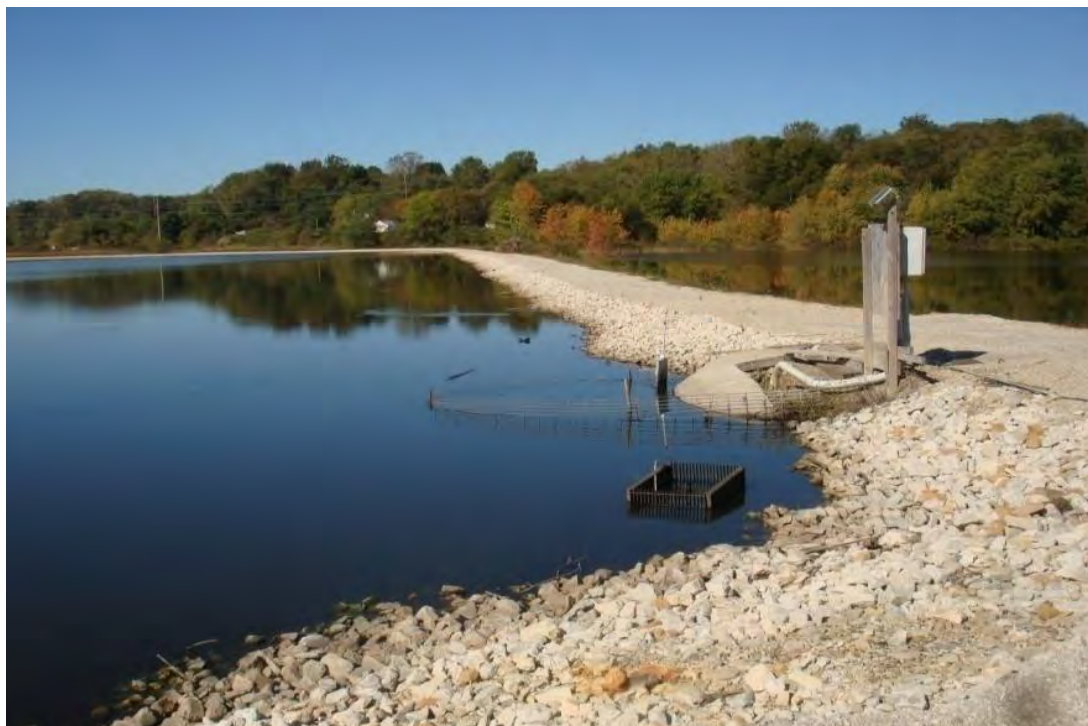
Figure 8.1-4: Ash Pond 1 Primary Spillway Riser

Ash Pond 1 [Upper Ash Pond] - Materials stored in Ash Pond 1 may include fly ash, bottom ash, and economizer ash from past sluicing activities. Wastewaters sent to Ash Pond 1 for further treatment include effluent from the Bottom Ash Pond, Economizer Ash Pond, and Coal Pile Runoff Pond (see Appendix A – Doc 6). Ash Pond 1 decant water flows to the primary spillway located in the northeast corner of the impoundment. Figure 8.1-4 shows the location of the low interior dike and the primary spillway entrance.

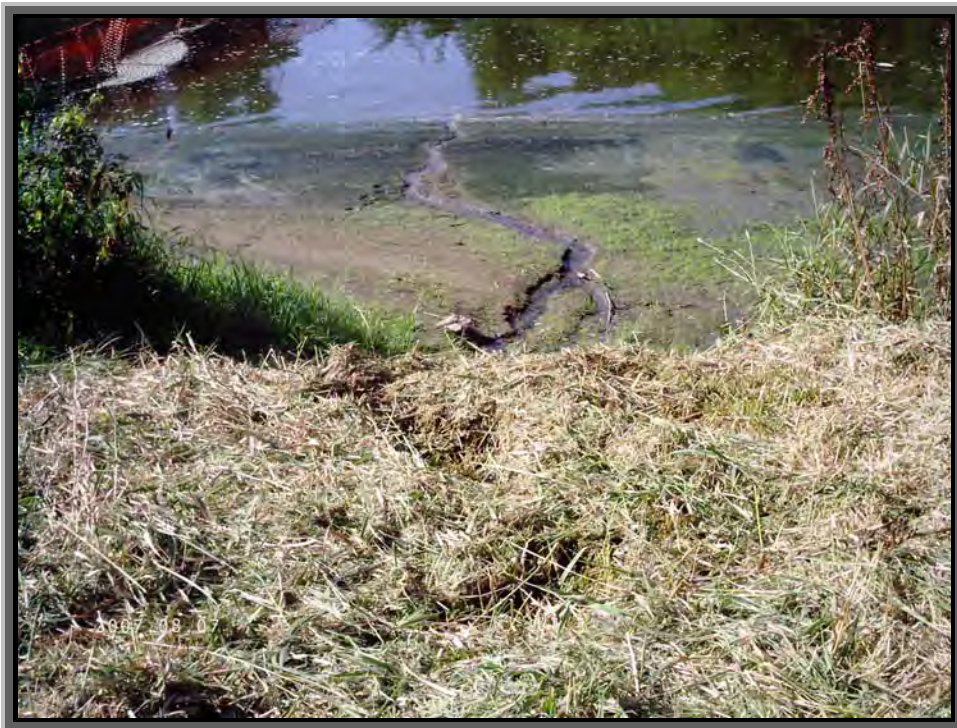
Photo 2) South – Seep Location in from Berm

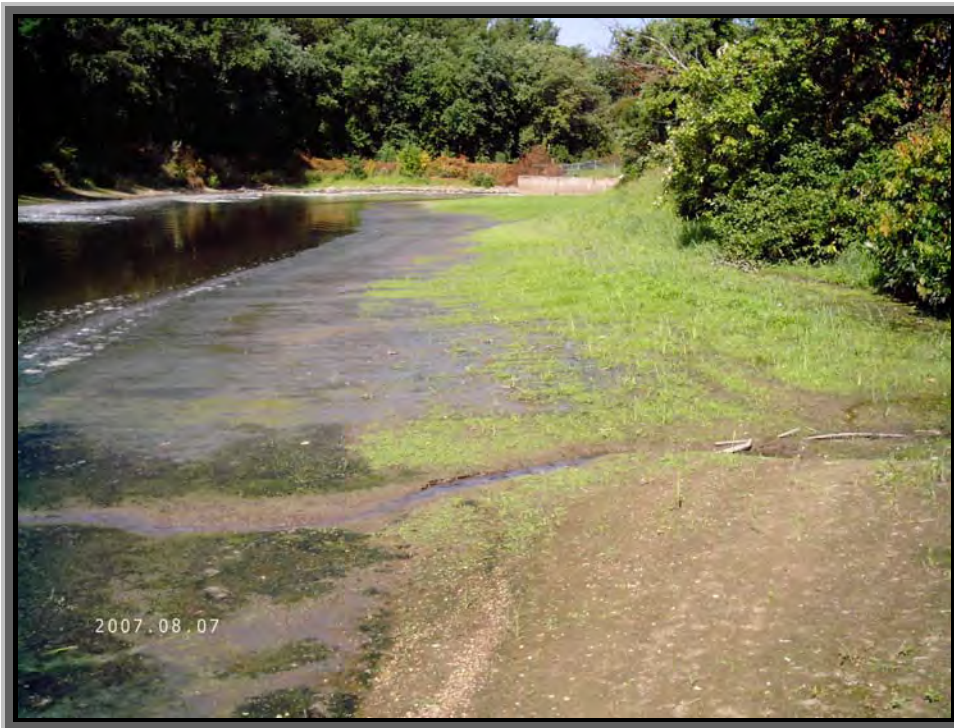
Photo 4) West - Facility Discharge Channel; Continuous Wet Ground after Dry Weather

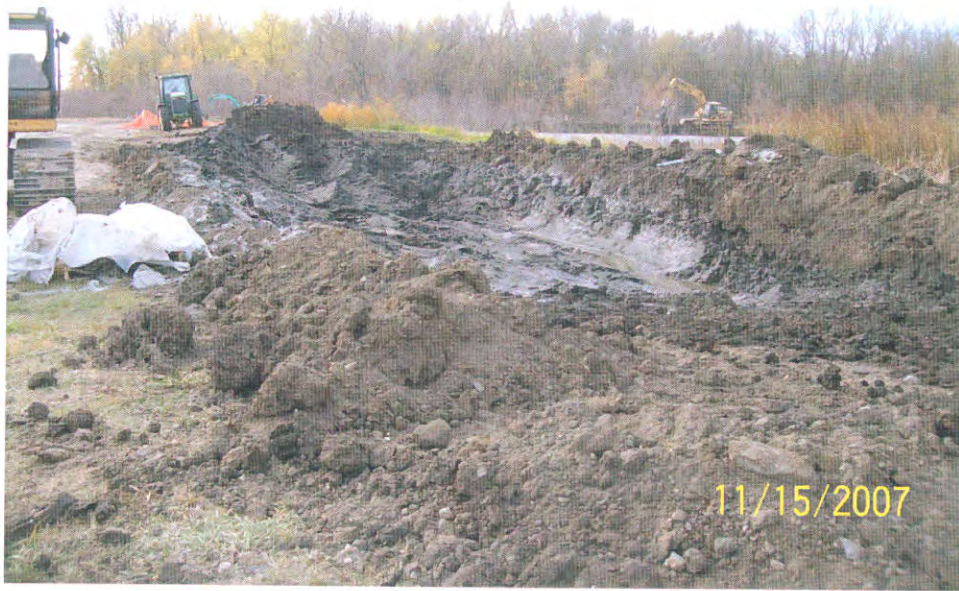
Soil/bentonite mixing pit. Slurry trench excavation is visible in background.

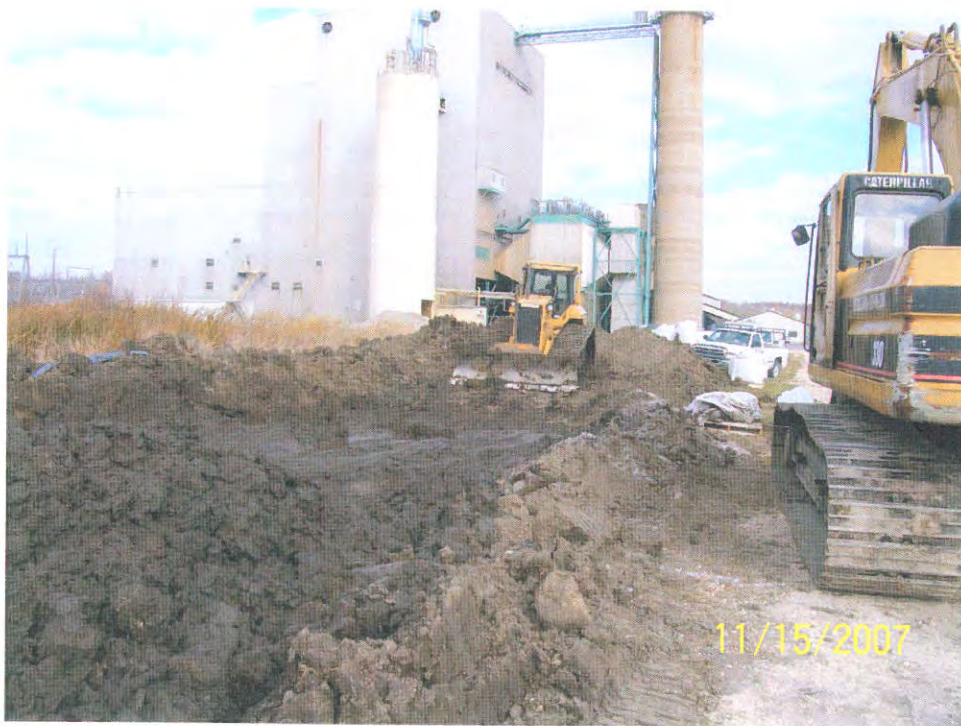
Another view of soil/bentonite mixing pit with generating station in background.

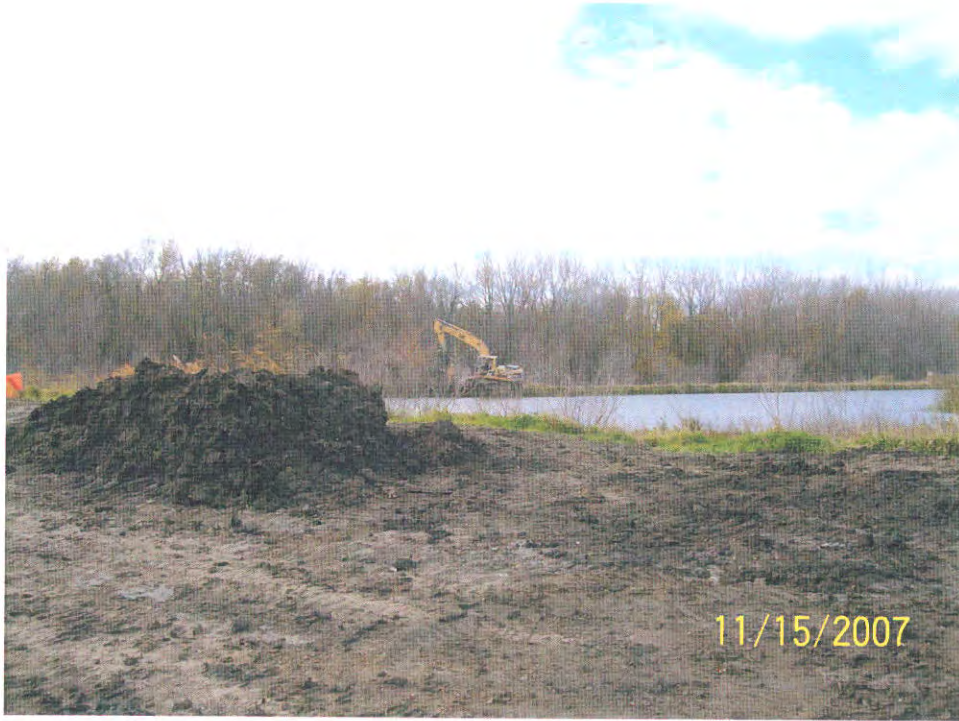
Looking across ash pond at excavator digging slurry trench in ash pond berm.

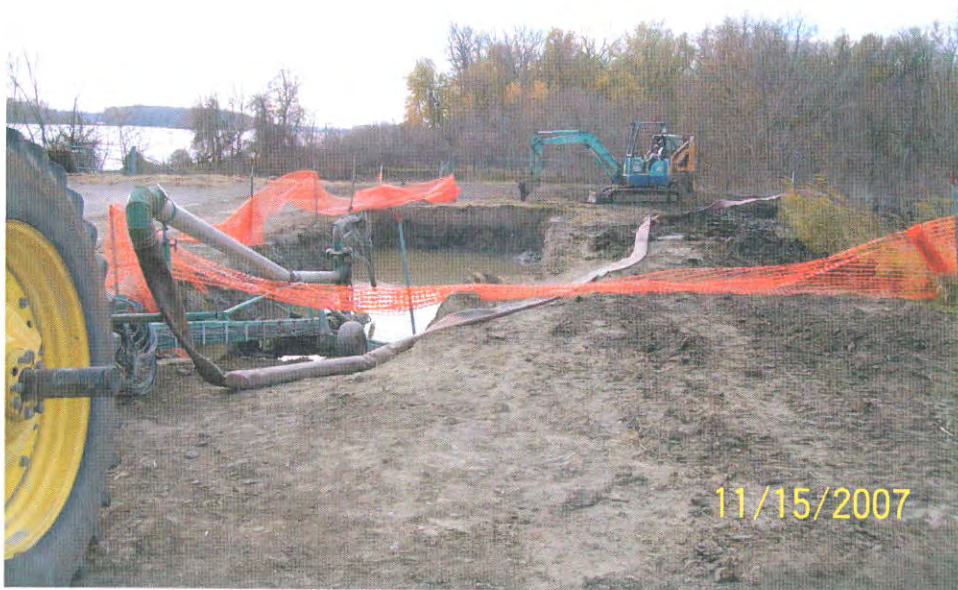
Photograph of bentonite slurry mixing pit. The Mississippi River is at background left and the ash pond is at far right.

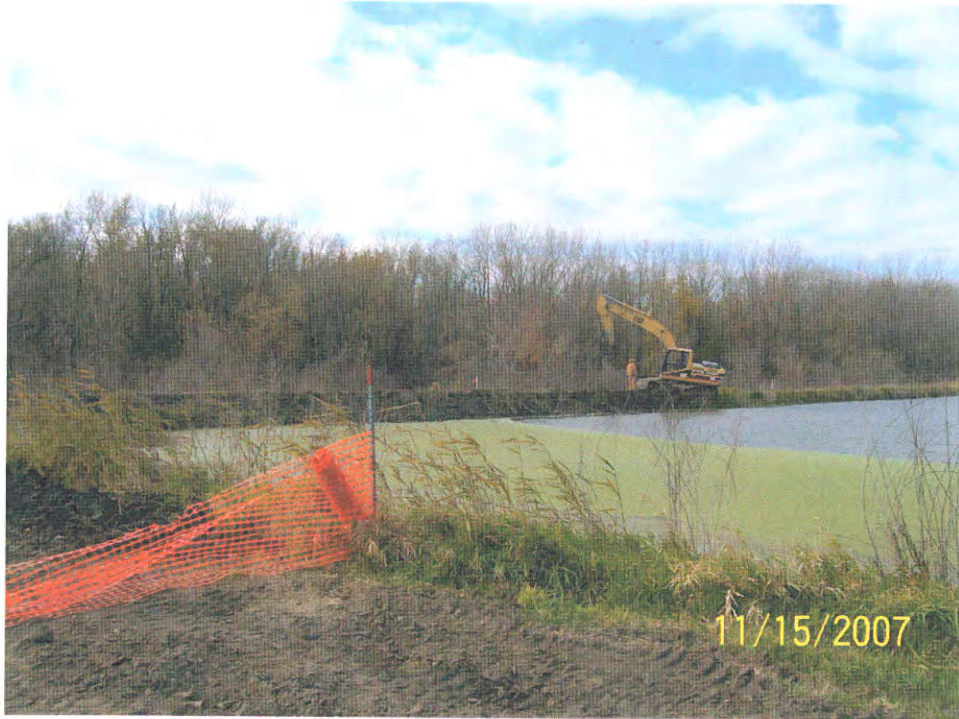
Another photo looking across the ash pond at the excavator digging the slurry trench.

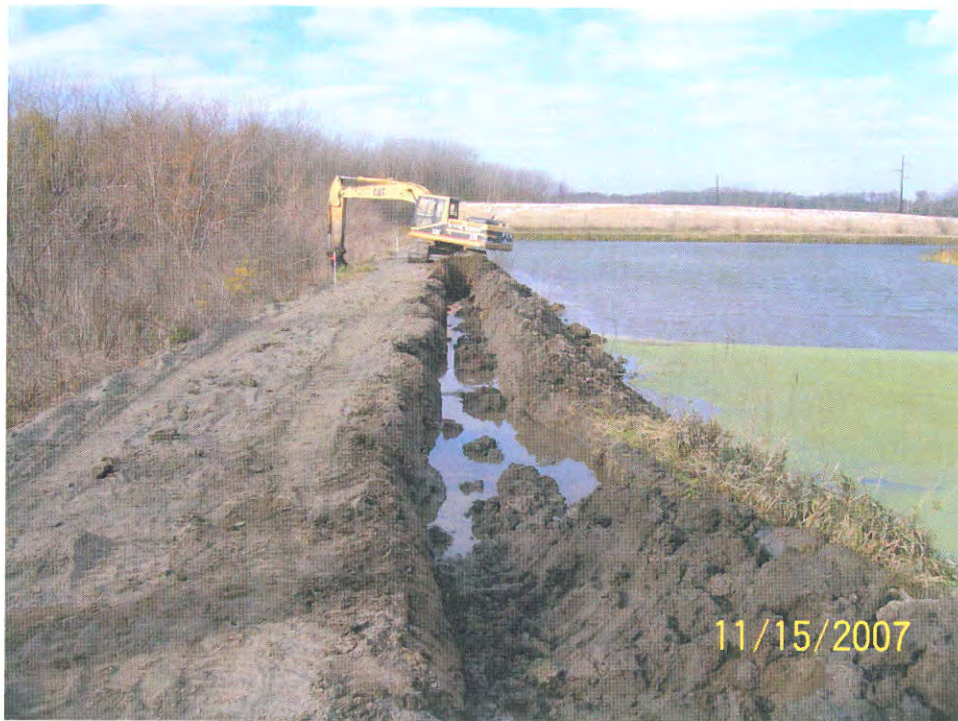
Photograph of slurry trench in berm along ash pond. Standing water is simply the bentonite slurry at the top of the trench.

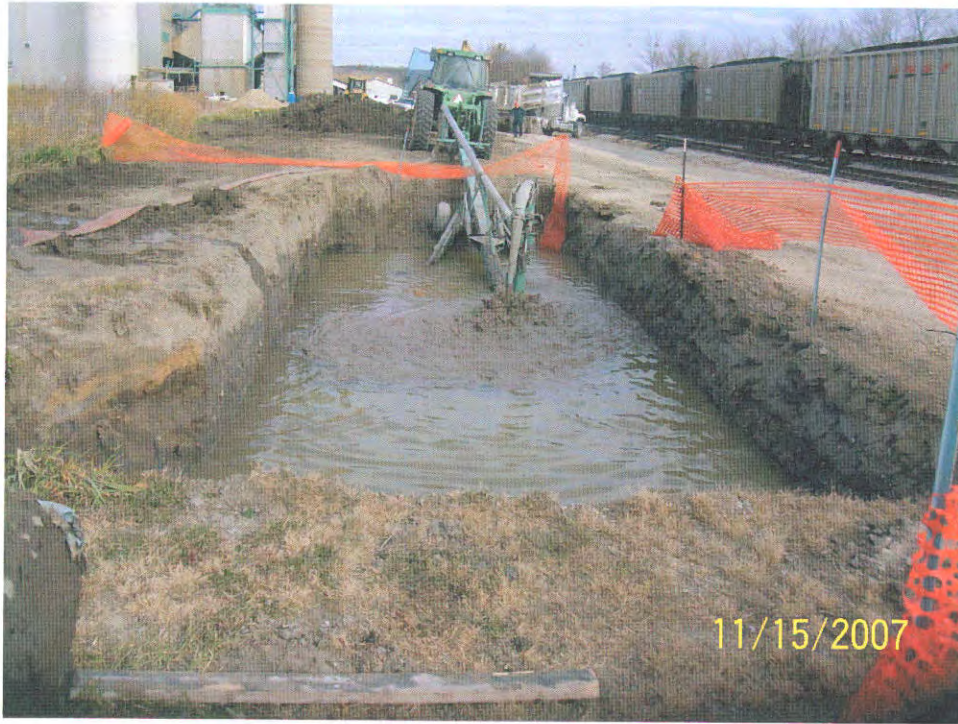
Photograph of bentonite slurry mixing in process.

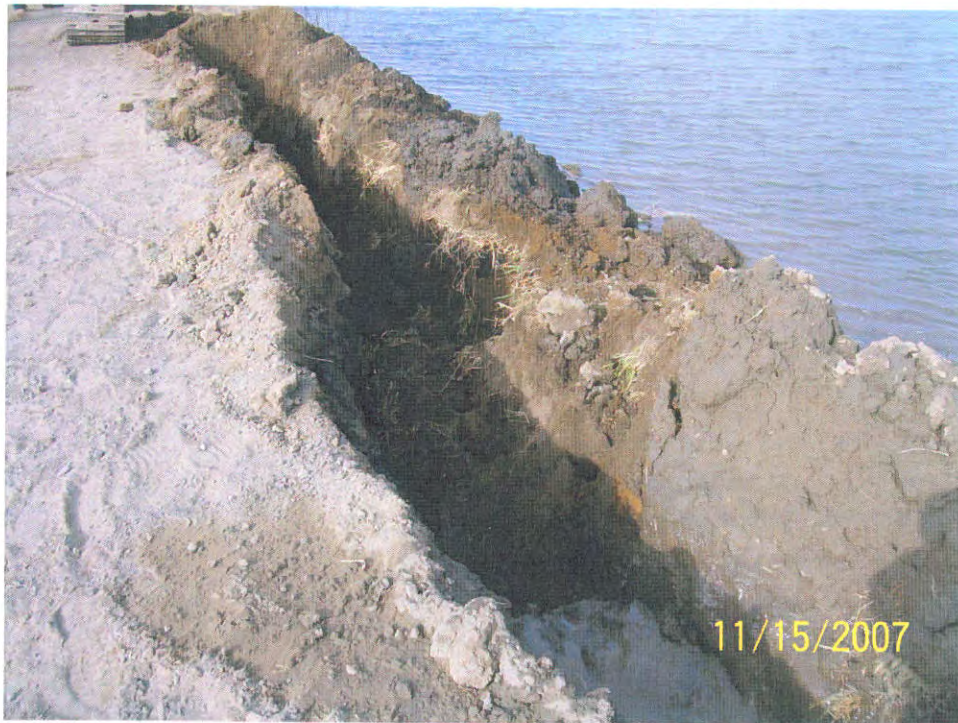
Photograph close-up of bentonite slurry running and filling the trench prior to placement of the soil/bentonite mixture.

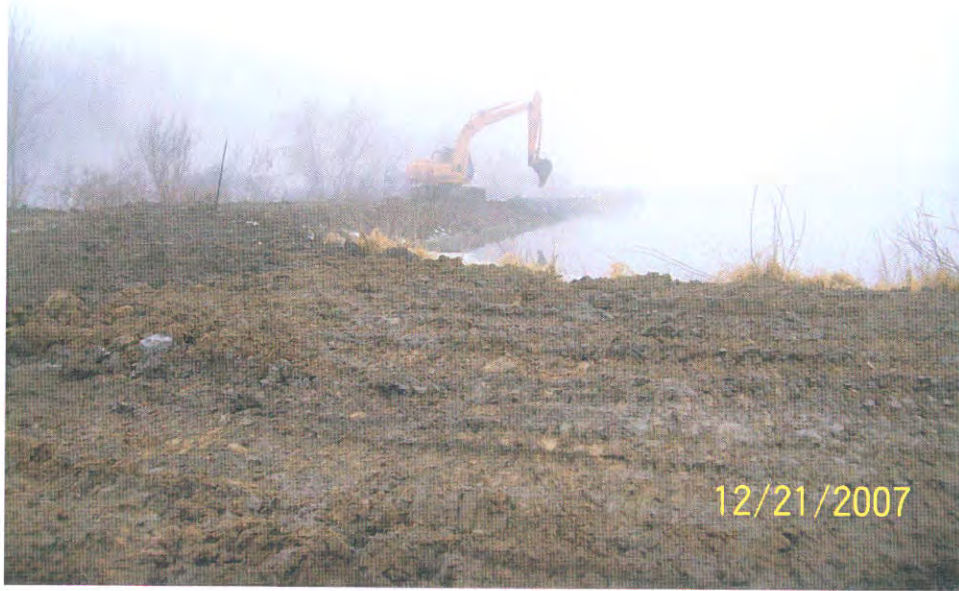
Photograph of final cap placement.

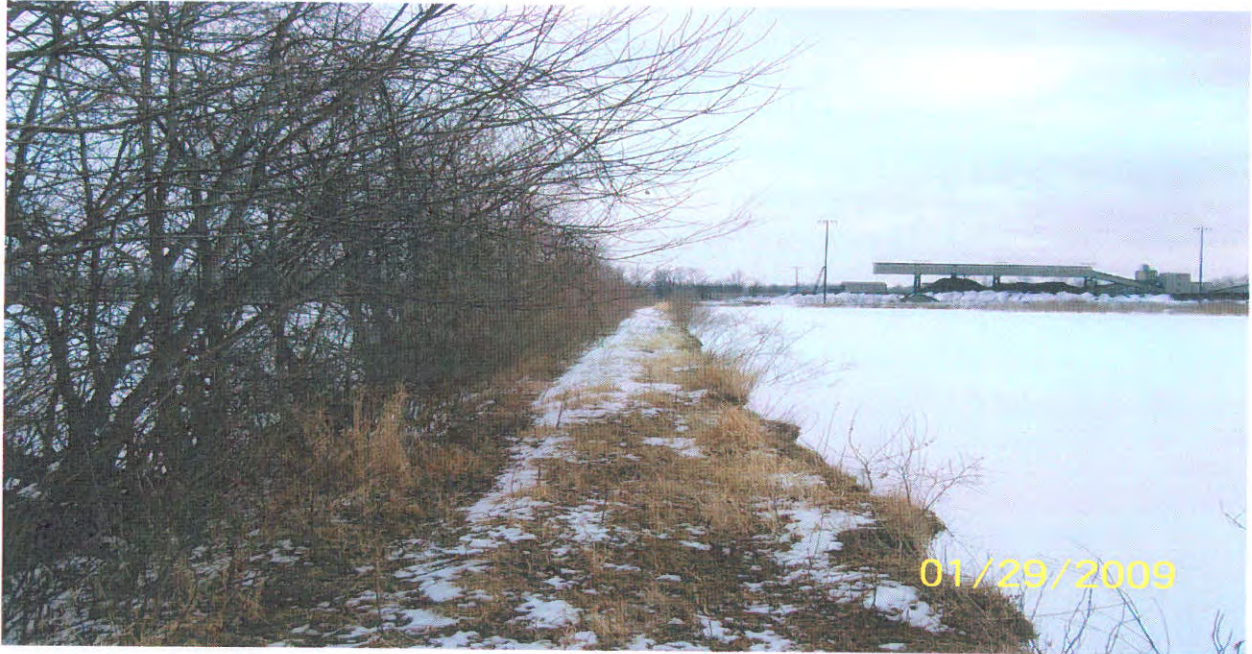
Upper Ash Pond levee prior to rehabilitation

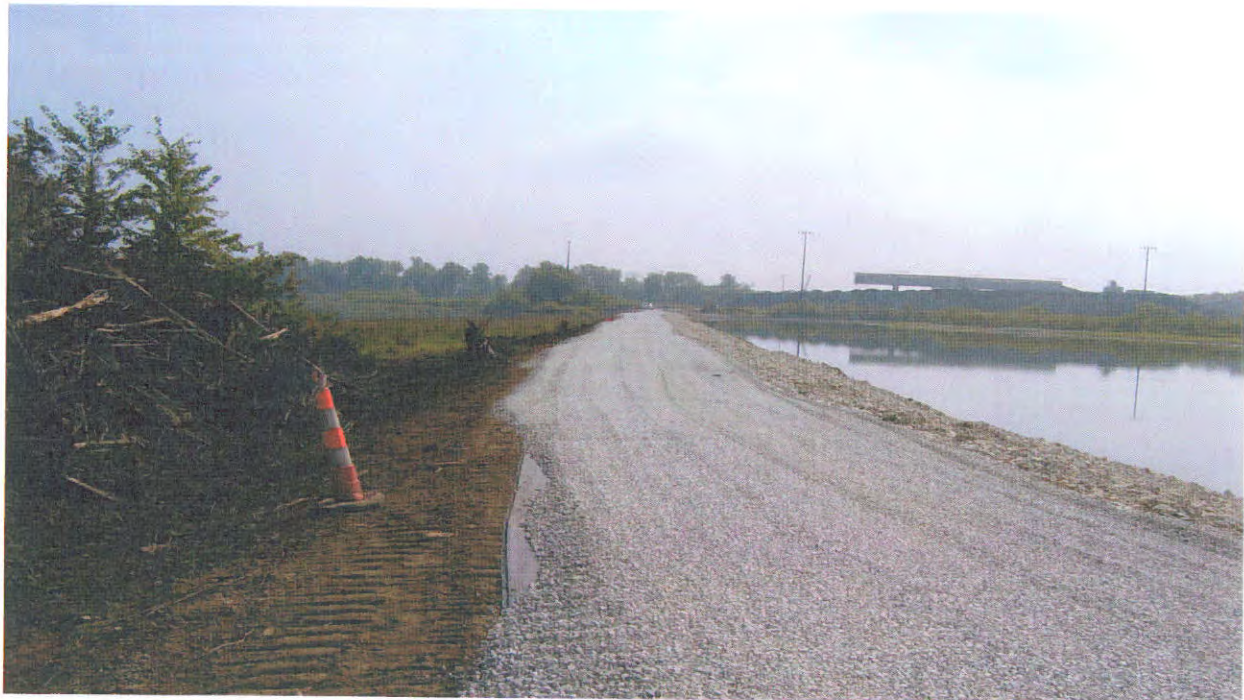
Upper Ash Pond levee after rehabilitation

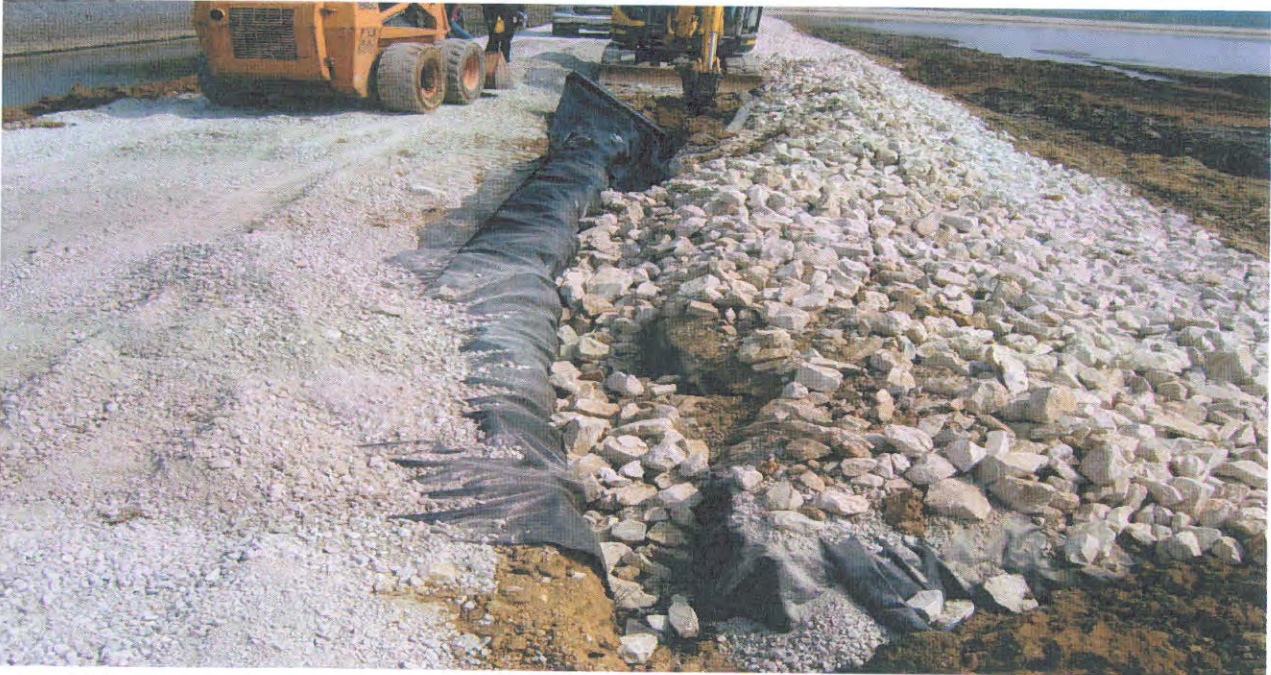
Notching geotextile fabric into top and inside slope

Initially when the fabric was being placed the contractor did not have the recommended lap between the rolls of fabric. It was recommended to the contractor to create a notch and place an additional strip of fabric in the notch, fill with rip-rap and lap this fabric over the already placed geotextile fabric. (See attached photo). This procedure was completed. After the fabric placement was completed a 6" aggregate base was laid so vehicles could travel on the levee without damaging it or becoming stuck. Rip-rap was placed to a depth of approximately 12" on the inside of the reconstructed levee from the top down (road) to two feet below normal pool elevation. When the pond elevation returns to normal, the rip-rap will be below normal water elevation and thus minimize erosion due to wave lap and overtopping.
