**Coal Combustion Waste Impoundment
Round 7 - Dam Assessment Report**

Burlington Generating Station

*Ash Impoundment Dikes
Interstate Power and Light
Burlington, Iowa*

June 2011

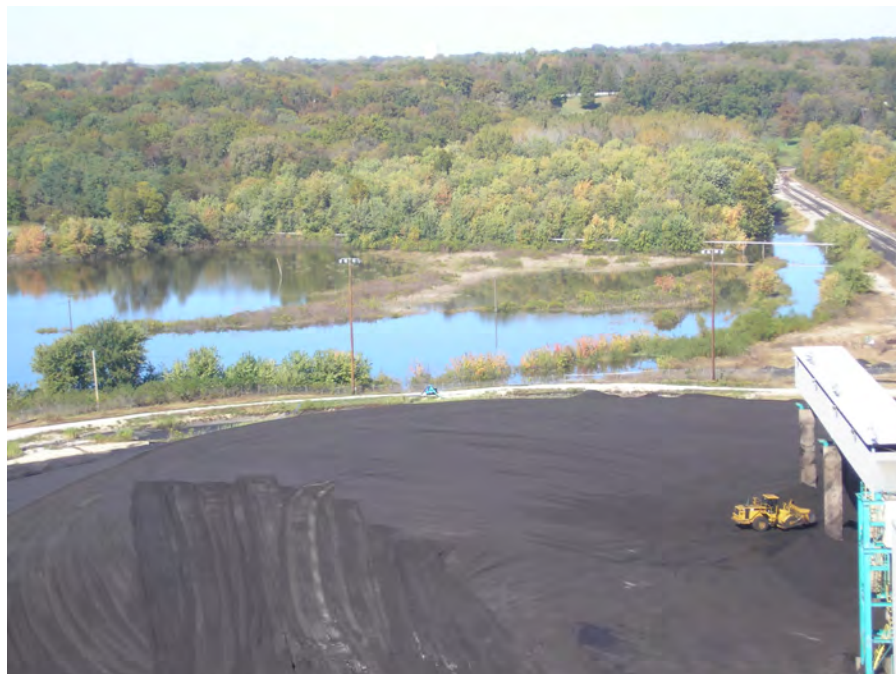
Photograph 7: Rooftop View of Ash Pond 2. Downstream Dike Located beneath Pipe Crossing in Upper Right. Dike Inundated by Flood Water from Mississippi River

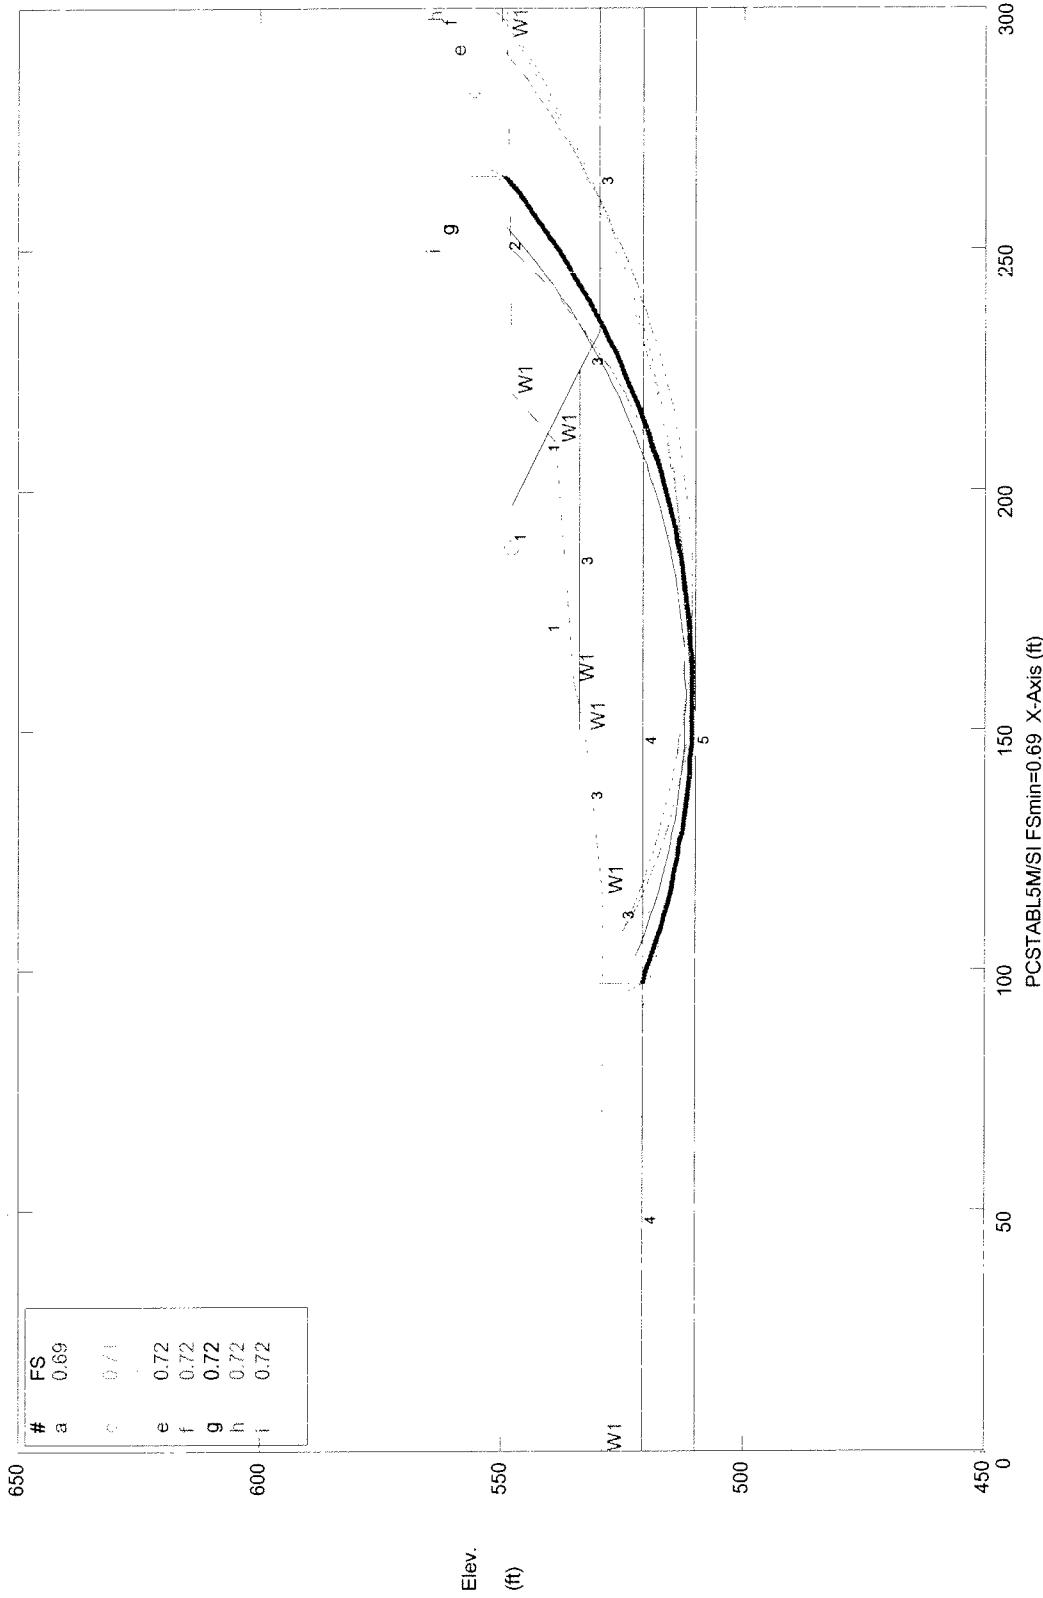
Alliant Burlington Economizer Pond North Ash Slope - Earthquake Case

PCSTABL5M/SI FSmin=0.69 X-Axis (ft)

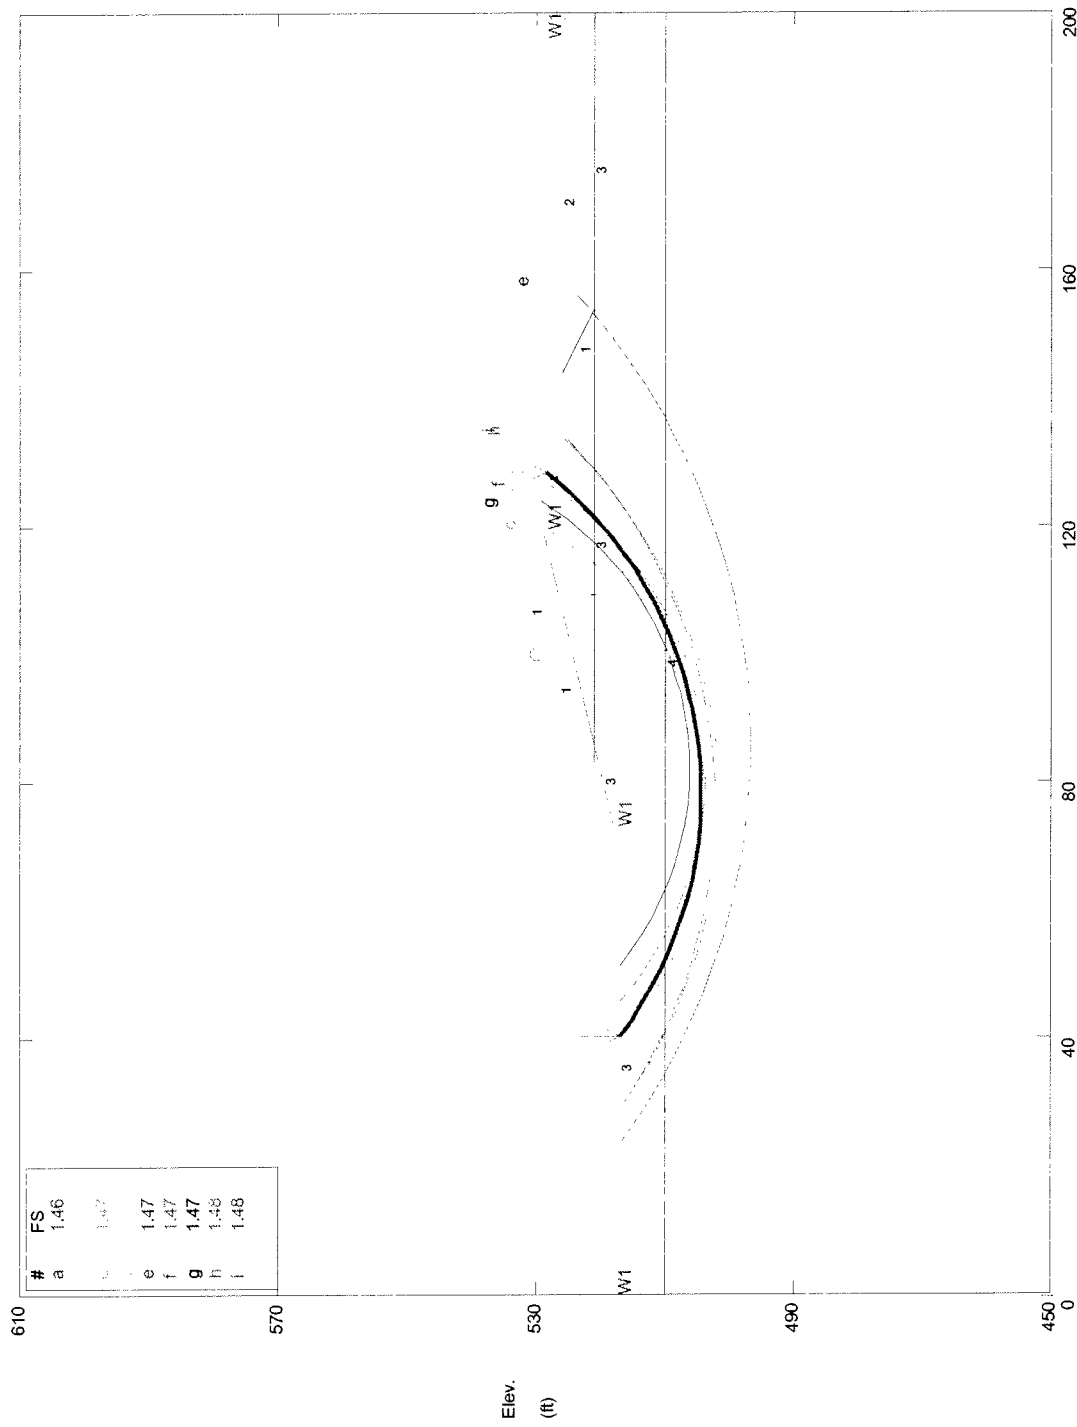
CONFIDENTIAL BUSINESS INFORMATION
 Alliant Burlington Between the Ash Ponds North Dike Slope - Earthquake Case
 Ten Most Critical. E:BURL41C2.PLT By: Tom Wells 01-15-11 12:31pm

PCSTABL5M/SI FSmin=1.46 X-Axis (ft)

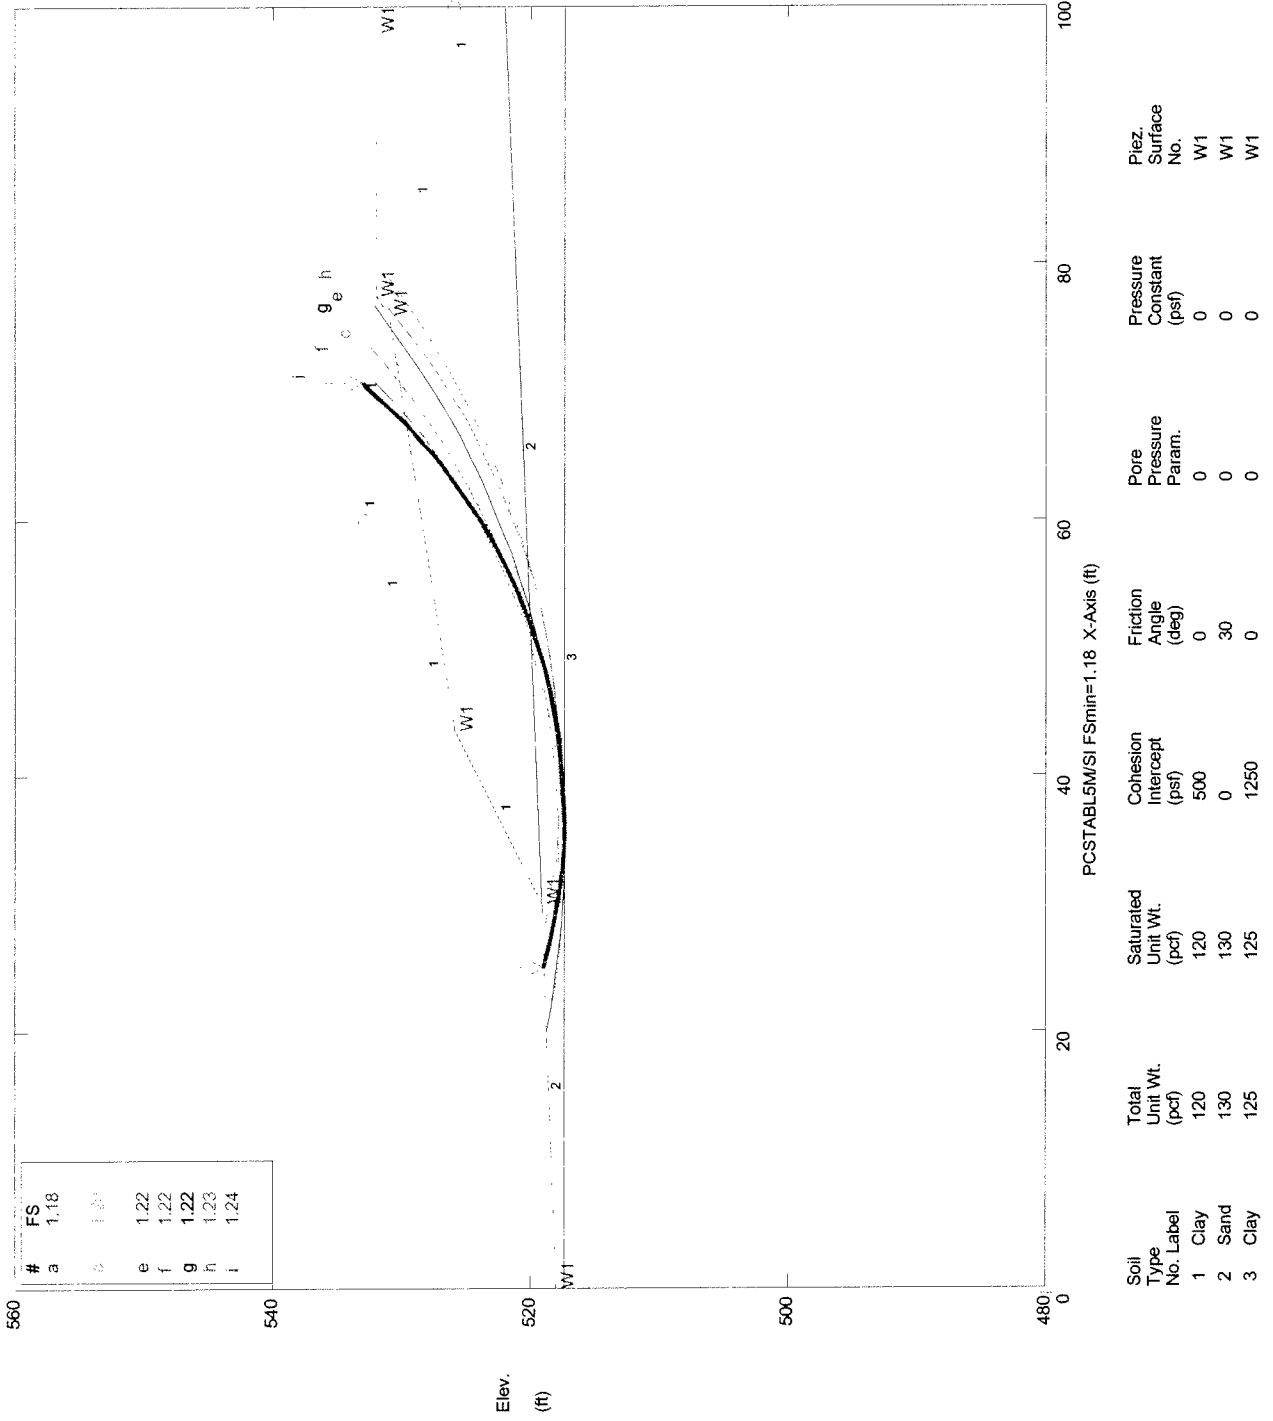
Alliant Burlington Ash Seal Pond South Dike - Earthquake Case
 Ten Most Critical. C:BURL51C.PLT By: TCW 01-18-11 11:04am

#	FS
a	1.18
b	1.21
e	1.22
f	1.22
g	1.22
h	1.23
i	1.24

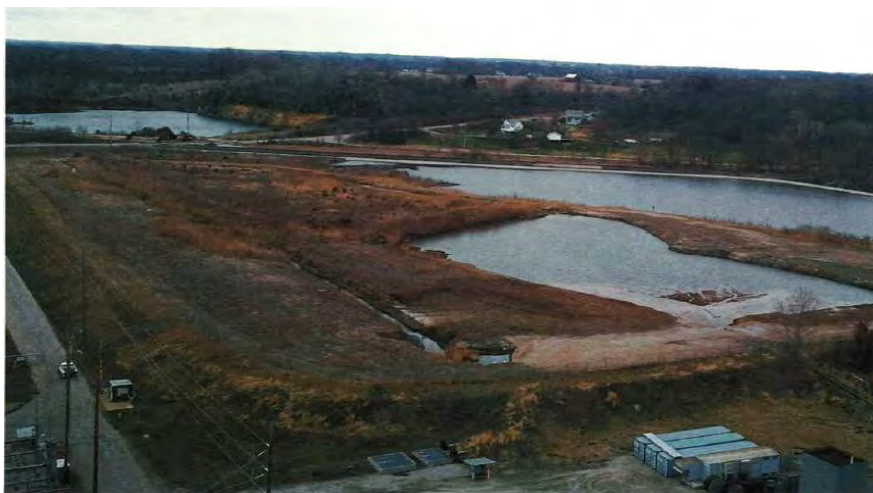
- Avoid Stockpiling on North Side of Economizer Ash Pond (Item C): In March the utility removed the observed ash stockpile off the North Side embankment. The utility stated that no further dredging and stockpiling is anticipated until late summer after the proposed additional geotechnical investigation is completed.

Figure 10.4.1-1 shows the Economizer Ash Pond as observed during the October 7, 2010 site visit. The stockpiles are as high as 20 feet. Figure 10.4.1-2 shows the Economizer Ash Pond with the stockpiles removed and construction equipment removed from the embankments.

Figure 10.4.1-2: Economizer Ash Pond with Stockpile and Construction Equipment Removed. (Photo courtesy of Burlington Generating Station)

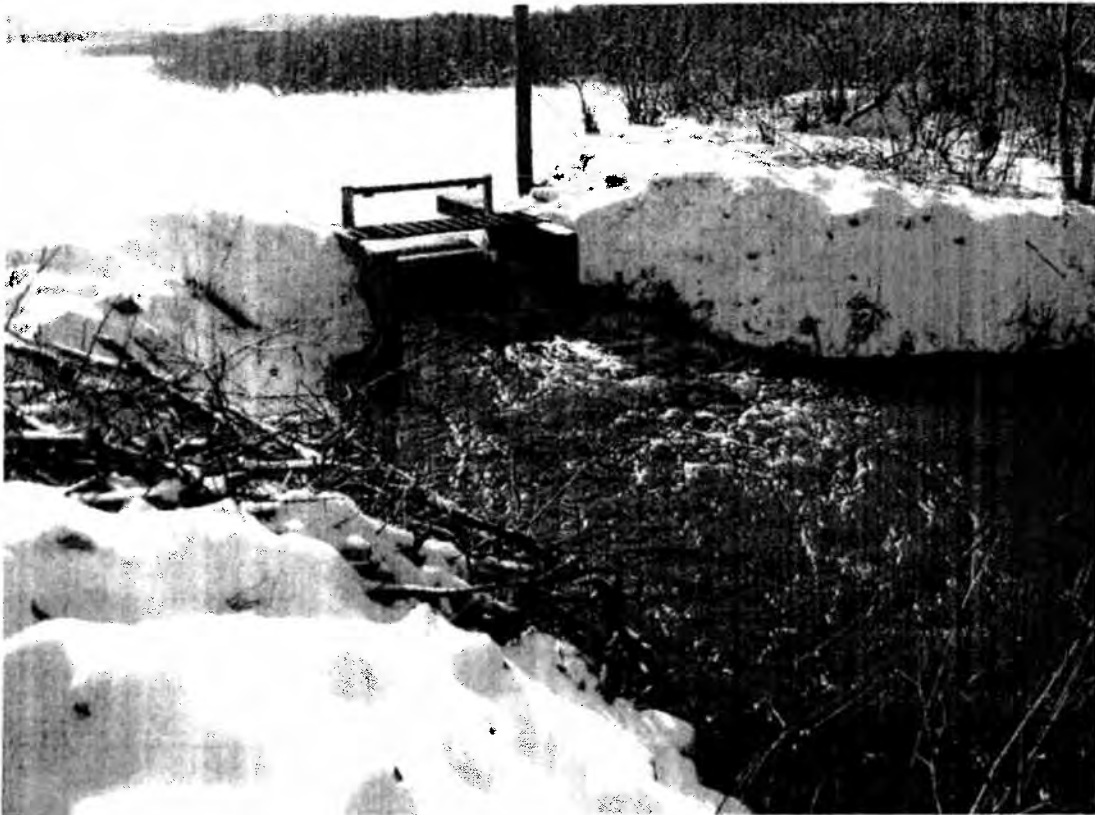
The capacity of the Upper Ash pond is approximately 1,000,000 cubic feet using only the eastern half of the Upper Ash pond for storage. If some ash goes over the Upper Ash pond embankment, the Lower Ash Pond is contained on the north end by a three foot high embankment, see photo below, with a concrete overflow weir. This is the final pond containment prior to discharge to the Mississippi River. The volume of the Lower Ash Pond from the top of the Upper Ash Pond embankment at 531 to the top of the final Lower Ash Pond embankment at 524 is approximately 5,000,000 cubic feet.

The analysis indicates that it is a sound judgment to conclude that the contents of a release from the Economizer Ash Pond will remain primarily in the Upper Ash Pond and that any release over the top of the Upper Ash Pond Embankment will be contained in the Lower Ash Pond. The only unusual event will be a pulse of water flowing to the Mississippi river at the time of the contained ash flow.

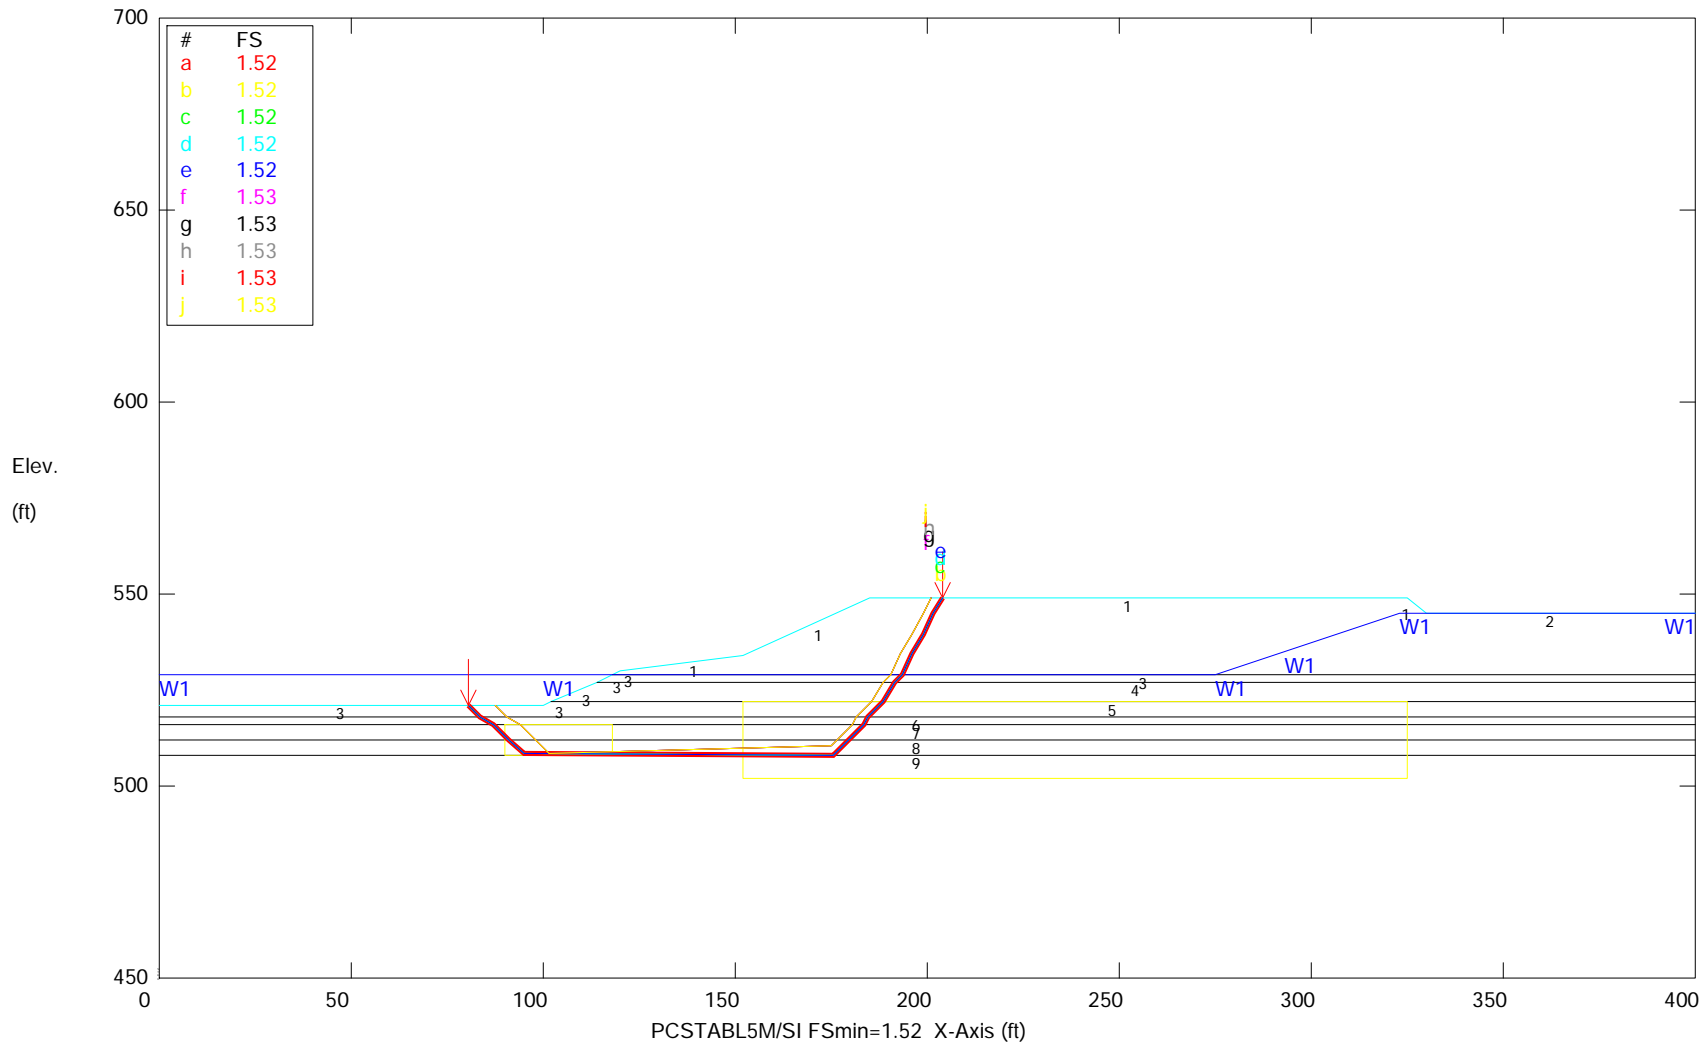
Alliant Burlington Economizer Pile East, North Ash Slope - Static Case

Static Embankment Stability – The Economizer Ash Pile has a minimum static safety factor of 1.5. The increase from 1.1 reported in February 3, 2011 is due to using stronger native clay and stronger ash embankment strengths based on the CPT data and the lowering of the ground water table to represent measured conditions. Based on the CPT data results, the Ash Seal, Main and Upper Ash Ponds have minimum static factors of safety from 2.2 to 4.3 based on higher strengths of the embankment clay and native clay layers as measured in the CPT data.

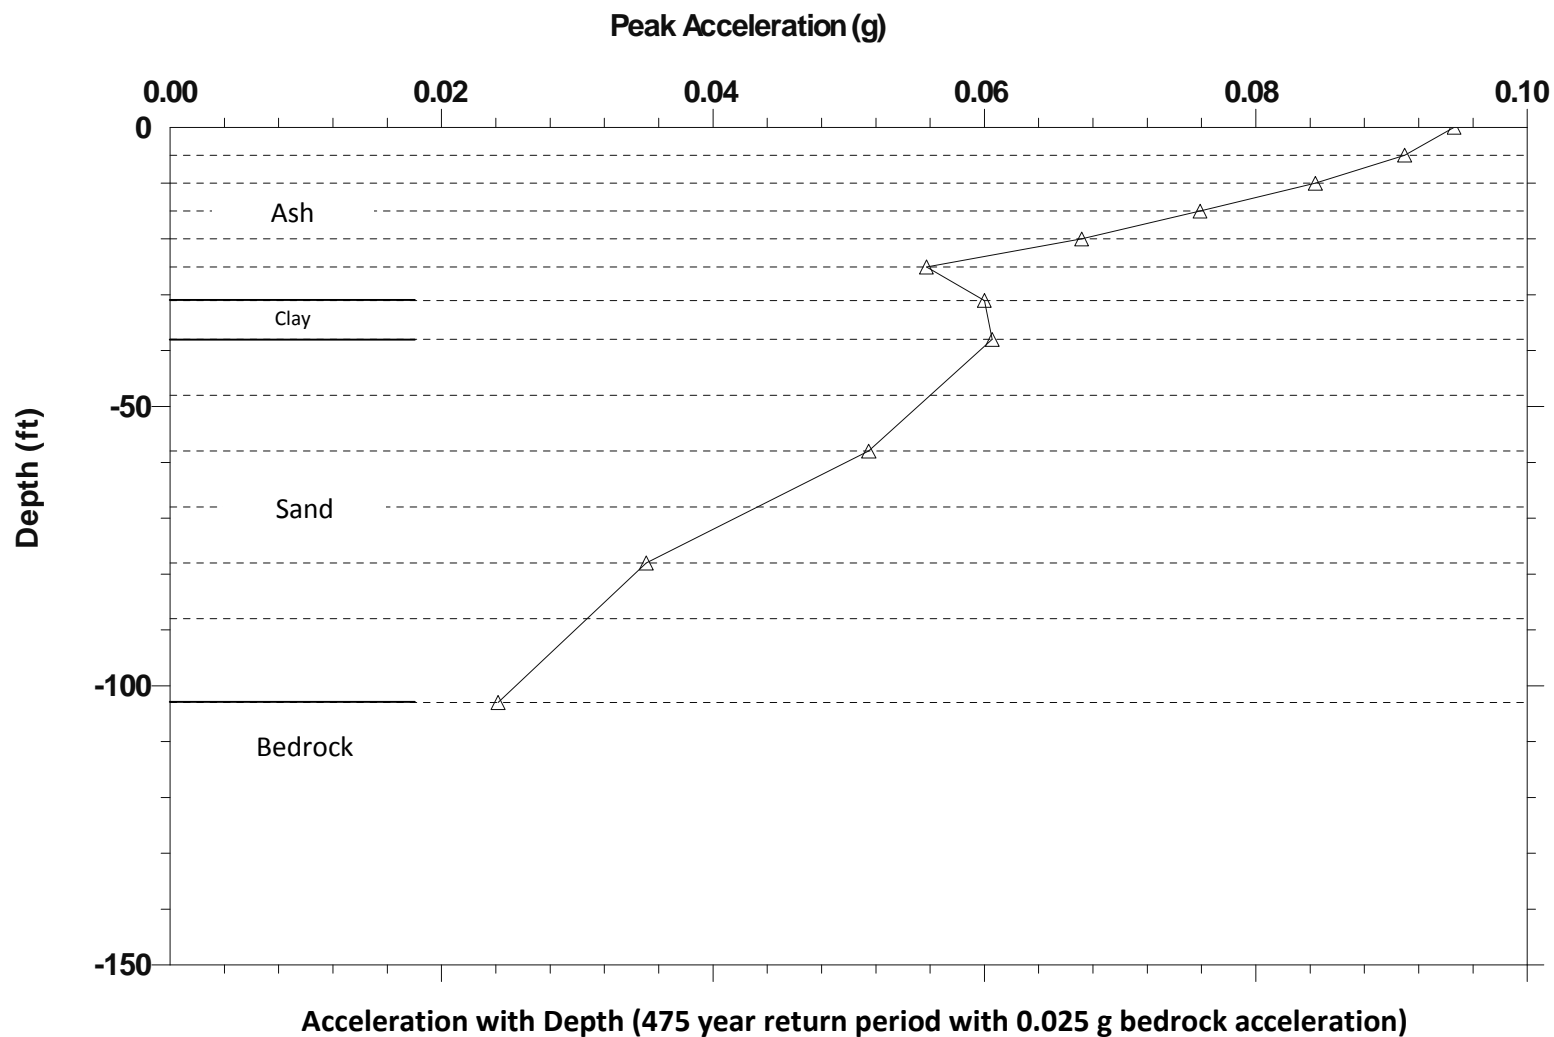
Economizer Ash Pile Sub-Surface Profile

To determine if the saturated CCRs will liquefy, an analysis of the cyclic stress ratio (CSR) from the design earthquake was completed for the Economizer Ash Pile and was compared to the cyclic resistance ratio (CRR) determined from the CPT data. The CPT data was converted to a CRR using the procedure proposed by Moss. The procedure incorporates data from known worldwide liquefaction results into the recommended procedures of the National Council for Earthquake Engineering and Research for establishing CRR from CPT results. The CRR results for the Economizer Ash Pile are shown in Attachment E. The CRR that will cause liquefaction in the saturated zone just above the native clay is 0.08. (CRR is the ratio of the shear stress to the effective confining stress).

The result of the SHAKE analysis is shown in Attachment E. The CSR in the saturated CCR is 0.105 which is greater than the CRR of 0.08 and liquefaction is probable during the seismic design event. Liquefaction will result in the saturated layer losing strength and the loss of strength along with the forces of ground motion could cause the slope of the north Economizer Ash Pile to slide into the Upper Ash Pond.

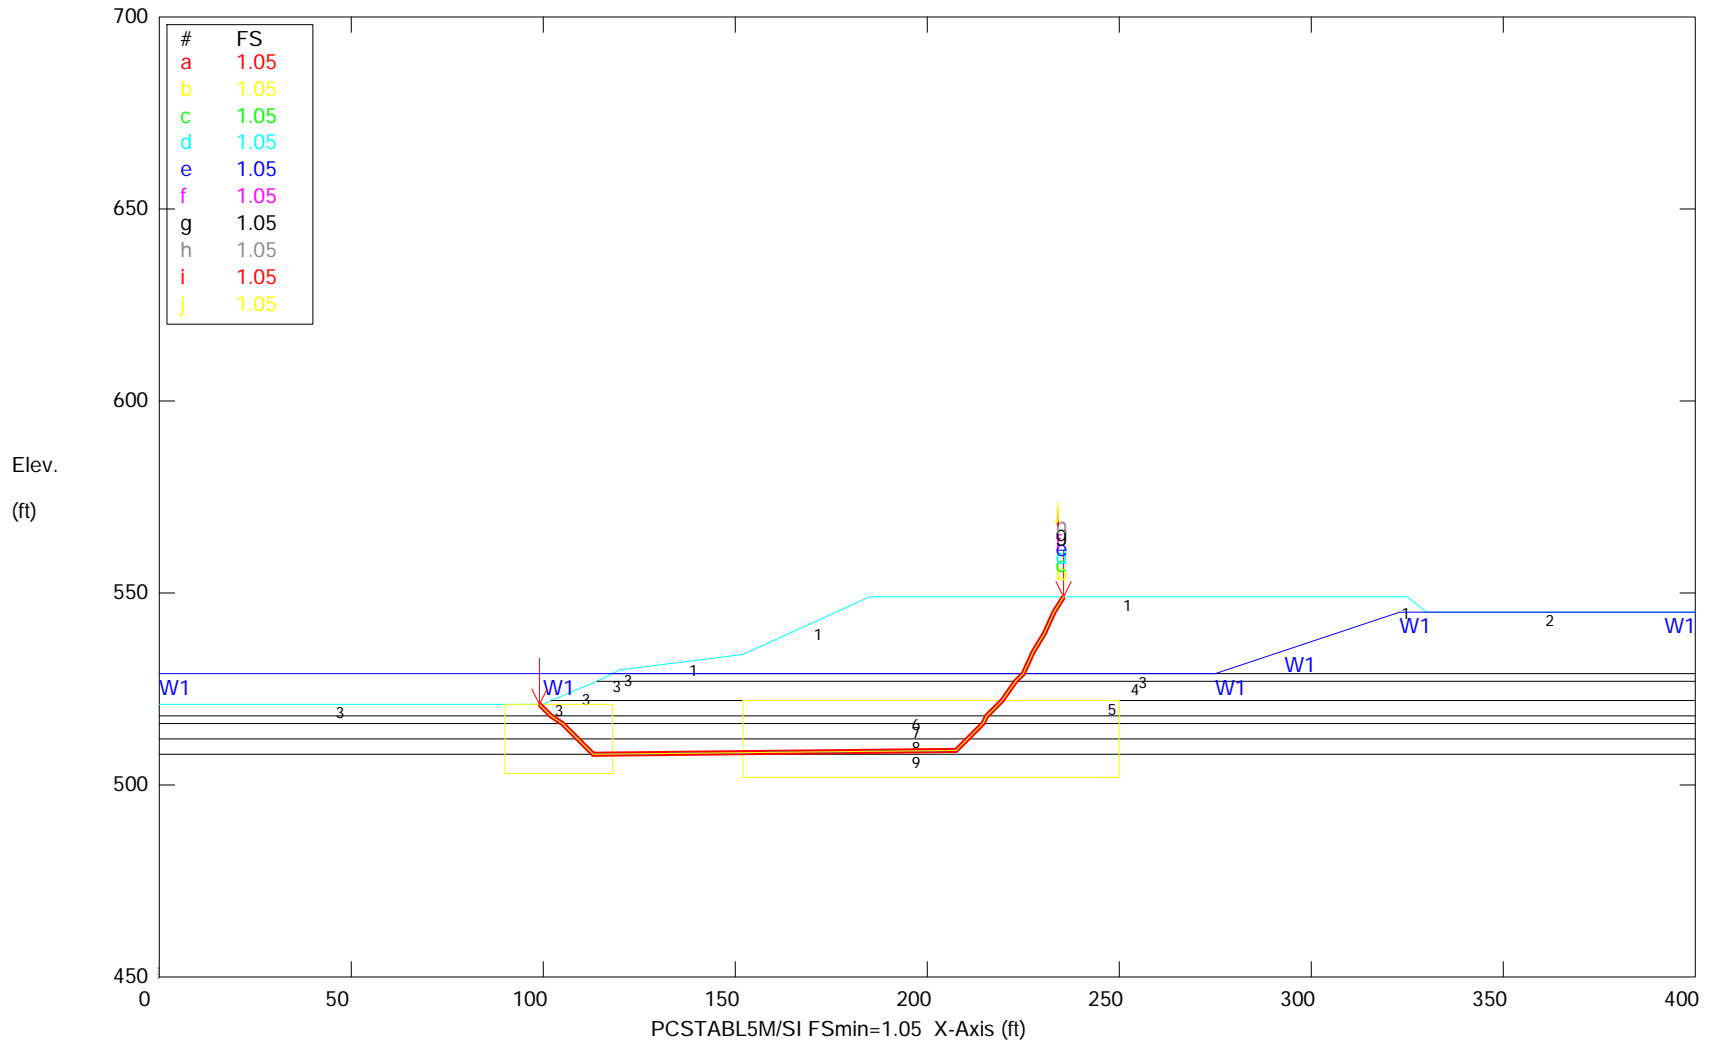
Alliant Burlington Economizer Pile East, North Ash Slope - EQ Case (0.075 & -0.05)

The result of the pseudo-static analysis is a safety factor of 1.0 with the surface going through the native clay and not the liquefied CCR which has a higher safety factor. The results of the analysis are presented in Attachment F. For the western cross-section of the Economizer Ash Pile, the failure also goes through the native clay with a minimum factor of safety of 1.1. Both safety factors indicate acceptable earthquake response in accordance with FEMA Guidelines for Dam Safety. Only the western cross-section meets the minimum safety factor of 1.1 established as EPA policy.
