**Coal Combustion Waste Impoundment
Round 7 - Dam Assessment Report**

Burlington Generating Station (Site 017)

Fly Ash Impoundment Dikes
Alliant Energy
Burlington, Iowa

November 2010

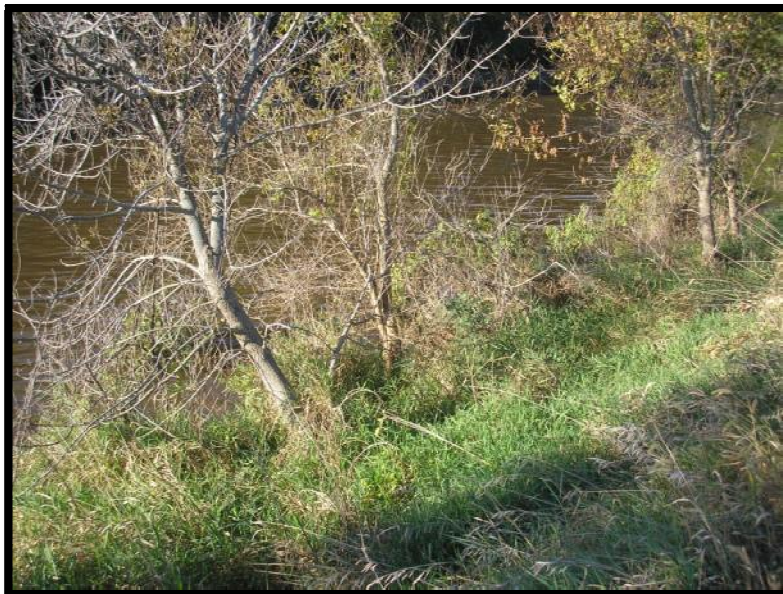
The Ash Seal Pond south dike is bordered by a drainage canal that empties directly into the Mississippi River. At the time of Dewberry's site visit, flooding of the Mississippi River raised the water level in the canal to reach the toe of the outside slope of the dike. Figure 5.2.3-2 shows the canal against the slope of the embankment.

Figure 5.2.3-2: Ash Seal Pond South Dike: Canal High Water against Toe of Outside Slope

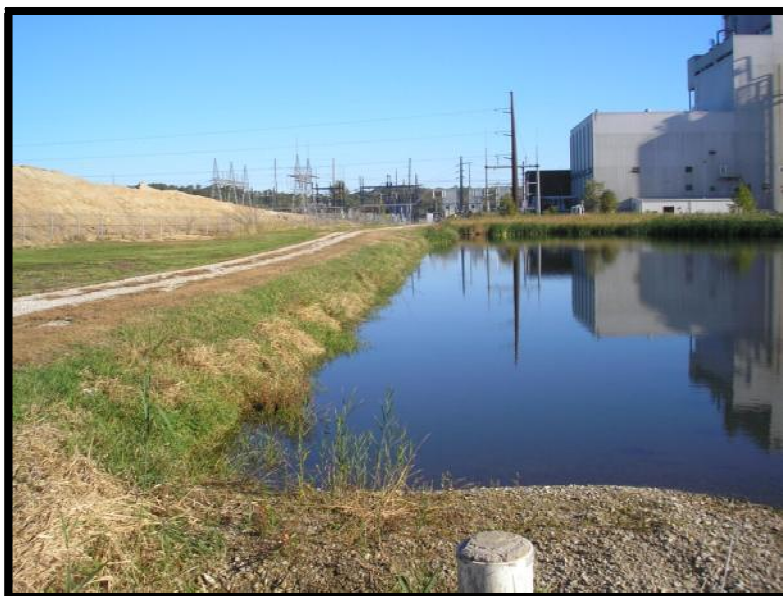
The area adjacent to the outside slope of the Ash Seal Pond west dike had been filled to serve as Eco-Stone (local product name for hydrated fly ash) storage. The Eco-Stone pile at the outside slope of the Ash Seal Pond west dike is shown in Figure 5.2.3-3.

Figure 5.2.3-3: Eco-Stone Storage Pile over Outside Slope Ash Seal Pond West Dike

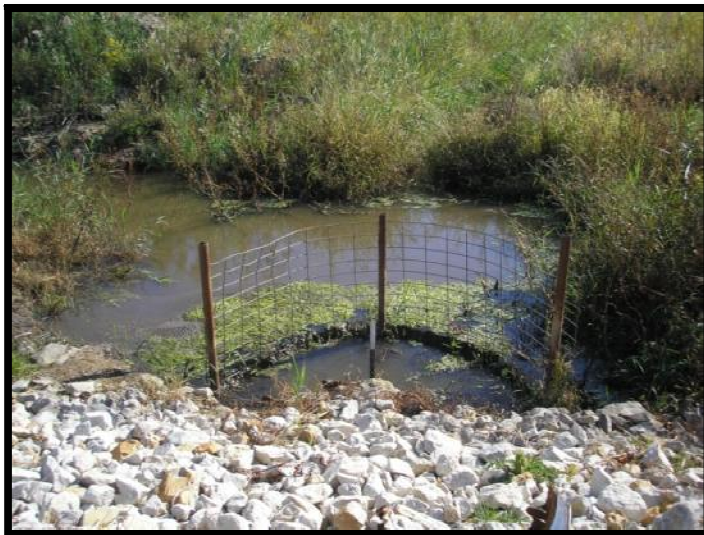
The Economizer Ash Pond east abutment area was filled with dry fly ash. As the west abutment was the location of the gravity discharge to Ash Pond 1, standing water was present. Figure 5.4.4-2 shows standing water at the western abutment of the Economizer Ash Pond dike.

Figure 5.4.4-2: Economizer Ash Pond West Abutment and Pipe Spillway Invert

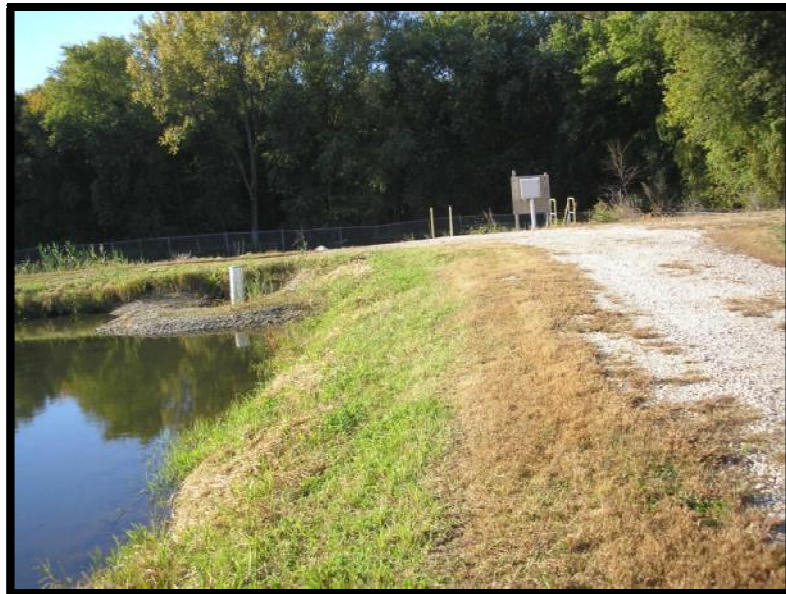
The Ash Seal Pond overflow structure is located in the southwest corner of the impoundment at the intersection of the south and west dikes. The overflow structure is located in an area separated from the main pond by a low elevation interior dike that forms a secondary settling basin. At the time of Dewberry's site visit the water level in the Ash Seal Pond was below the top of the interior dike and water was not entering the spillway. Figure 5.7.1-1 shows the overflow structure.

Figure 5.7.1-1: Ash Seal Pond Primary Overflow Structure

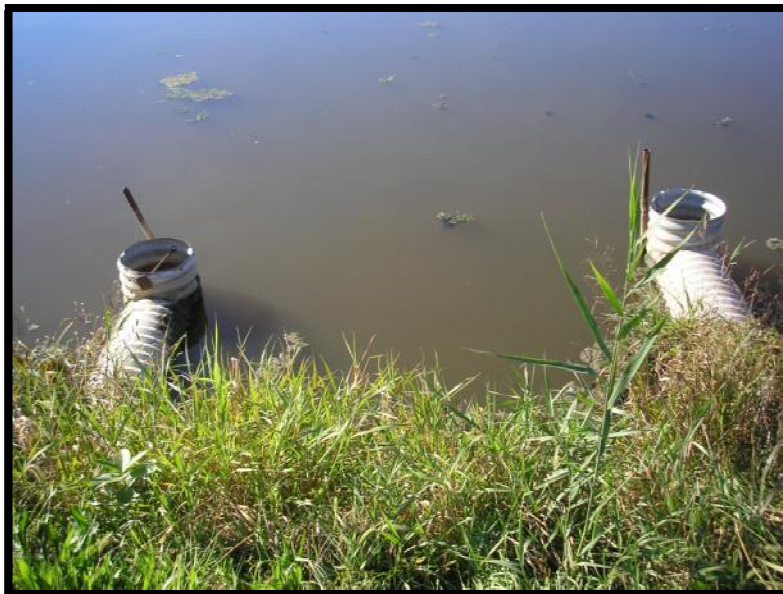
Water in the Bottom Ash Pond is routed by interior ditches to the south and west, then north to the main plant access road embankment, which also serves as the north dike of the Bottom Ash Pond. Water then flows from the Bottom Ash Pond through two 18-inch diameter corrugated metal pipes through the access road embankment. Figure 5.7.1-2 shows the Bottom Ash Pond spillway structures.

Figure 5.7.1-2: Bottom Ash Pond Primary Spillway Structure

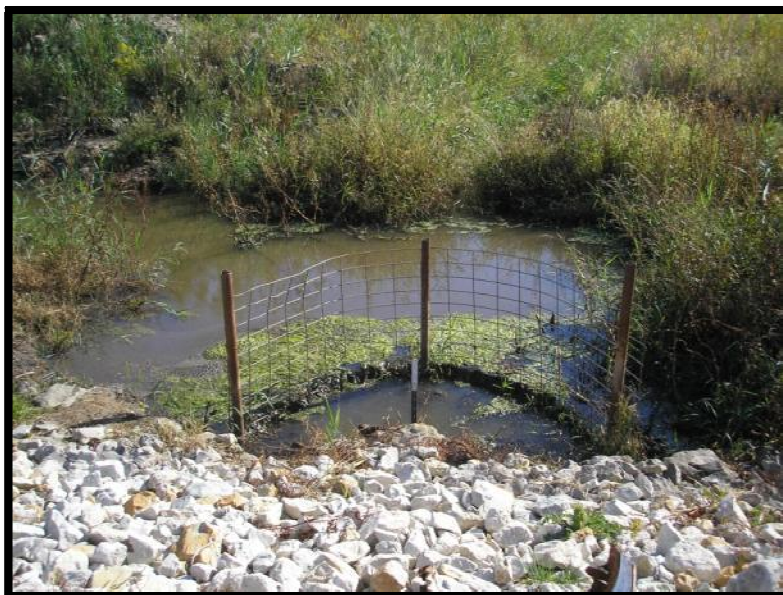
Water in the Economizer Ash Pond is routed by interior ditches to the southwest corner of the impoundment. Water flows through an inlet structure to two 18-inch diameter concrete pipes. At the time of Dewberry's site visit the Economizer Ash Pond water level had submerged the spillway inlet. Figure 5.7.1-3 shows the Economizer Ash Pond spillway inlet location.

Figure 5.7.1-3: Economizer Ash Pond Spillway Location

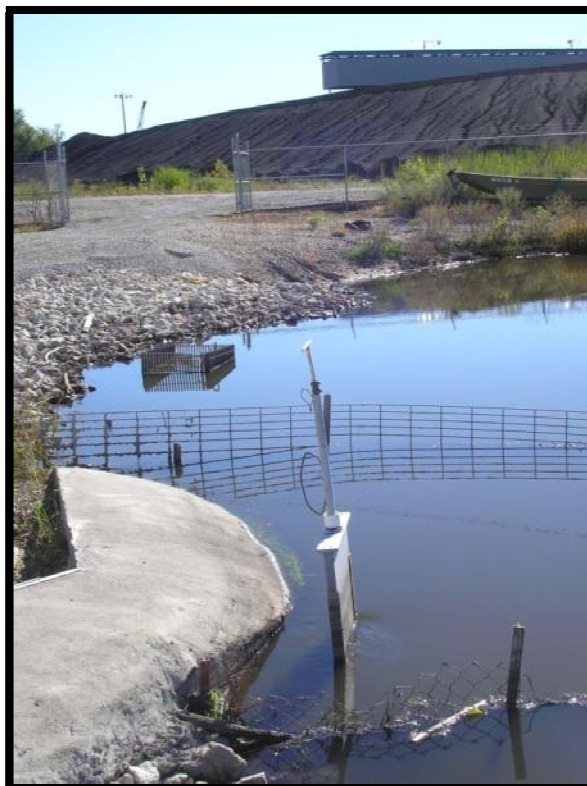
The Ash Pond 1 primary spillway is located in the northeast corner of the impoundment. The spillway area is bordered by wire fencing serving as a trash rack. A manually operated screw lift stop log is used to control discharge from Ash Pond 1. Figure 5.7.1-4 shows the Ash Pond 1 spillway inlet location.

Figure 5.7.1-4: Ash Pond 1 Spillway Location

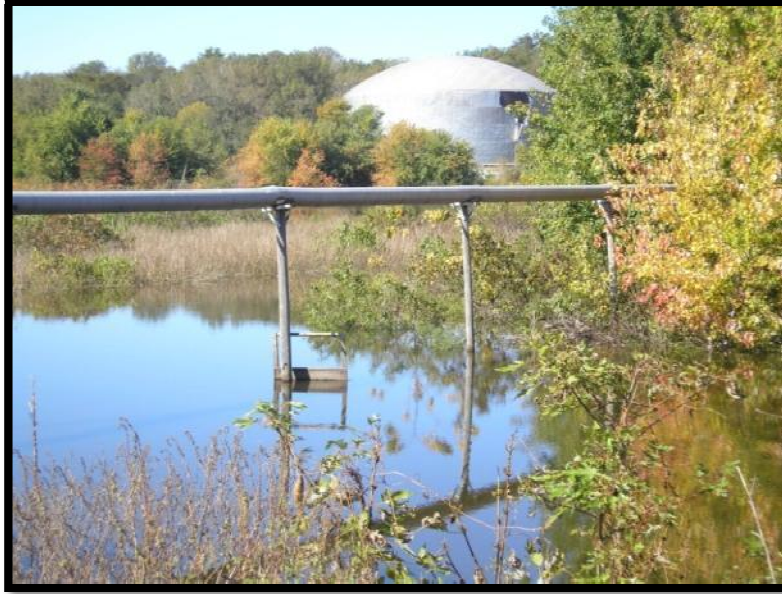
The Ash Pond 2 spillway is located in the northeastern portion of the impoundment. As floodwater from the Mississippi River had overtopped the Ash Pond 2 dike, only the top of the spillway stop log was visible during Dewberry’s site inspection. Figure 5.7.1-5 shows the top of the manually operated spillway stop log device.

Figure 5.7.1-5: Ash Pond 2 Top of Spillway Stop Log Device

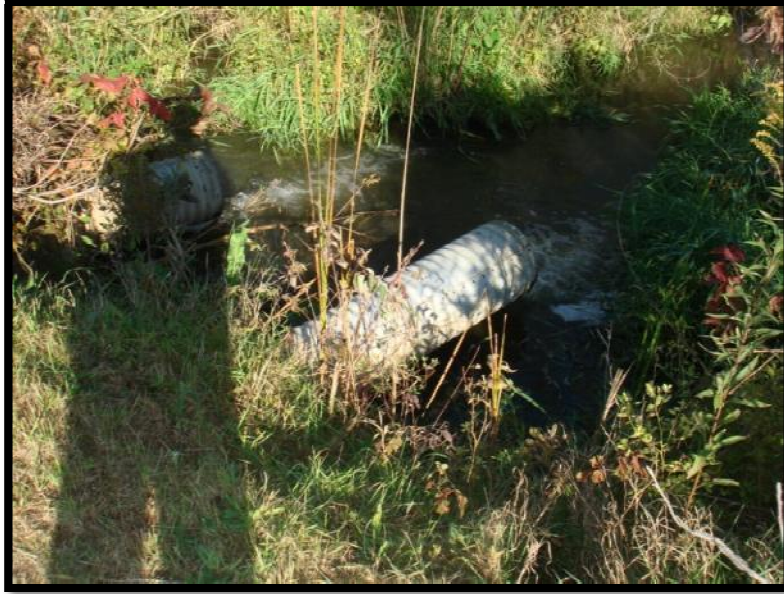
The Bottom Ash Pond discharges into an interior drainage ditch at the southwest corner of Ash Pond 1. Figure 5.7.2-1 shows the Bottom Ash Pond spillway outlet discharge pipes.

Figure 5.7.2-1: Bottom Ash Pond Spillway Outlet Conduits

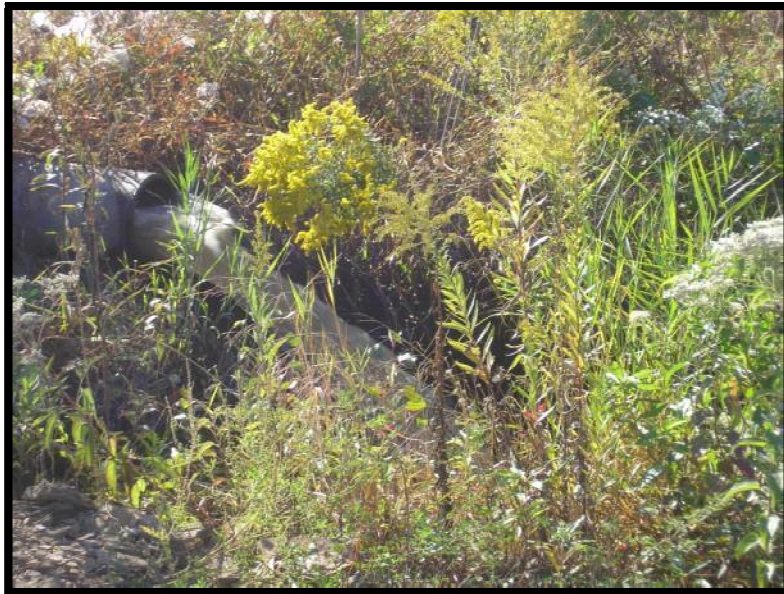
The Economizer Ash Pond spillway pipes also discharge into the interior drainage ditch at the southwest corner of Ash Pond 1. Figure 5.7.2-2 shows the Economizer Ash Pond spillway discharge pipes.

Figure 5.7.2-2: Economizer Ash Pond Spillway Outlet Conduits

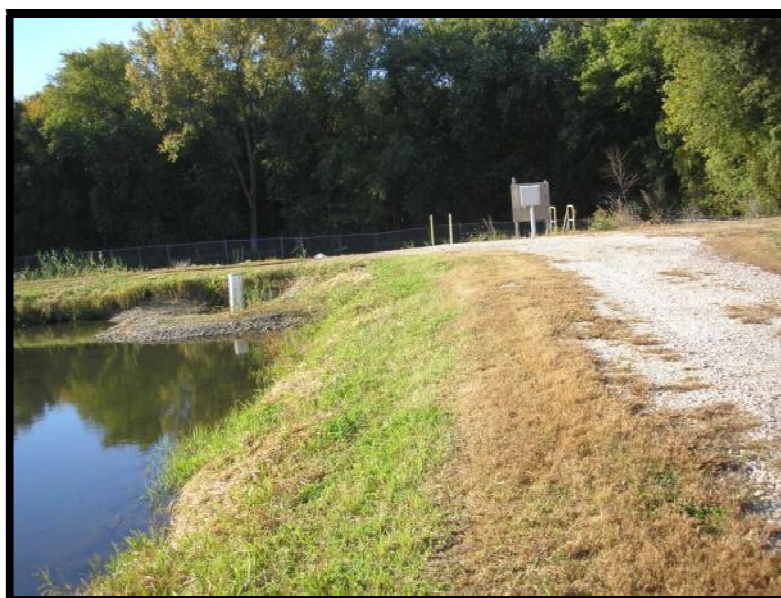
The Ash Seal Pond is operated for the storage of wet fly ash, bottom ash and economizer ash as well as water from other plant sources including boiler seal water, boiler wash water, storm runoff from the plant site, storm runoff from the C-Stone (product name for hydrated fly ash) storage pile, and plant floor drains (See Appendix A – Document 6). Decant water flows to the primary spillway located in the southwest corner of the impoundment. A low dike around the spillway riser provides another settling basin prior to water entering the spillway. Figure 8.1-1 shows the location of the low interior dike and the primary spillway entrance.

Figure 8.1-1: Ash Seal Pond Interior Low Dike and Spillway Riser

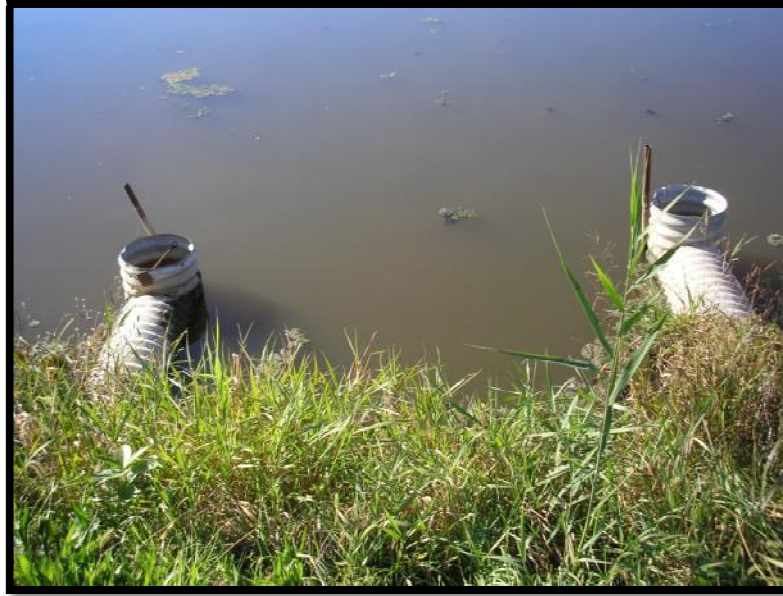
The Bottom Ash Pond is operated to store fly ash; bottom ash; ash transport water; boiler wash water; air heater wash; storm runoff from the plant site; storm runoff for C-Stone Storage Pile and plant floor drains (See Appendix A – Doc 6). Water collected in the Bottom Ash Pond is routed through interior drainage ditches to the northwest corner of the impoundment where it flows through a spillway consisting of two 18-inch diameter corrugated metal pipes beneath the main plant access road embankment into Ash Pond 1. Figure 8.1-2 shows the spillway inlet.

Figure 8.1-2: Bottom Ash Pond Primary Spillway Inlet

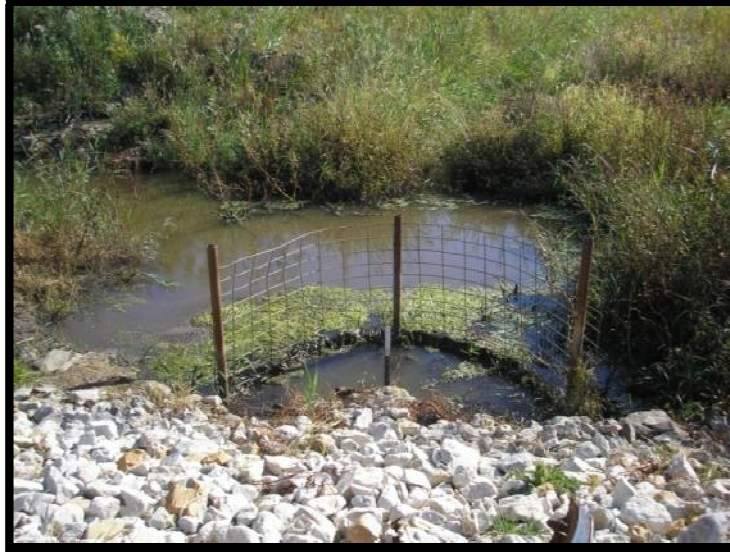
The Economized Ash Pond is operated to store fly ash; bottom ash; economizer ash; ash transport water; boiler wash water; air heater water; steam grade water production wastewater; storm runoff from plant site; storm water runoff from C-Stone Storage Pile; plant floor drains; Solids Contact Units sludge for the treatment of Mississippi River water; coal pile runoff, and boiler blowdown (See Appendix A – Document 6). Water in the Economizer Ash Pond is routed to the south and west with interior perimeter ditches to the southwest corner of the impoundment. The water flows through two 18-inch diameter concrete pipes beneath the Economizer Ash Pond dike discharging into an Ash Pond 1 interior drainage ditch. Figure 8.1-3 shows the Economizer Ash Pond spillway inlet.

Figure 8.1-3: Economizer Ash Pond Spillway Inlet

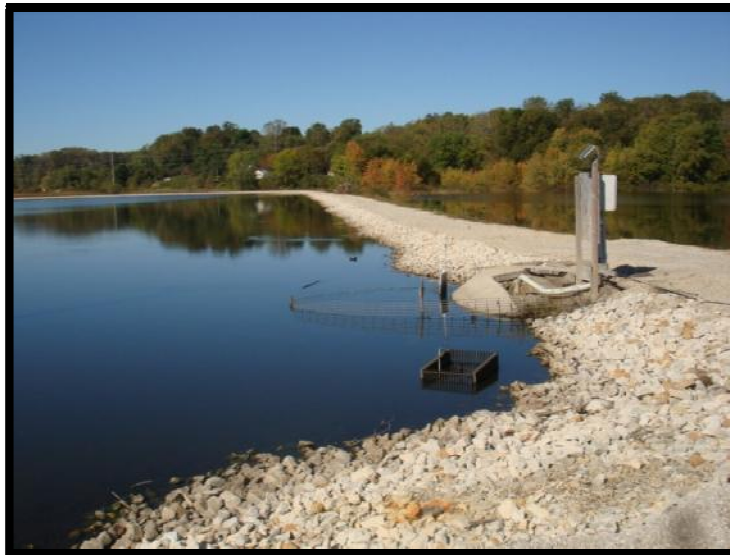
Ash Pond 1 is operated to store fly ash; bottom ash; economizer ash; ash transport water; boiler wash water; air heater water; steam grade water production wastewater; storm runoff from plant site; storm water runoff from C-Stone Storage Pile; plant floor drains; Solids Contact Units sludge for the treatment of Mississippi River water; coal pile runoff, and boiler blowdown (See Appendix A – Document 6). Ash Pond 1 decant water flows to the primary spillway located in the northeast corner of the impoundment. Figure 8.1-4 shows the location of the low interior dike and the primary spillway entrance.

Figure 8.1-4: Ash Pond 1 Primary Spillway Riser

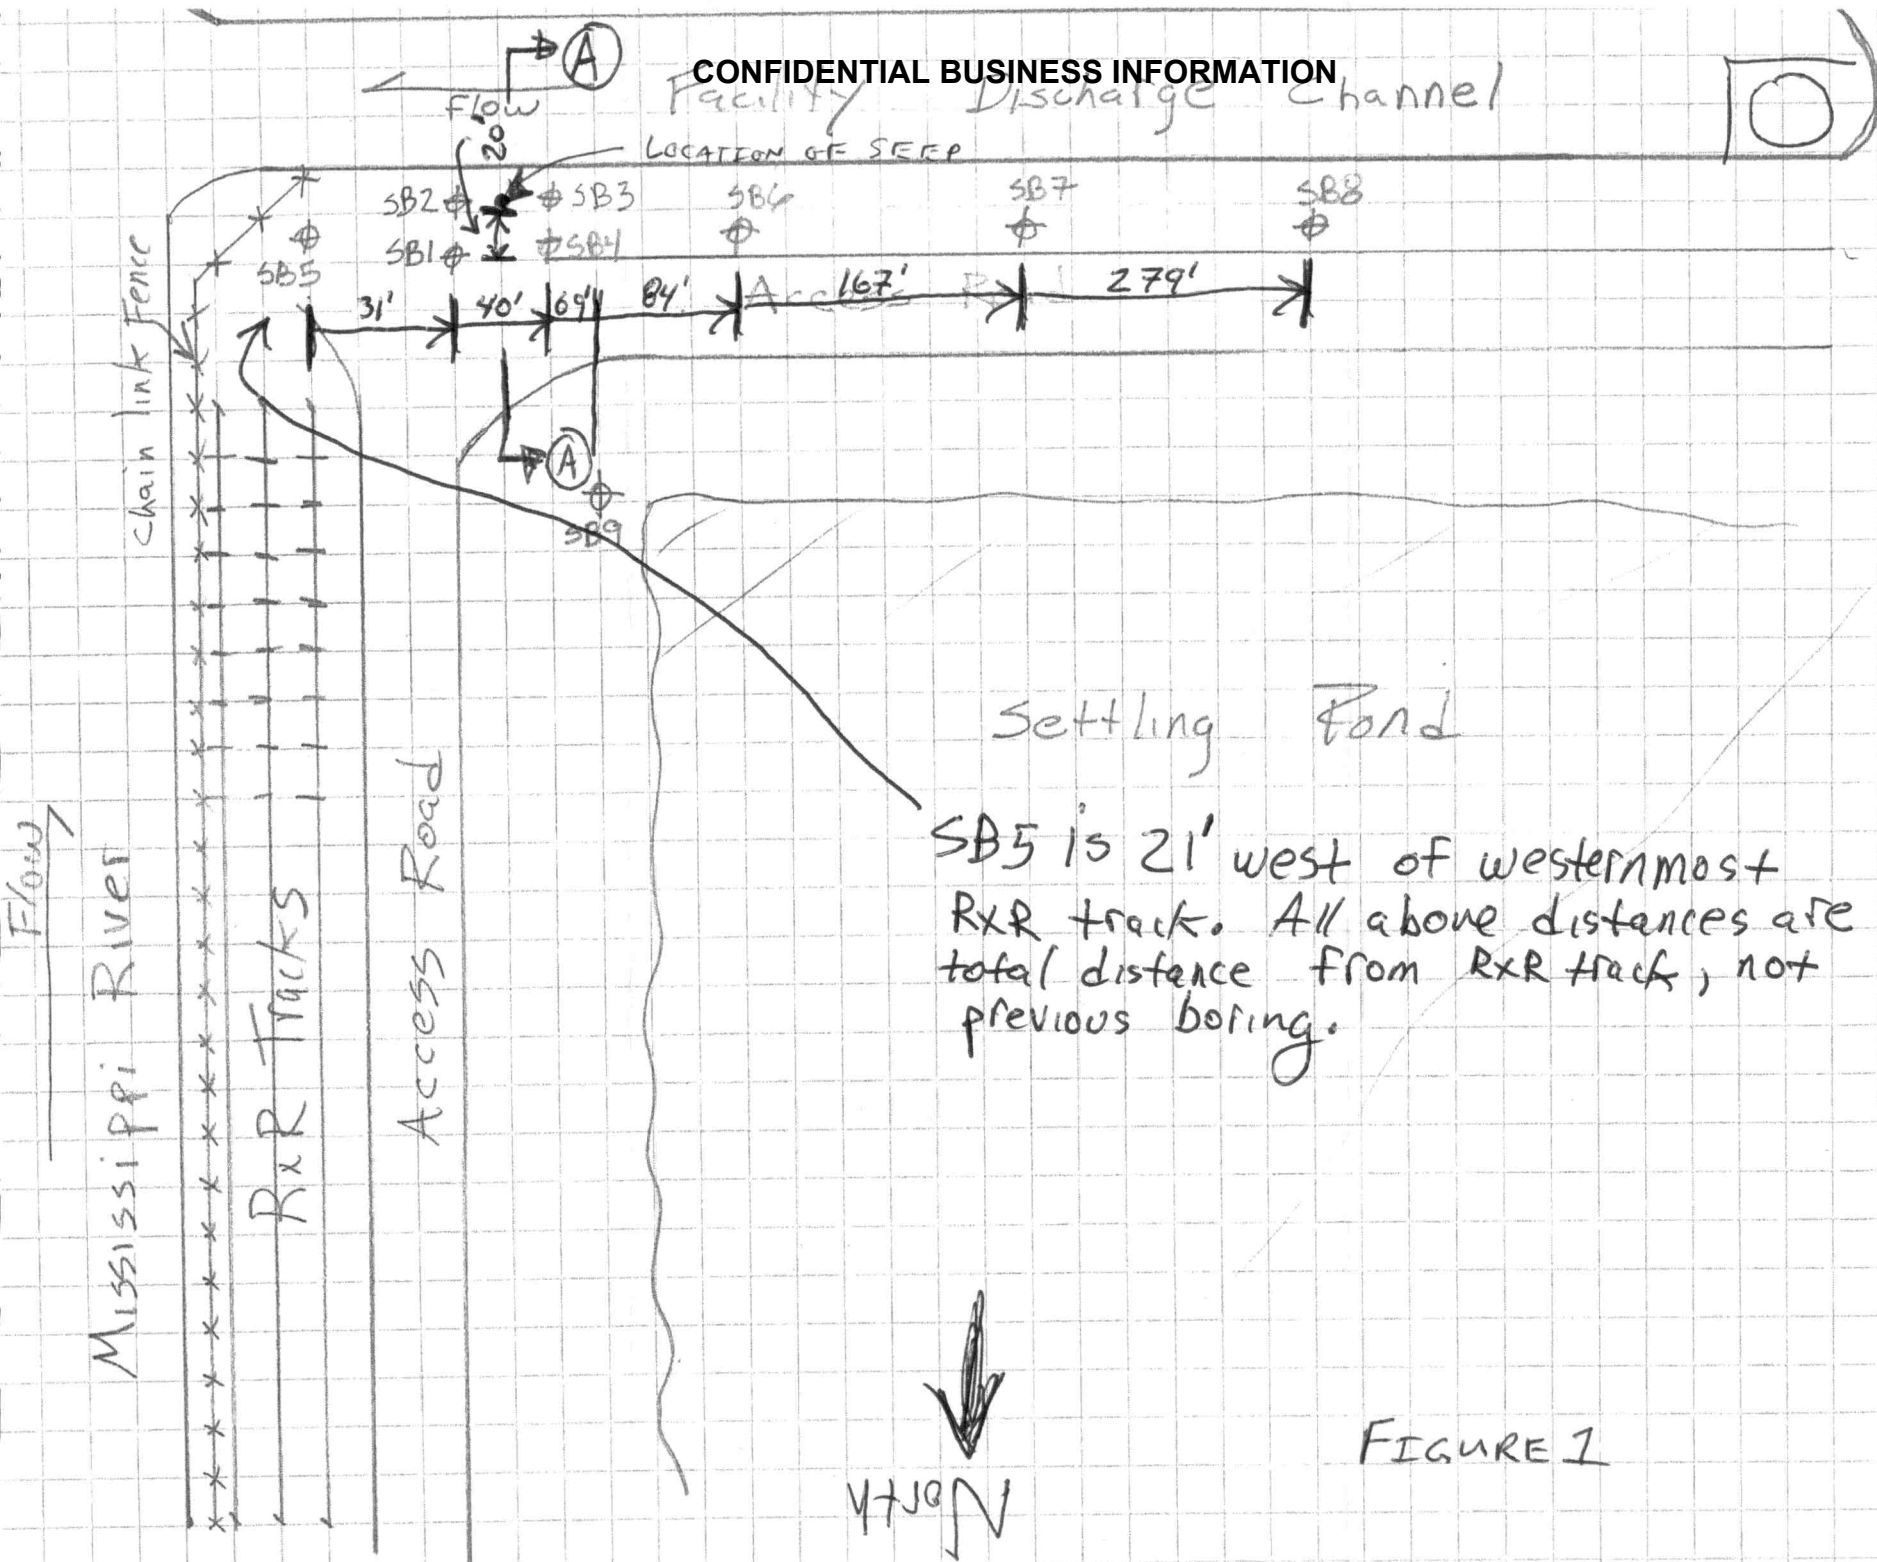
FIGURE 1

Interstate Power & Light Co. (IP&L) retained Hard Hat Services (HHS) to investigate the stability of the berm that isolates the settling pond from the drainage channel, which discharges directly in the Mississippi River, and to determine the origin of the seep that was observed by IP&L in the southeast corner of the settling pond (Figure 1).

LOCATION OF SEEP

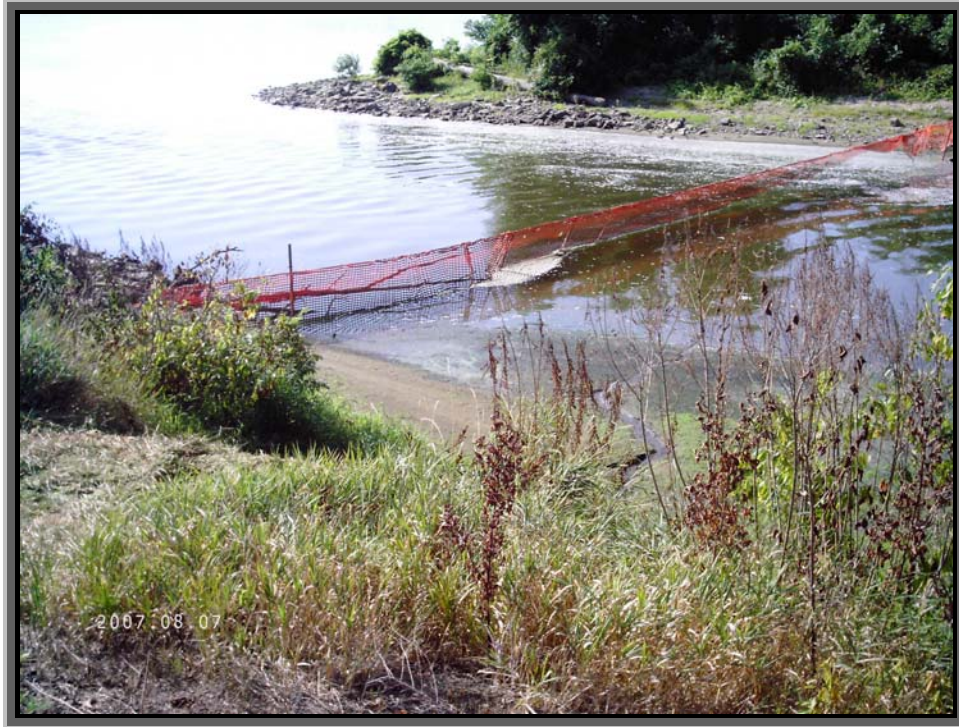
Photo 1) Southeast – Facility Discharge Channel Toward the Mississippi River

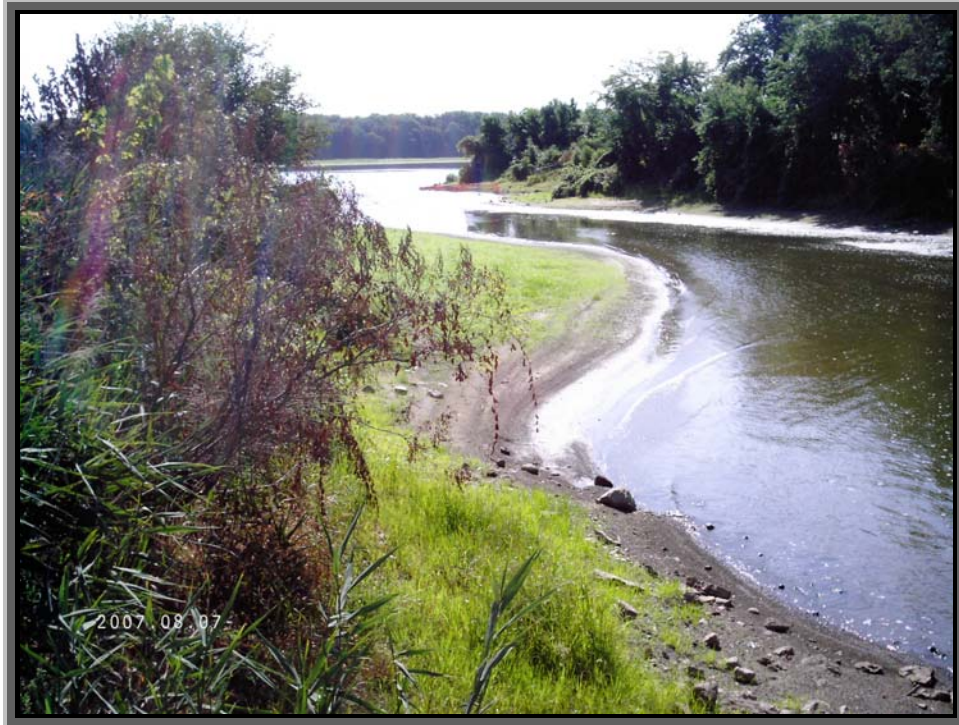
Photo 3) East - Facility Discharge Channel Toward the Mississippi River

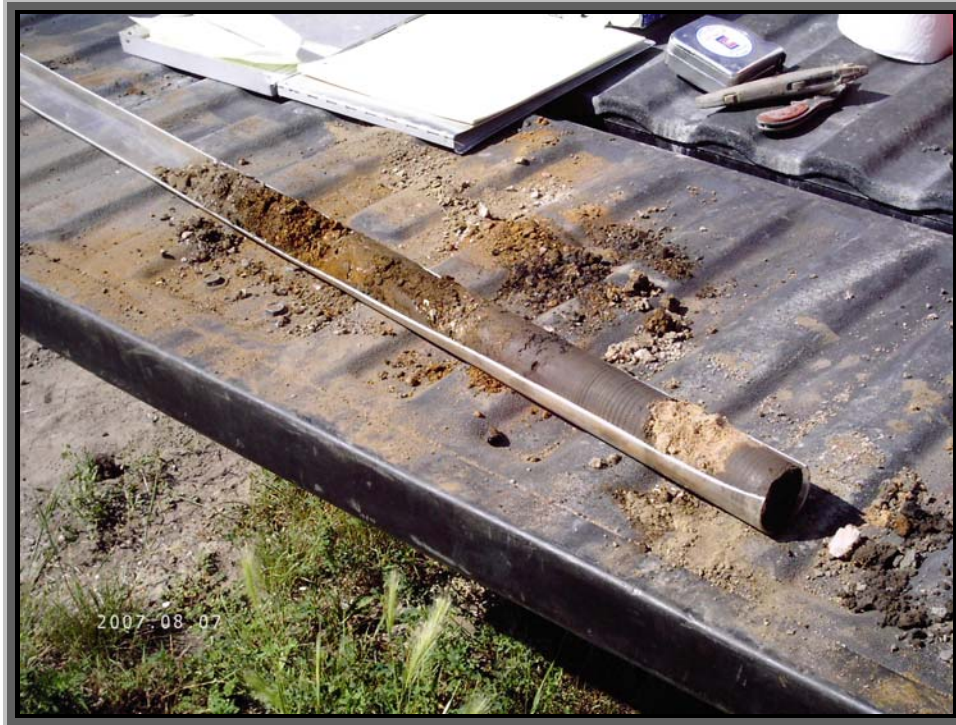
Photo 5) Soil Core from Geoprobe

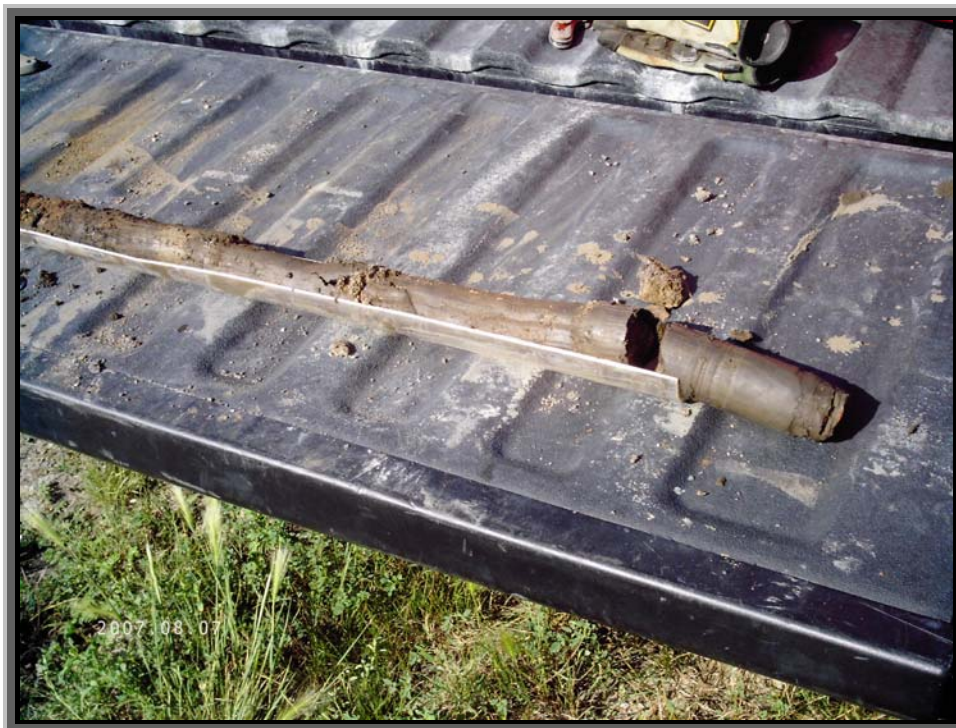
Photo 6) Soil Core from Geoprobe

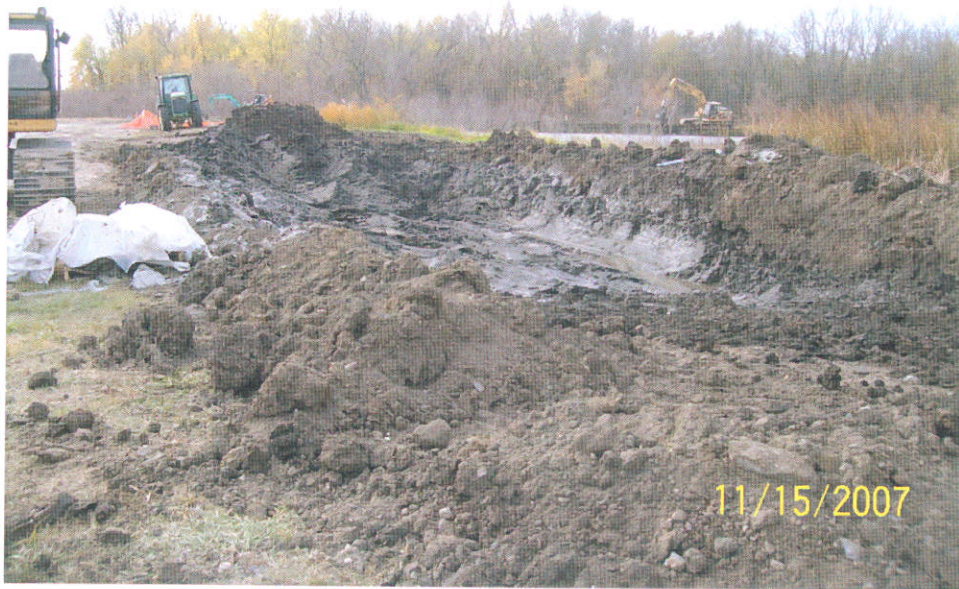
Soil/bentonite mixing pit. Slurry trench excavation is visible in background.

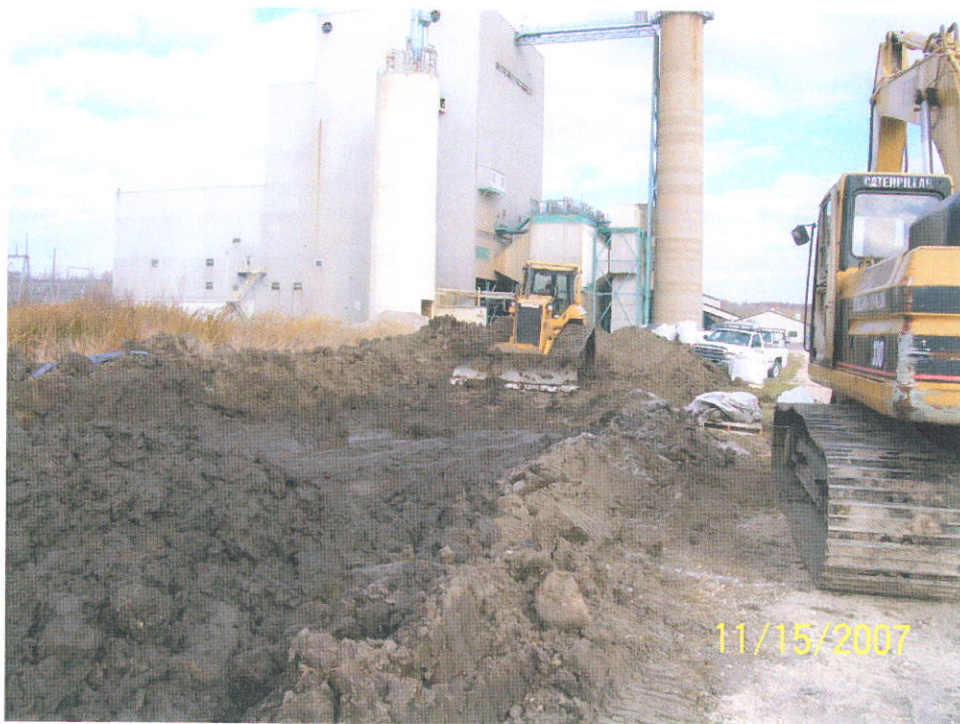
Another view of soil/bentonite mixing pit with generating station in background.

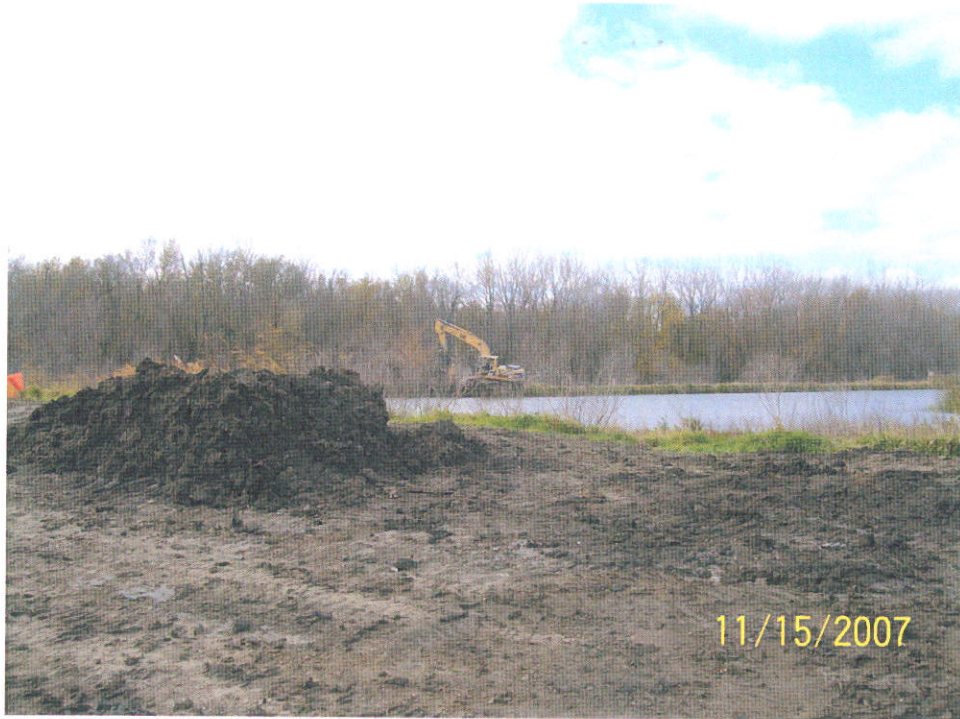
Looking across ash pond at excavator digging slurry trench in ash pond berm.

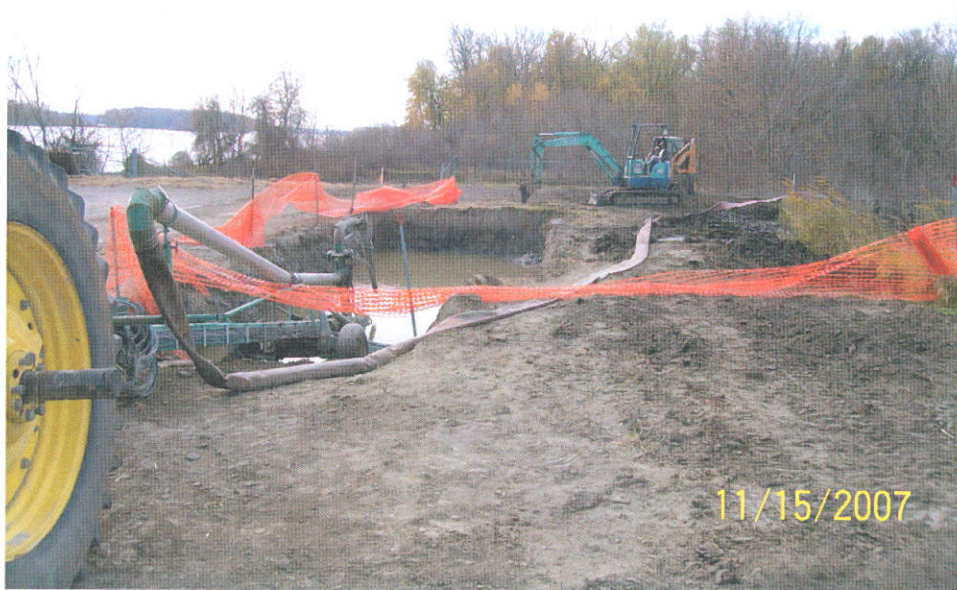
Photograph of bentonite slurry mixing pit. The Mississippi River is at background left and the ash pond is at far right.

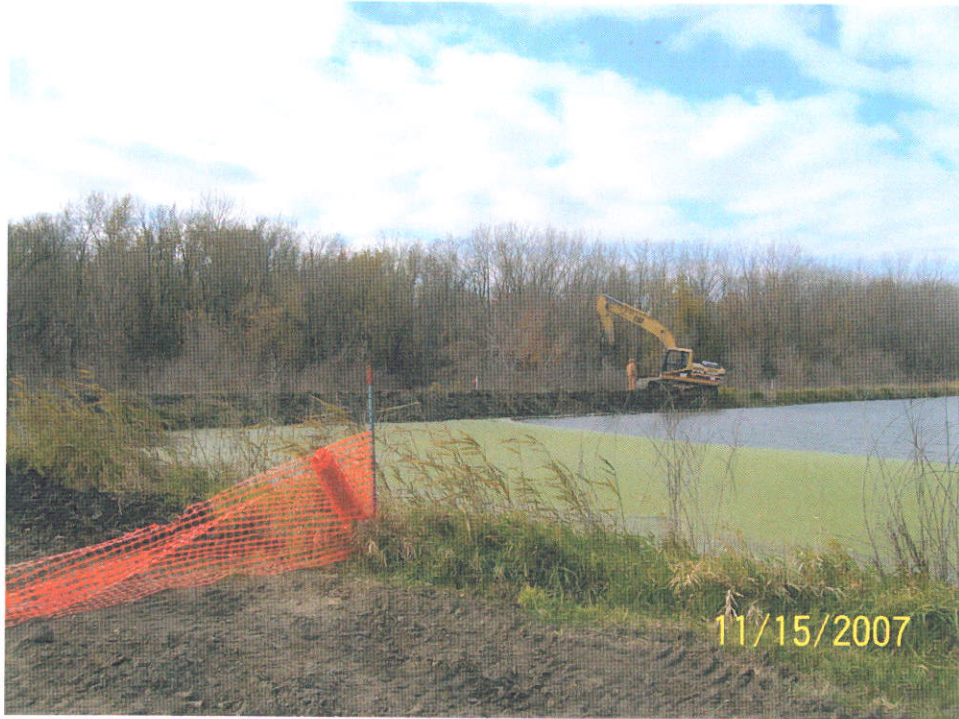
Another photo looking across the ash pond at the excavator digging the slurry trench.

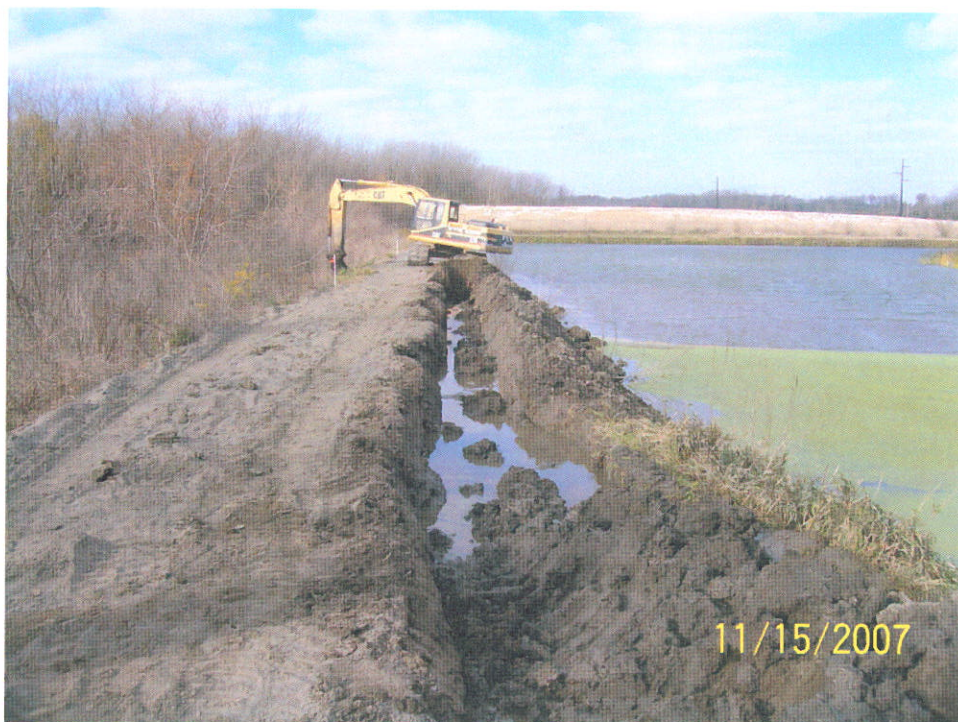
Photograph of slurry trench in berm along ash pond. Standing water is simply the bentonite slurry at the top of the trench.

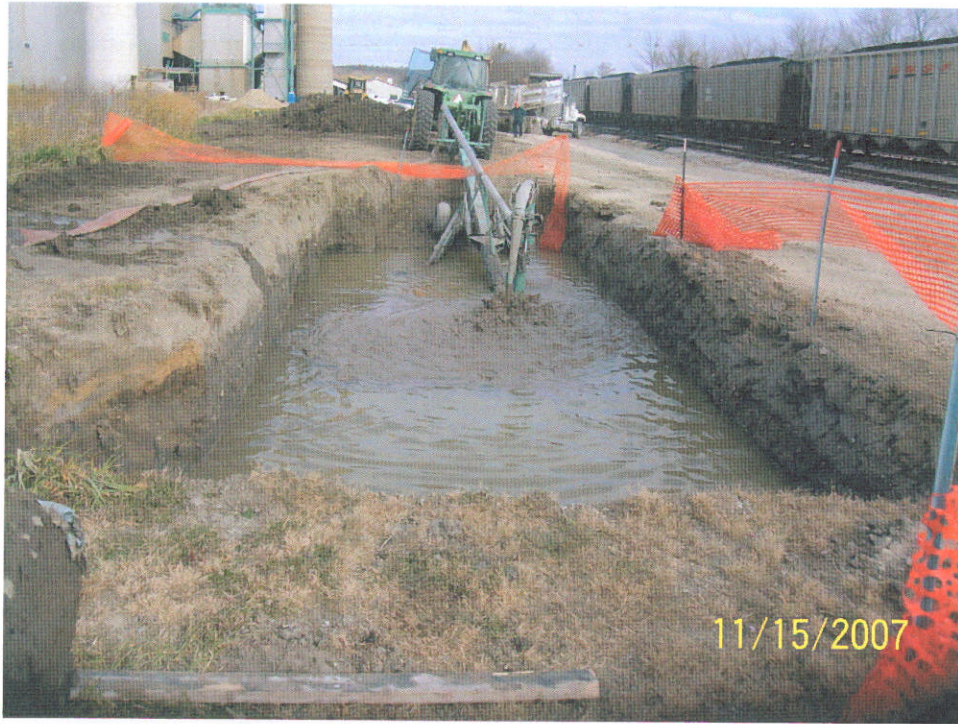
Photograph of bentonite slurry mixing in process.

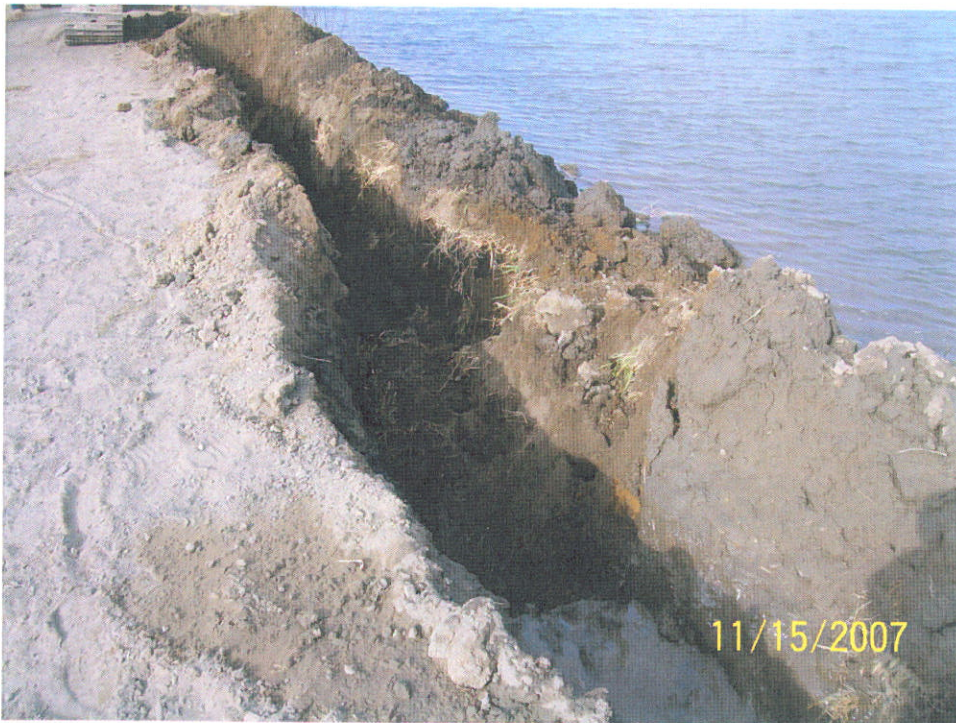
Photograph close-up of bentonite slurry running and filling the trench prior to placement of the soil/bentonite mixture.

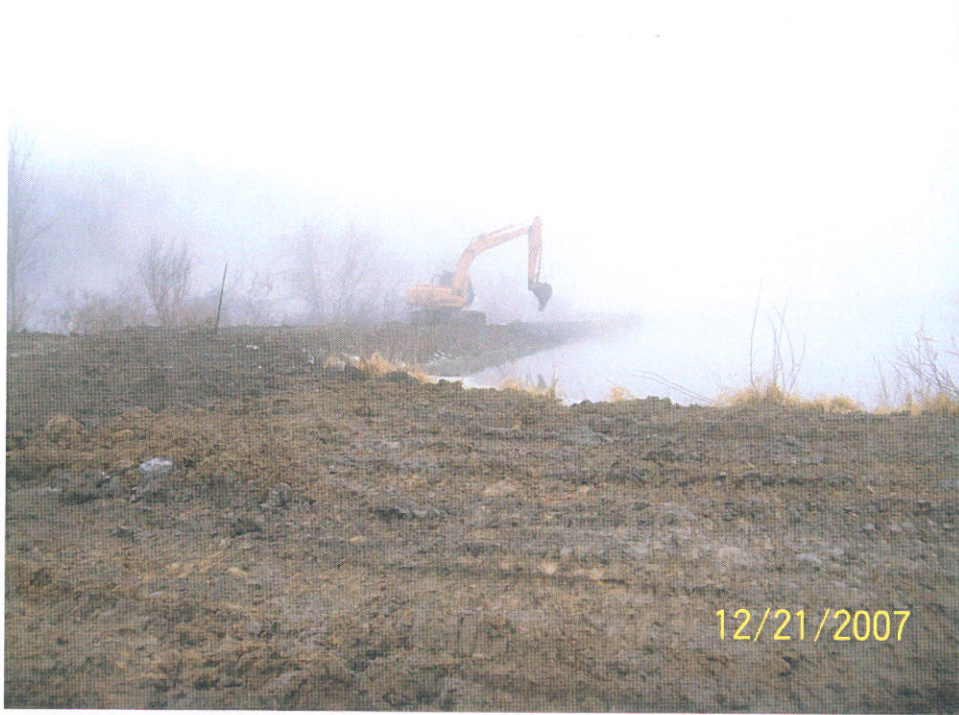
Photograph of final cap placement.

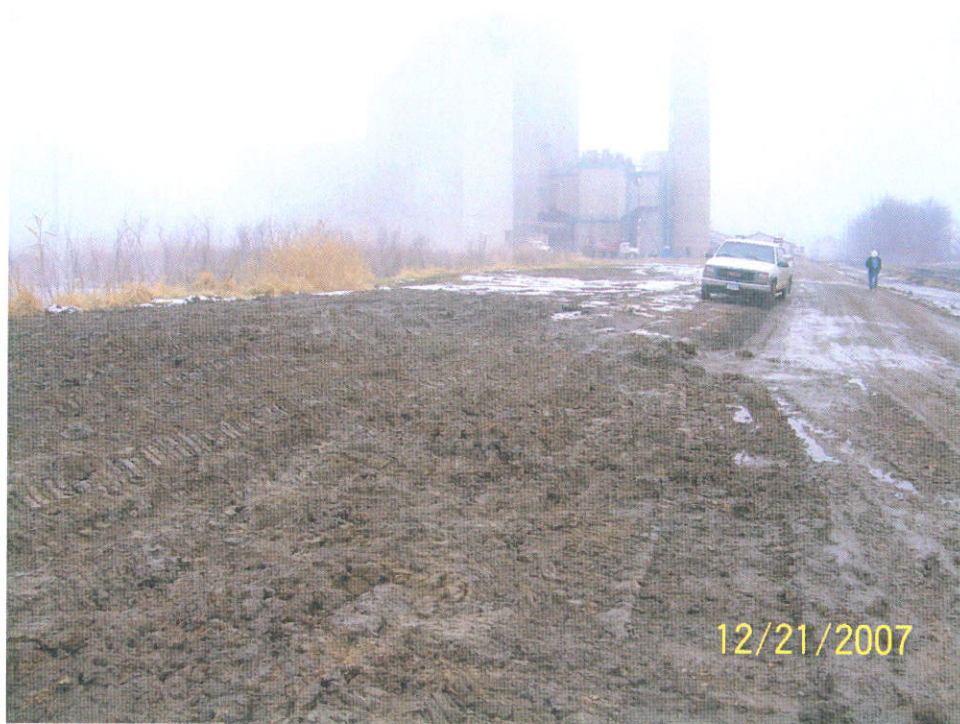
Photograph of filled-in mixing area.

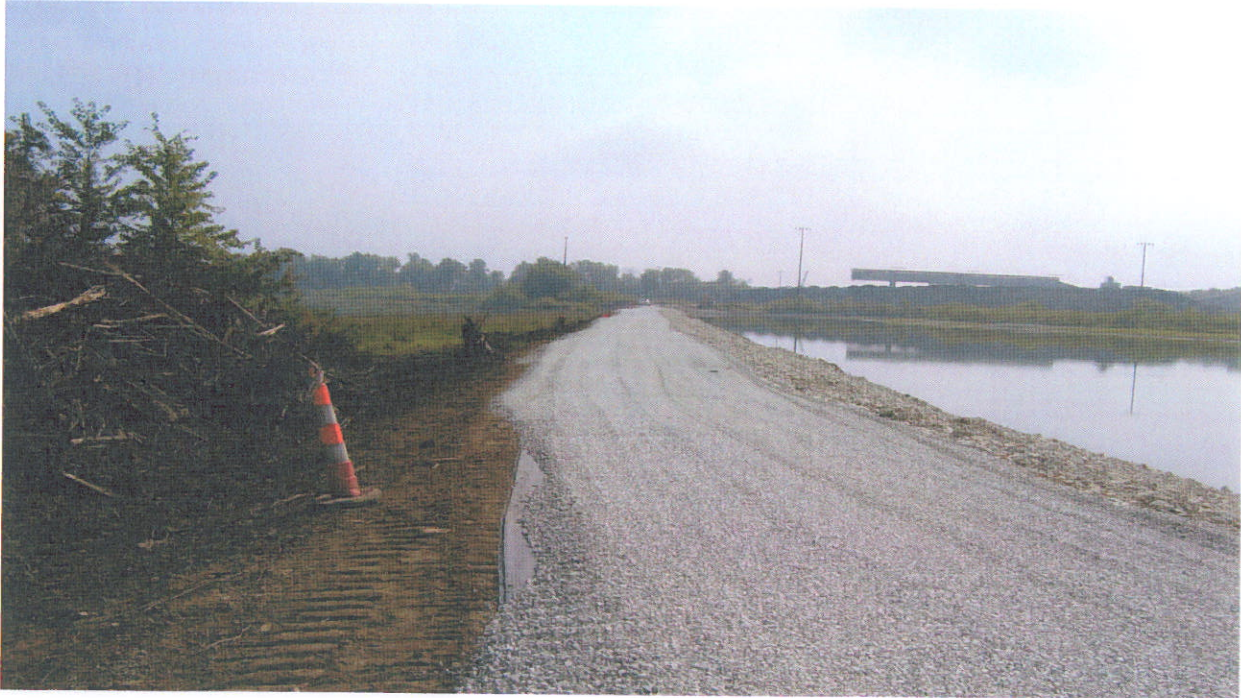
Upper Ash Pond levee after rehabilitation

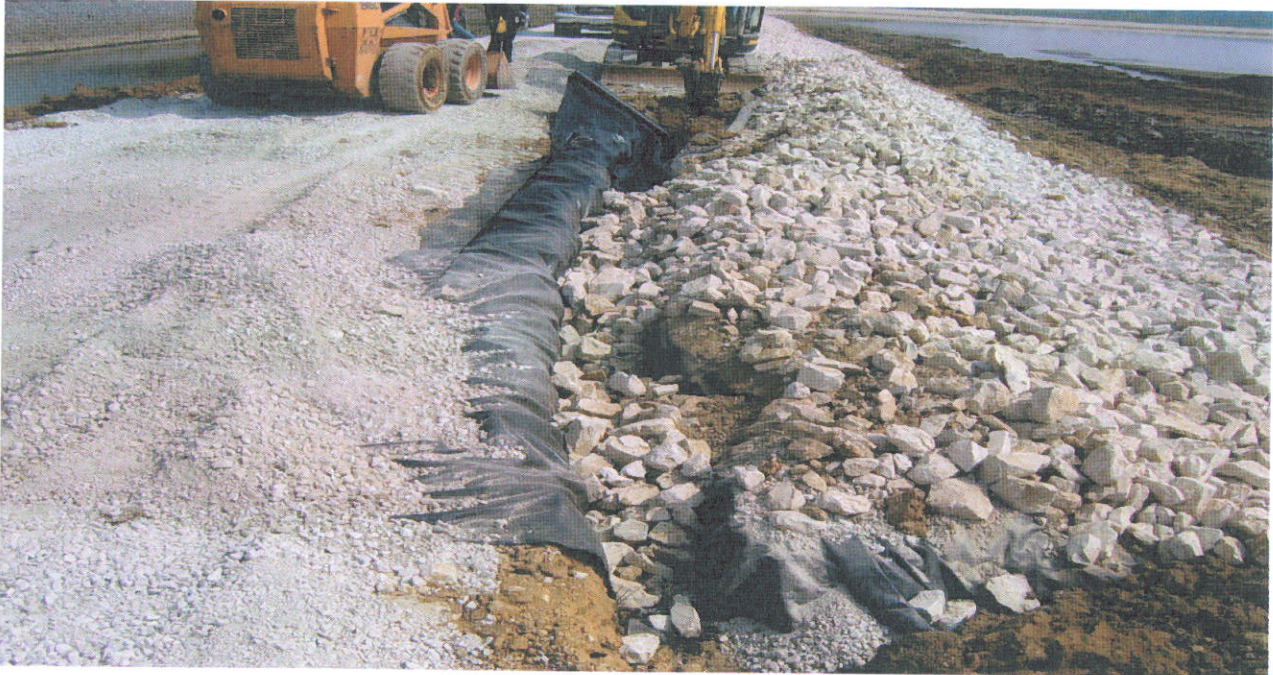
Notching geotextile fabric into top and inside slope

Initially when the fabric was being placed the contractor did not have the recommended lap between the rolls of fabric. It was recommended to the contractor to create a notch and place an additional strip of fabric in the notch, fill with rip-rap and lap this fabric over the already placed geotextile fabric. (See attached photo). This procedure was completed. After the fabric placement was completed a 6" aggregate base was laid so vehicles could travel on the levee without damaging it or becoming stuck. Rip-rap was placed to a depth of approximately 12" on the inside of the reconstructed levee from the top down (road) to two feet below normal pool elevation. When the pond elevation returns to normal, the rip-rap will be below normal water elevation and thus minimize erosion due to wave lap and overtopping.
