**Coal Combustion Waste Impoundment
Round 7 - Dam Assessment Report**

Burlington Generating Station (Site 017)

Fly Ash Impoundment Dikes
Alliant Energy
Burlington, Iowa

November 2010

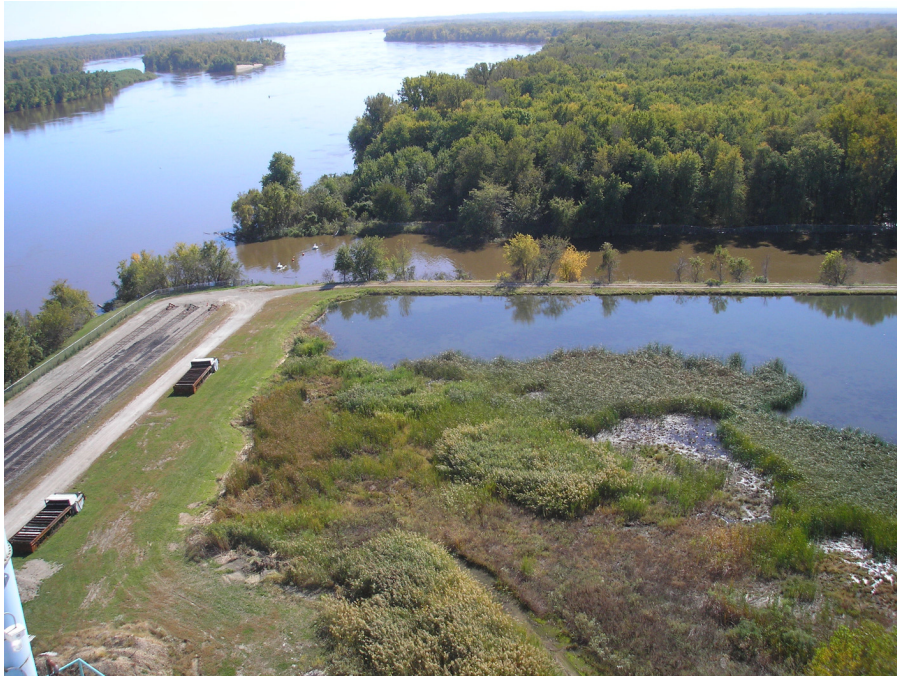
Photograph 1: Rooftop View of East Side of Ash Seal Pond

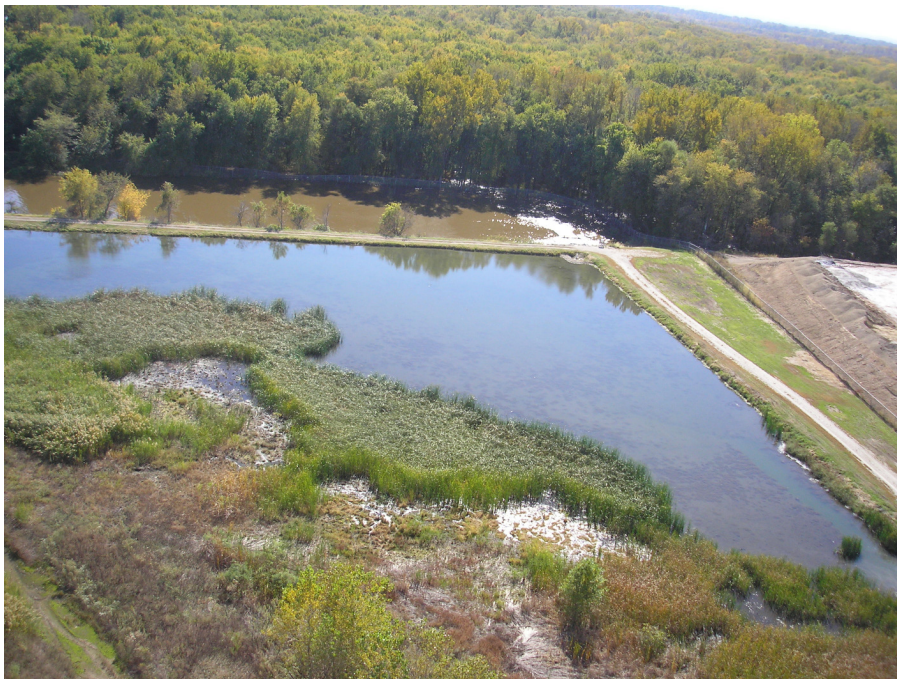
Photograph 2: Rooftop View of West Side of Ash Seal Pond

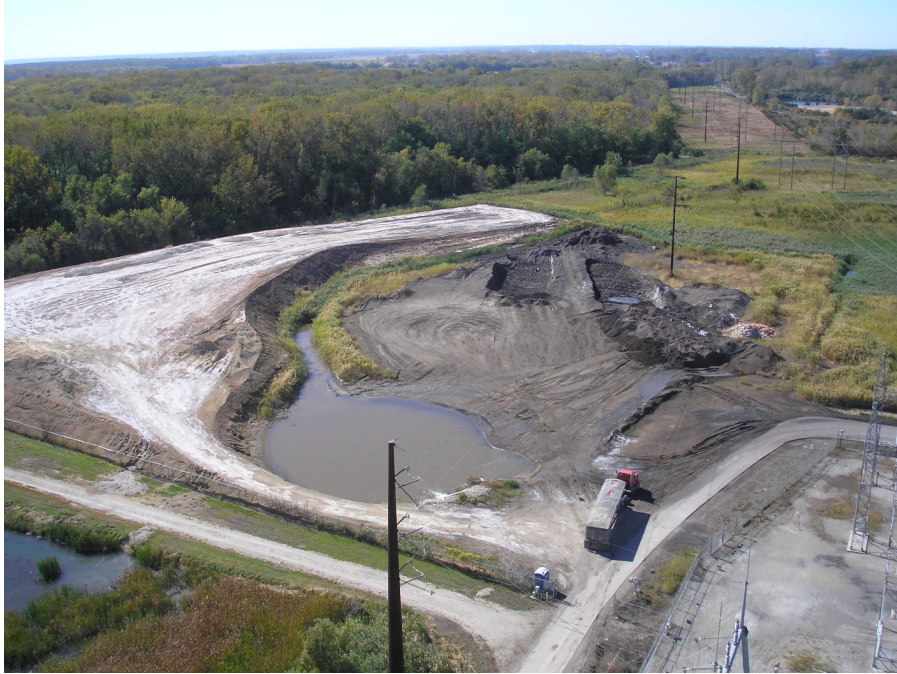
Photograph 3: Rooftop View of South Side of Bottom Ash Pond with Eco-Stone Storage Pile

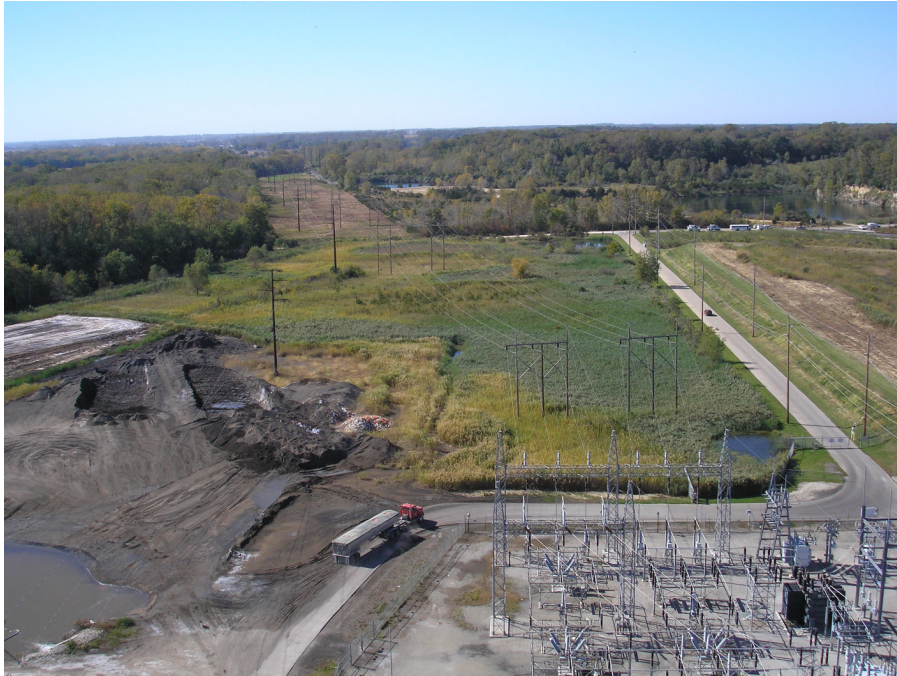
Photograph 4: Rooftop View of North Side of Bottom Ash Pond

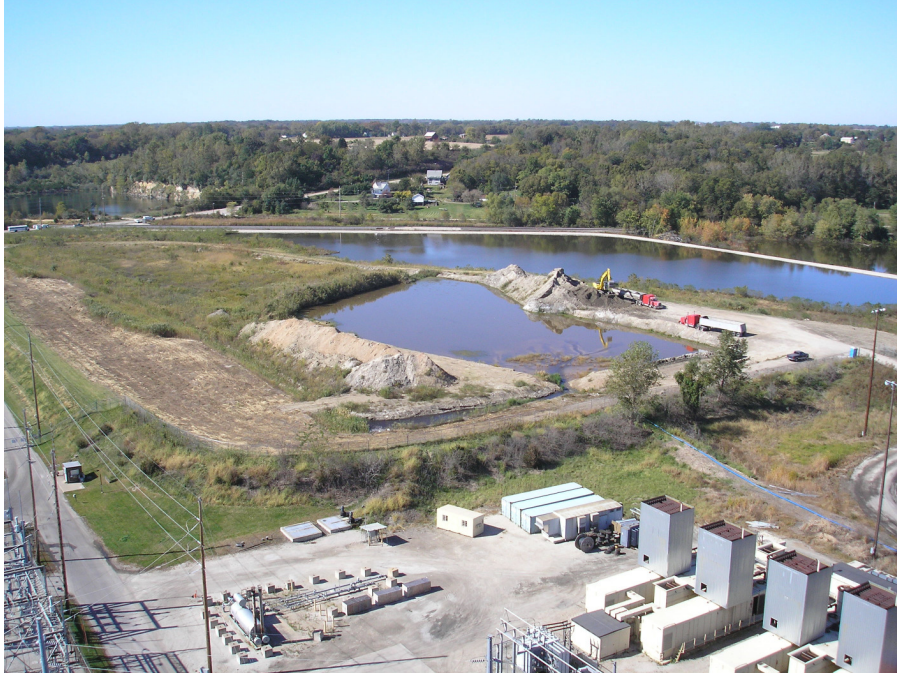
Photograph 5: Rooftop View of Economizer Ash Pond. Economizer Ash Pond in Foreground. Ash Pond 1 in Background

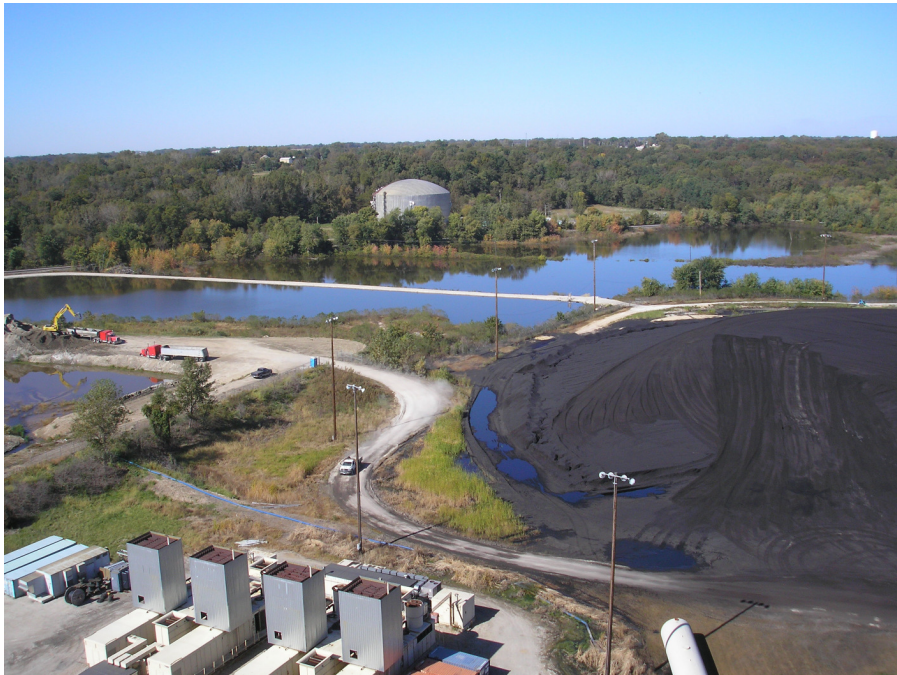
Photograph 6: Rooftop View of Ash Pond 1 Ash Pond 1 Upstream Dike Abutment Located at Construction Equipment. Ash Pond 1 Downstream Dike Located Above Downstream Dike.

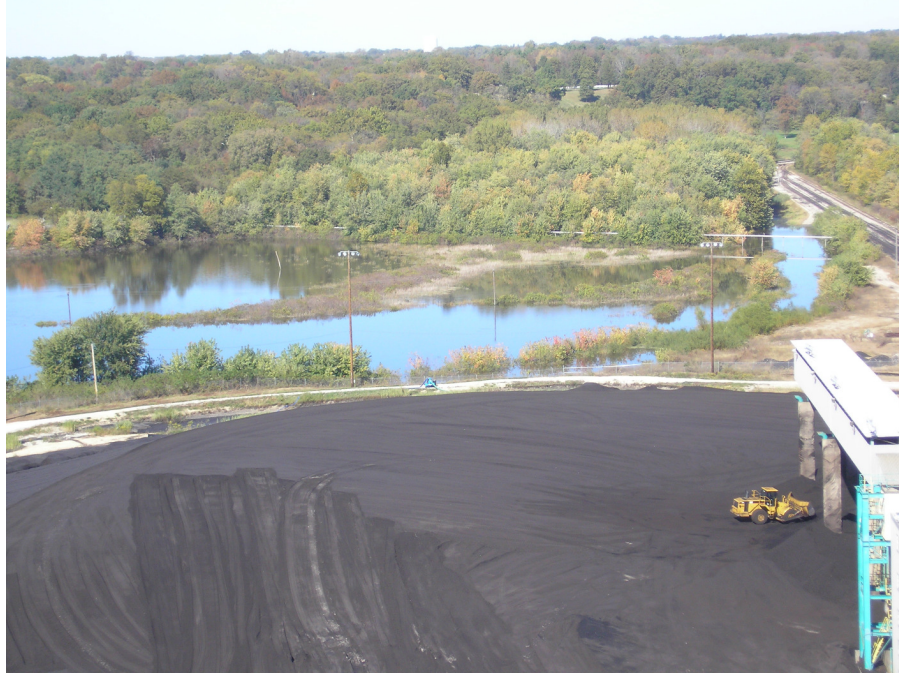
Photograph 7: Rooftop View of Ash Pond 2. Downstream Dike Located beneath Pipe Crossing in Upper Right. Dike Inundated by Flood Water from Mississippi River
